# Interim Reclamation and Stormwater Inspection

February 10, 2023

Operator: UPLAND EXPLORATION LLC- #10701

Location ID: 456651

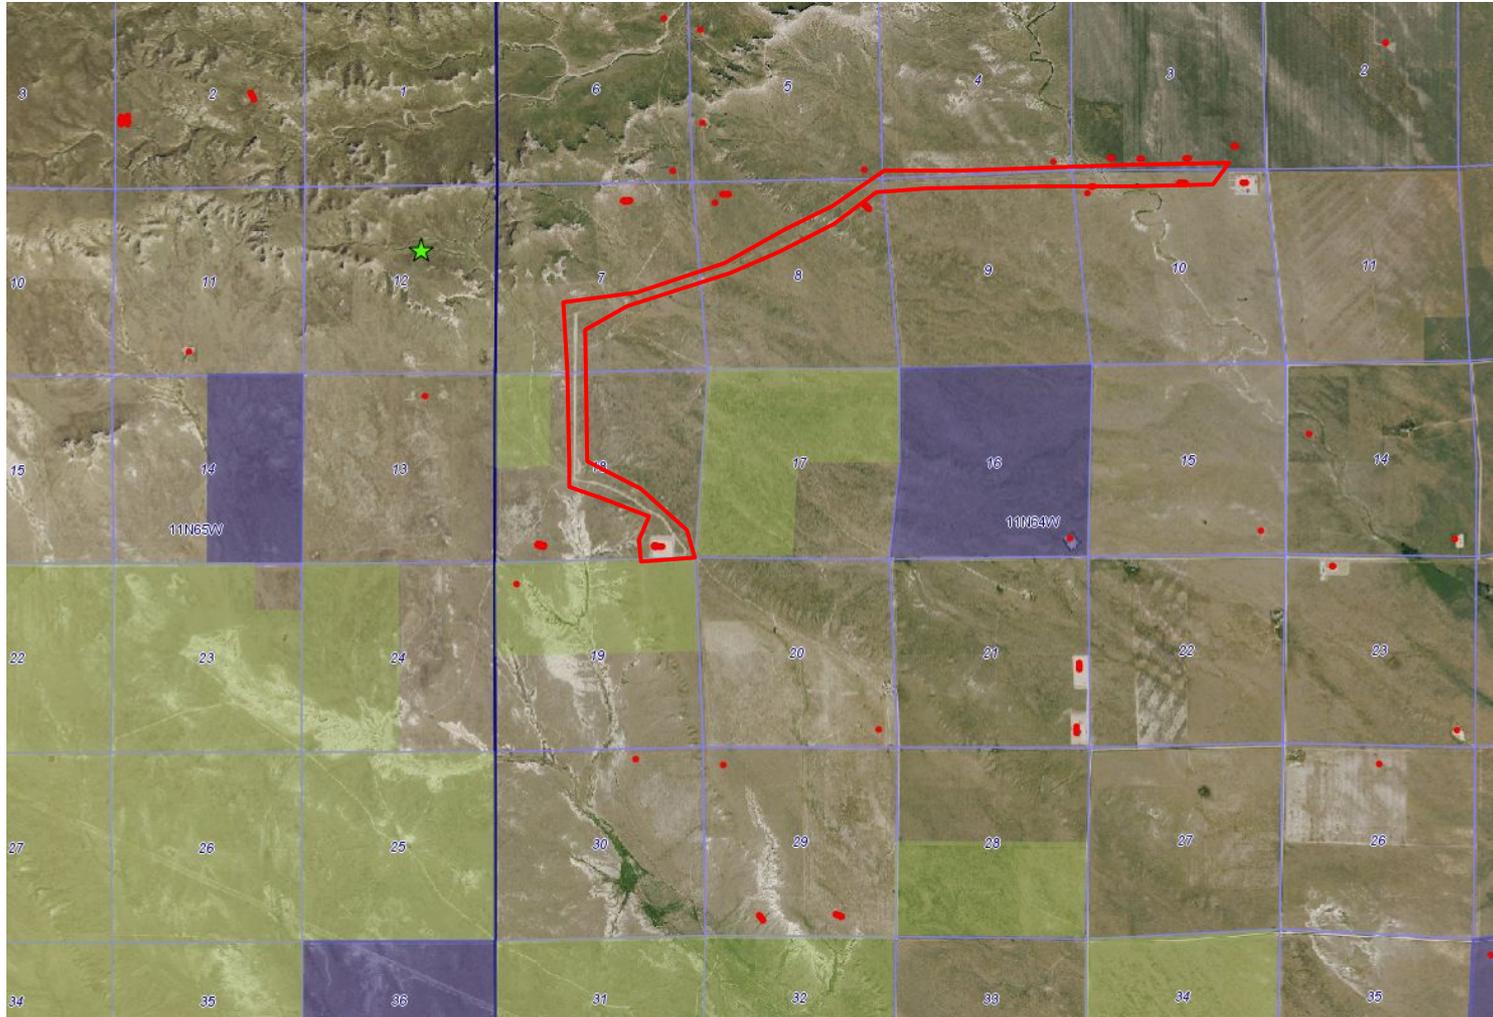
**Photo 1.** Photo illustrates the approximate access road and location in relation to Pawnee National Grassland (green color), State Land Board (purple) and everything else is private land. Access road and location encompass the following sections of 11N 64W: 7, 8, 9, 10, 18.

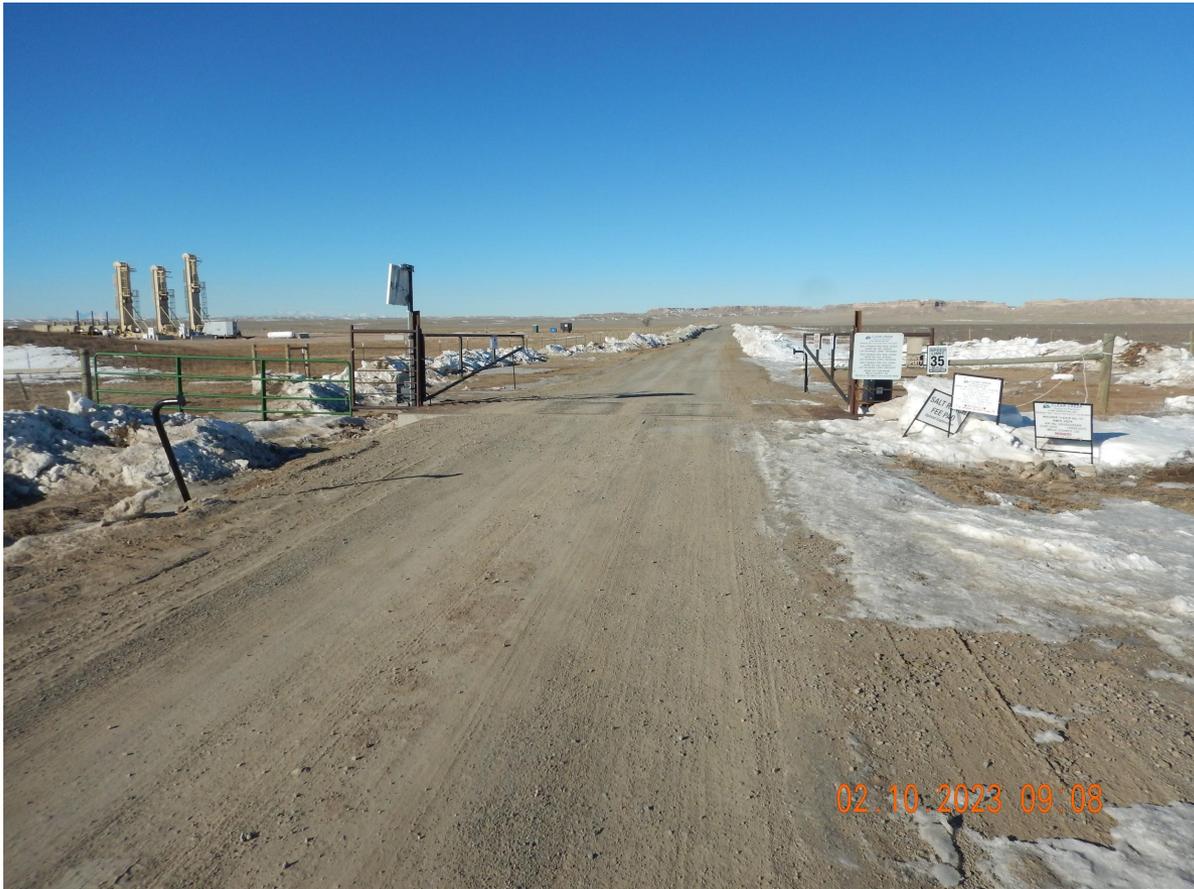
**Photo 2.** Photo taken from the entrance of location off CR57, facing West. Photo illustrates Operator has failed to restrict access by unauthorized persons, as the automated gates are open and cannot be closed due to automated issues.

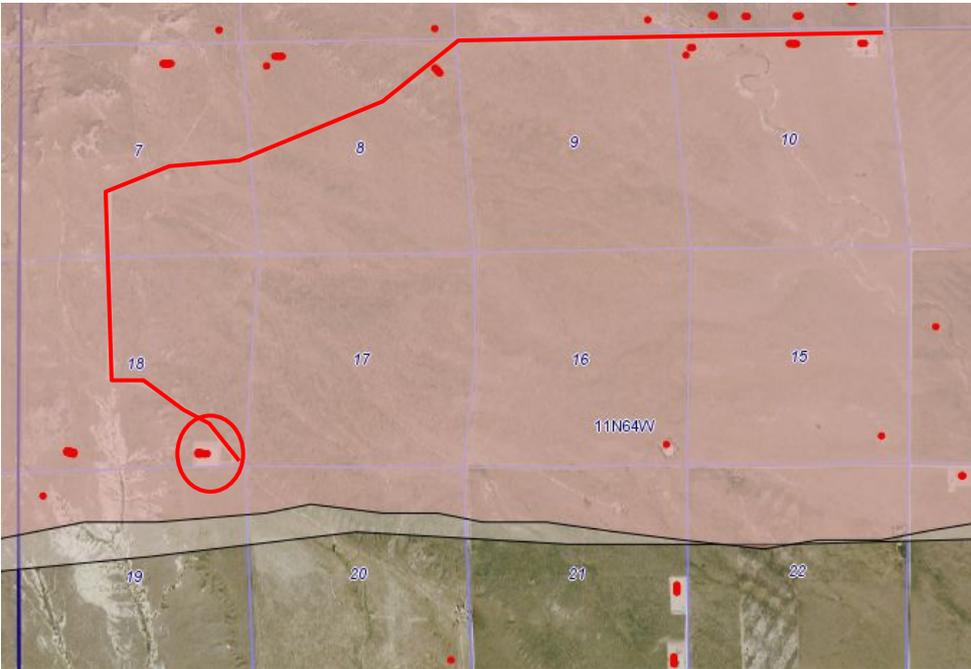
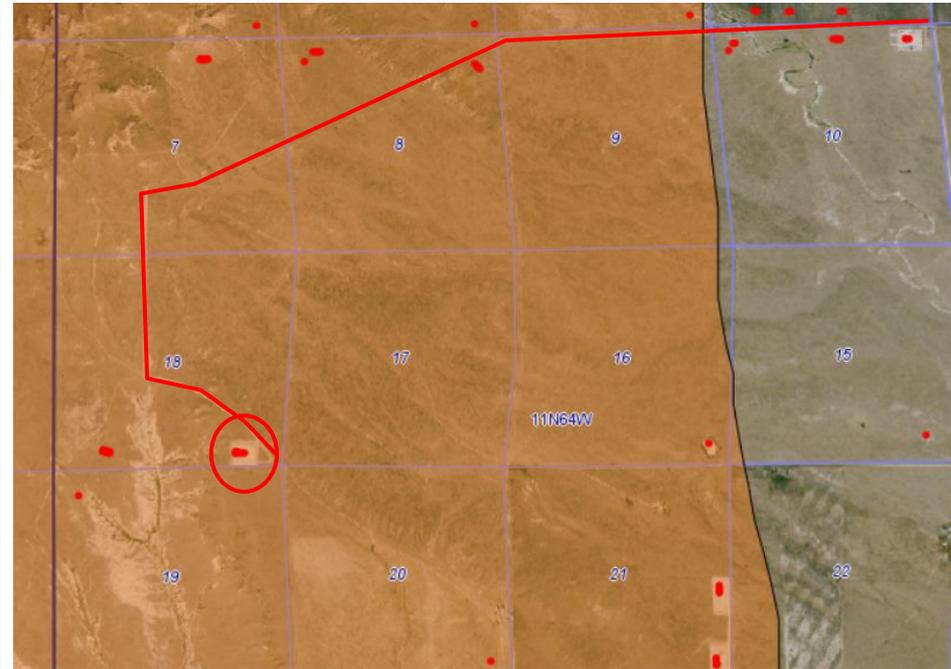
**Photo 3.** Photo illustrates the access road and location are within the following High Priority Habitat: Mule Deer Severe Winter Range and Mule Deer Winter Concentration area (left image), and Pronghorn Winter Concentration area (right image).

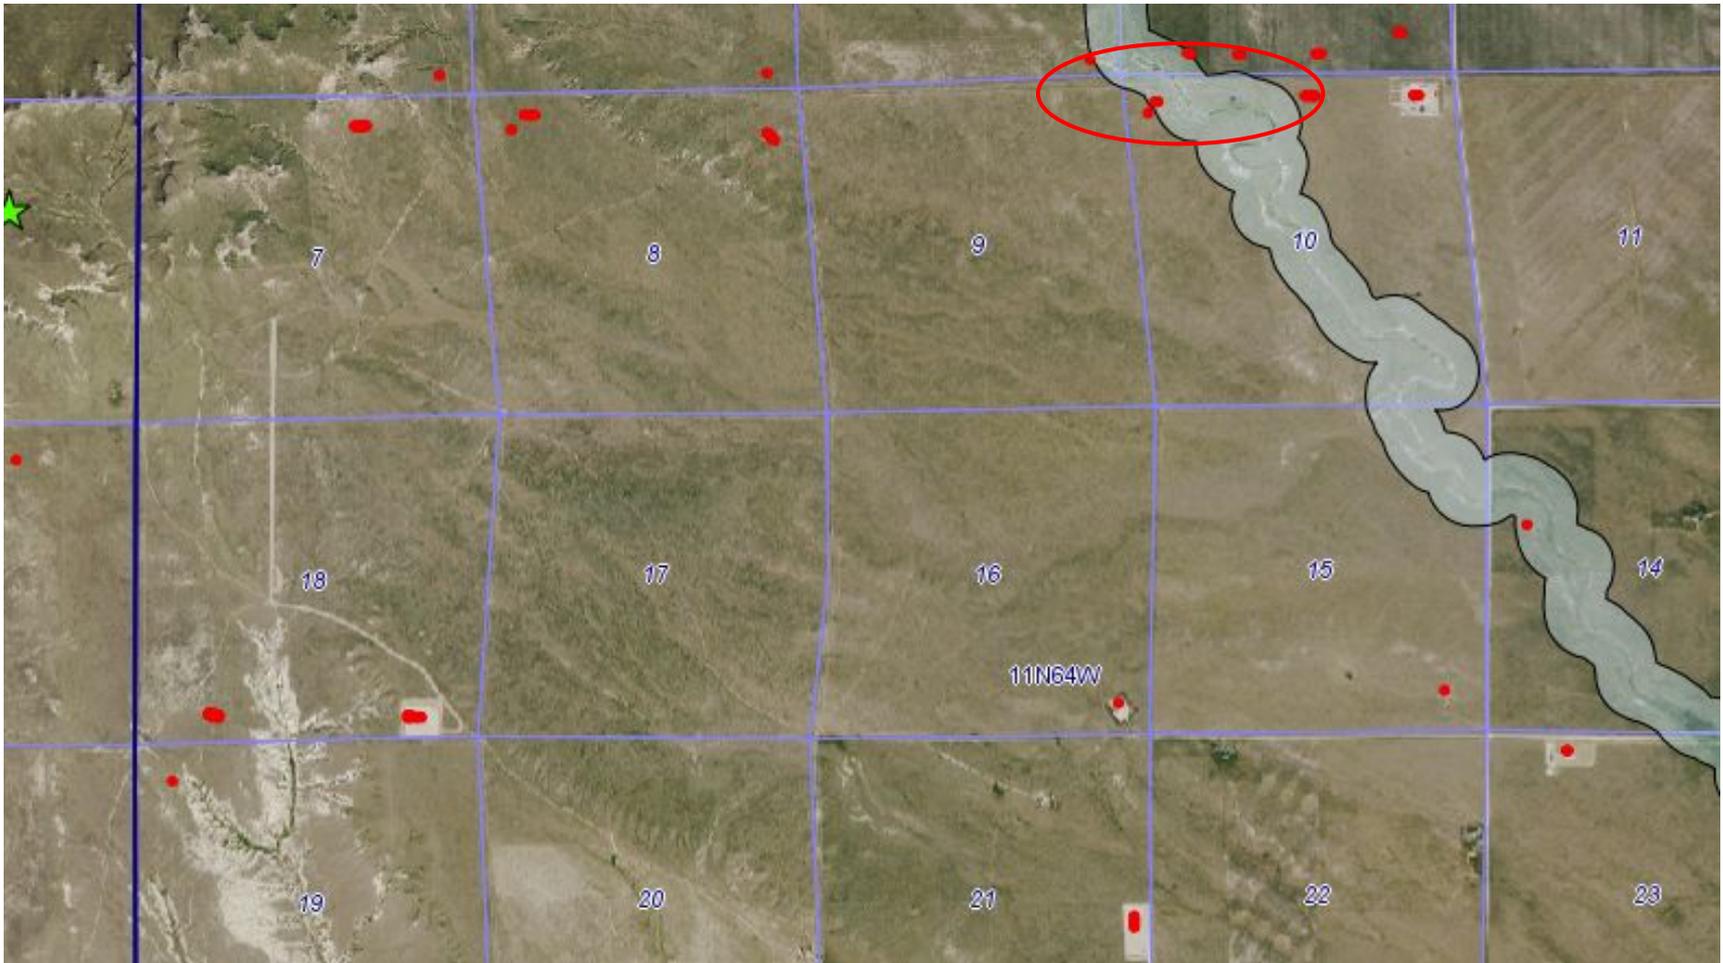
**Photo 4.** Photo illustrates a portion of the access road crosses a High Priority Habitat (Aquatic Native Species Conservation Waters) at Geary Creek. Operator has failed to prevent sediment discharge into Geary Creek- refer to the photos 5-8.

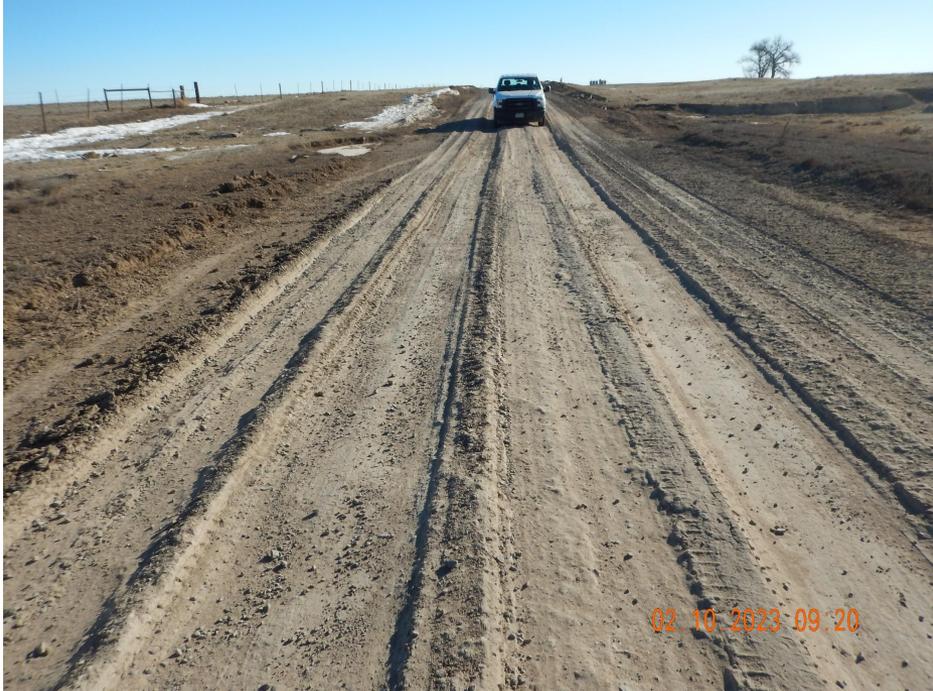
**Photo 5.** Photo taken from the intersection of the access road and Geary Creek, facing East. Photo illustrates the access road is not sufficiently stabilized which is contributing to sediment discharge into Geary Creek.

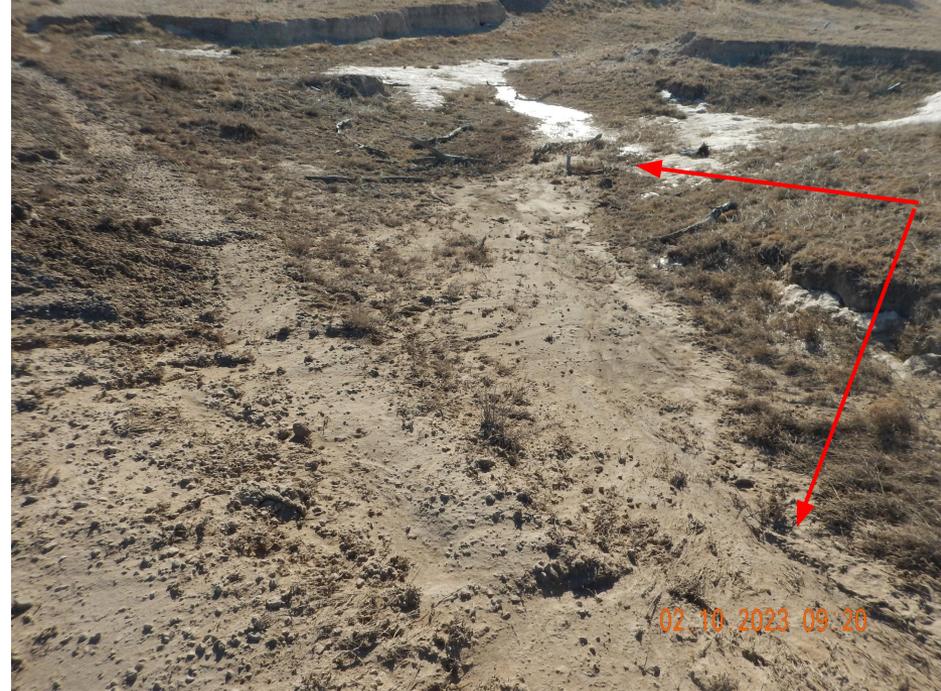
**Photo 6.** Photo taken from Geary Creek, facing South. Photo illustrates sediment discharge into Geary Creek.

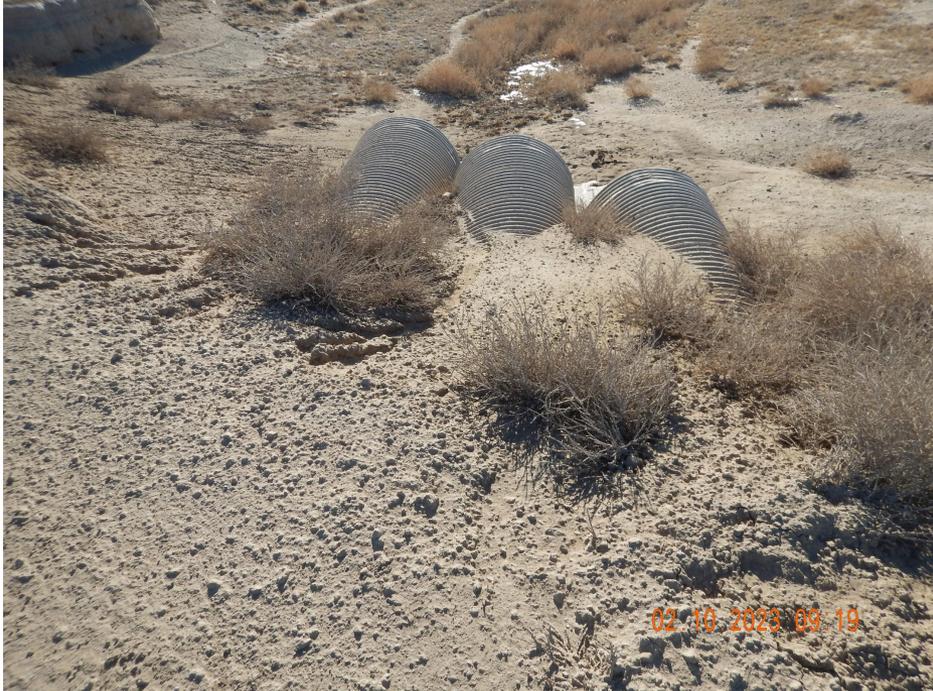
**Photo 7.** Photo taken from intersection of the access road and Geary Creek, facing South. Photo illustrates sediment discharge into Geary Creek without stormwater BMPs.

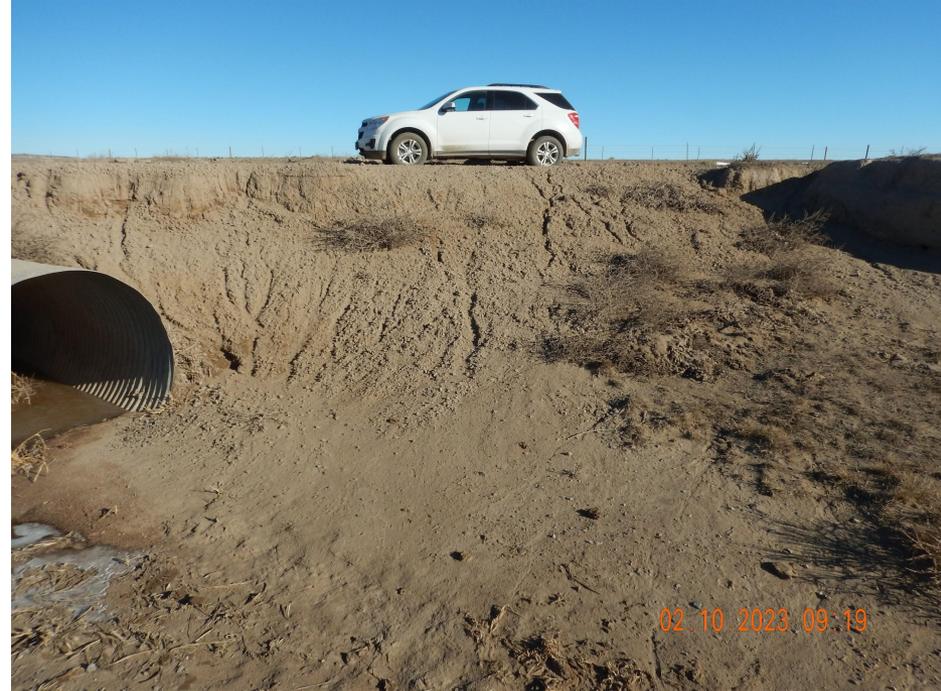
**Photo 8.** Photo taken from Geary Creek, facing North. See comments under Photo 7.

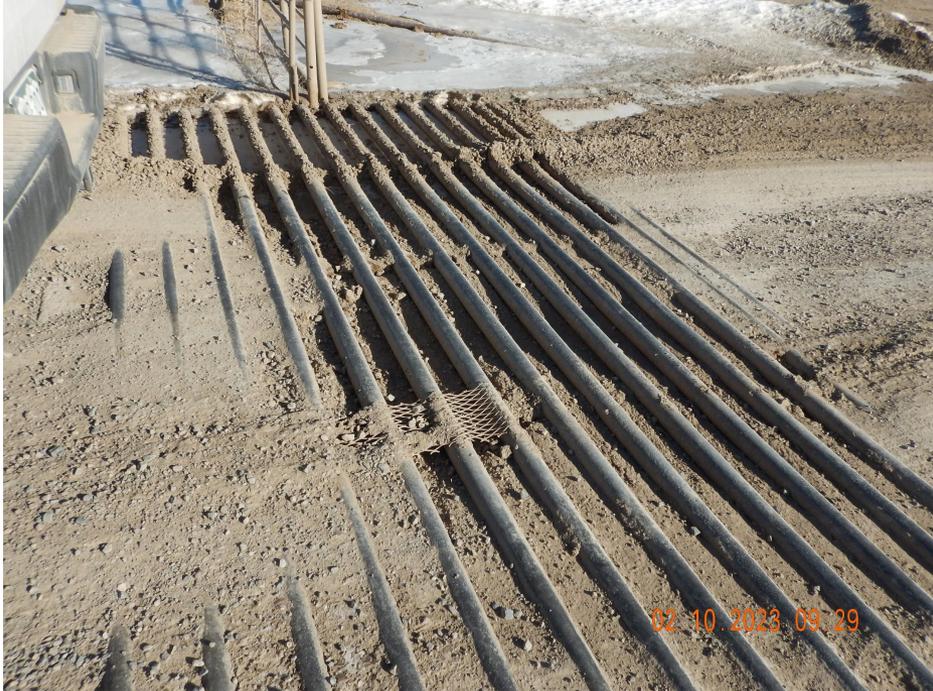
**Photo 9.** Photo taken from a portion of the access road, facing North. Photo illustrates the cattle guard is not in proper functioning condition to exclude cattle.

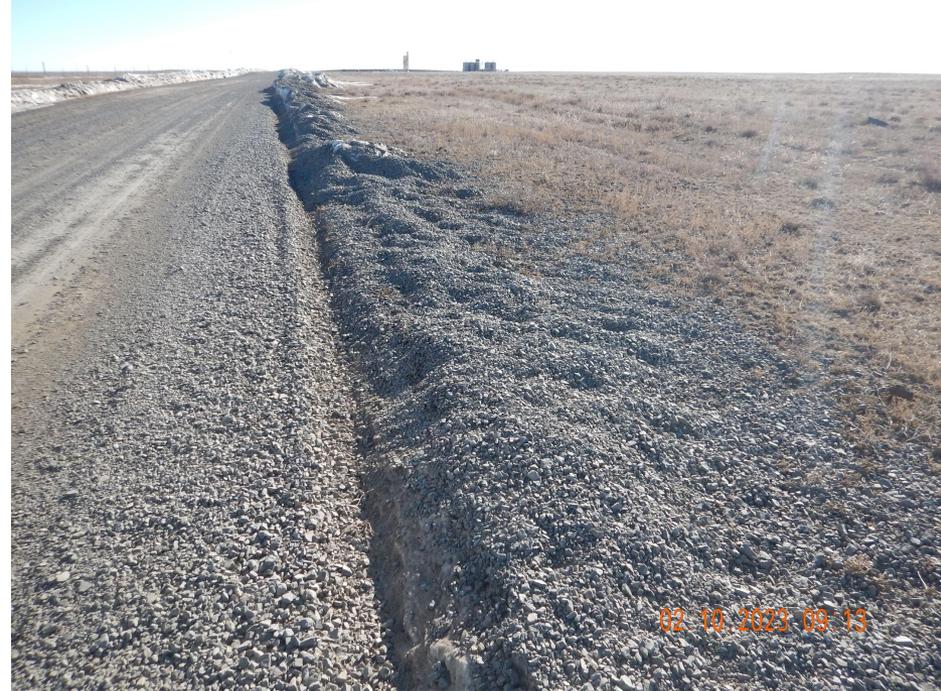
**Photo 10.** Photo taken from a portion of the access road, facing East. Photo illustrates Operator has conducted snow removal on the access road and is creating additional disturbances by plowing road base onto reference areas.

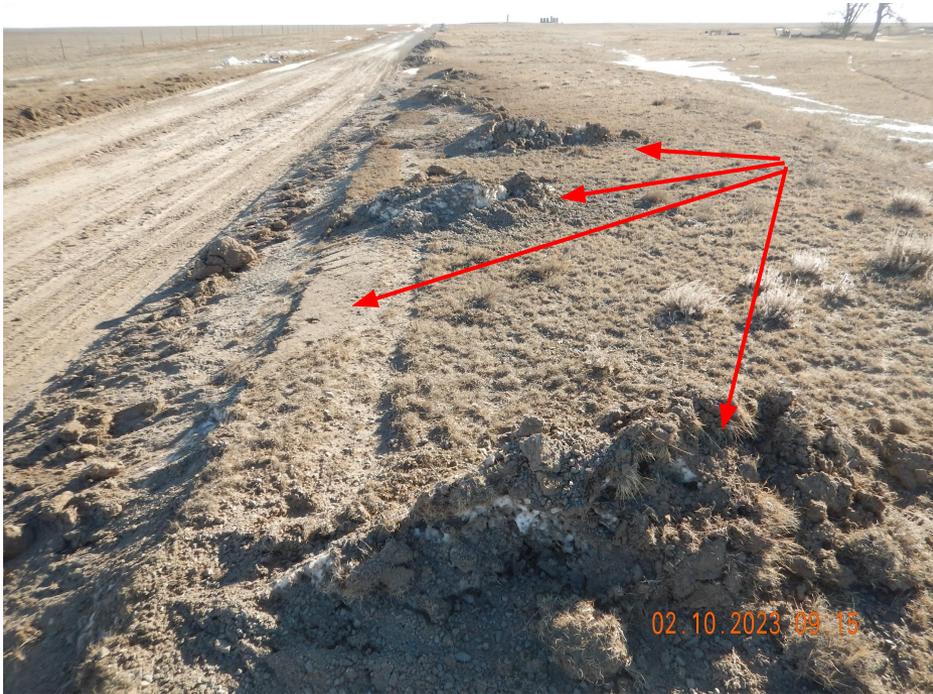
**Photo 11.** Photo taken from a portion of the access road, facing East. Photo illustrates Operator has conducted snow removal on the access road and is creating additional disturbances by plowing off of the lease road onto private land. Red arrows indicate some of the additional disturbances.

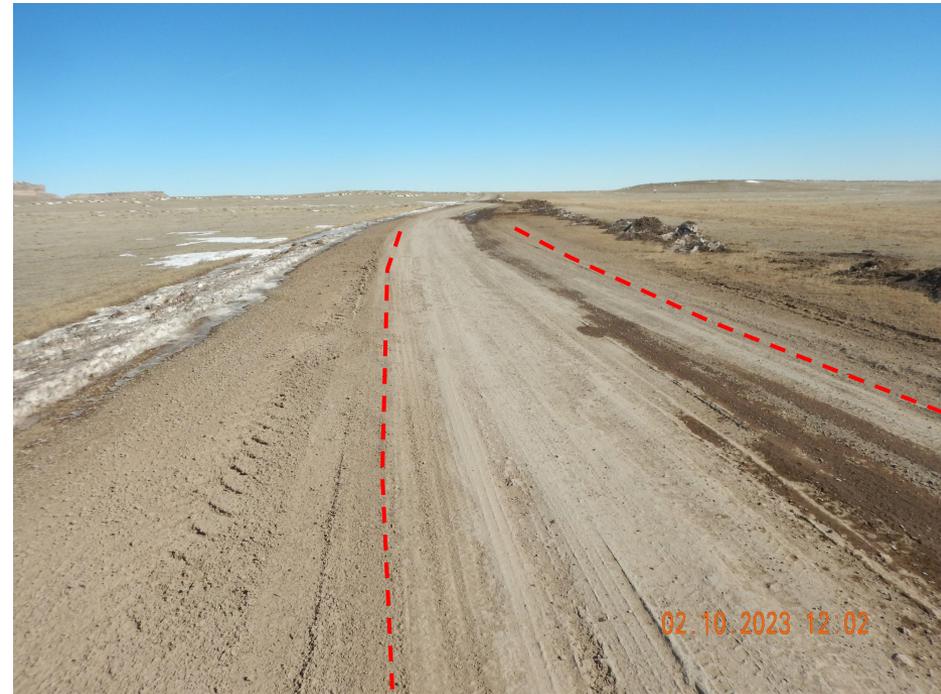
**Photo 12.** Photo taken from a portion of the access road, facing East. See comments under Photo 8.

Note- this photo is demonstrating that the access road is now nearly twice the width of the original access road due to poor road maintenance. The red-dashed lines indicate the approximate size of the original access road before snow removal disturbances.

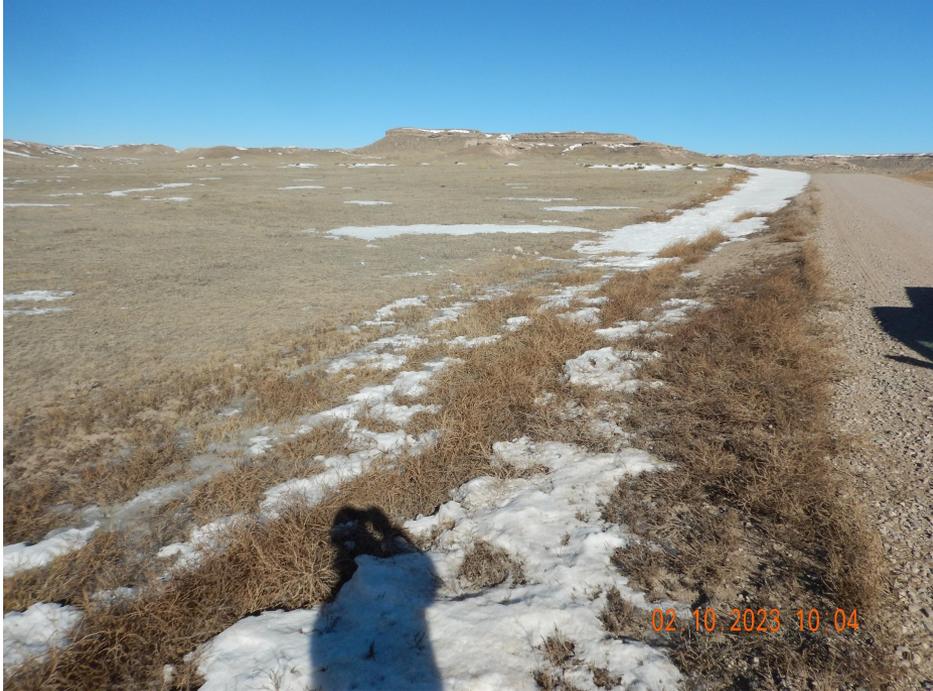
**Photo 13.** Photo taken from a portion of the access road, facing North. Photo illustrates the roadside ditch, where topsoil is being stored, consisting of weedy, annual vegetation which can spread onto adjacent reference areas if not properly managed.

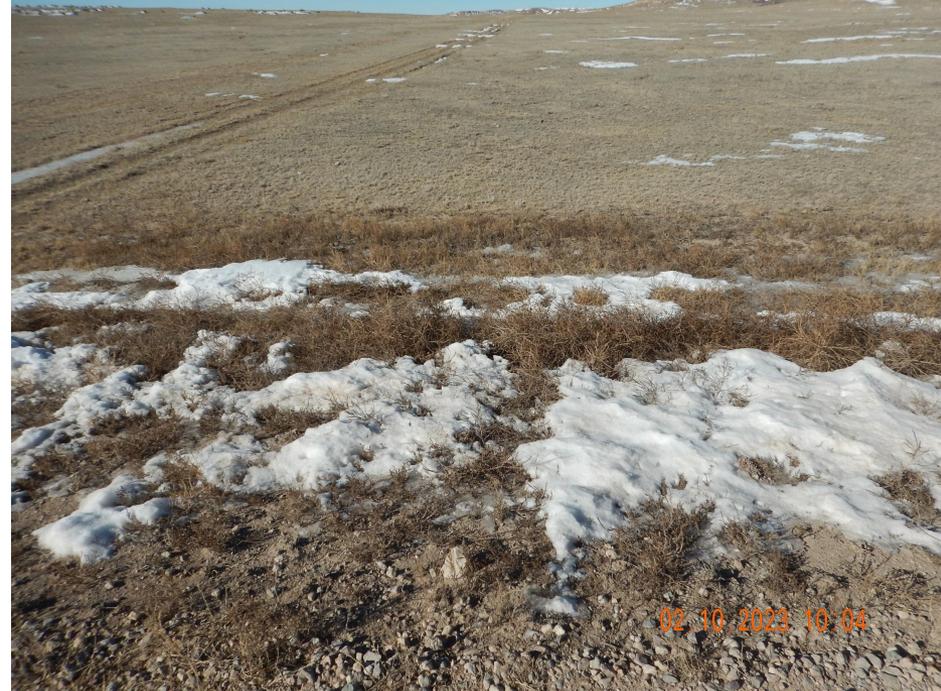
**Photo 14.** Photo taken from a portion of the access road, facing West. See comments under Photo 13.

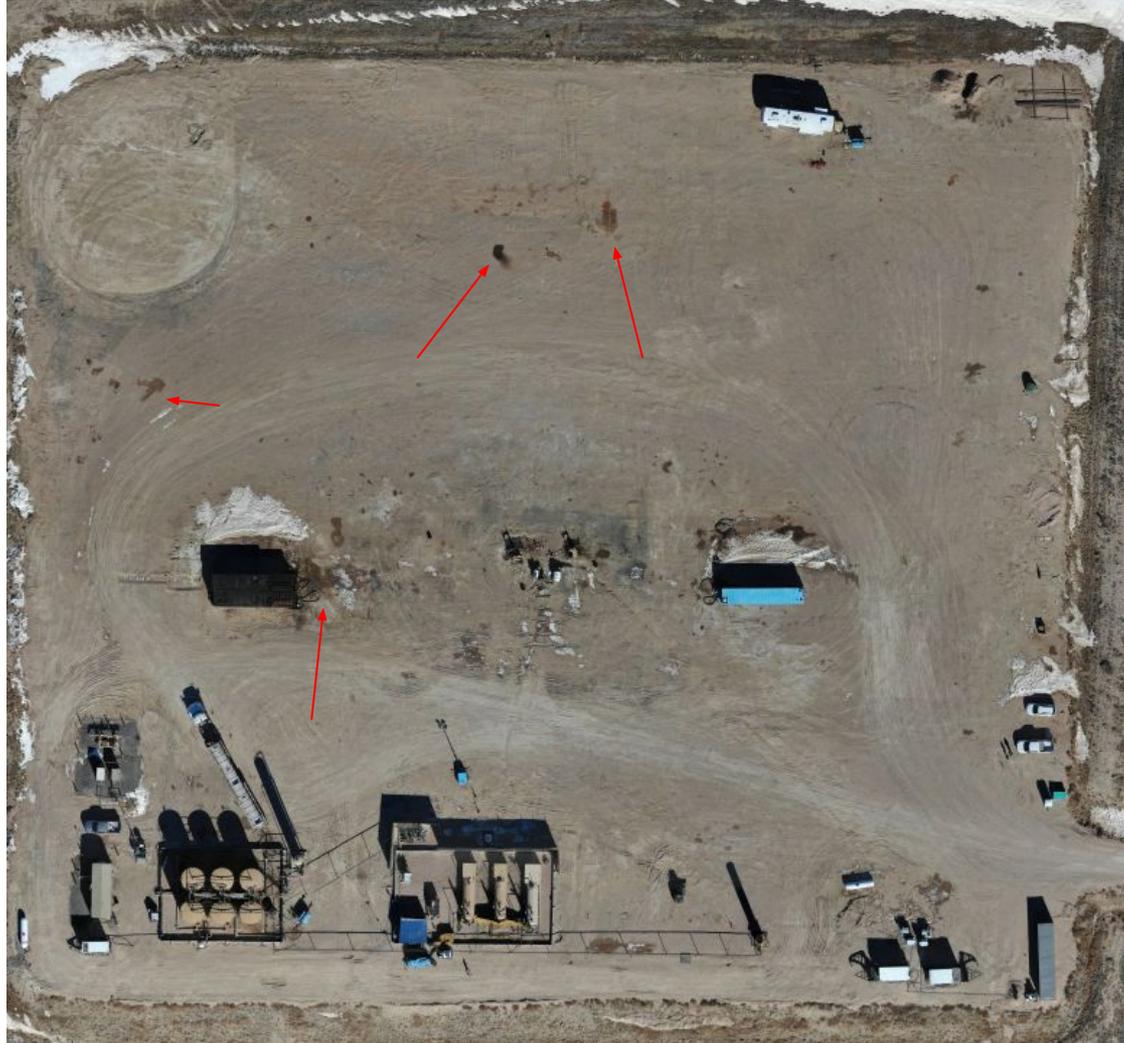
**Photo 15.** Drone aerial imagery illustrates stained soil throughout the location which has not been properly disposed of. Larger spills/releases were observed near frac tanks- refer to Photos 16-18. Red arrows indicate some of the stained soil and spills.

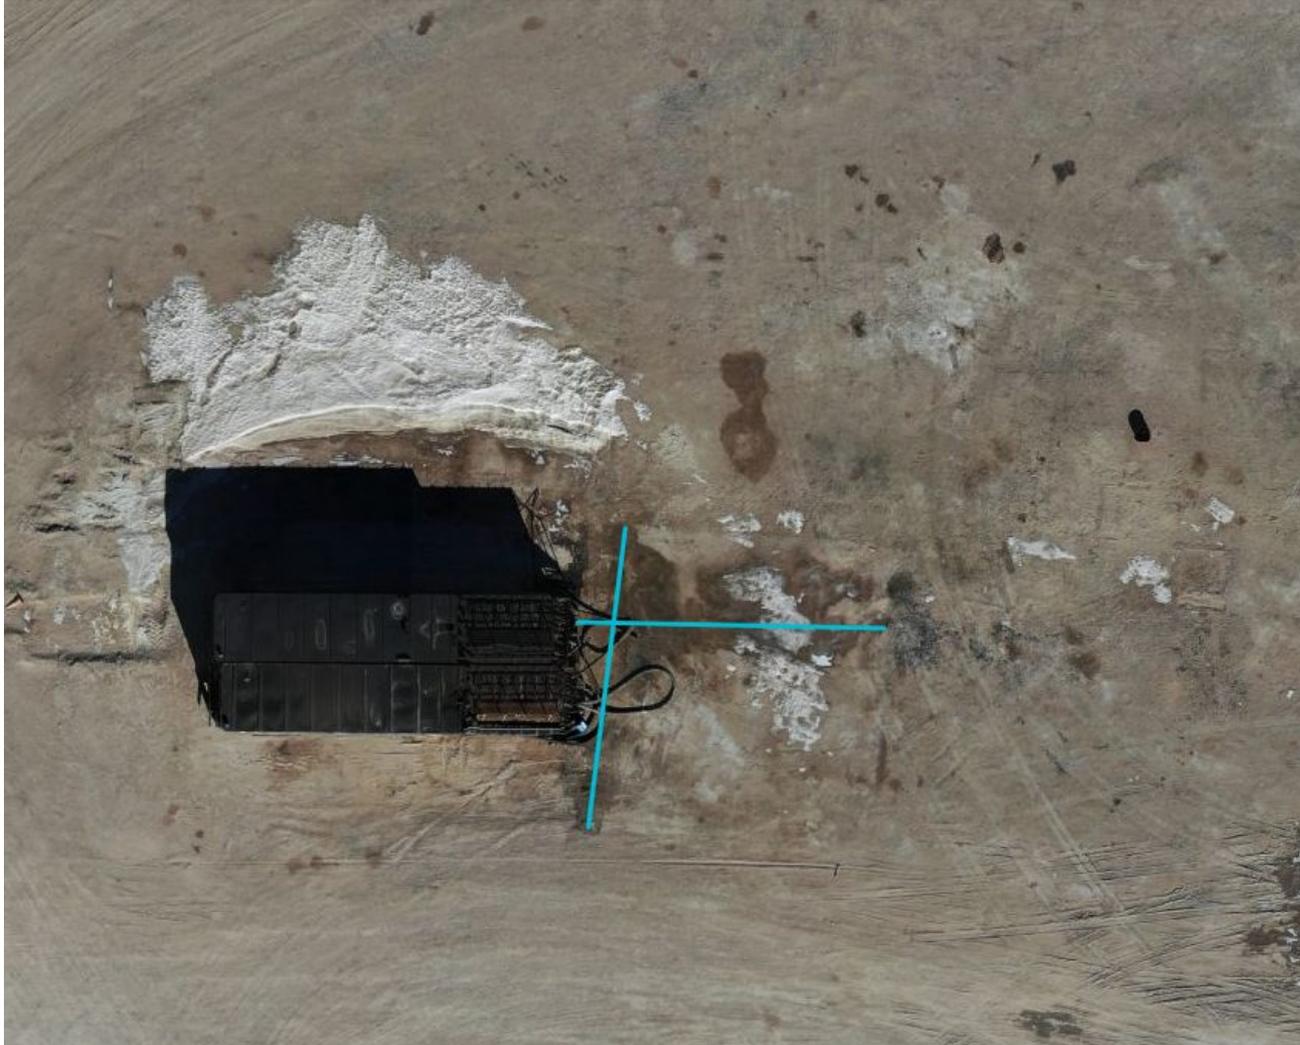
**Photo 16.** Zoomed in drone aerial imagery illustrates a larger spill/release near a frac tank. The blue lines indicate an approximate length of 37 feet. COGCC staff would consider this a reportable spill.

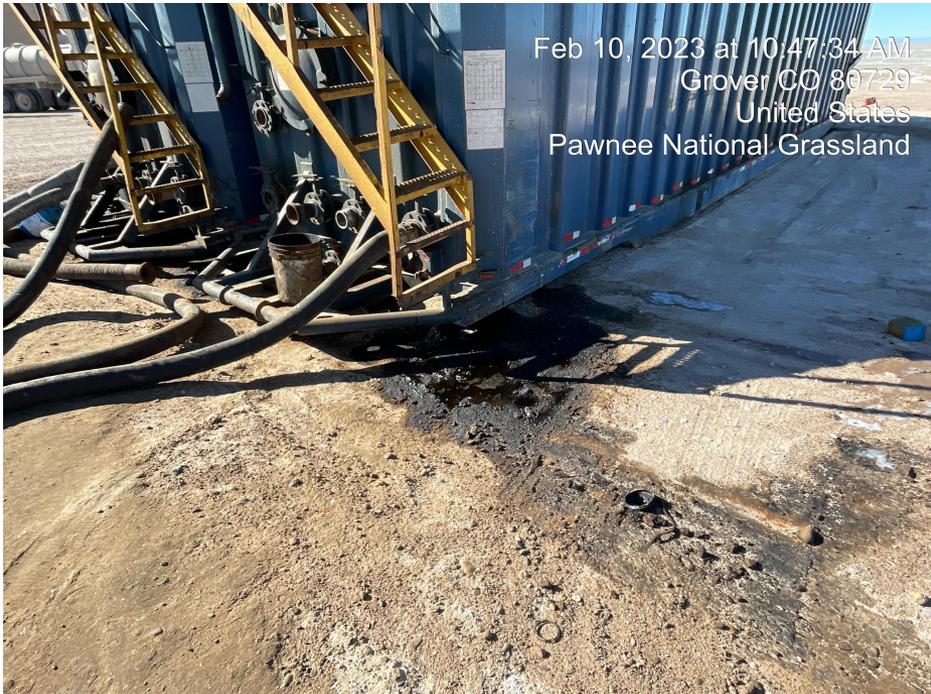
**Photo 17.** Photo taken from a frac tank on location. Photo illustrates frac tank is leaking oily waste. Oily waste appears to be underneath the frac tank.

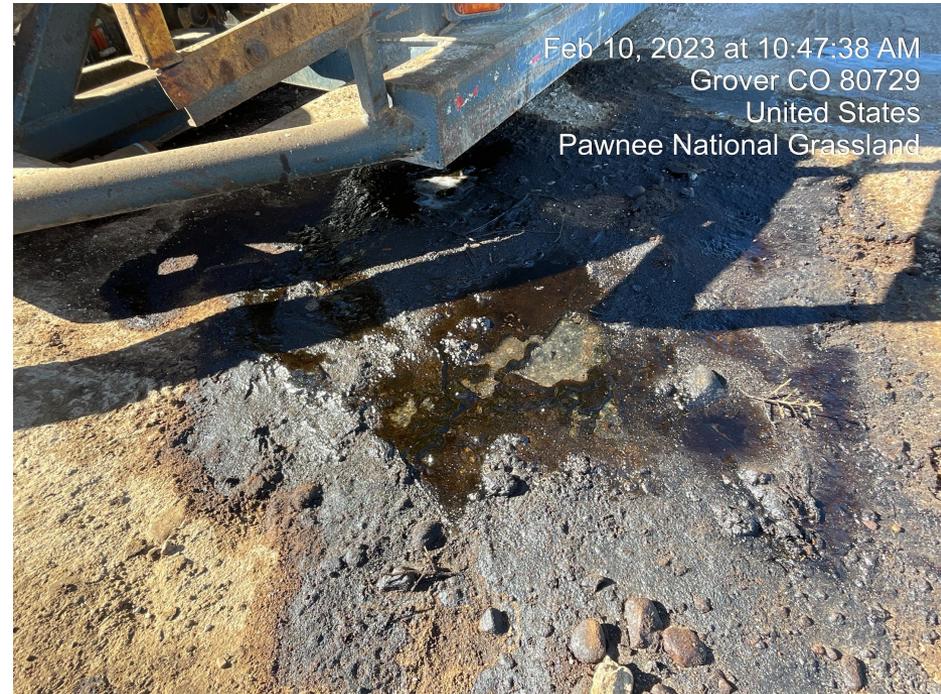
**Photo 18.** Close up photo of leaking frac tank from the previous photo.

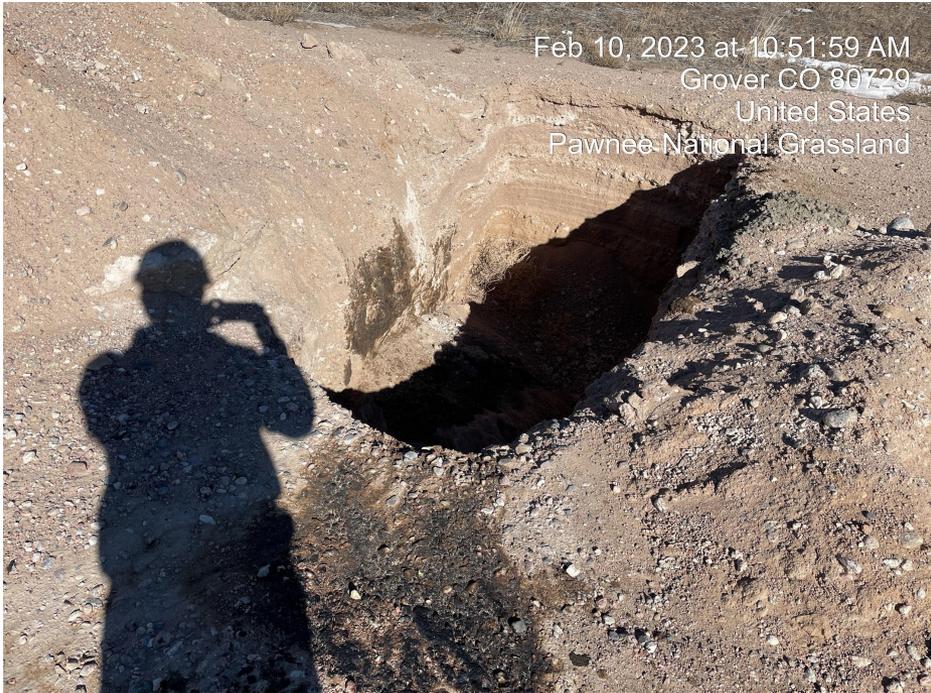
**Photo 19.** Photo taken from the northeastern location. Photo illustrates an excavation approximately 3'x 8' in size with an unknown depth but ~5-6' deep, which would be considered a pit. The western sidewall of the excavation had observed soil staining, as well as the surface adjacent to the excavation. Also, there is no wildlife fencing or netting.

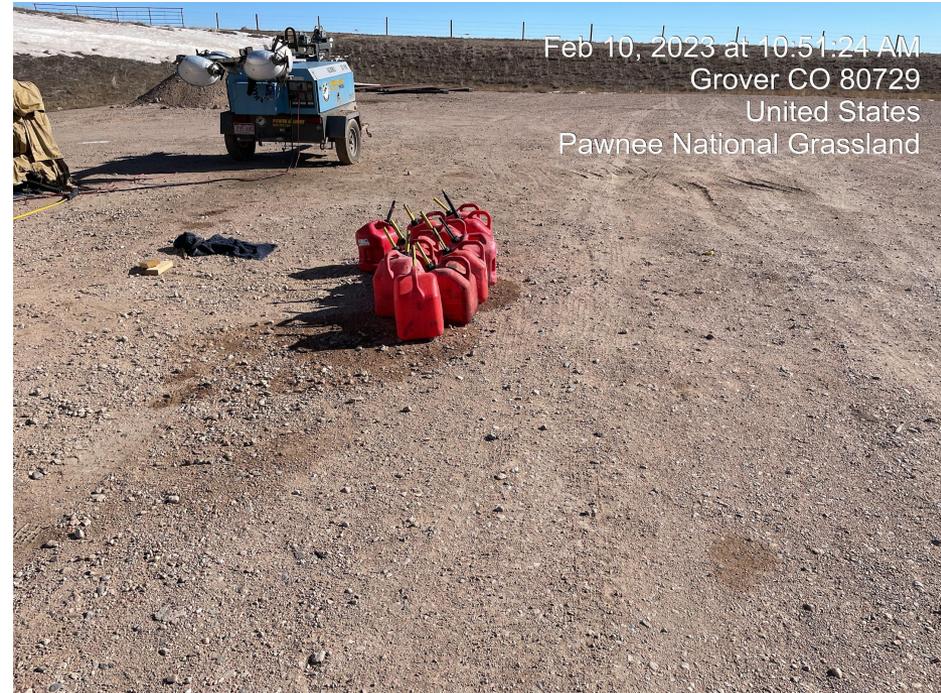
**Photo 20.** Photo taken from the northeastern location, facing East. Photo illustrates leaky gasoline. Operator does not have proper material handling and spill prevention.

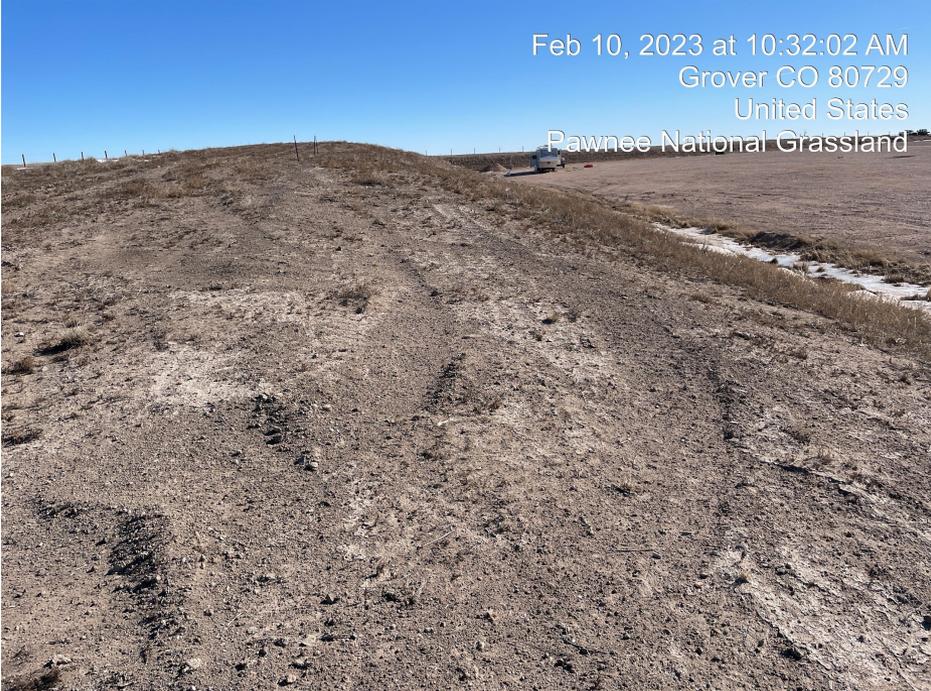
**Photo 21.** Photo taken from the northwestern location, facing East. Photo illustrates the topsoil stockpile which is bare or has weedy, annual vegetation.

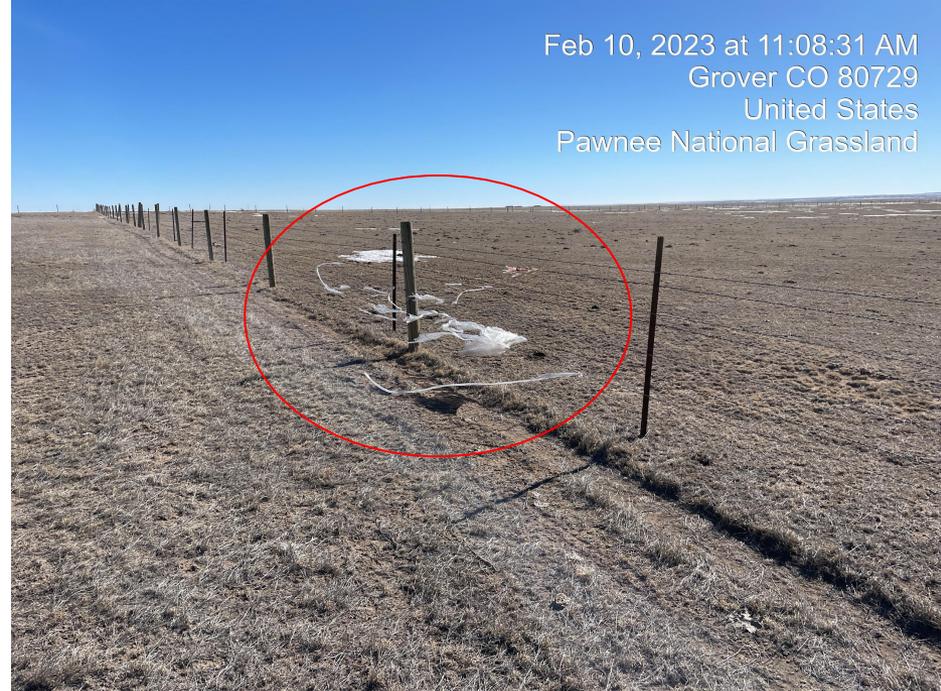
**Photo 22.** Photo taken east and off of location, facing East. Photo illustrates trash has blown off location and Operator has not maintained good housekeeping. Trash was observed within the fenceline throughout sections of fencing off location.

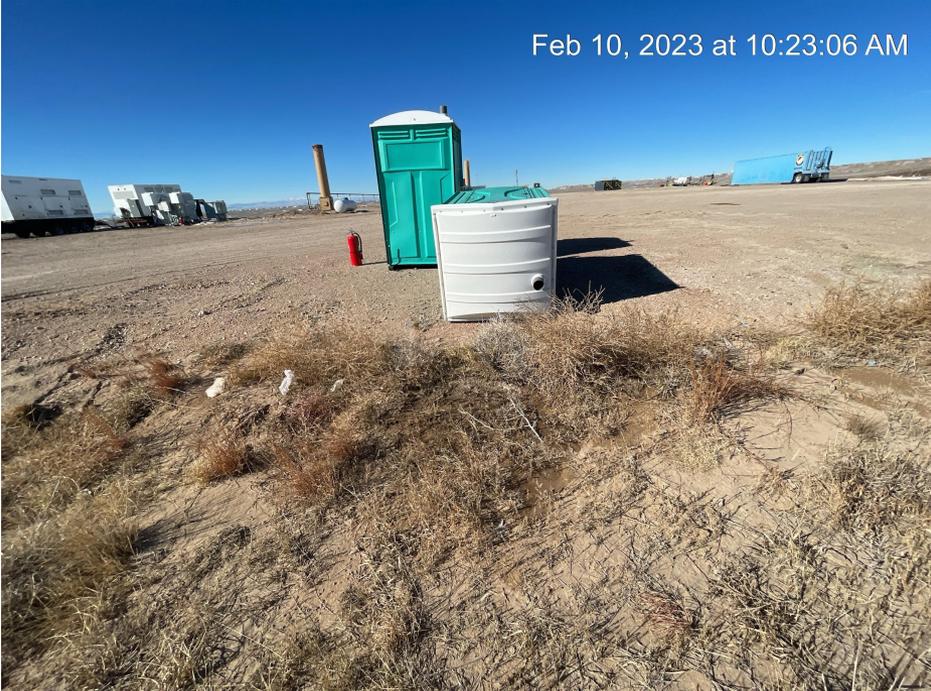
**Photo 23.** Photo taken from the southeastern location, facing West. Photo illustrates a porta-john laying on its side/knocked over. BMPs to prevent or contain a spill are missing or insufficient at the porta-john.

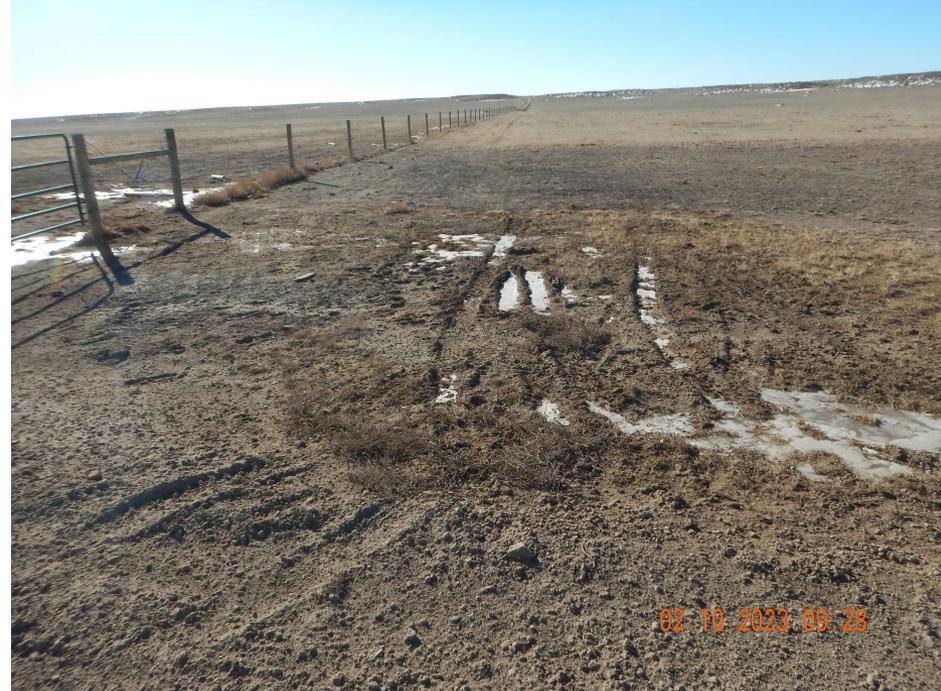
**Photo 24.** Photo taken from Photo 9, facing South. Photo illustrates vehicle traffic off the lease road.
