Inspection Photos

Operator: Caerus Piceance LLC - #10456

Location Name: CEDAR SPRINGS RANCH-67S93W/11NWSE

Inspection Document #: 702801264

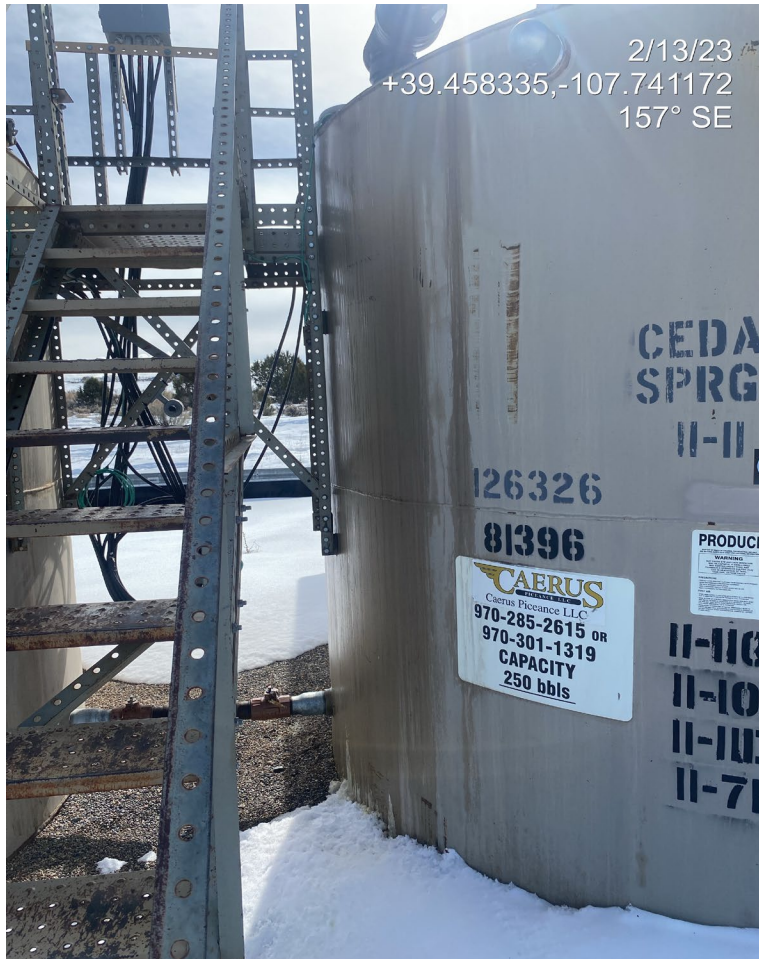
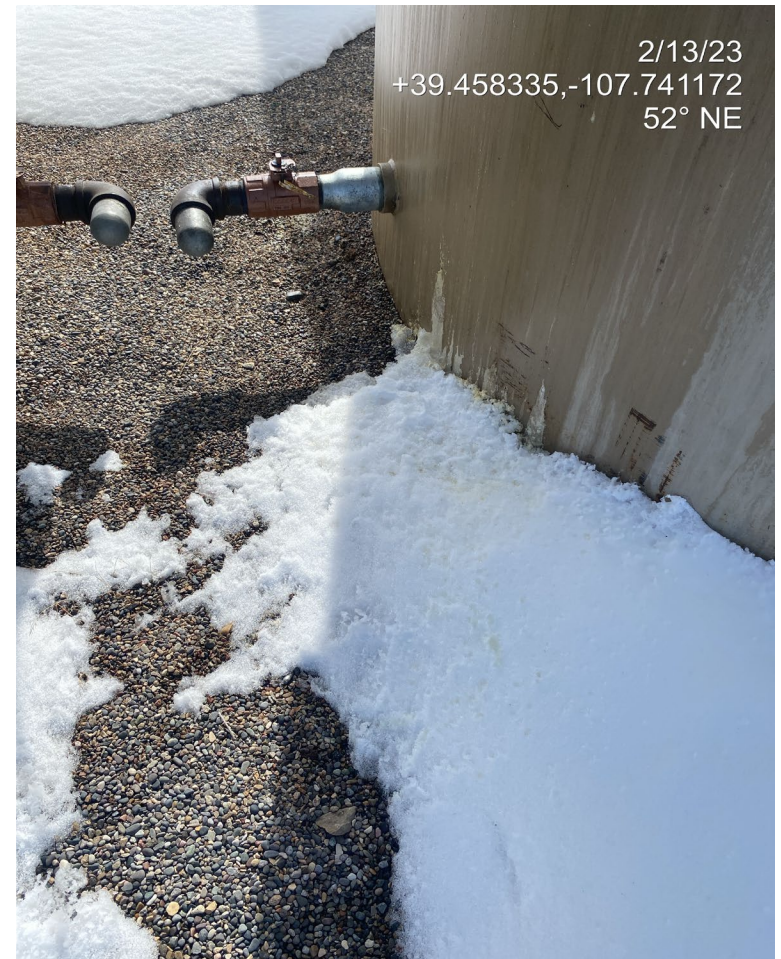
Photo 1. Photos show produced water/condensate tank # 81396 appears to have spilled from the top. Stained gravel observed in secondary containment below the spill (right).

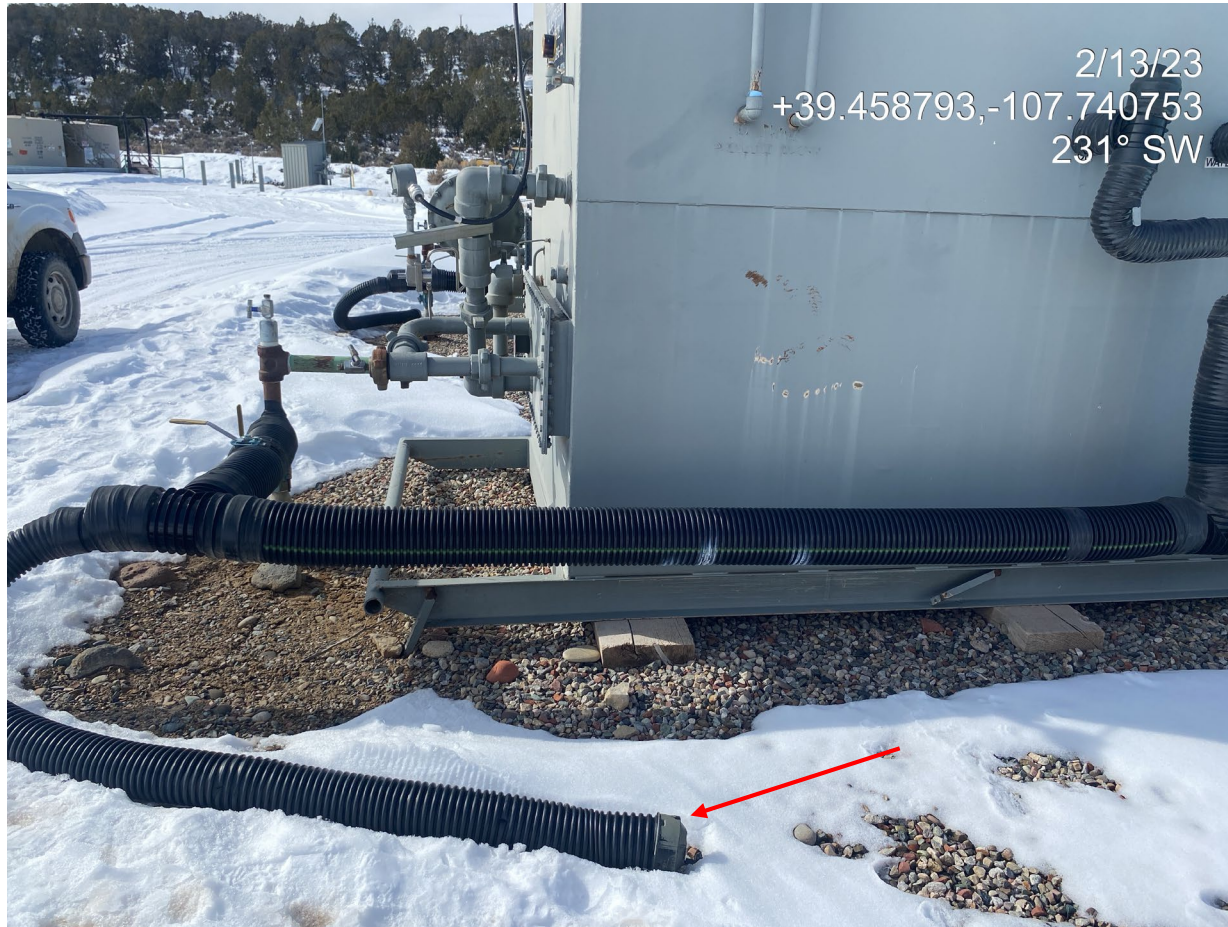
Photo 2. Photo shows a cap has been installed on separator piping per previous corrective action.
