Final Reclamation Inspection

Operator: NOBLE ENERGY INC- 100322

Location ID: 328608

Inspection Photos
Location Name: SPIKE STATE #CC 6-12
Location ID: 328608

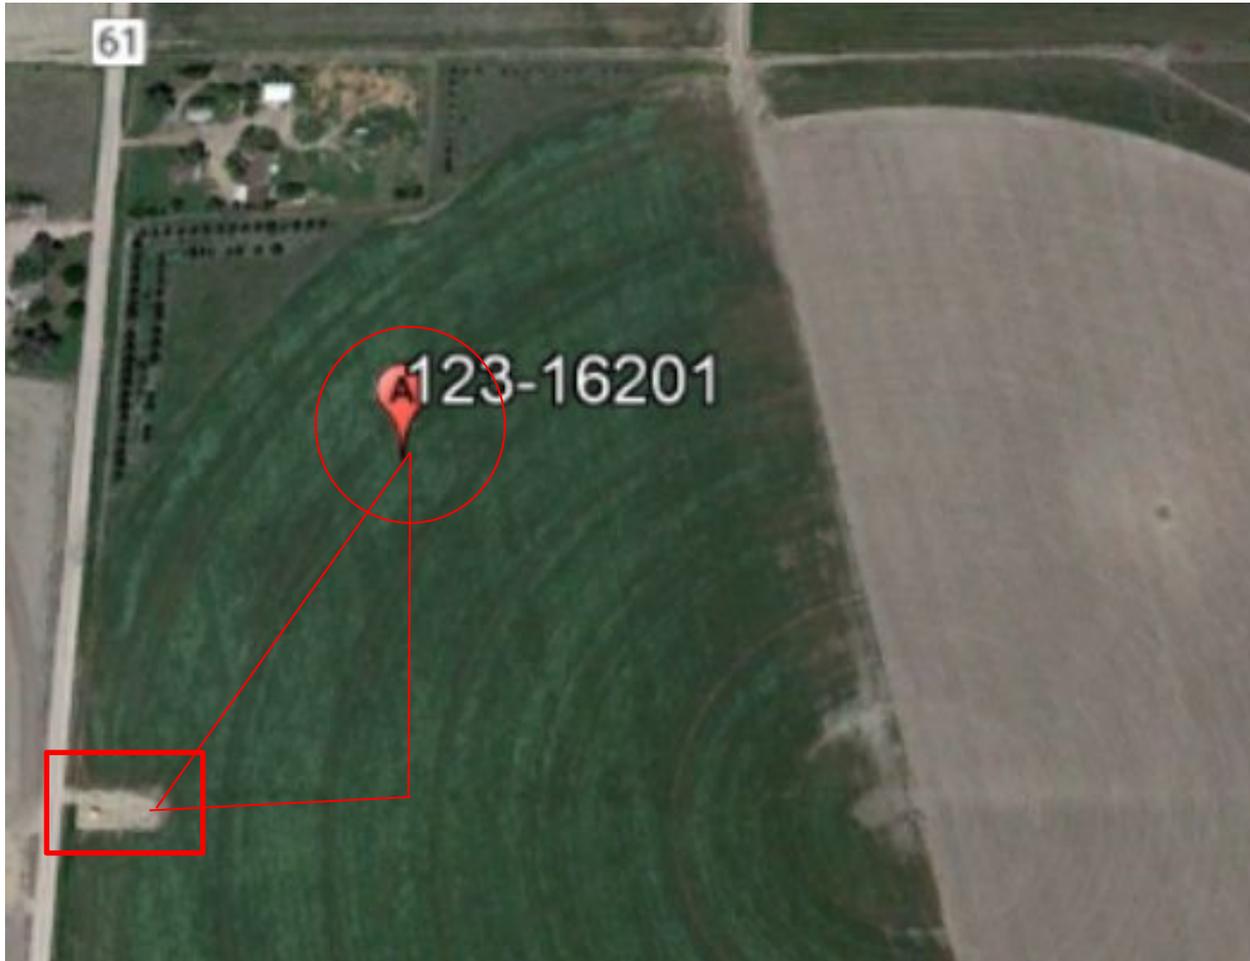
Photo 1. Google Earth aerial imagery taken 6/2016 during active operations. Photo illustrates the well location (red circle), approximate flowlines (red lines), and tank battery (red rectangle).

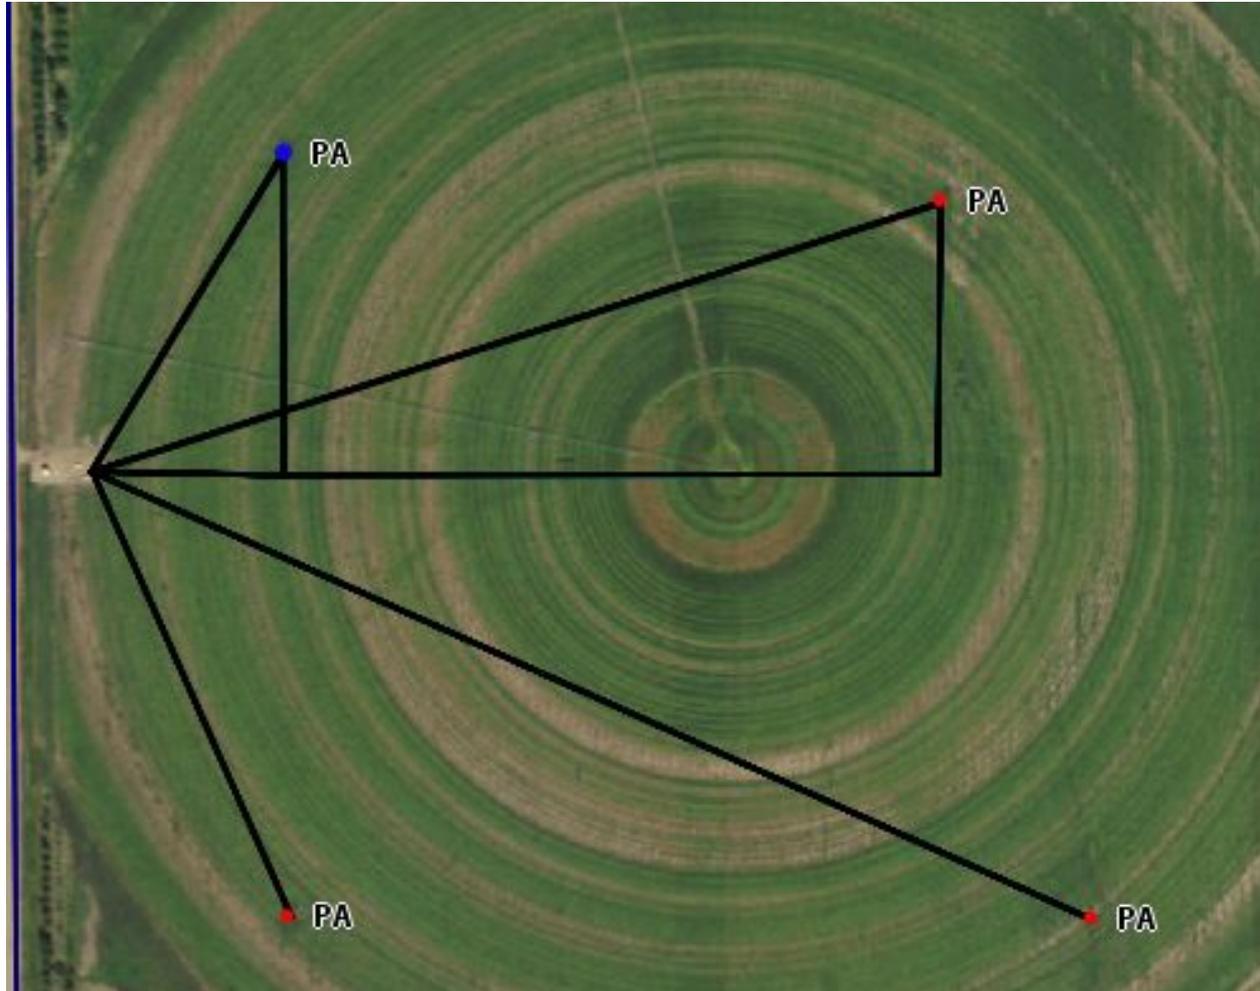
Photo 2. COGCC Online Map aerial imagery 2019 with related wells (red dots), subject well (blue dot), tank battery (near left center), and flowlines (black lines). Flowline abandonment form has not been submitted.

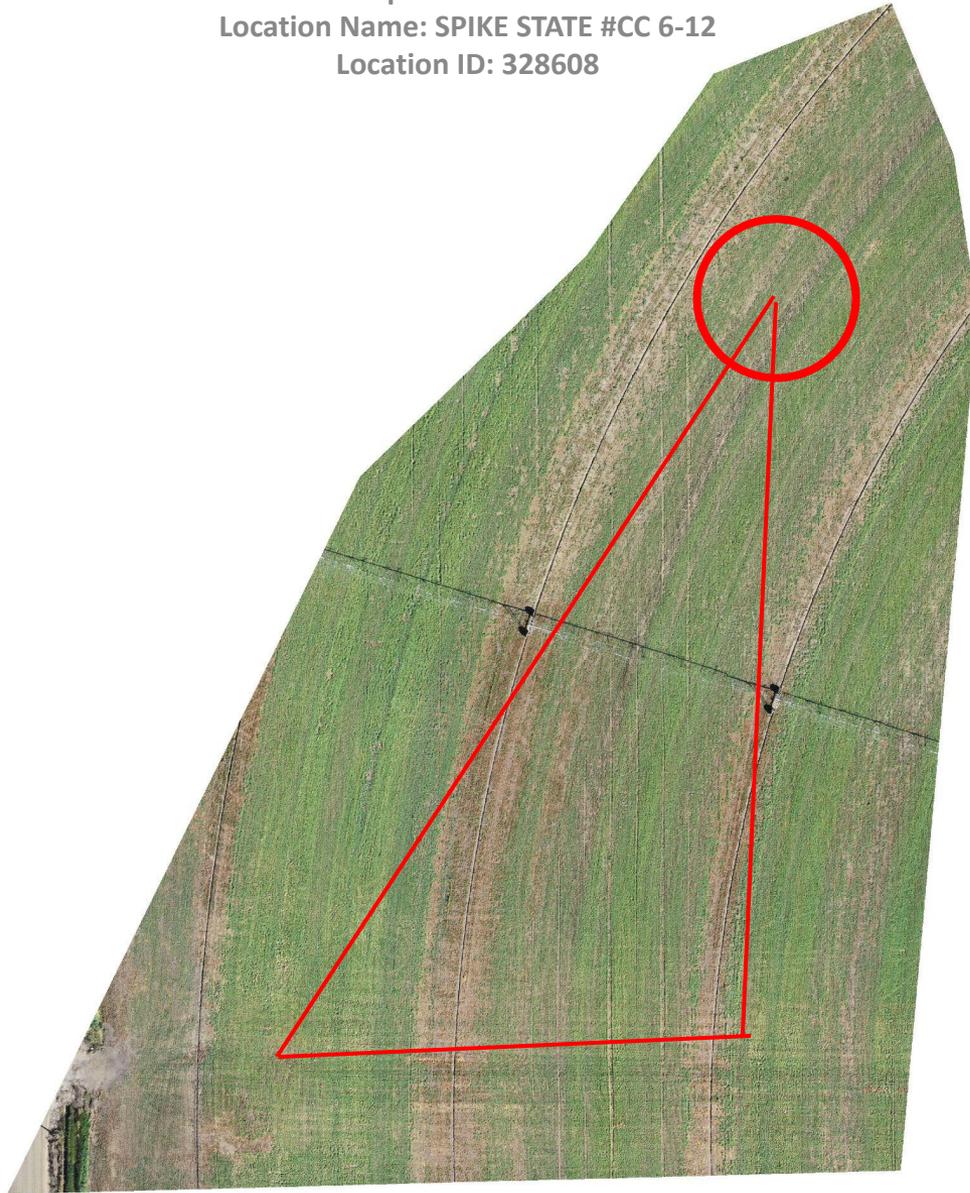
Photo 3. Orthomosaic drone aerial imagery taken from 200 ft (Sept. 2022). Illustrates growth on and around the well location (red circle), flowline (red lines).

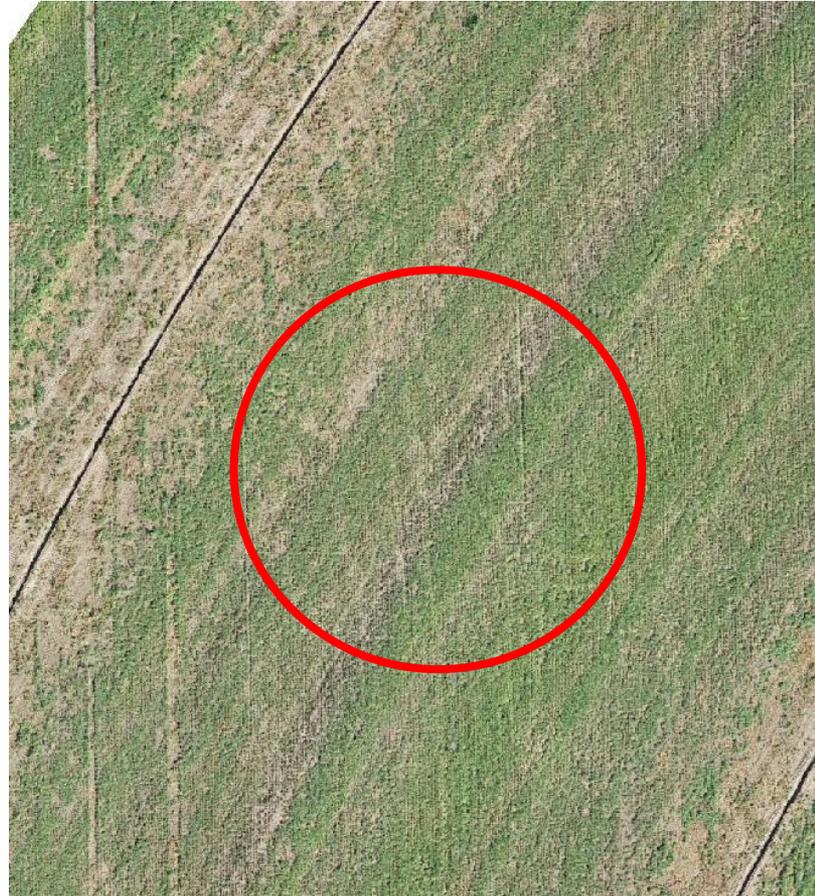
Photo 4. Zoomed in Orthomosaic drone aerial imagery taken from 200 ft (Sept. 2022). Illustrates growth on and around the well location (red circle).

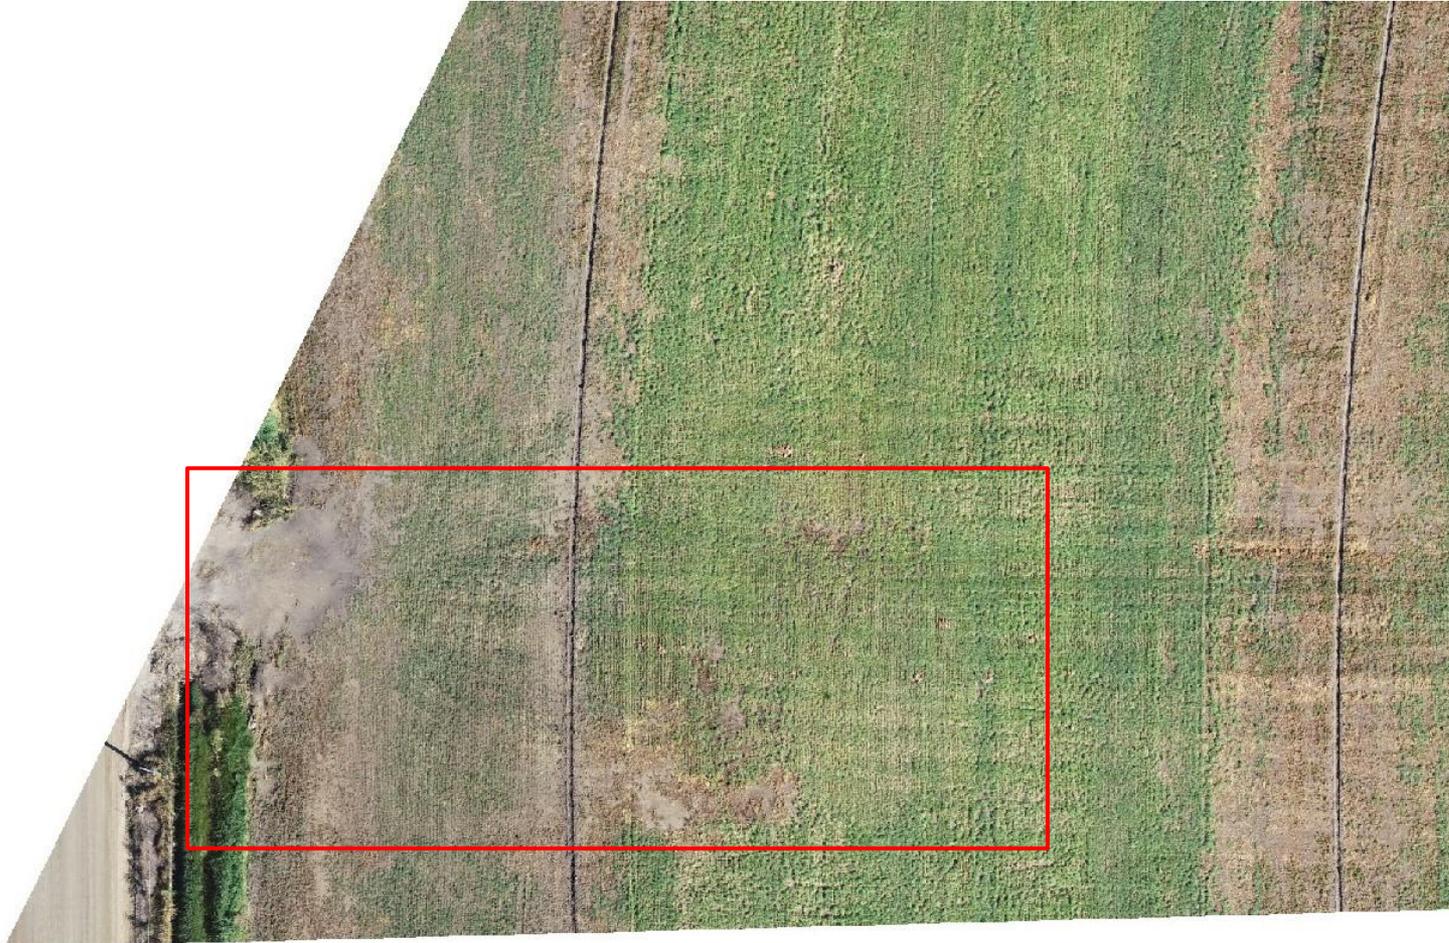
Photo 5. Zoomed in Orthomosaic drone aerial imagery taken from 200 ft (Sept. 2022). Illustrates growth on and around the tank battery (red rectangle). Old entrance to tank battery appears shared with agriculture use for field access from county road. Appears similar to rest of area, however crop height cannot be fully evaluated. Another inspection is required when crop is actively growing.
