Final Reclamation Inspection

Operator: NOBLE ENERGY INC- 100322

Location ID: 323668

Inspection Photos
Location Name: KISSLER #3-2
Location ID: 323668

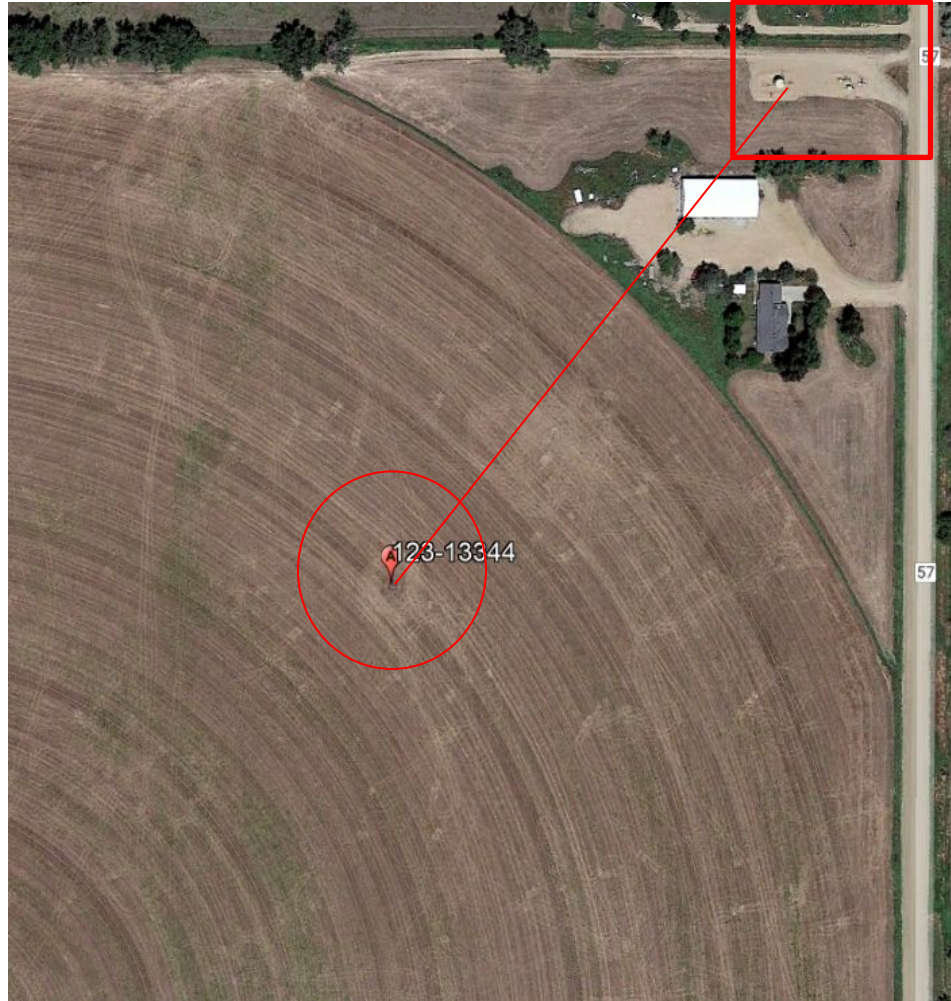
Photo 1. Google Earth aerial imagery taken 2/2020 during active operations. Photo illustrates the well location (red circle), tank battery (red rectangle), and flowline (red line).

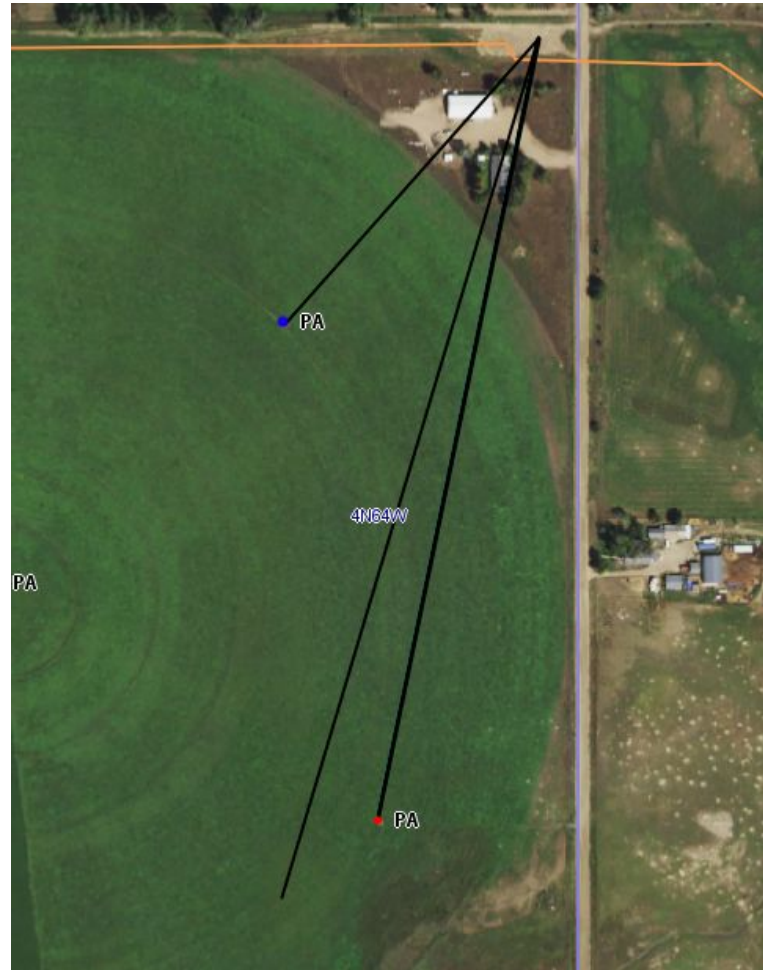
Photo 2. COGCC Online Map aerial imagery 2019 with subject well (blue dot), related well (red dot), tank battery (northwest corner) and flowlines (black lines). Flowline abandonment form has not been submitted.

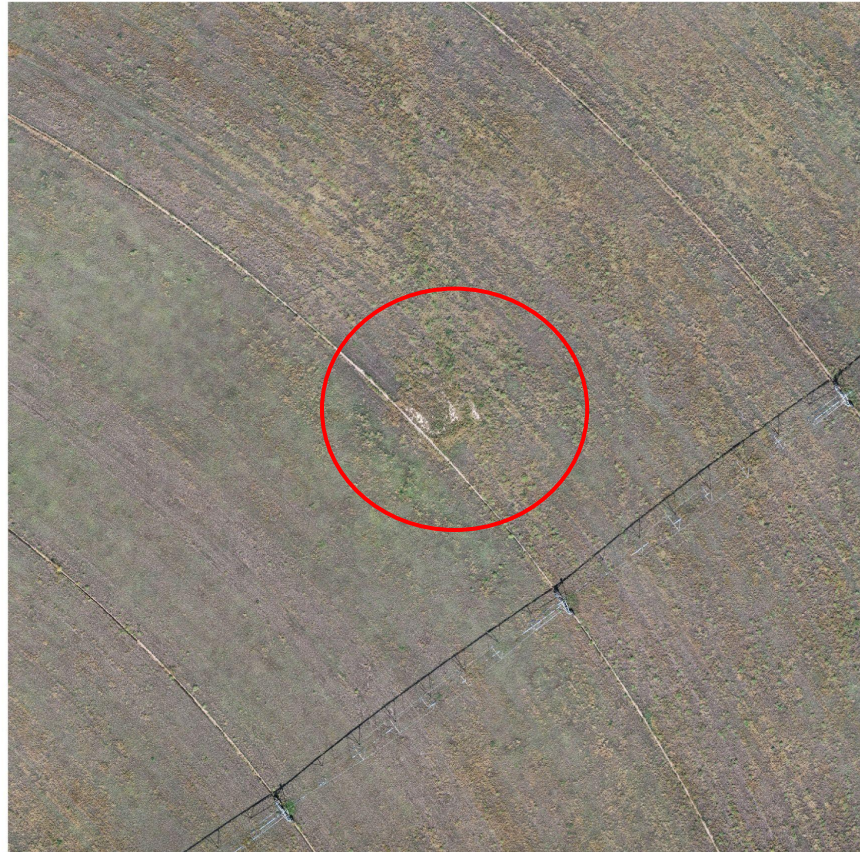
Photo 3. Orthomosaic drone aerial imagery taken from 200 ft (Sept. 2022). Illustrates growth on and around the well location (red circle). Tank battery is addressed in Location 329783 report.

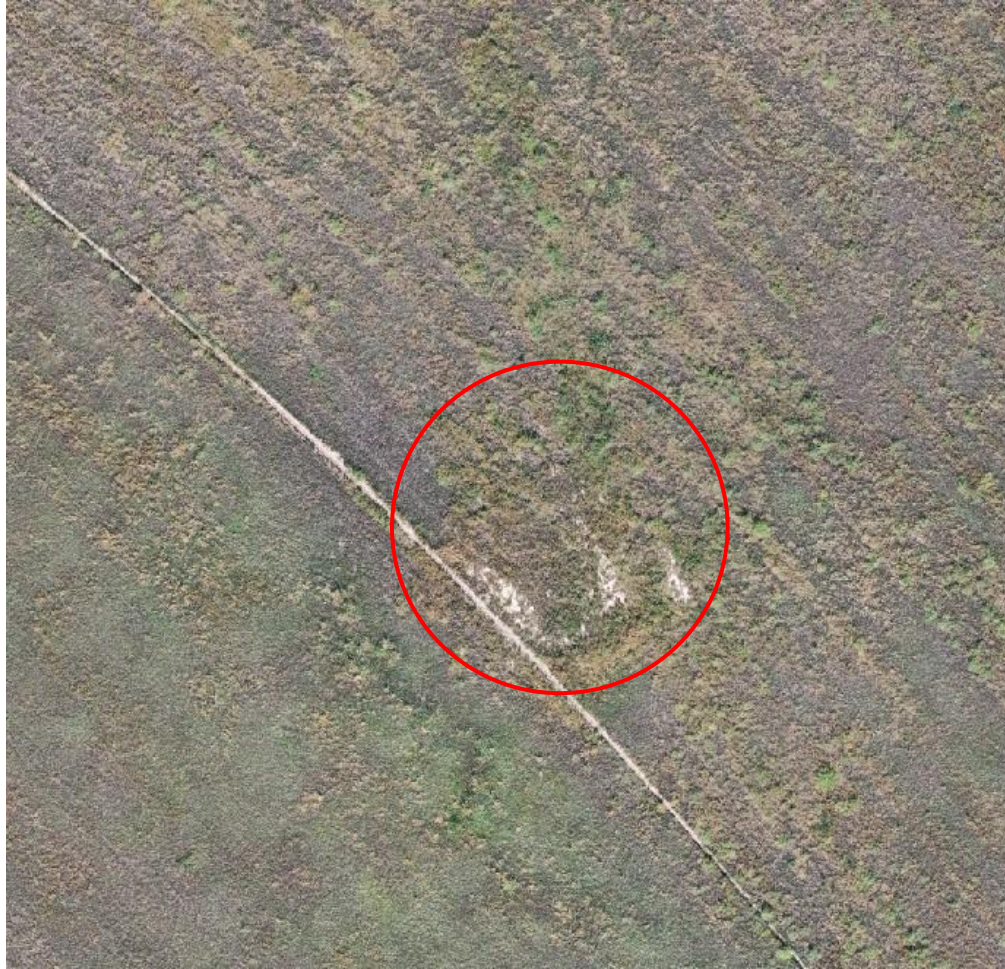
Photo 4. Zoomed in Orthomosaic drone aerial imagery taken from 200 ft (Sept. 2022). Illustrates growth on and around the well location (red circle). Some bare soil is visible however it appears to be less than 5% or 10%. Appears similar to rest of area, however crop height cannot be fully evaluated. Another inspection is required when crop is actively growing.
