Final Reclamation Inspection

Operator: NOBLE ENERGY INC- 100322

Location ID: 332012

Inspection Photos
Location Name: CONNELL C #4-5
Location ID: 332012

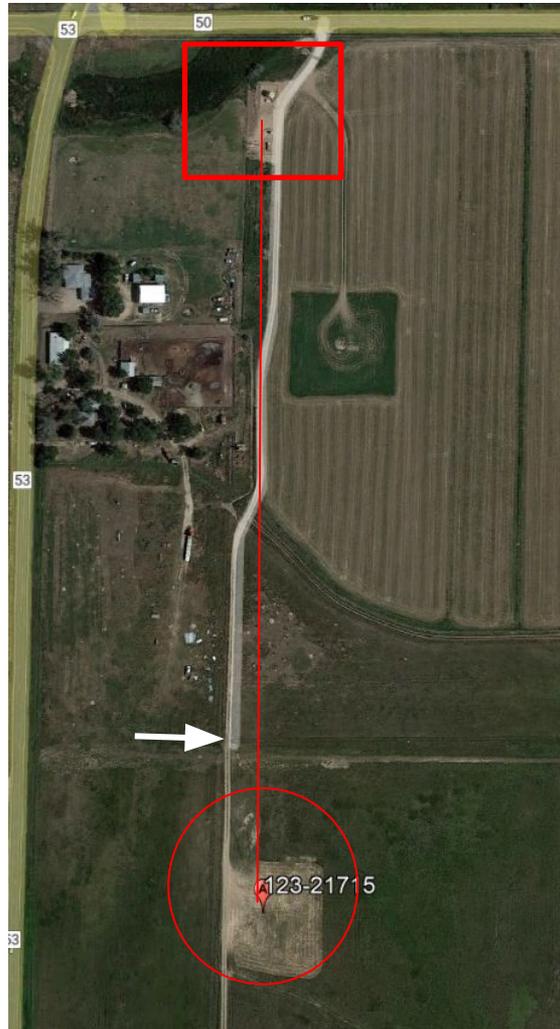
Photo 1. Google Earth aerial imagery taken 7/2019 during active operations. Photo illustrates the well location (red circle), tank battery (red rectangle), access road (white arrow), and approximate flowlines (red line).

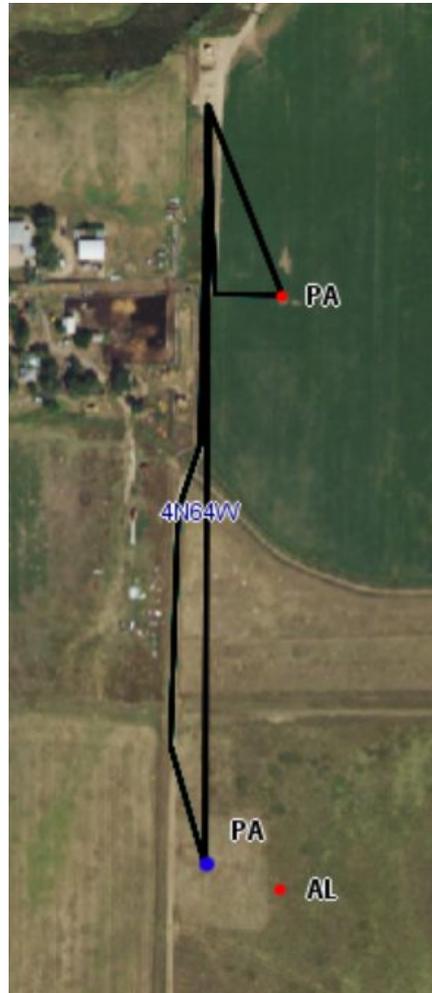
Photo 2. COGCC Online Map aerial imagery 2019 with subject well (blue dot), related wells (red dots), tank battery (north center) and flowlines (black lines). Flowline abandonment form has not been submitted.

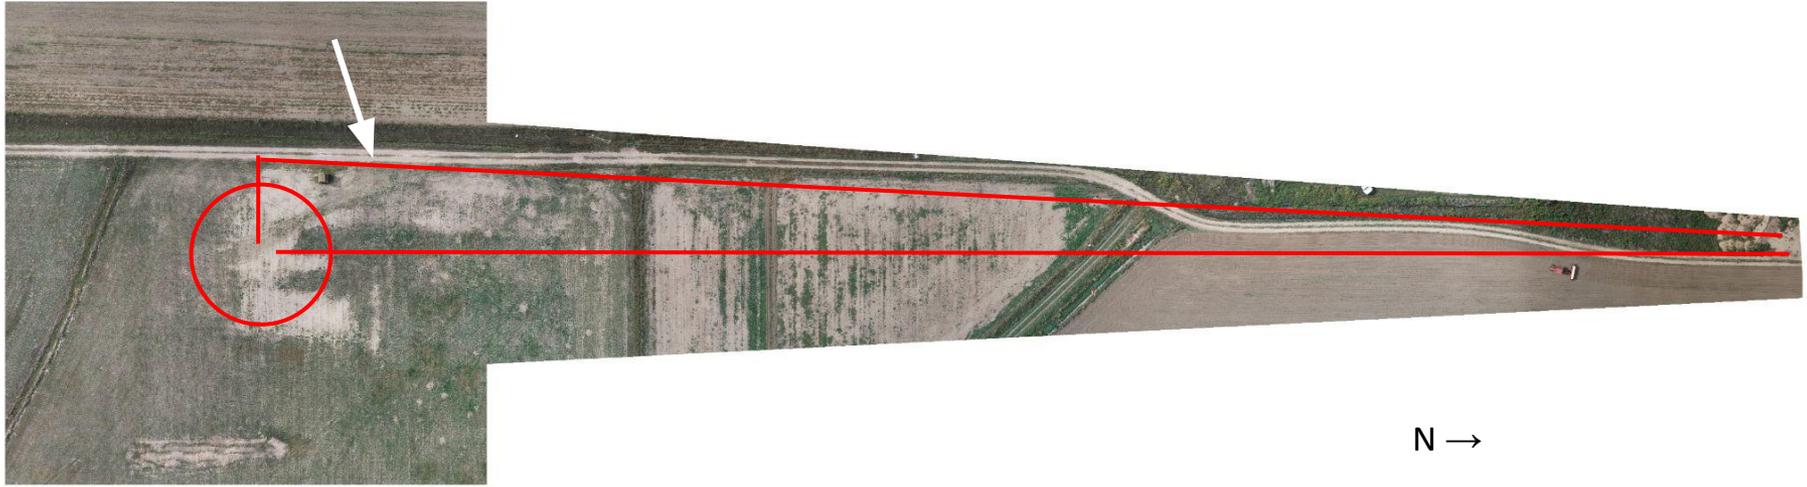
Photo 3. Orthomosaic drone aerial imagery taken from 200 ft (Sept. 2022). Illustrates growth on and around the well location (red circle), flowlines (red lines) and access road (white arrow). Red line is approximate flowlines. Tank Battery is addressed in Location 319182 report.

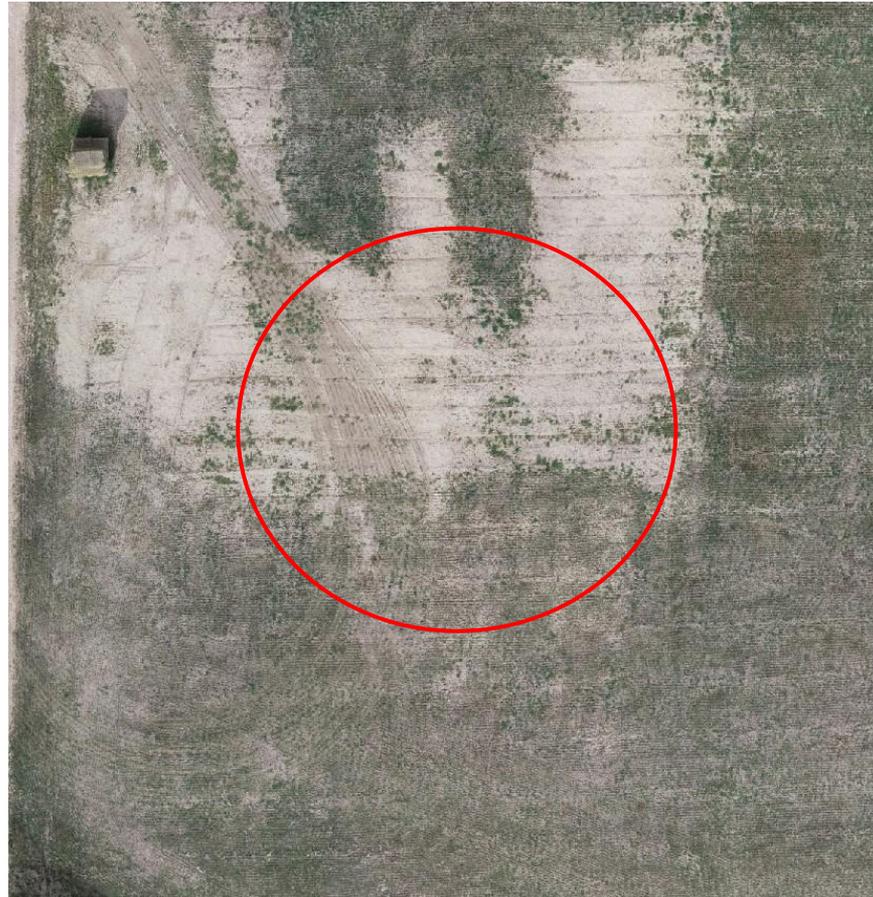
Photo 4. Zoomed in Orthomosaic drone aerial imagery taken from 200 ft (Sept. 2022). Illustrates lack of growth on and around the well location (red circle). Appears to have bare soil. Appears similar to rest of area, however crop height cannot be fully evaluated. Another inspection is required when crop is actively growing.
