# Final Reclamation Inspection

Operator: KERR MCGEE OIL & GAS ONSHORE LP -  
47120

Location ID: 332111

Inspection Photos  
Location Name: MOSER \*15-4  
Location ID: 332111

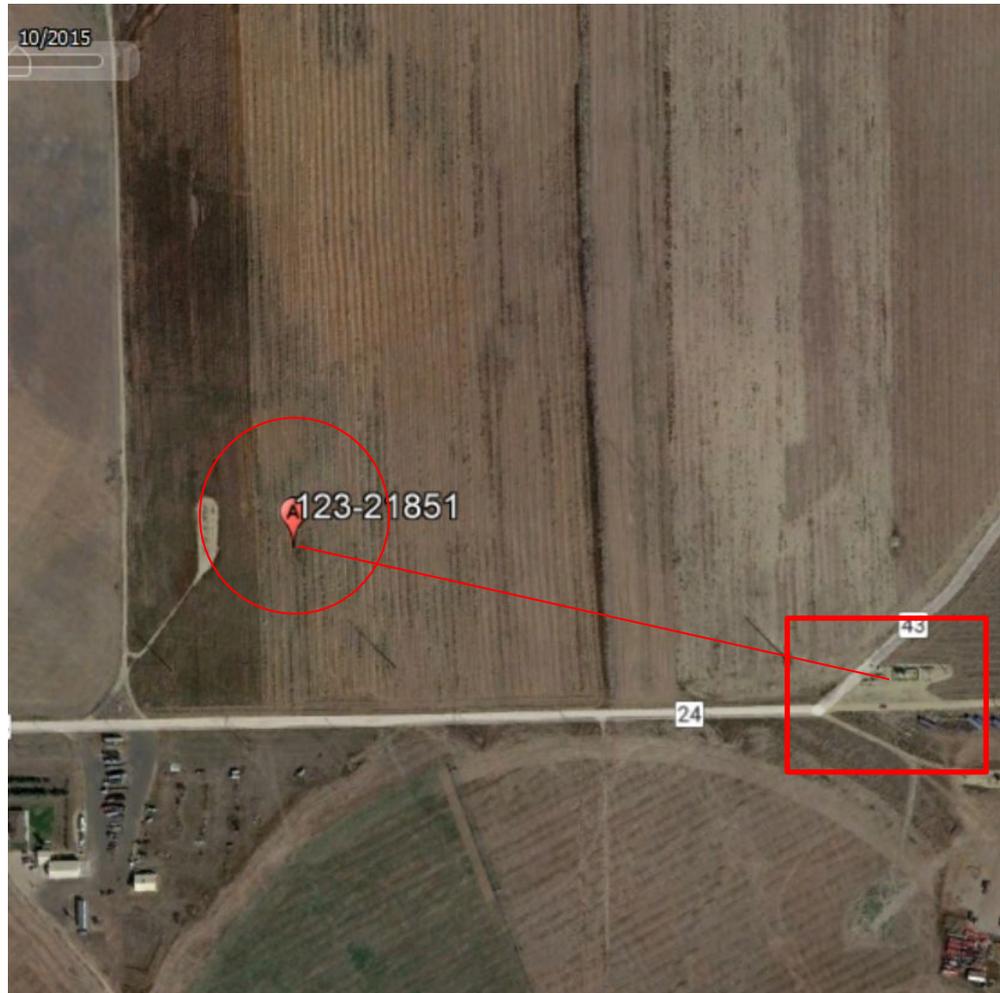
**Photo 1.** Google Earth aerial imagery taken 10/2015 during active operations. Photo illustrates the well location (red circle), tank battery (red square), and flowline (red line).

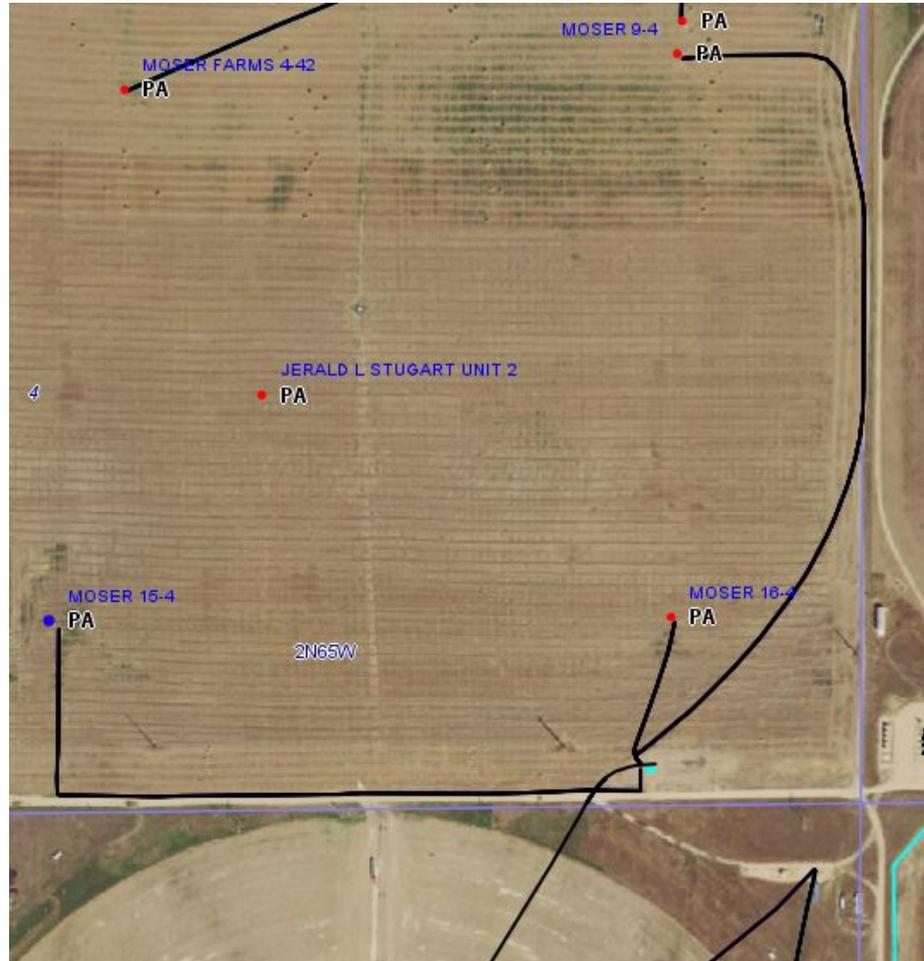
**Photo 2.** COGCC Online Map aerial imagery 2019 with related wells (red dots), subject well (blue dot), tank battery (near southeast corner) and flowlines (black lines).

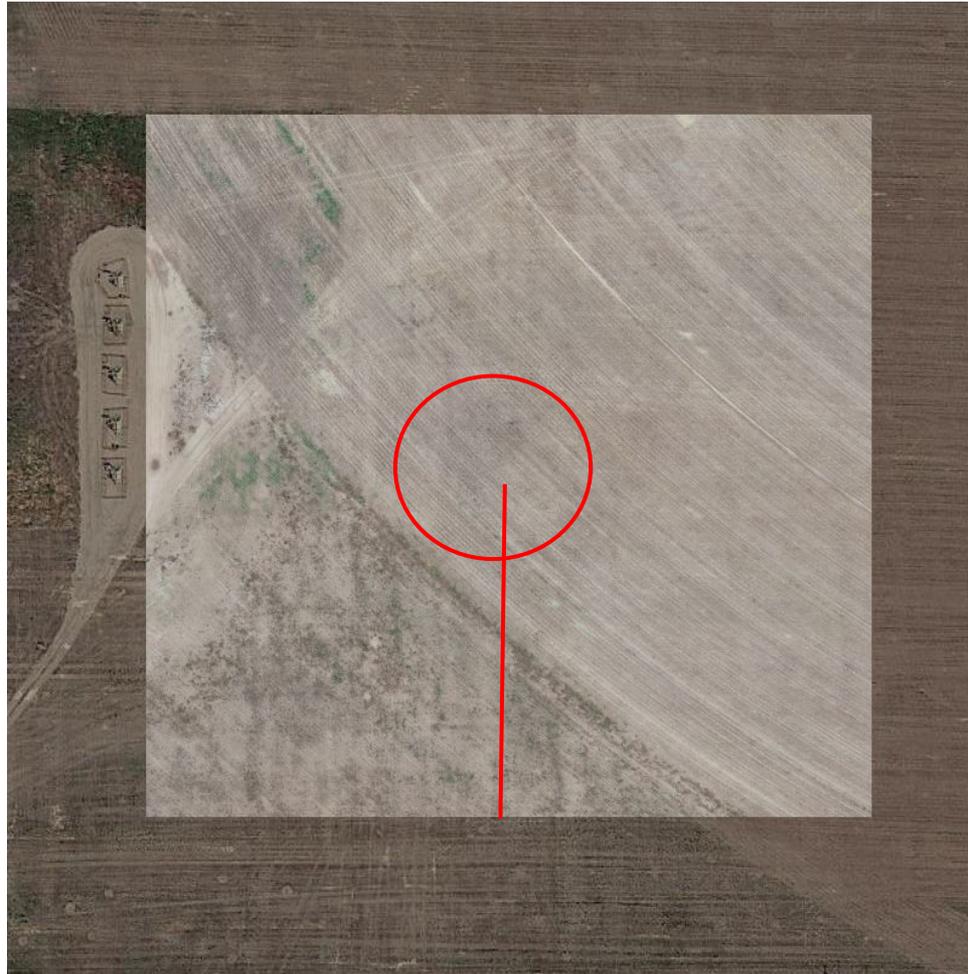
**Photo 3.** Orthomosaic drone aerial imagery taken from 200 ft (Oct. 2022). Illustrates harvested crop on and around the well location (red circle) and flowline (red line). Access road is not visible. Tank Battery is addressed in Location 305754 report.

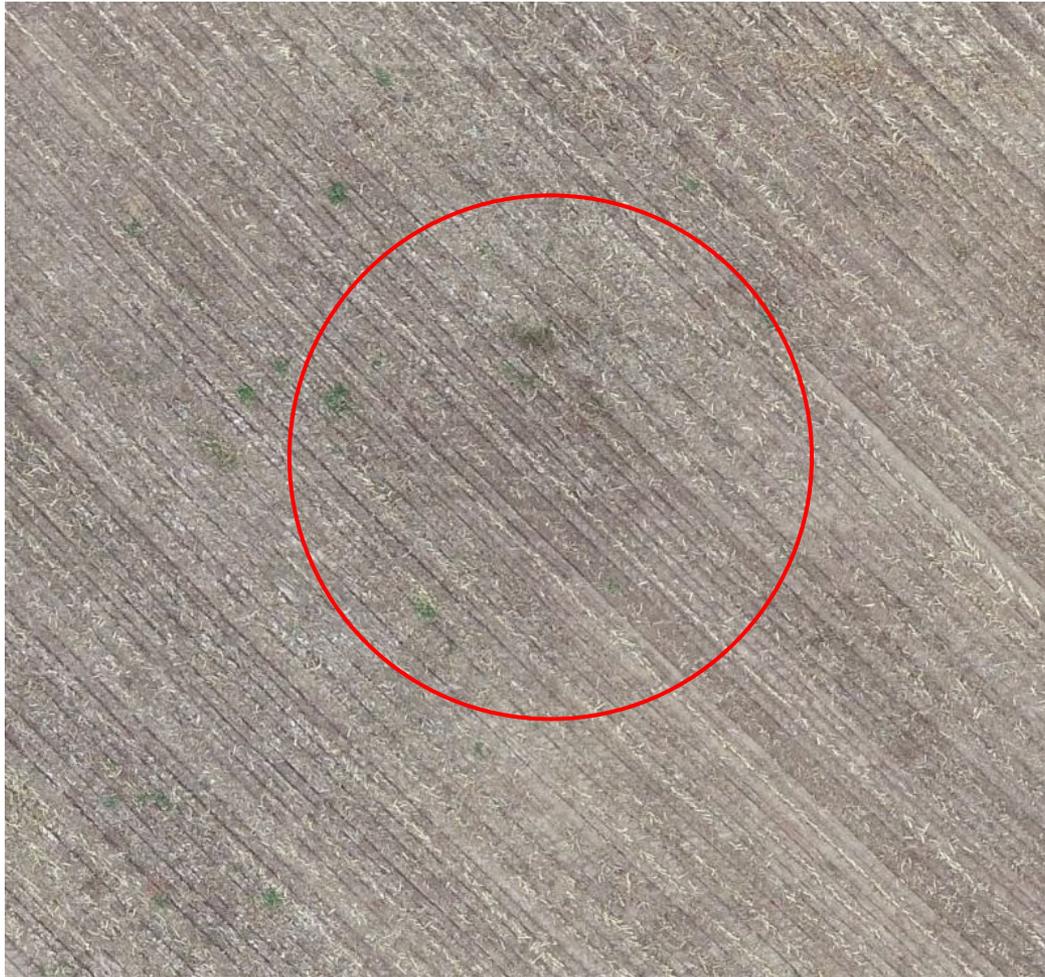
**Photo 4.** Zoomed in Orthomosaic taken from 200 ft (Oct. 2022). Illustrates harvested crop on and around the well location (red circle). Appears similar to rest of area, however crop height cannot be fully evaluated. Another inspection is required when crop is actively growing.

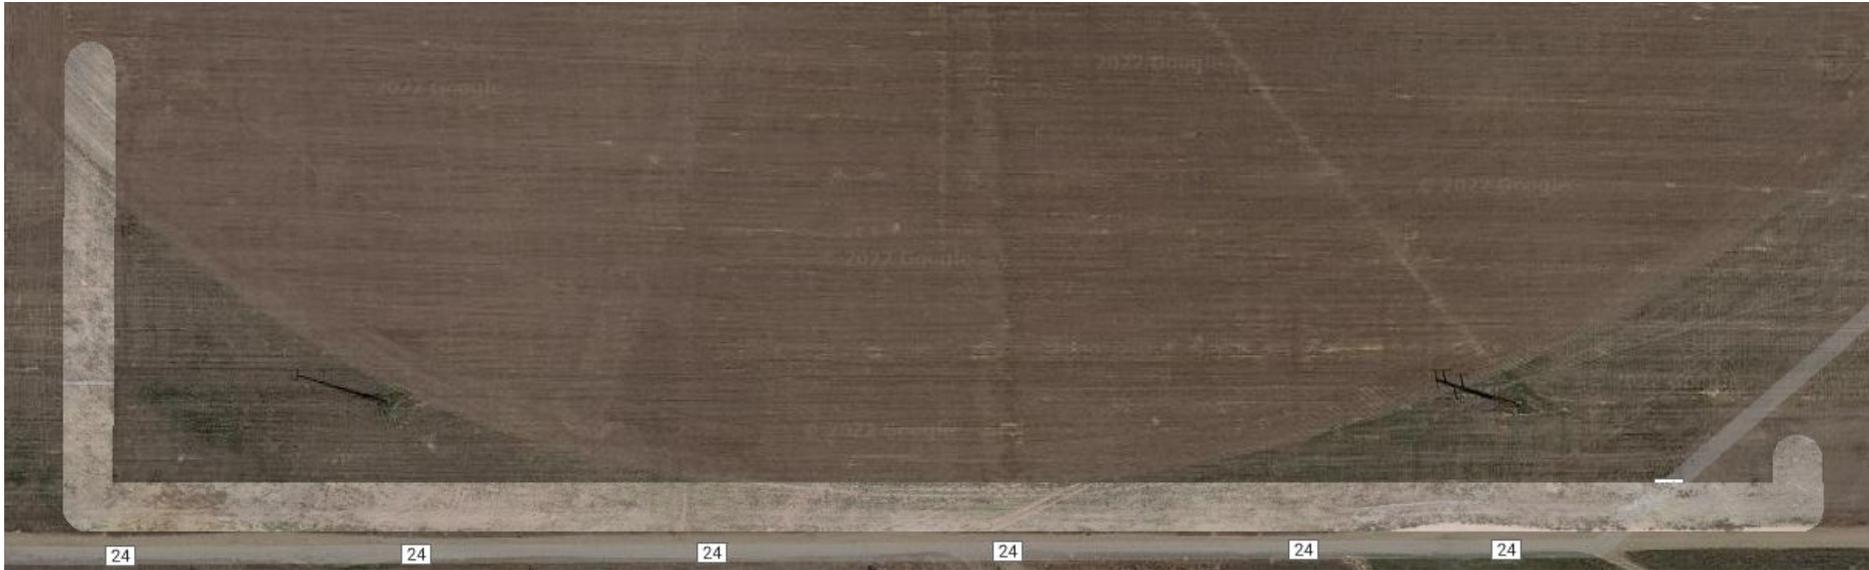
**Photo 6.** Zoomed in Orthomosaic taken from 200 ft (Oct. 2022). Illustrates mainly rangeland growth with some harvested crop on and around the flowline. Located mainly on the edge of the field.
