Final Reclamation Inspection

Operator: KERR MCGEE OIL & GAS ONSHORE LP -
47120

Location ID: 336489

Inspection Photos
Location Name: CANNON X *04-30D
Location ID: 336489

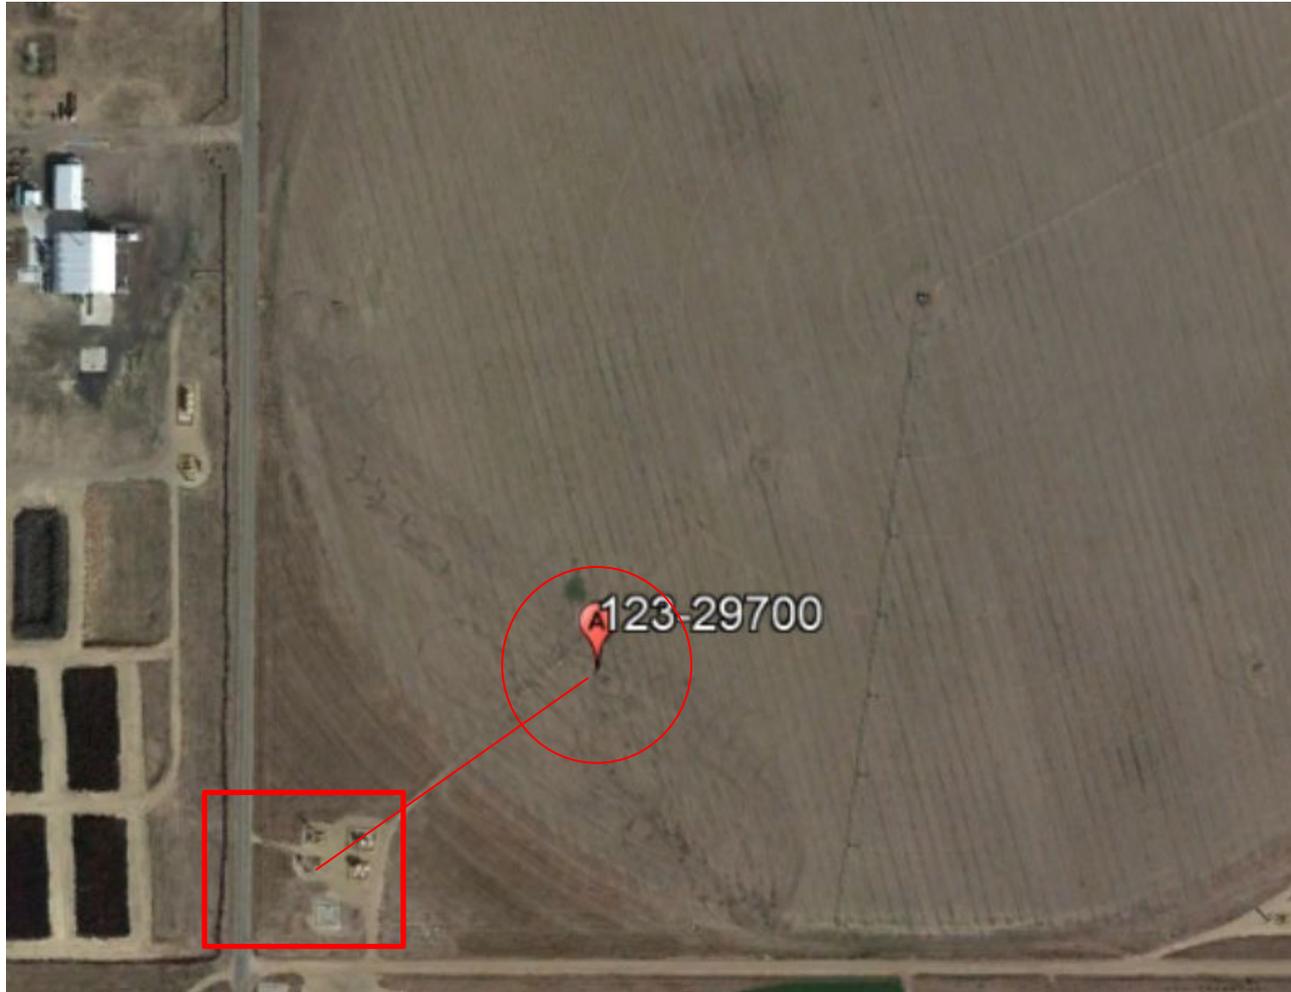
Photo 1. Google Earth aerial imagery taken 10/2015 during active operations. Photo illustrates the well location (red circle), tank battery (red square), and flowline (red line).

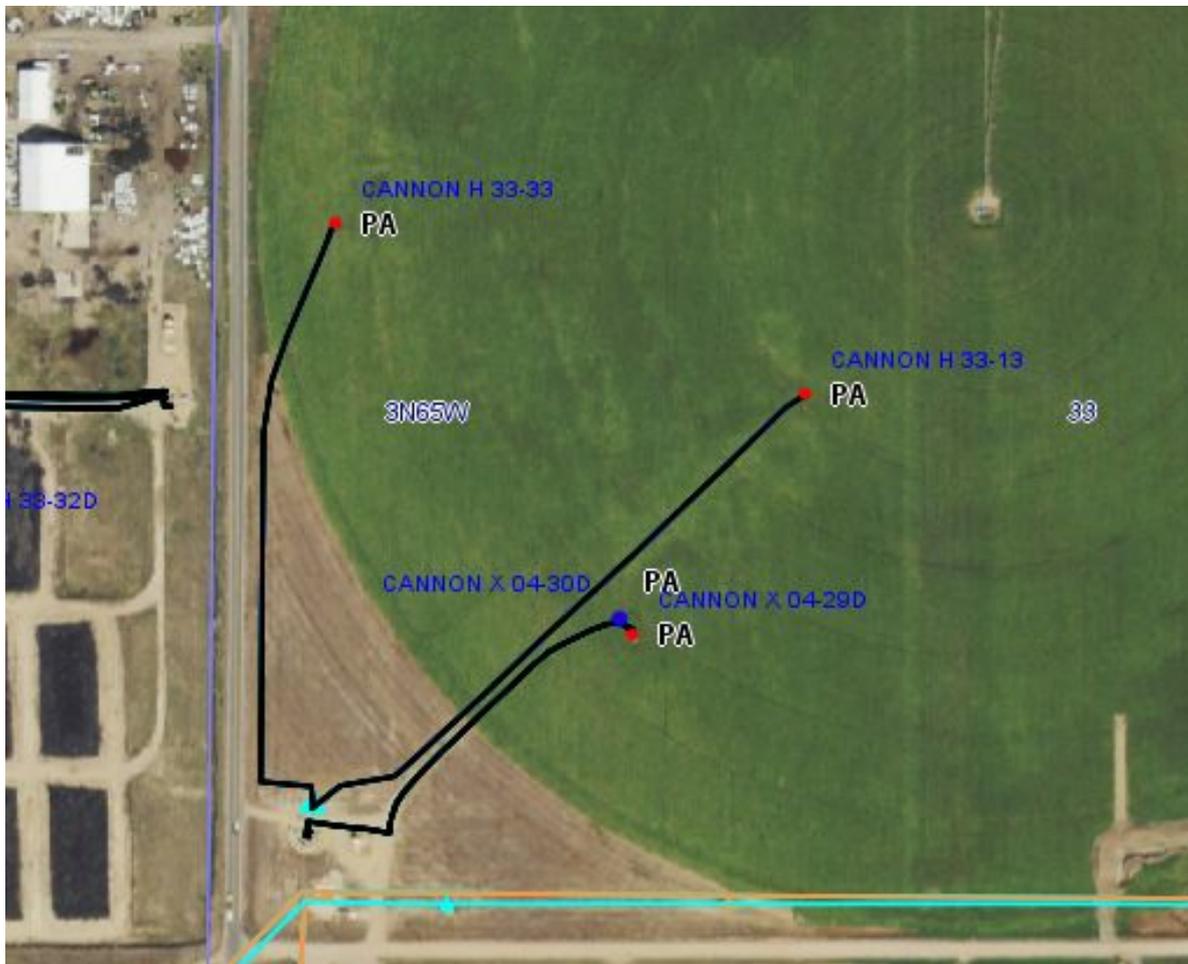
Photo 2. COGCC Online Map aerial imagery 2019 with related wells (red dots), subject well (blue dot), tank battery (near southwest corner) and flowlines (black lines).

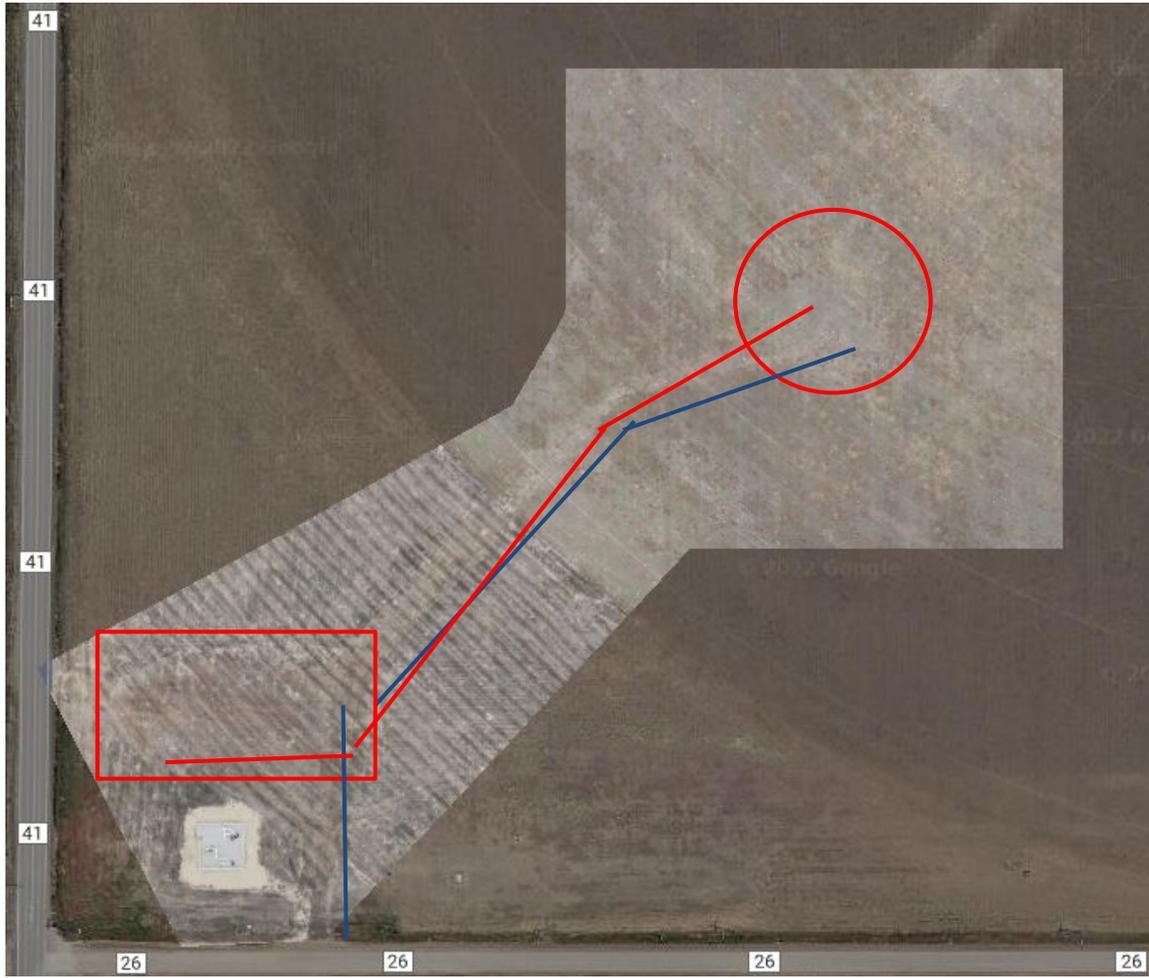
Photo 3. Orthomosaic drone aerial imagery taken from 200 ft (Oct. 2022). Illustrates rangeland growth on and around the well location (red circle), flowline (red line), tank battery (red rectangle) and access road (blue line). Tank battery area and access road still visible, so not full rangeland coverage.

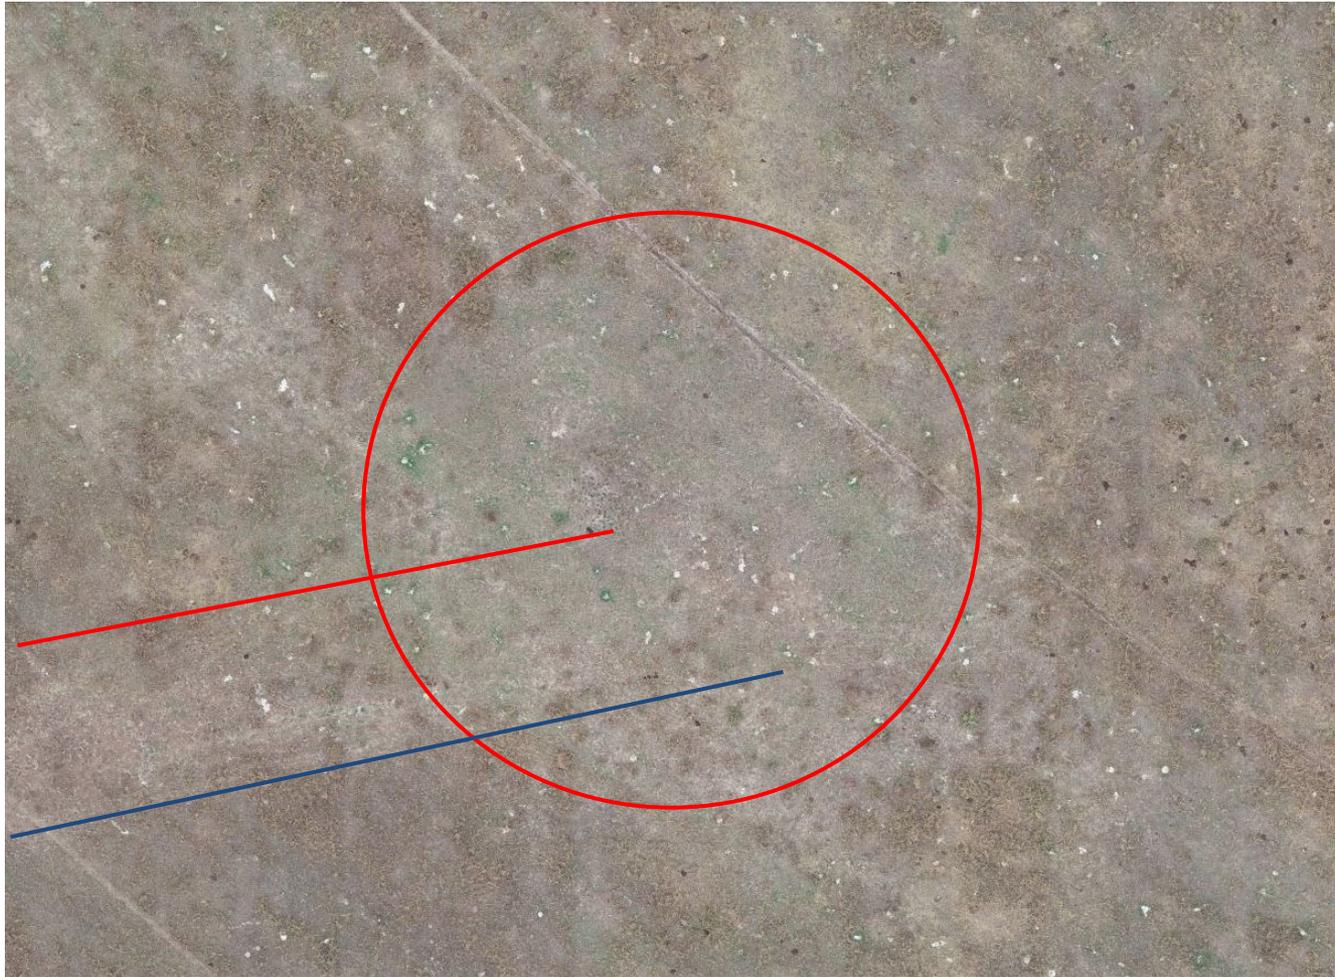
Photo 4. Zoomed in Orthomosaic taken from 200 ft (Oct. 2022). Illustrates rangeland growth on and around the well location (red circle) and access road (blue line). Comparable to surrounding area.

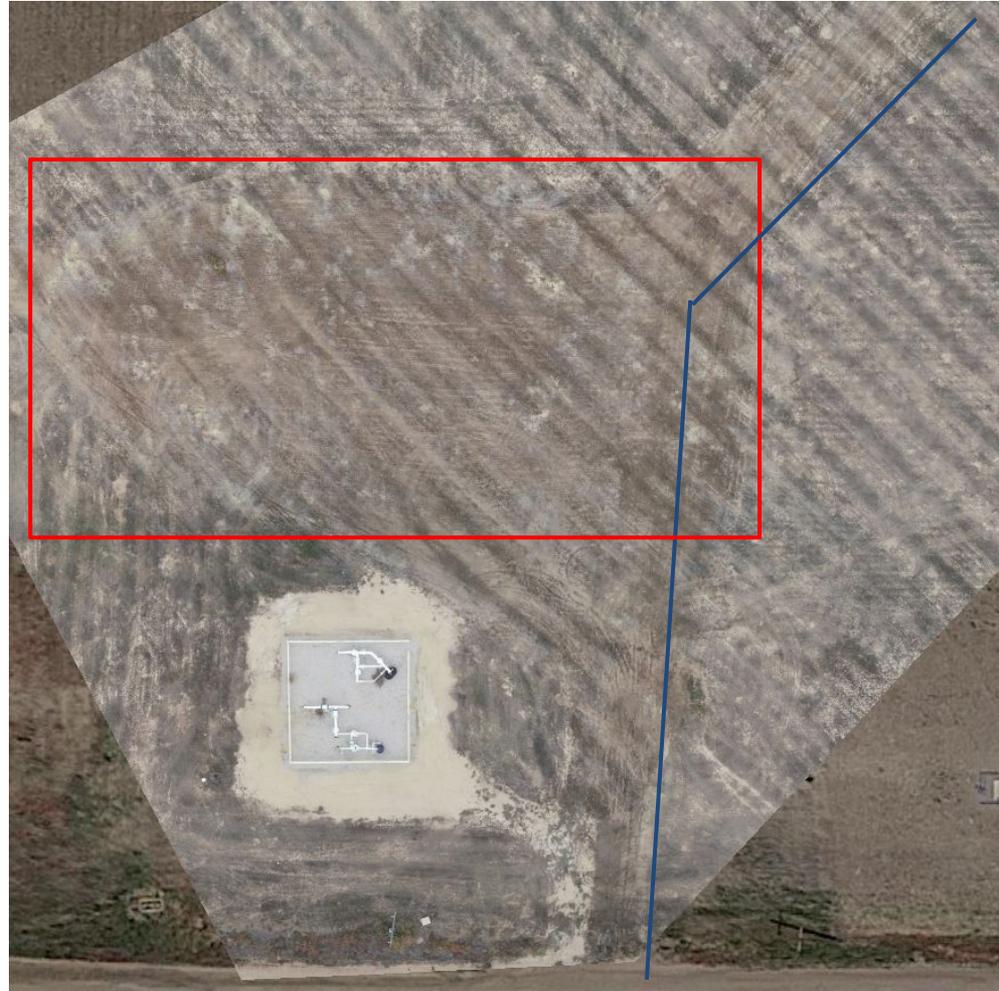
Photo 5. Zoomed in Orthomosaic taken from 200 ft (Oct. 2022). Illustrates some rangeland growth on and around the tank battery (red rectangle) and access road (blue line). Tank battery is removed.
