Final Reclamation Inspection

Operator: KERR MCGEE OIL & GAS ONSHORE LP -
47120

Location ID: 329678

Inspection Photos
Location Name: UPRC *33-12J5
Location ID: 329678

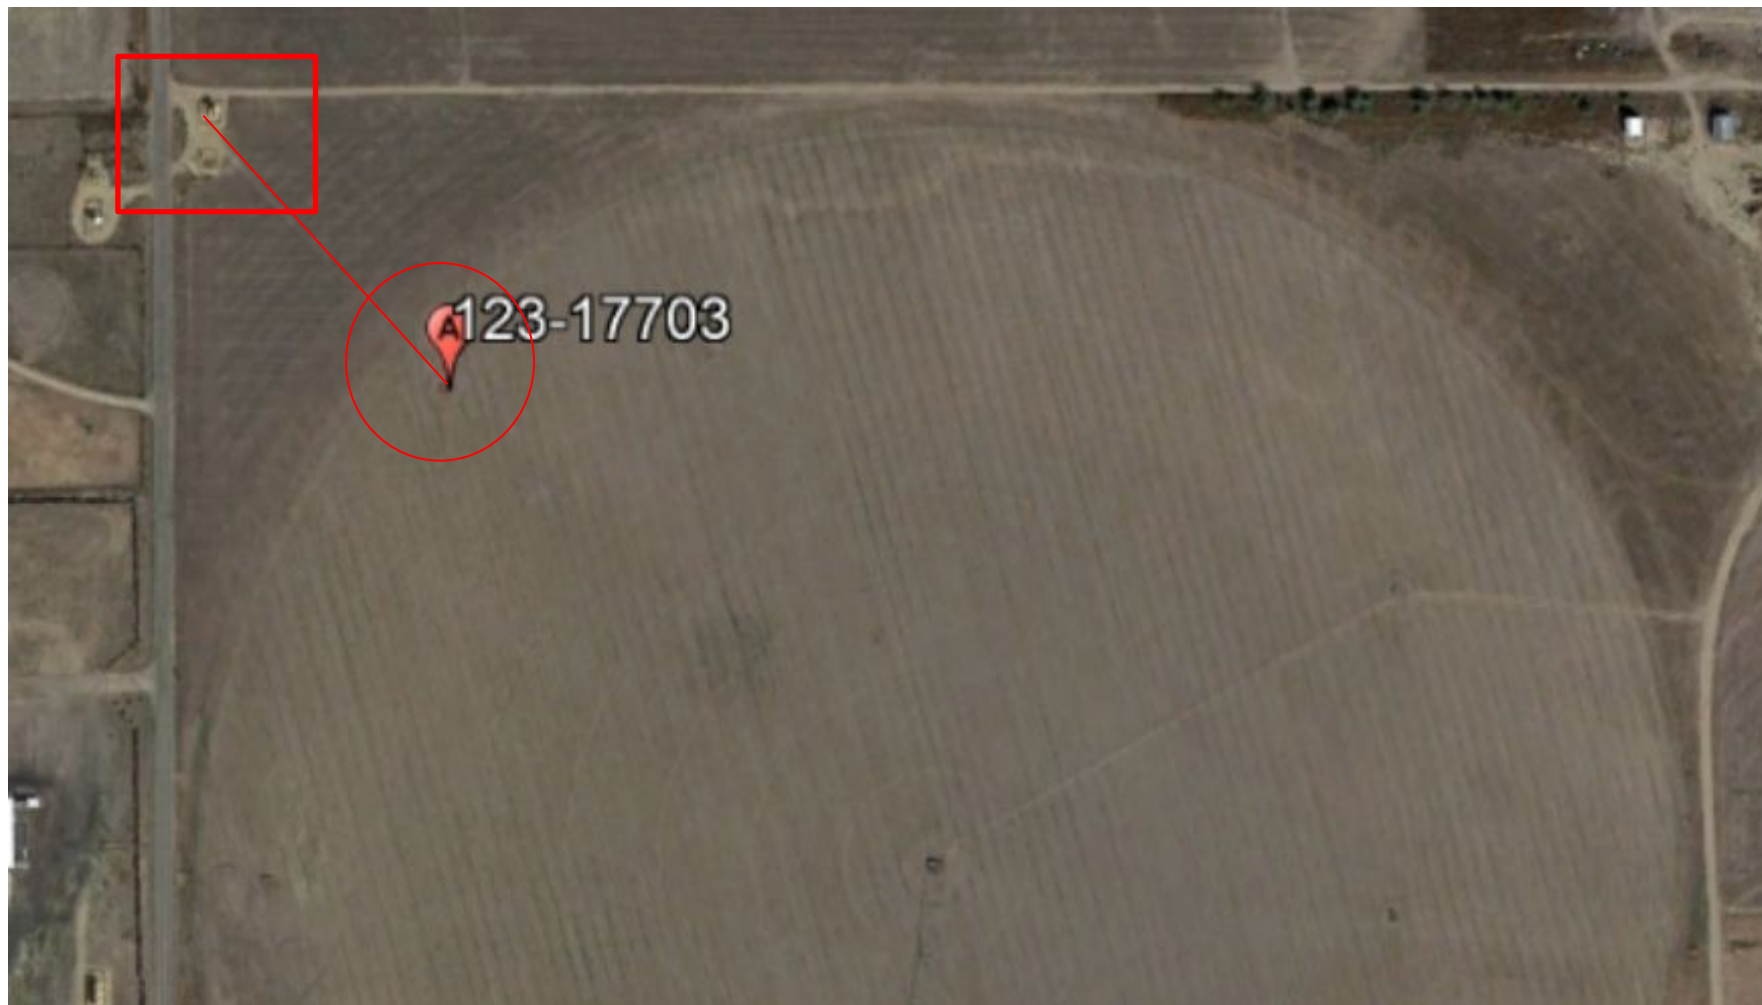
Photo 1. Google Earth aerial imagery taken 10/2015 during active operations. Photo illustrates the well location (red circle), tank battery (red square), and flowline (red line).

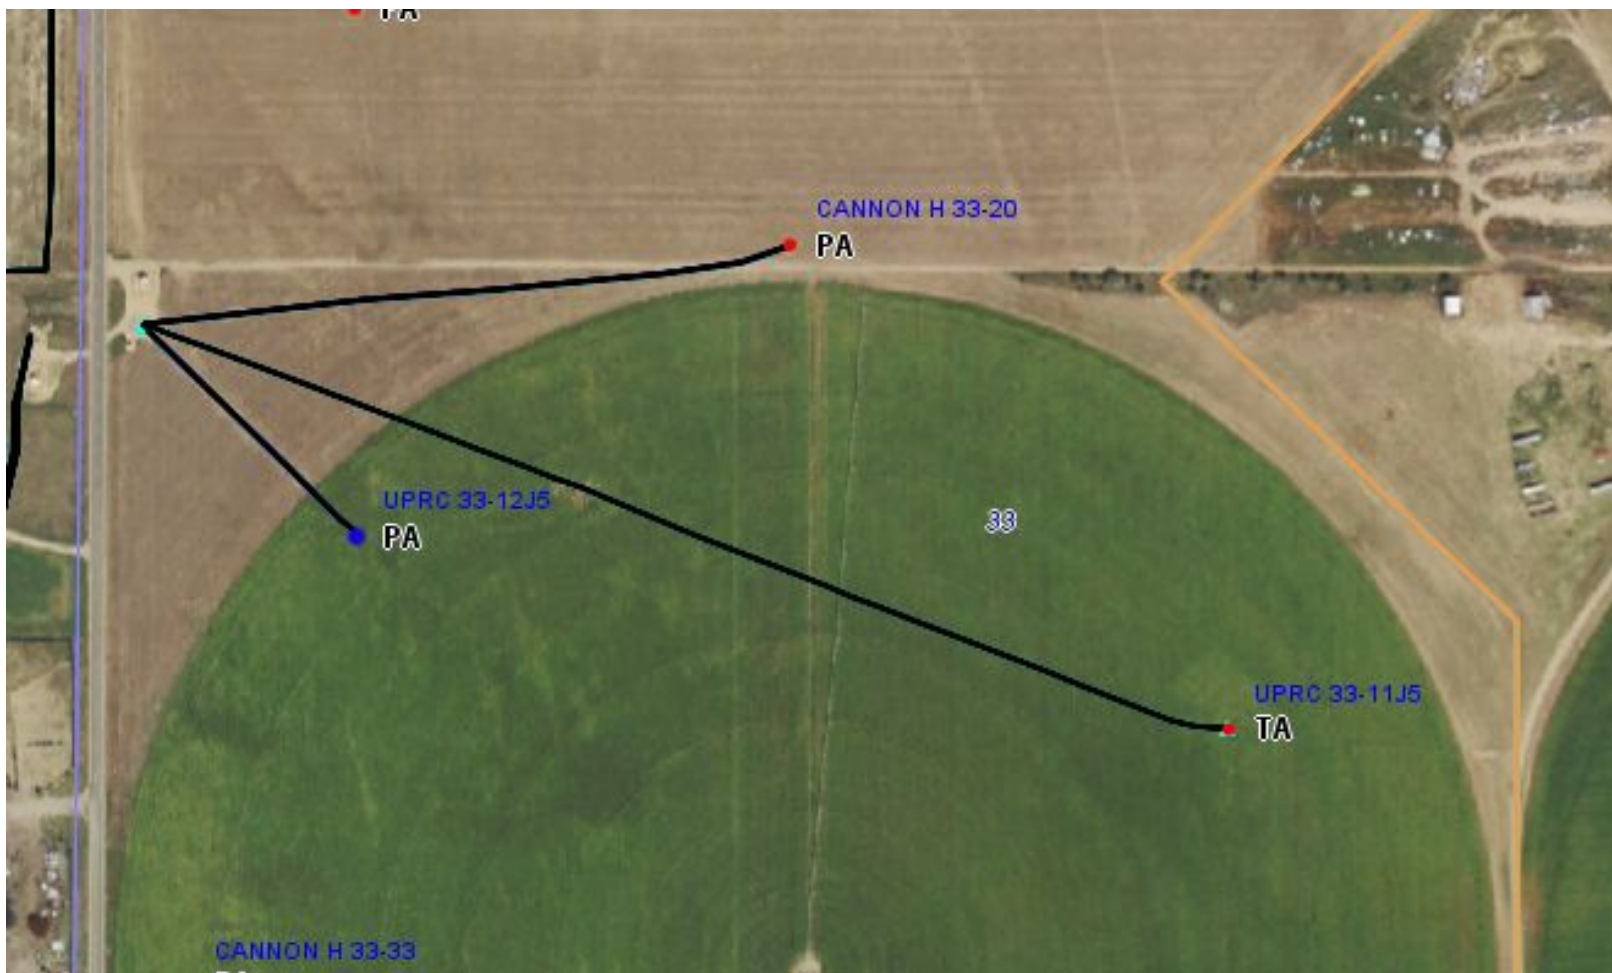
Photo 2. COGCC Online Map aerial imagery 2019 with related wells (red dots), subject well (blue dot), tank battery (near northwest corner) and flowlines (black lines).

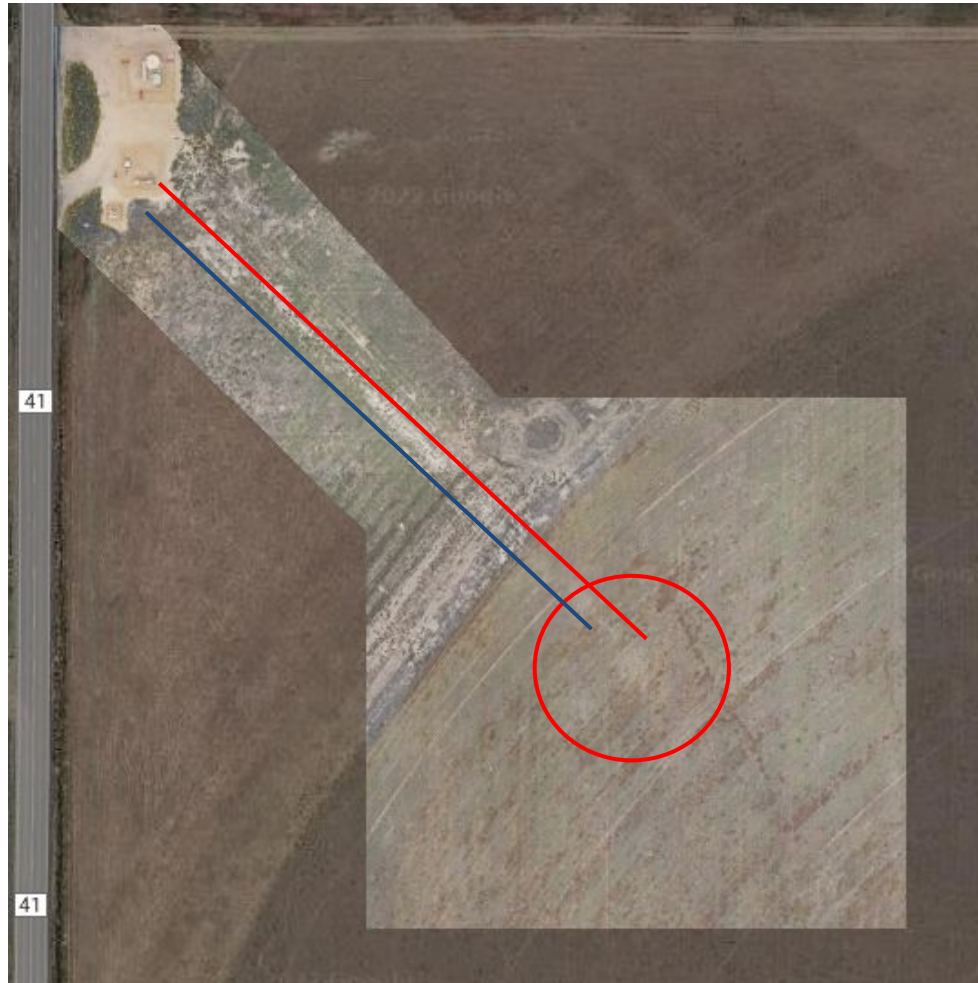
Photo 3. Orthomosaic drone aerial imagery taken from 200 ft (Oct. 2022). Illustrates rangeland on and around the well location (red circle), flowline (red line), and access road (above blue line). Tank battery is still has equipment remaining. Access road is still visible.

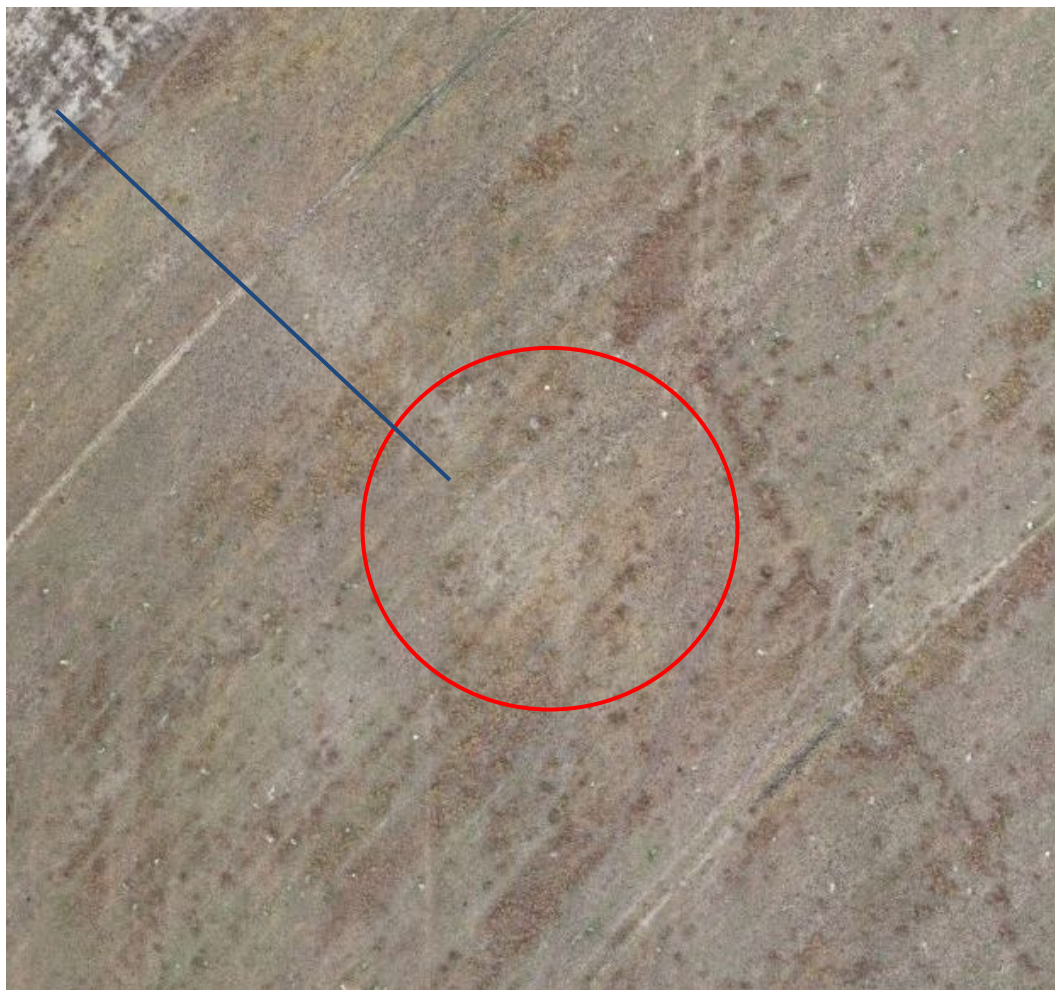
Photo 4. Zoomed in Orthomosaic taken from 200 ft (Oct. 2022). Illustrates rangeland growth on and around the well location (red circle) that is comparable to surrounding area. Access road (blue line) is barely visible in an agricultural field.

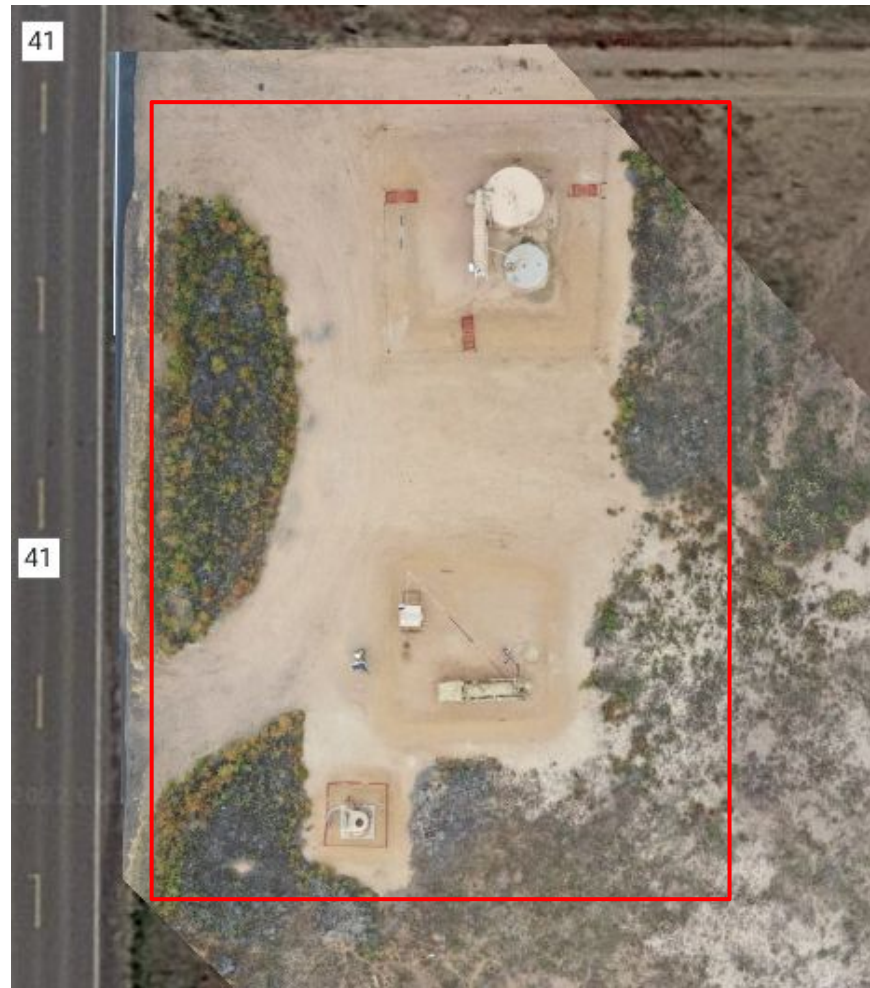
Photo 5. Zoomed in Orthomosaic taken from 200 ft (Oct. 2022). Illustrates equipment remaining on tank battery (red rectangle).

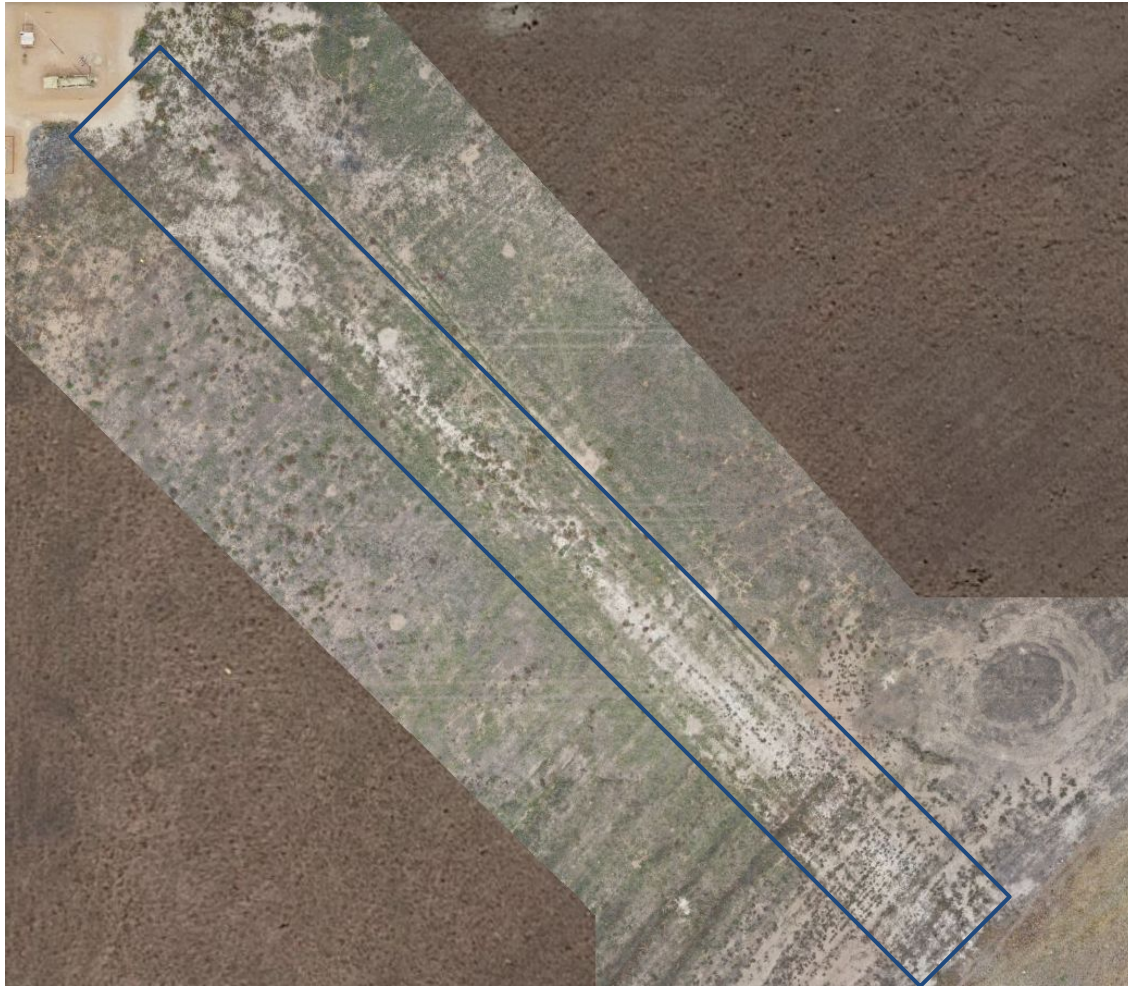
Photo 6. Zoomed in Orthomosaic taken from 200 ft (Oct. 2022). Illustrates lack of full rangeland growth on and around the access road (blue line).
