# Interim Reclamation and Stormwater Inspection

Operator: UPLAND EXPLORATION LLC- #10701

Location ID: 462919

Location Name: Little Lady 21/South Well Pad

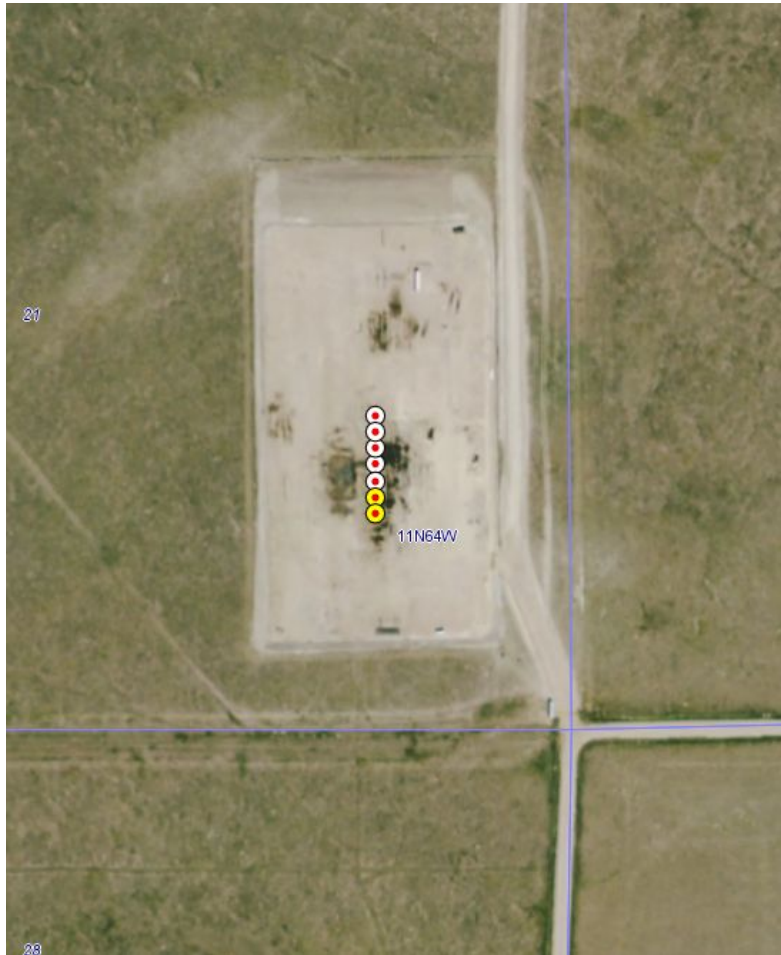
**Photo 2.** COGCC GISOnline aerial imagery from 2019 illustrates the location. At the time of this inspection, the location remains the same size and interim reclamation has not been performed- refer to Photos 4-5.

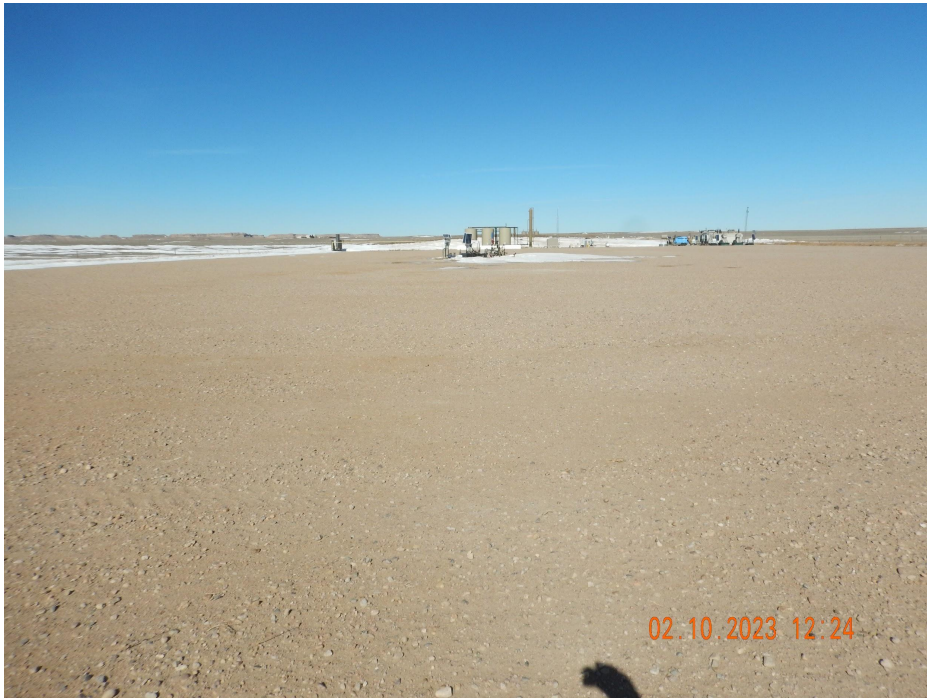
**Photo 4.** Photo taken from the southern location, facing North. Photo illustrates interim reclamation has not been performed.

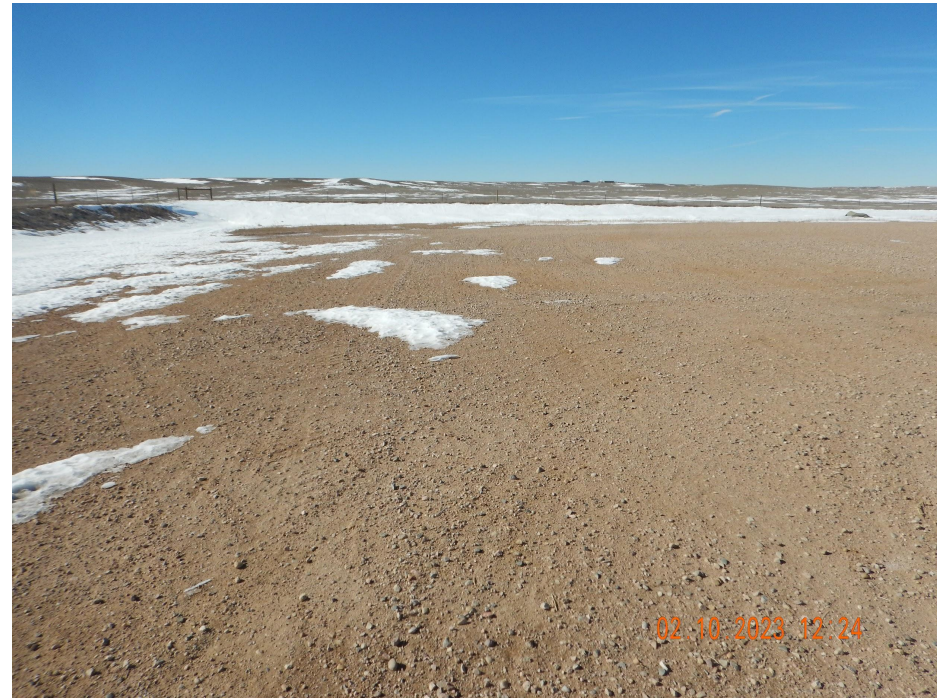
**Photo 5.** Photo taken from the southern location, facing West. See comments under Photo 4.

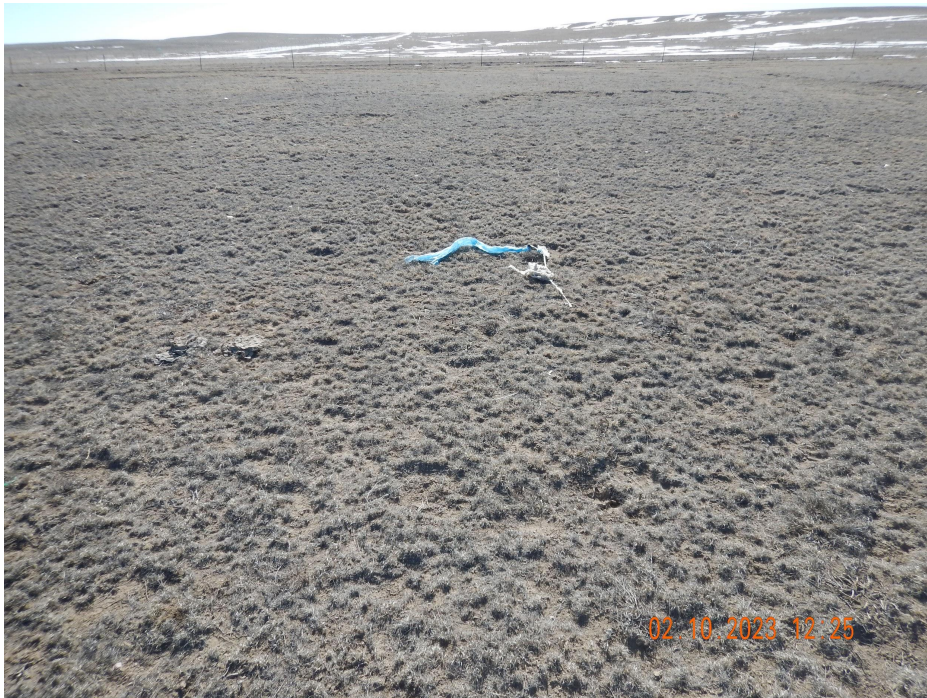
**Photo 6.** Photo taken from the southern location, facing South. Photo illustrates trash has blown off location.

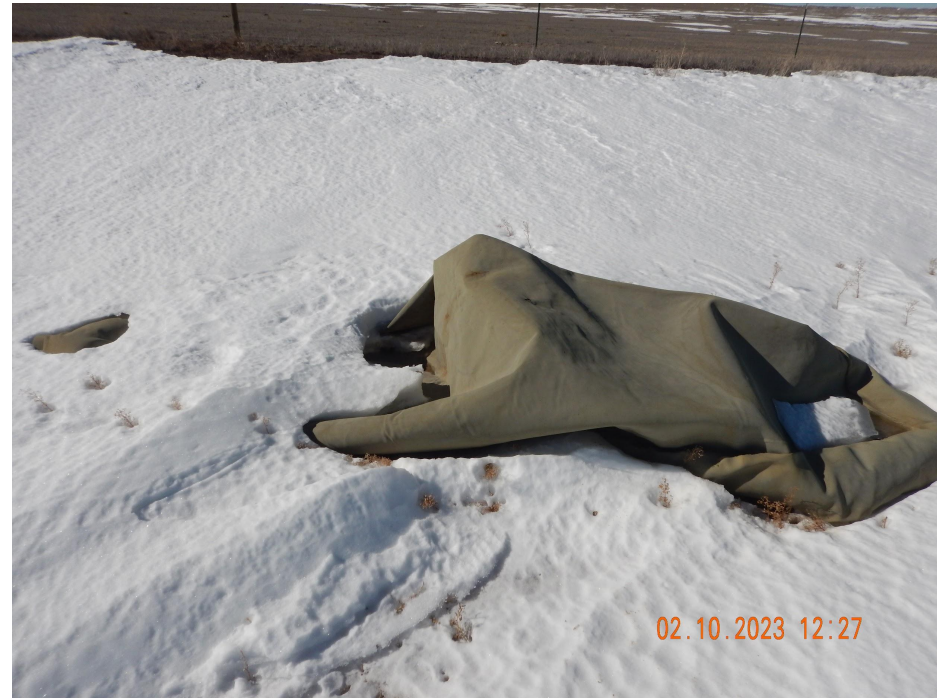
**Photo 7.** Photo taken from the western location, facing West. Photo illustrates a potential tarp that was not secured and is not considered trash/debris.

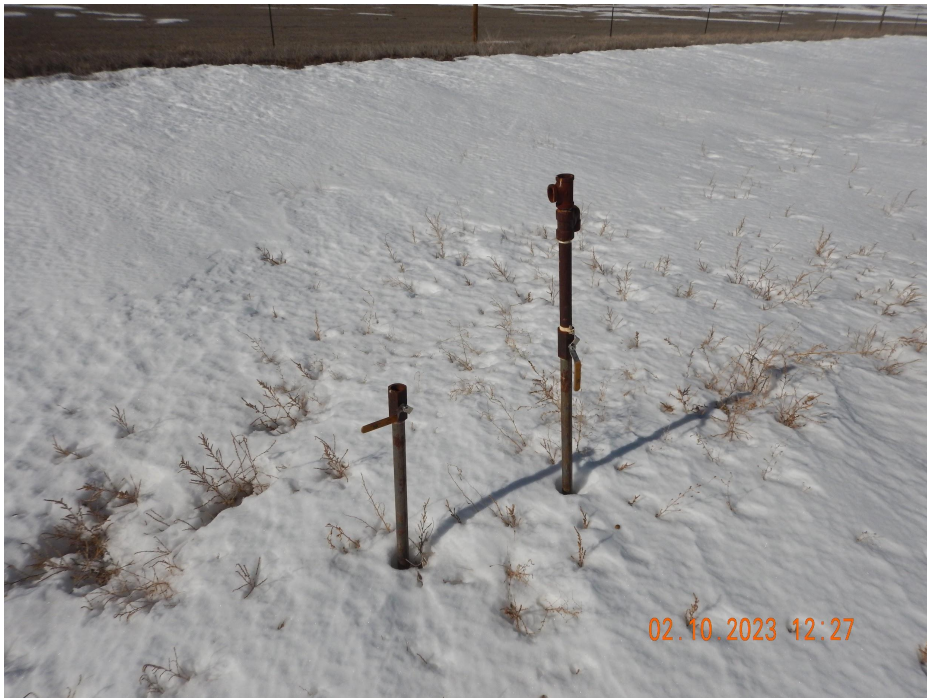
**Photo 8.** Photo taken from the western location, facing Northwest. Photo illustrates unused risers and this is considered unused equipment.

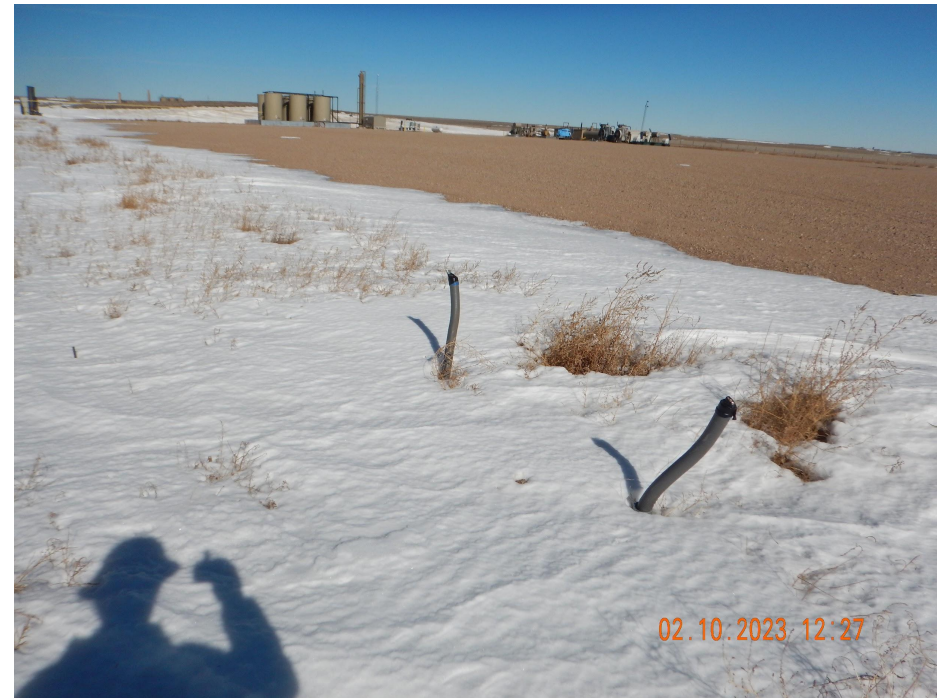
**Photo 9.** Photo taken from the western location, facing Northeast. Photo illustrates electrical power sources related to the risers; this is considered unused equipment.

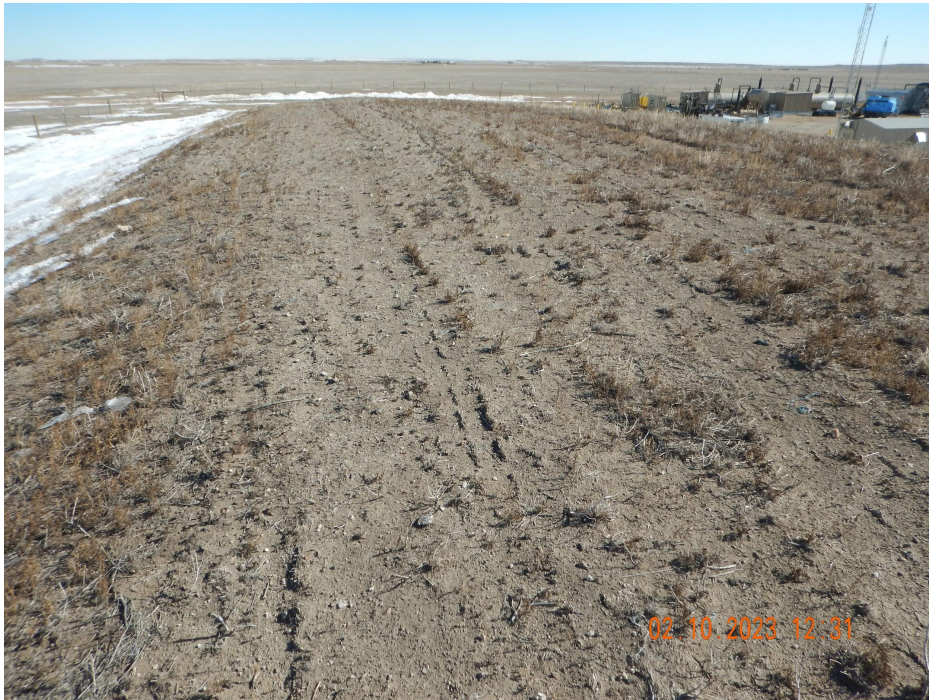
**Photo 10.** Photo taken from the northern location, facing East. Photo illustrates the topsoil stockpile which is primarily bare or has weedy, annual vegetation with minimal perennial vegetation that would not met the standard.

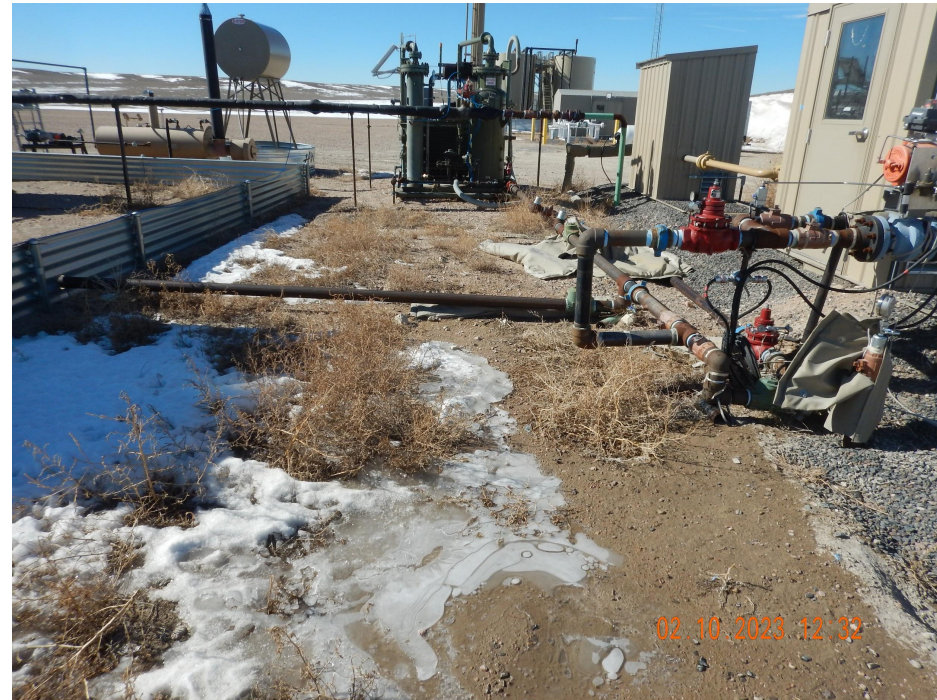
**Photo 11.** Photo taken from the northeastern location, facing West. Photo illustrates weed debris and weedy vegetation around production equipment.

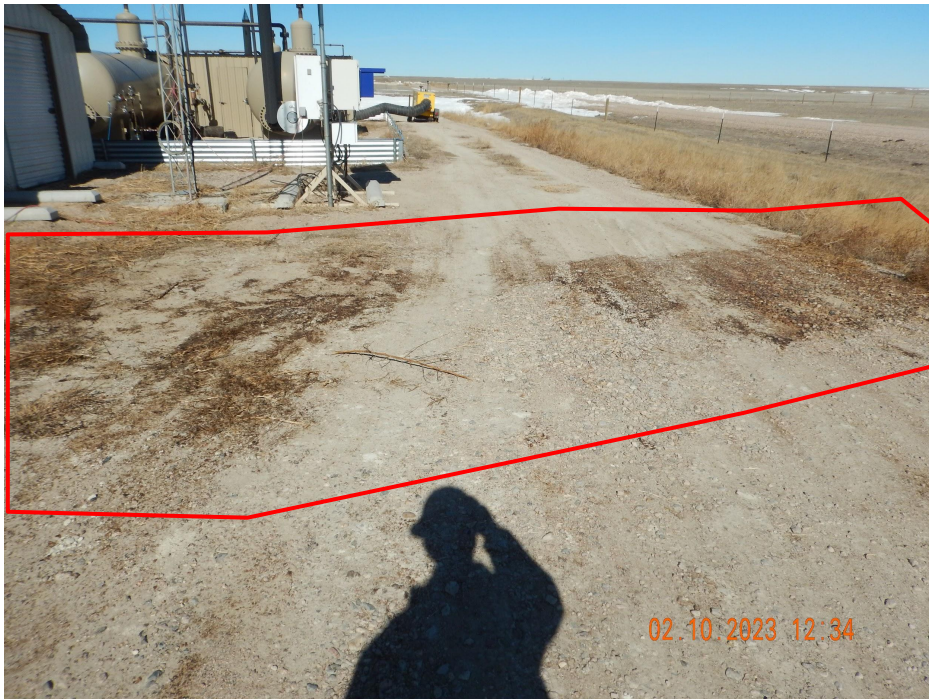
**Photo 12.** Photo taken from the eastern location, facing North. Photo illustrates a spill of what appears to be non-E&P exempt waste from a Mobil Pegasus SAE 40 container. This will need to be reported to CDPHE and this appears to be a violation of Rule 906.

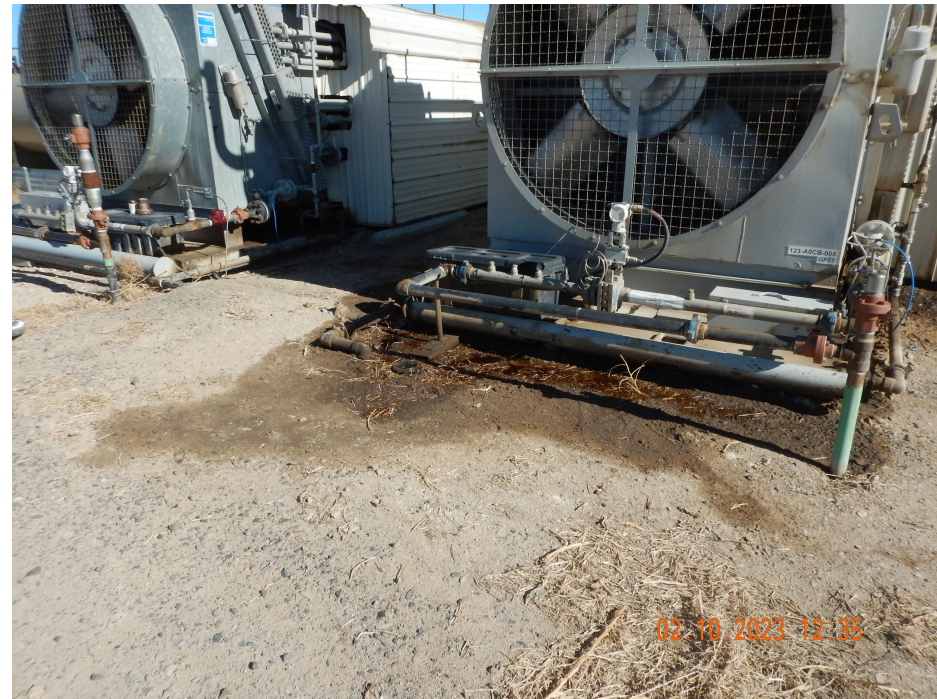
**Photo 13.** Photo taken from the eastern location, facing East. Photo illustrates stained soil/spill related to the compressor.

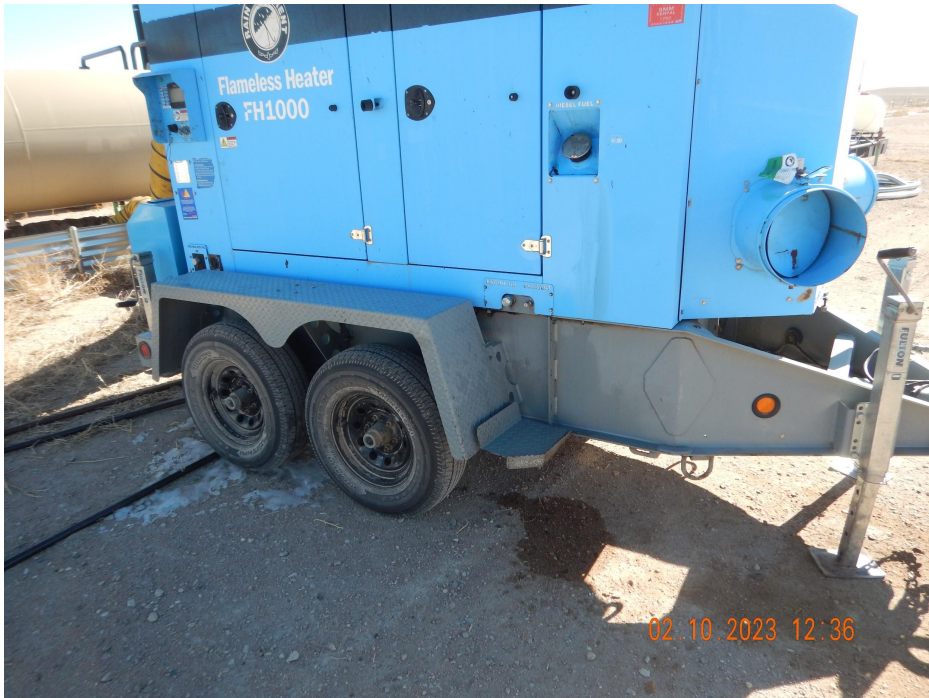
**Photo 14.** Photo taken from the eastern location. Photo illustrates poor housekeeping, as diesel fuel has spilled onto the ground. Operator will be required to have secondary containment for materials handling and spill prevention practices.

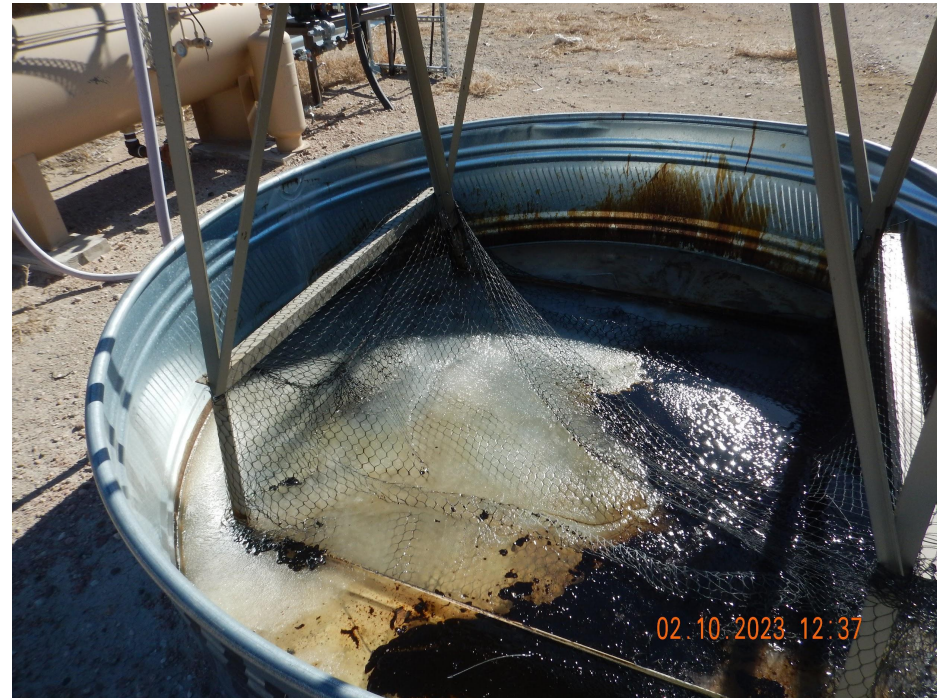
**Photo 15.** Photo taken from the eastern location. Photo illustrates netting is in disrepair. Remove and properly dispose fluids from within the secondary containment.

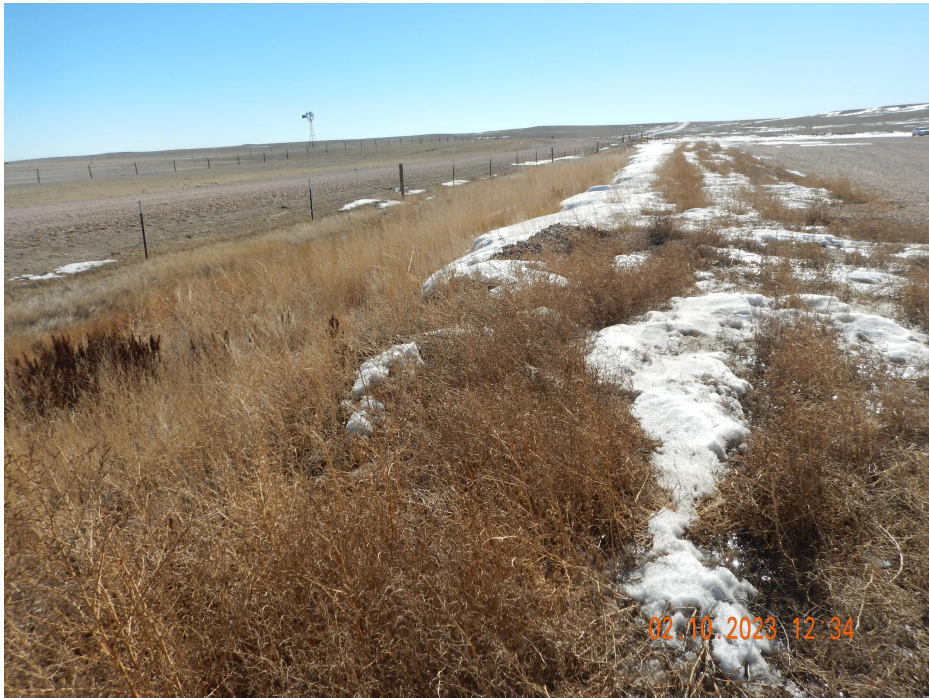
**Photo 16.** Photo taken from the eastern location, facing South. Photo illustrates unmanaged, weedy vegetation along the eastern well pad and the BMP area.

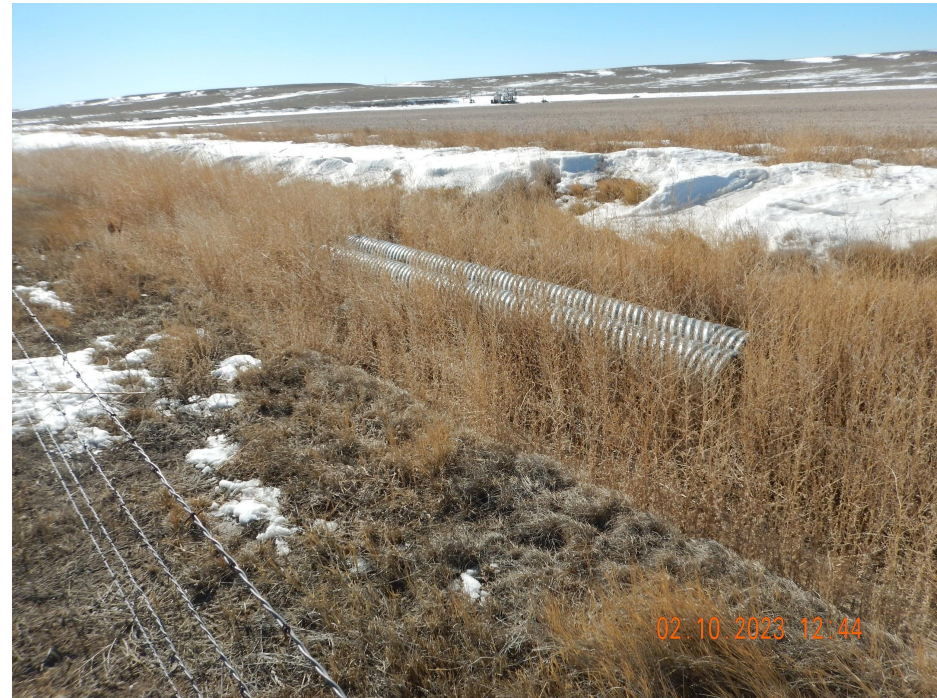
**Photo 17.** Photo taken from the eastern location, facing Southwest. Photo illustrates the weedy vegetation within the BMP area, as well as unused equipment.

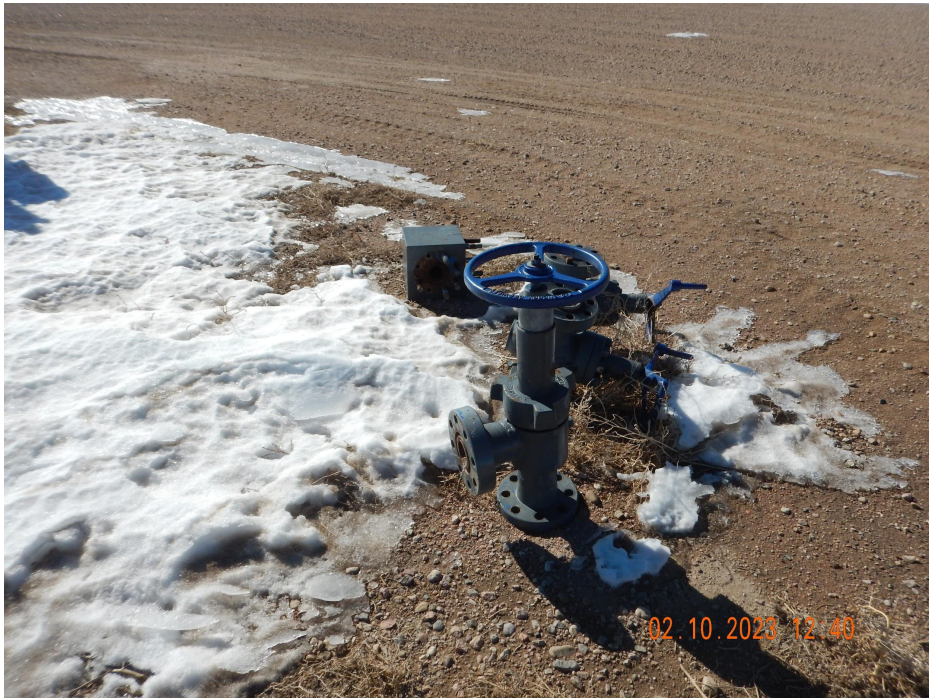
**Photo 18.** Photo taken from the wellheads. Photo illustrates unused equipment.

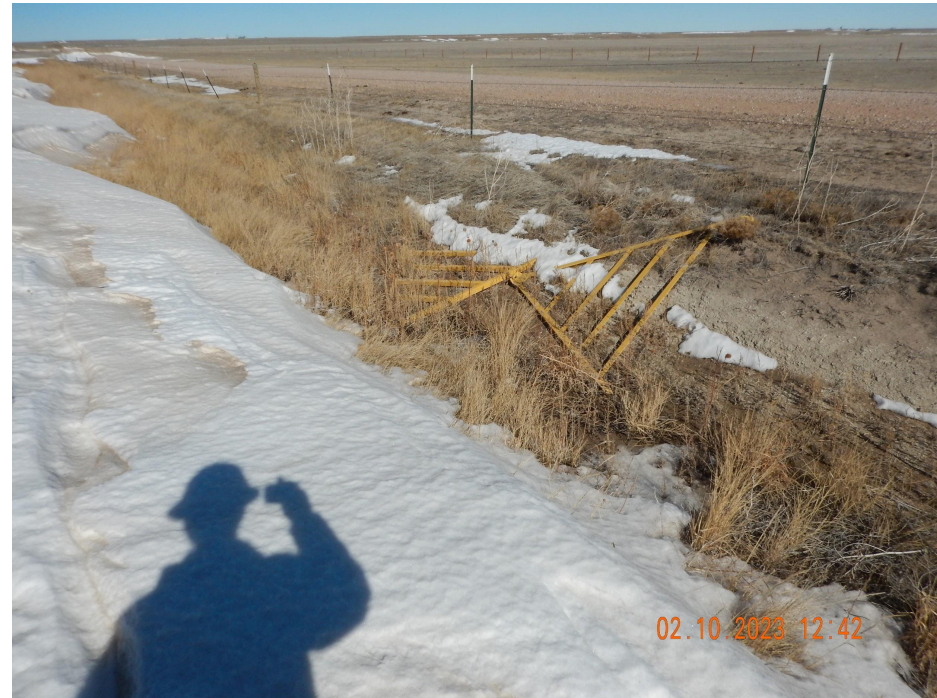
**Photo 19.** Photo taken from the southeastern location, facing Northeast. Photo illustrates unused equipment within the BMP area.
