**Re: M. B. Larson C11 X 25 – Flowline to Satellite 38 Header – Pipeline
Abandonment COGCC Rule 1105.f**

This letter is intended to certify the pipeline abandonment in place requirements were performed in accordance with COGCC Rule 1105.e (items 1-4), to comply with the COGCC Rule 1105.f (2) (D). A vicinity map showing the location of the pipeline is included at the end of this inspection report. The following are the details of the pipeline abandonment work that was witnessed.

CHEVRON (USA), INC.
M.B. LARSON C11X25 FLOWLINE
ABANDONMENT INSPECTION
 LOCATED IN: SEC. 25, T2N, R102W, 6TH P.M.
 RIO BLANCO COUNTY, CO

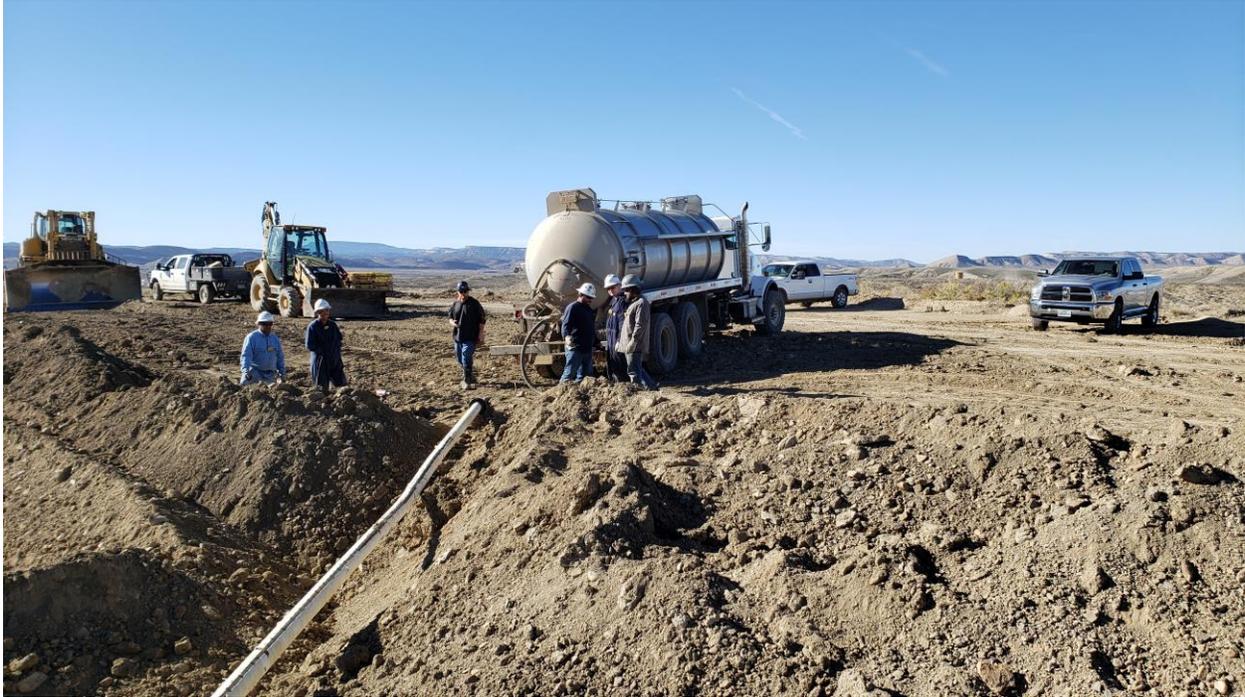
Figure 1 - Flowline at M. B. Larson C11X25 Wellhead

This pipeline was previously temporarily closed and taken out of service. The hydrocarbons and produced water had been removed and flushed previously. Crossfire (Contractor) excavated the line from the wellhead to the road crossing (located along the north edge of the well pad). The previously capped end (at the wellhead) was cut off and a flanged end was welded to the end of the pipe for connection to water truck line. The end at the Satellite 38 Header was excavated 4 feet below grade. A water truck connection was attached to the flanged end of the pipe that had been disconnected from the header.

The flowline on the M.B. Larson C11X25 Well Pad end was excavated and removed from the wellhead to the edge of the road along the north edge of the pad (approximately 130 feet). The depth was approximately 5.5 feet deep.

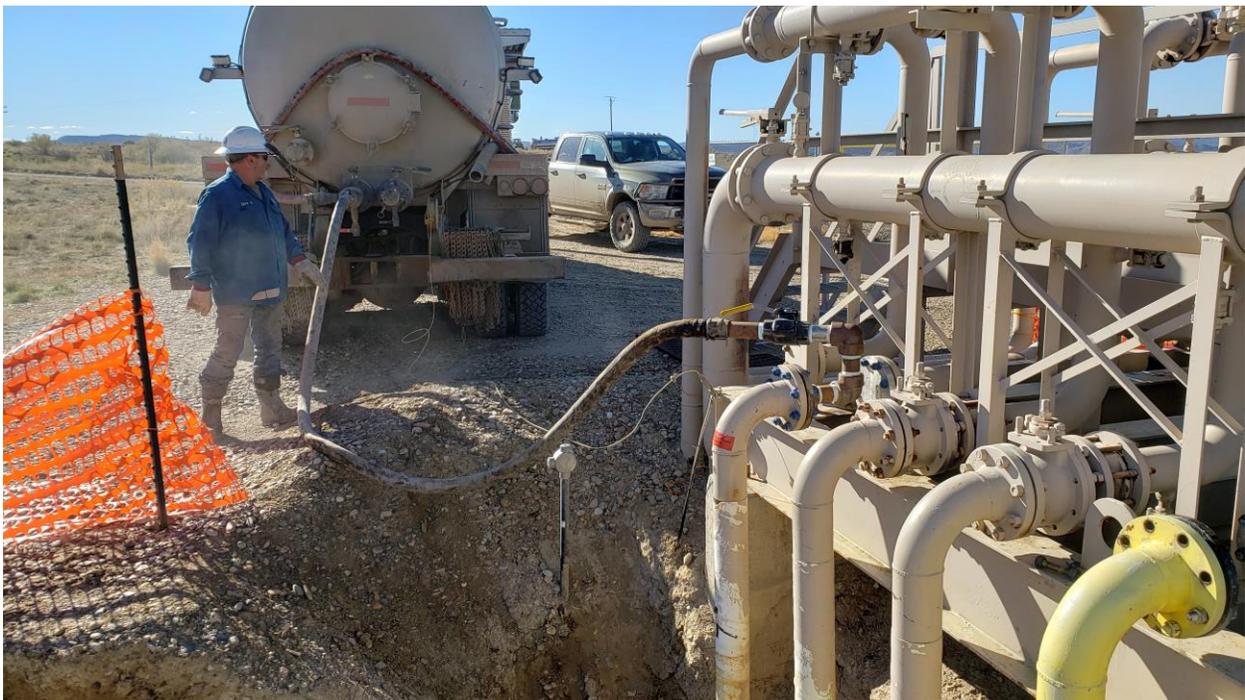
Figure 2 - Flowline at Satellite 38 Header

The Satellite 38 Header end of the flowline was cut off at 3 feet below grade.

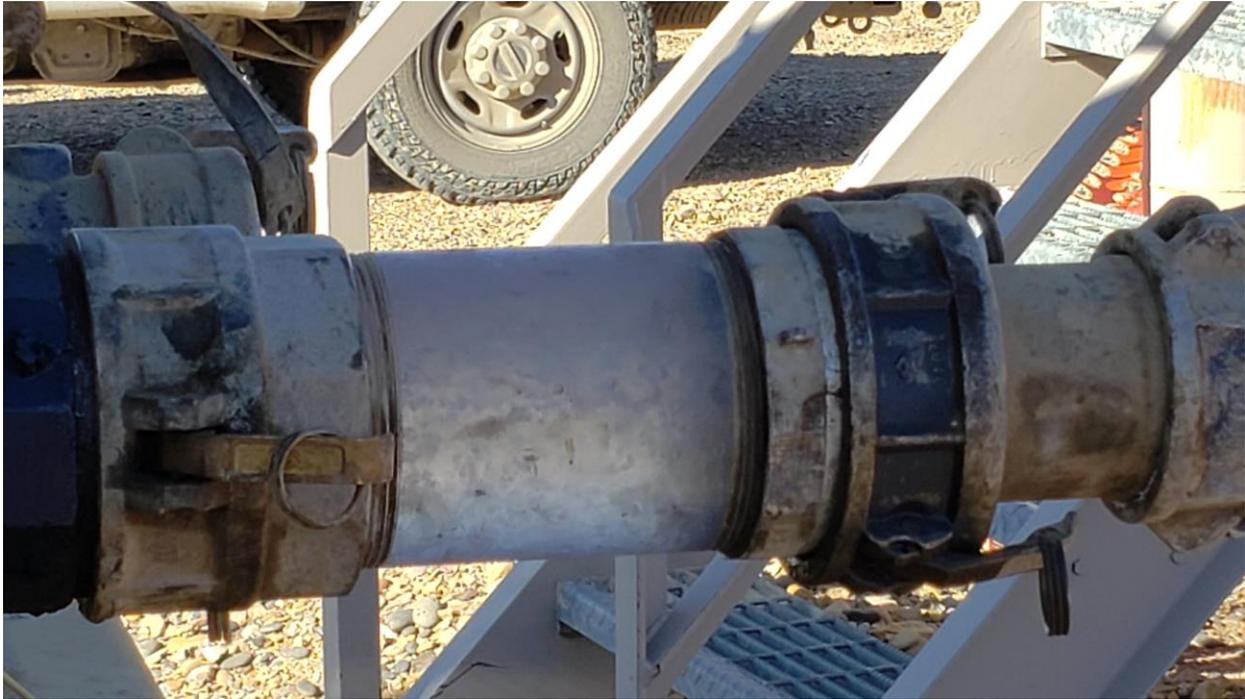
Figure 3 - Transparent Pipe Spool at Suction Truck Showing Clear Water After Flushing

Fresh water was supplied by an 80 Bbl water hauler truck and was connected at the M. B. Larson C 11 X 25 wellhead end of the flowline. An empty 90 Bbl water hauler truck was connected at the Satellite 38 Header end of the flowline to suction the line. The line was flushed with 80 Bbls of fresh water. A clear (see-through) spool of pipe was added to the line at the suction truck to confirm the water was clear and free from

hydrocarbons/produced water.

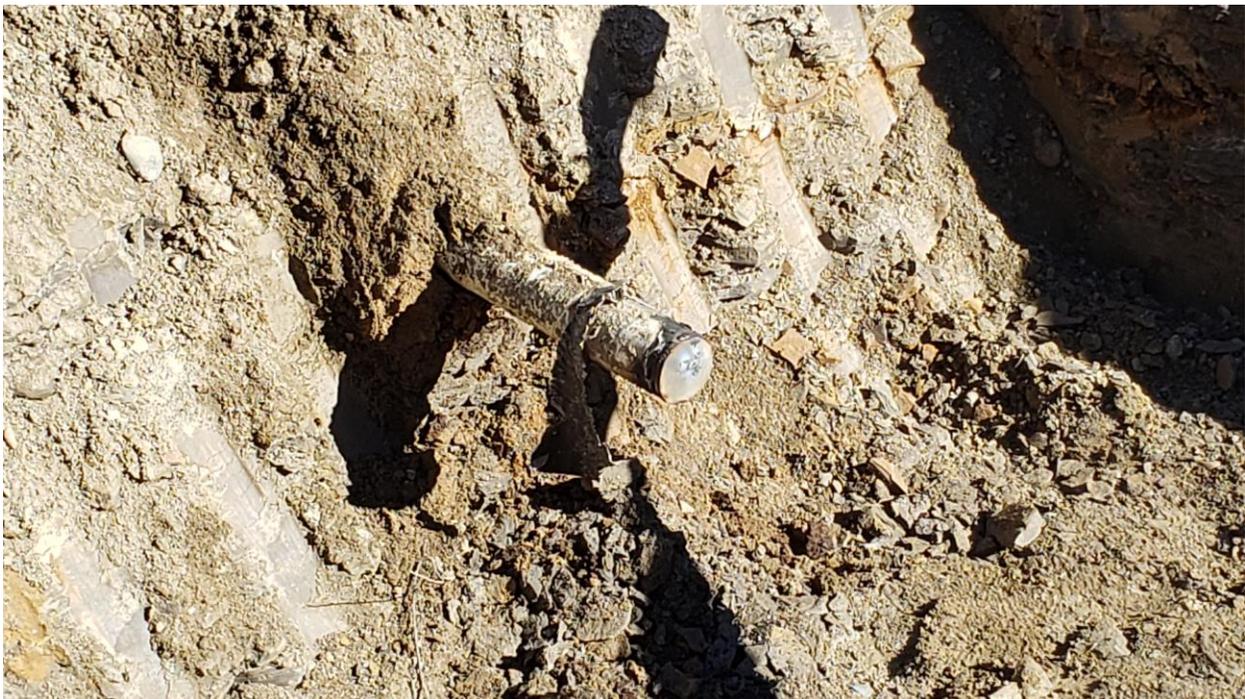
Figure 4 - Capped Flowline at M. B. Larson C11X25 End.

The flowline on the M.B. Larson C11X25 Well Pad end was capped with a 1/4” steel plate welded to the pipe end at the flowline depth at the edge of the road.

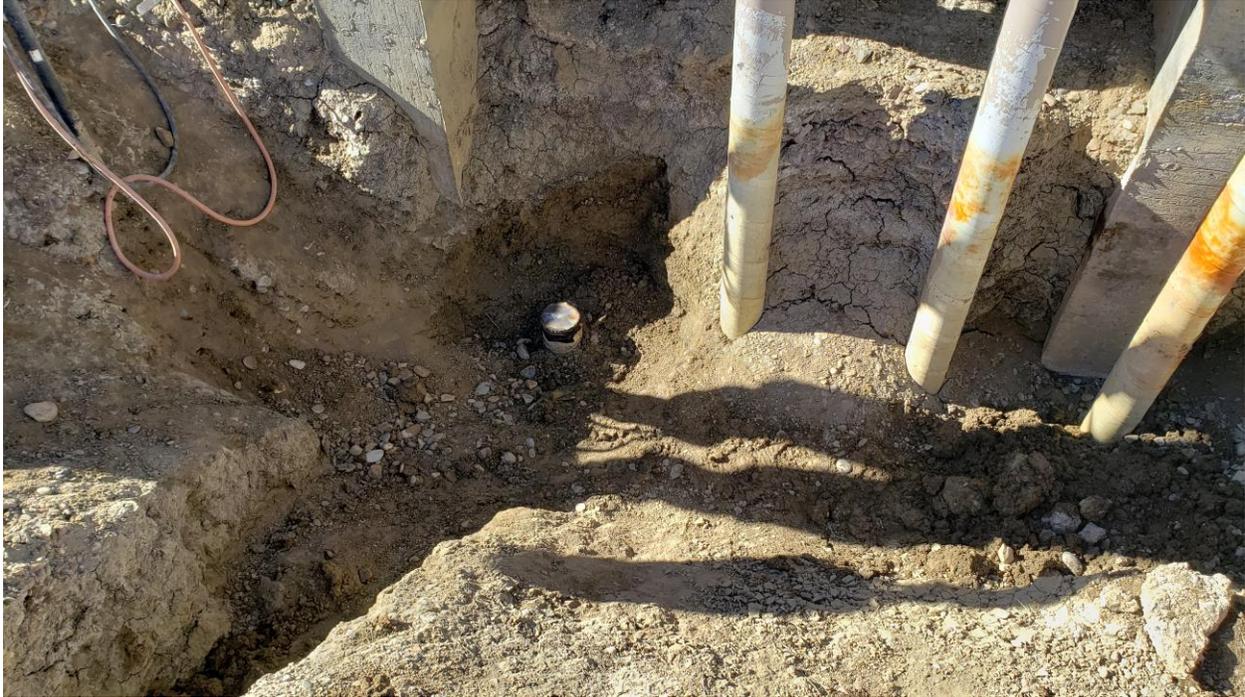
Figure 5 - Capped Flowline at Satellite 38 Header End

The Satellite 38 Header end of the flowline was capped with a 1/4” steel plate welded to the pipe end.
