# Inspection Photos

Operator: TEP ROCKY MOUNTAIN LLC #96850

Location #334359

Garfield County, CO

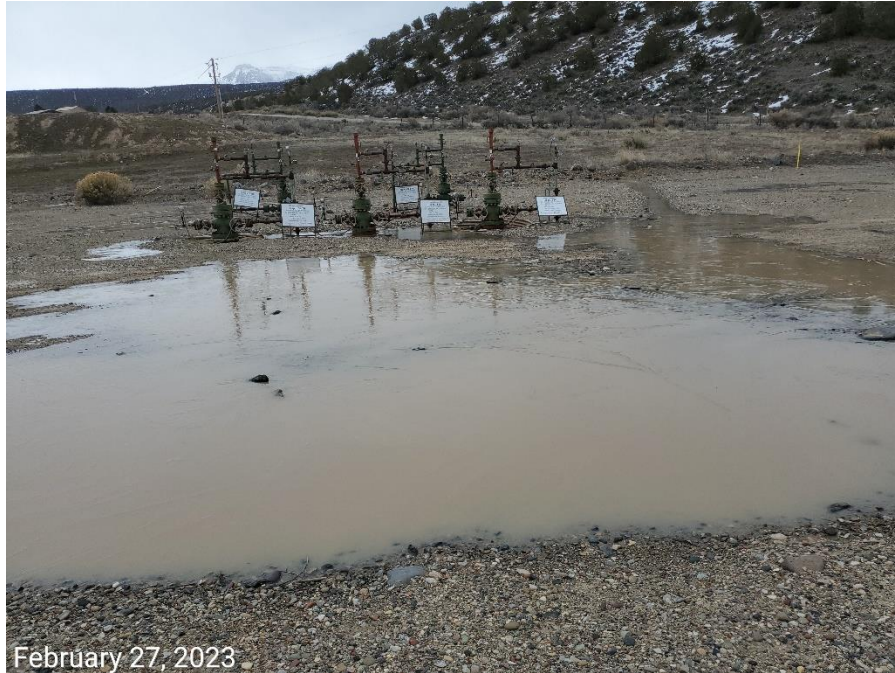
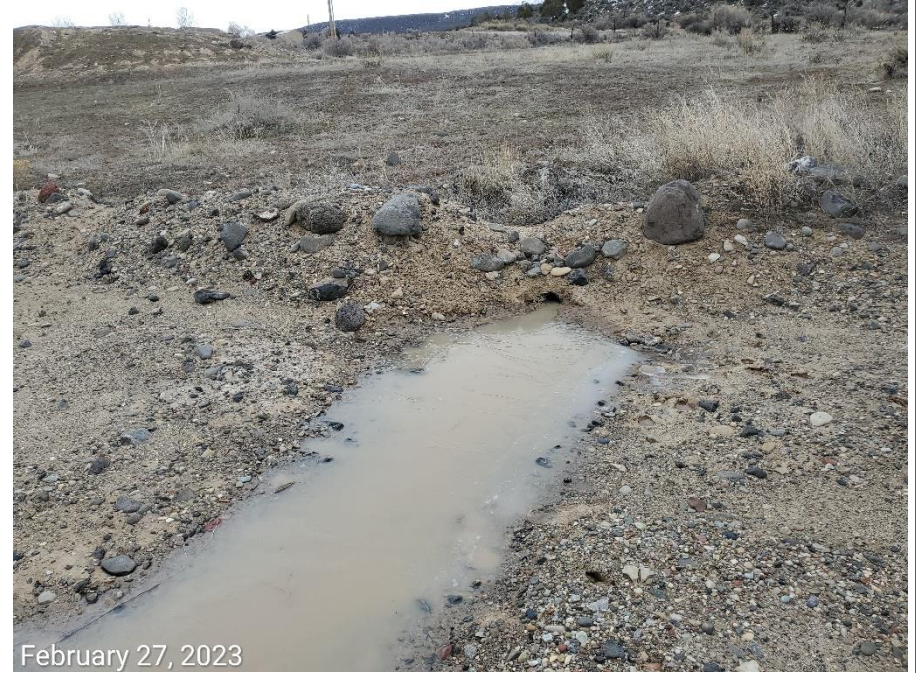
**Photo 1:** Photos taken from the central working pad area, facing east. Photo left shows stormwater ponding on the working pad area. Photo right shows drain connected to the perimeter stormwater diversion ditch; drain has been repaired; BMPs remain missing or insufficient to allow for proper stormwater discharge from the Location.

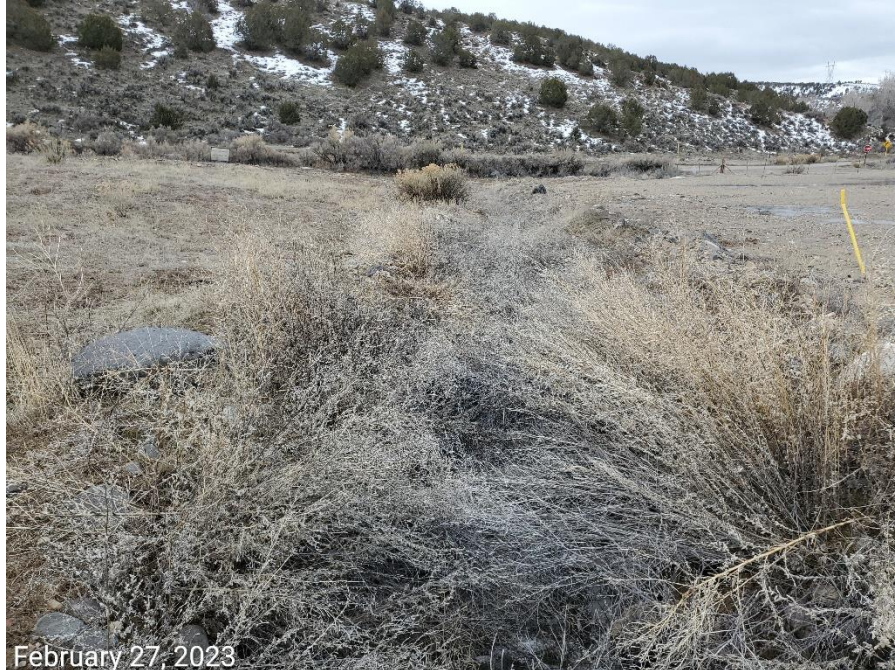
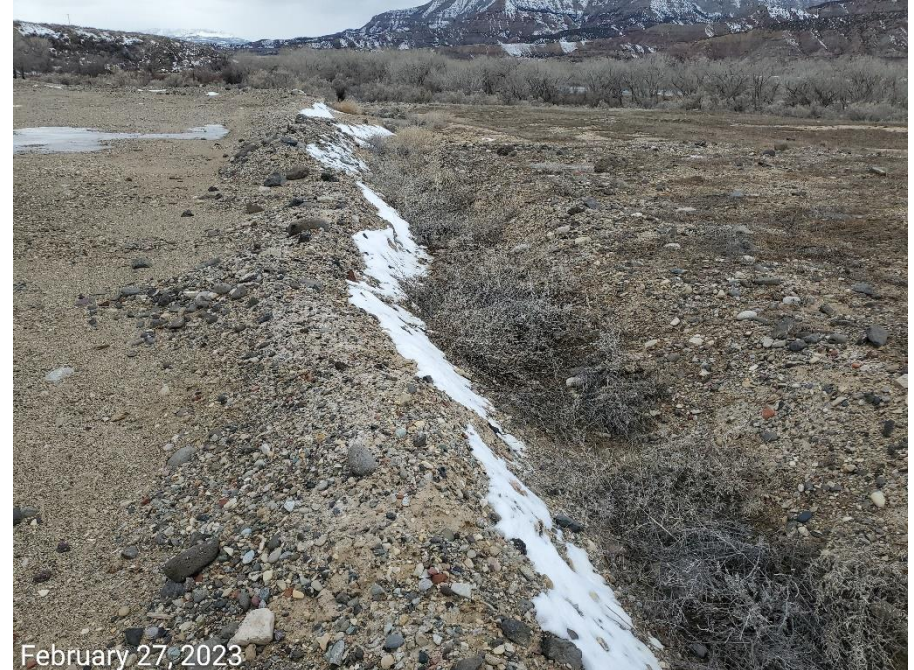
**Photo 2:** Photos examples showing Undesirable Plant establishment and Weed debris observed within the perimeter stormwater diversion ditch.

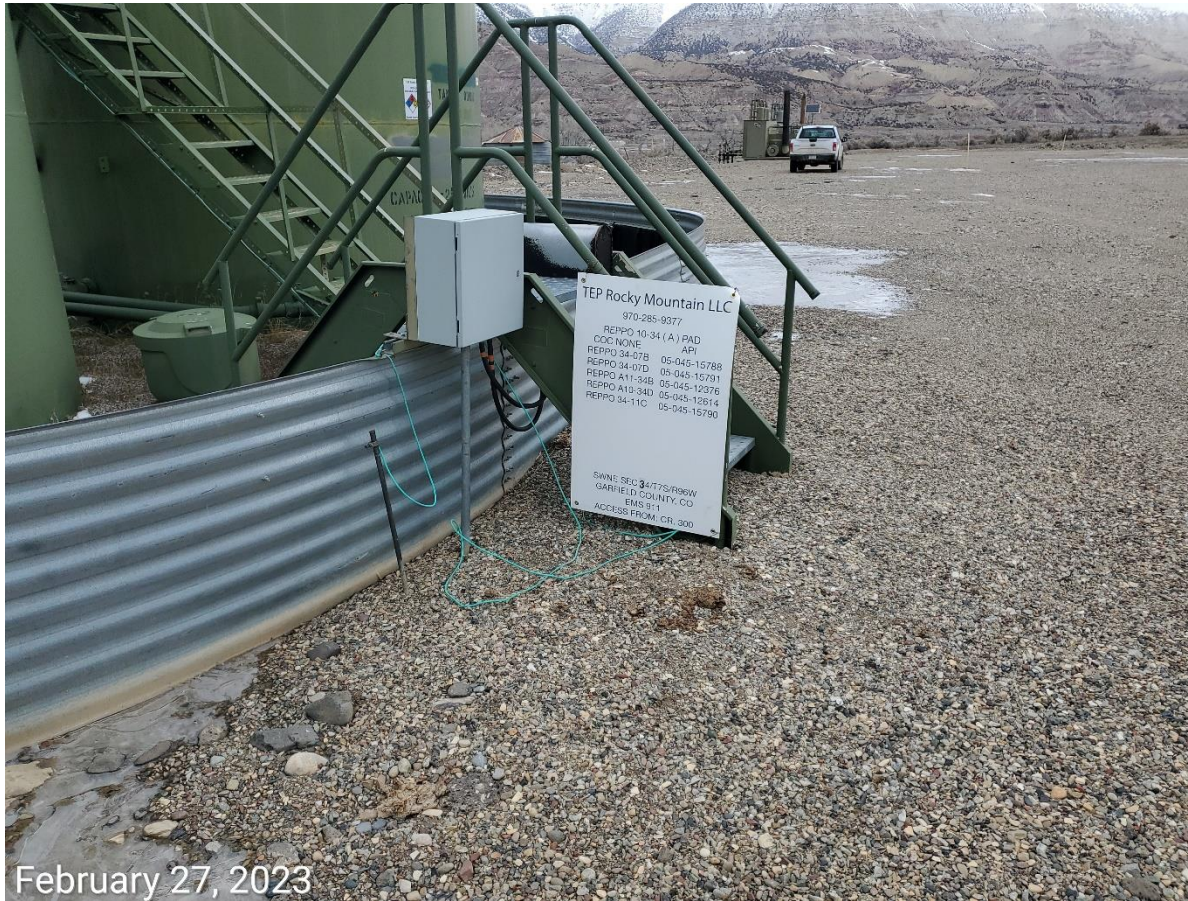
**Photo 3:** Signage at tank battery.
