Inspection Photos

Operator: TEP ROCKY MOUNTAIN LLC #96850

Location #334393

Garfield County, CO

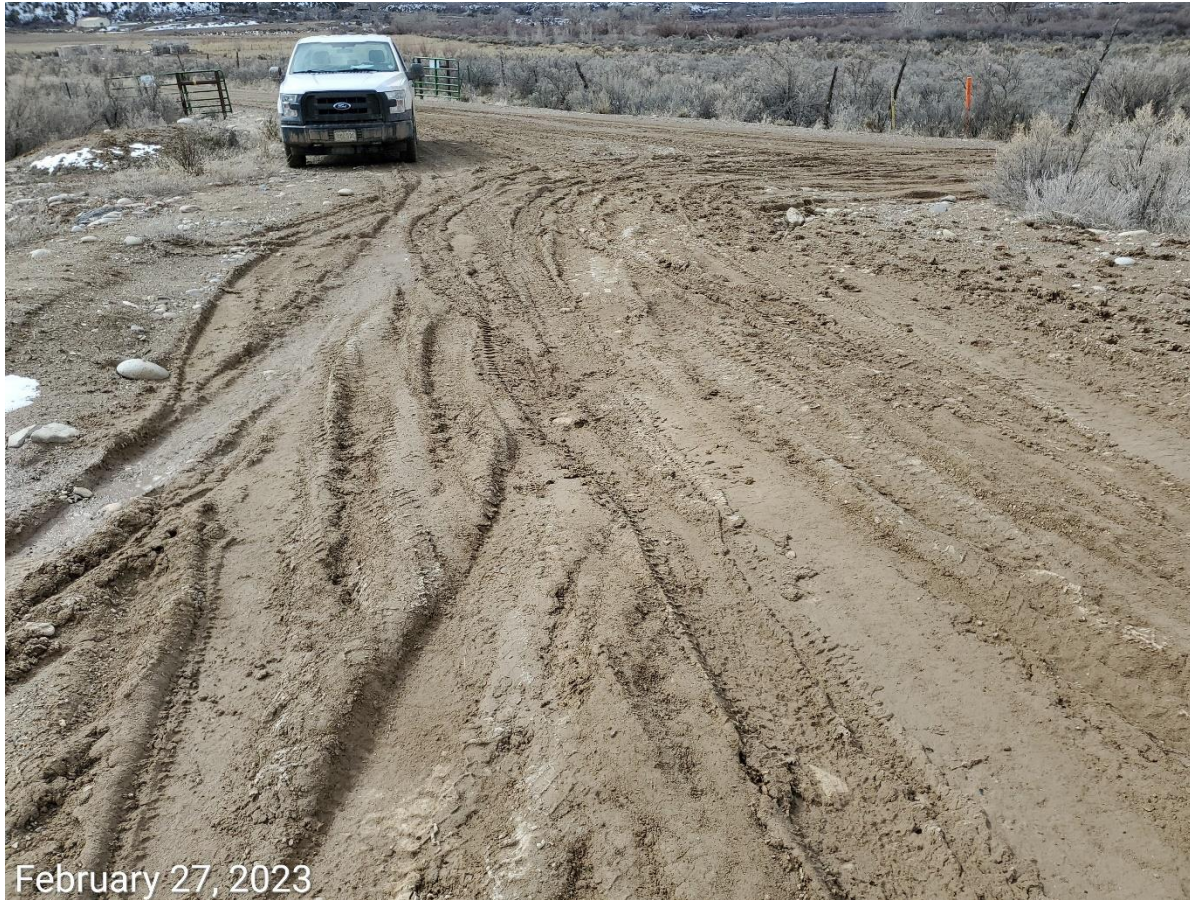
Photo 1: Photo taken from the Location entrance on the southwest end of the Location. Photo shows that BMPs to stabilize the Location, and to minimize degradation, tracking and sediment transport from the working pad areas remain missing or insufficient.

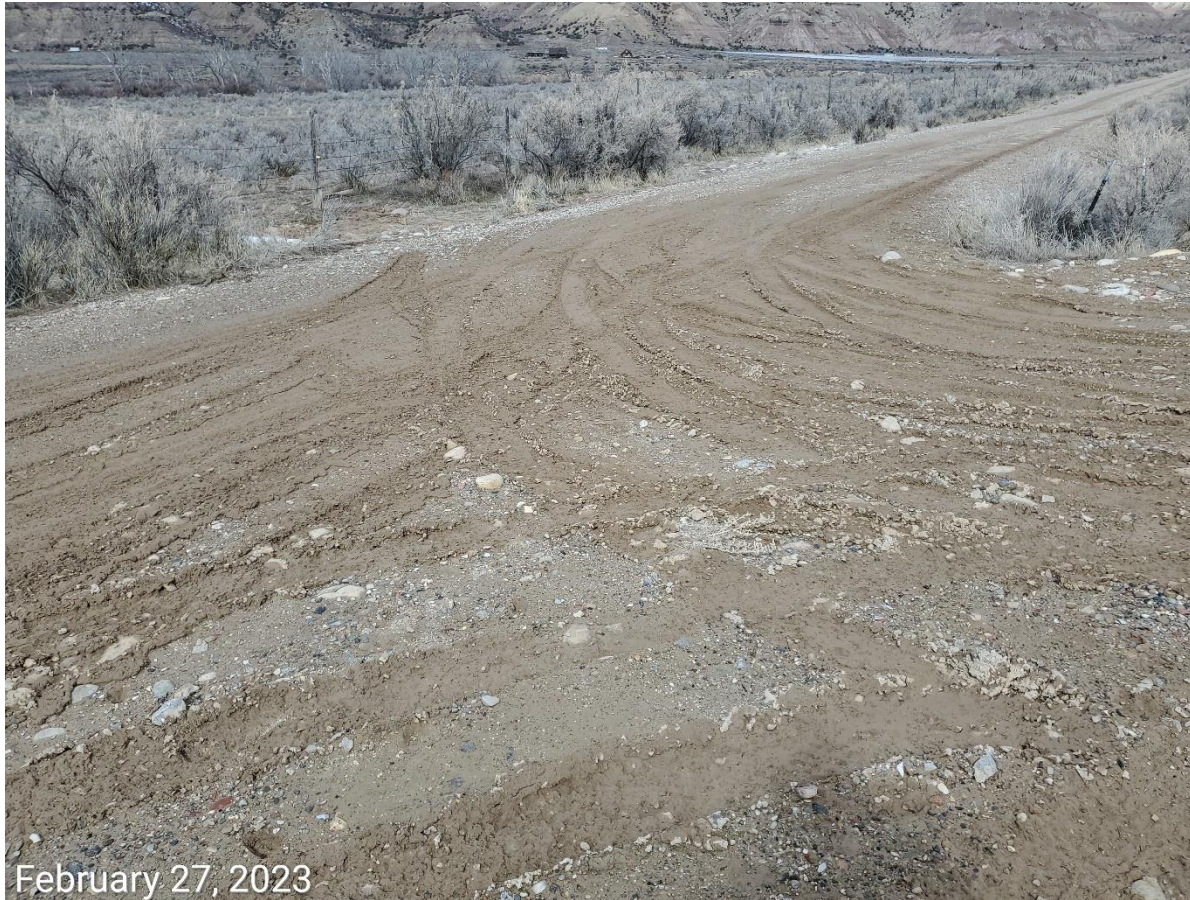
Photo 2: See comments under photo 1. Photo shows tracking from Location onto access road.

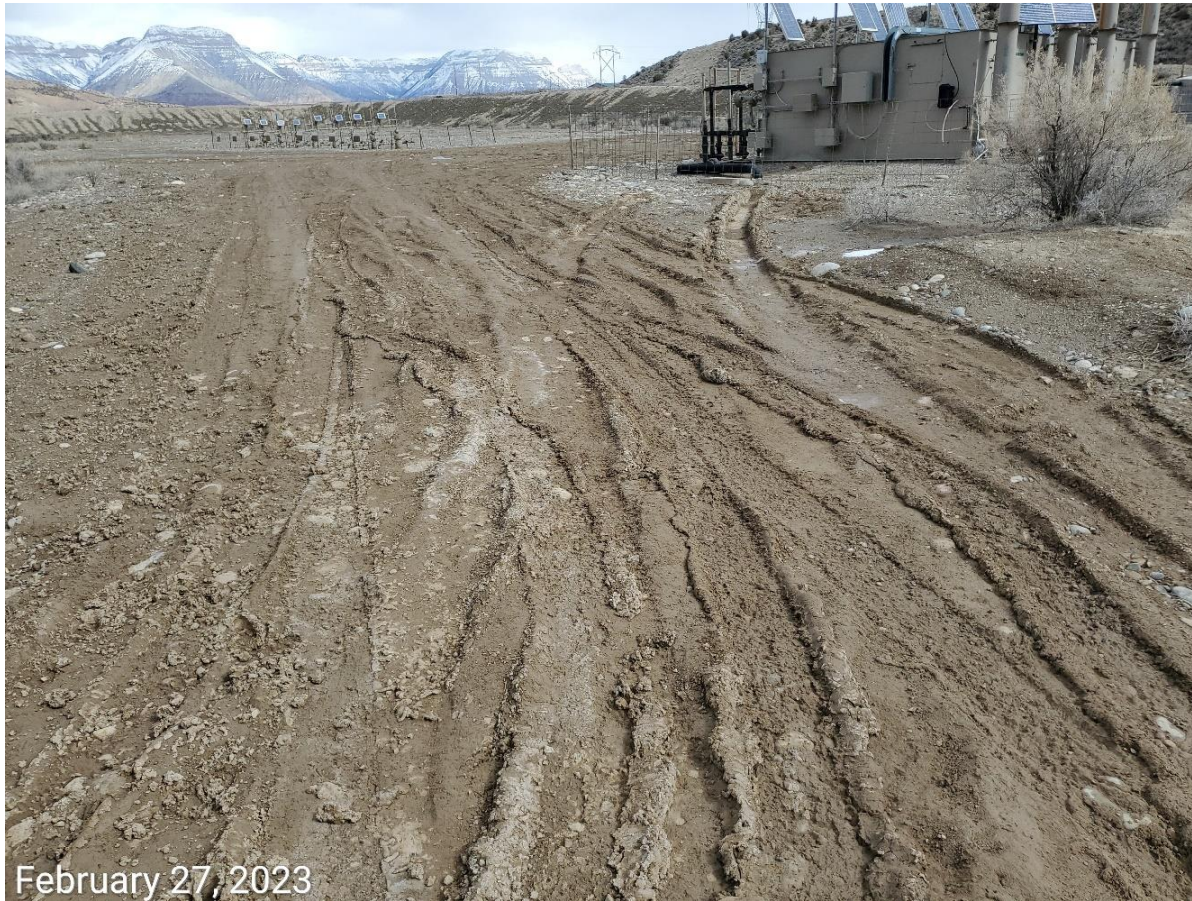
Photo 3: Photo taken from the Location entrance on the southwest end of the Location. Photo shows that BMPs to stabilize the Location, and to minimize degradation, tracking and sediment transport from the working pad areas remain missing or insufficient.

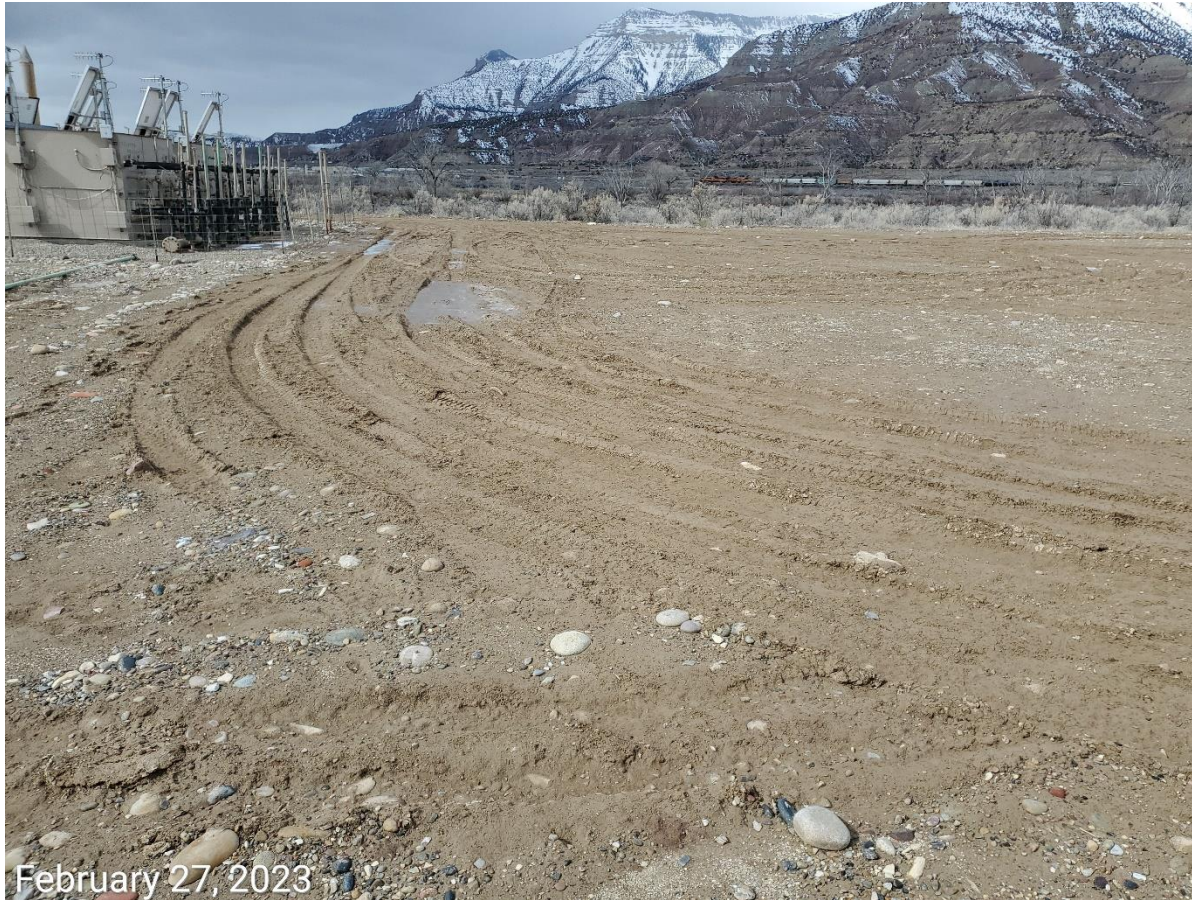
Photo 4: Photo taken from southeast end of the Location, facing west. Photo shows that BMPs to stabilize the Location, and to minimize degradation, tracking and sediment transport from the working pad areas remain missing or insufficient.

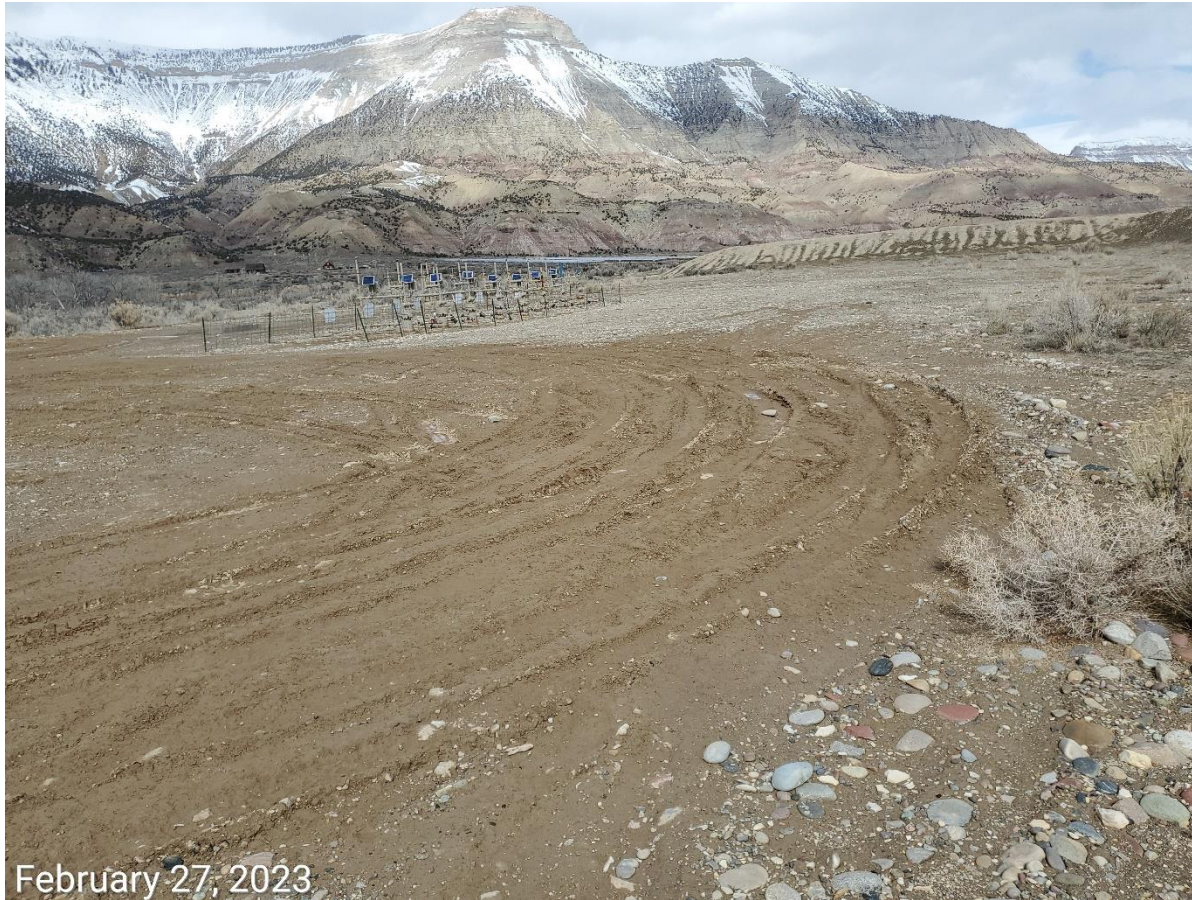
Photo 5: Photo taken from southeast end of the Location, facing northwest. Photo shows that BMPs to stabilize the Location, and to minimize degradation, tracking and sediment transport from the working pad areas remain missing or insufficient.

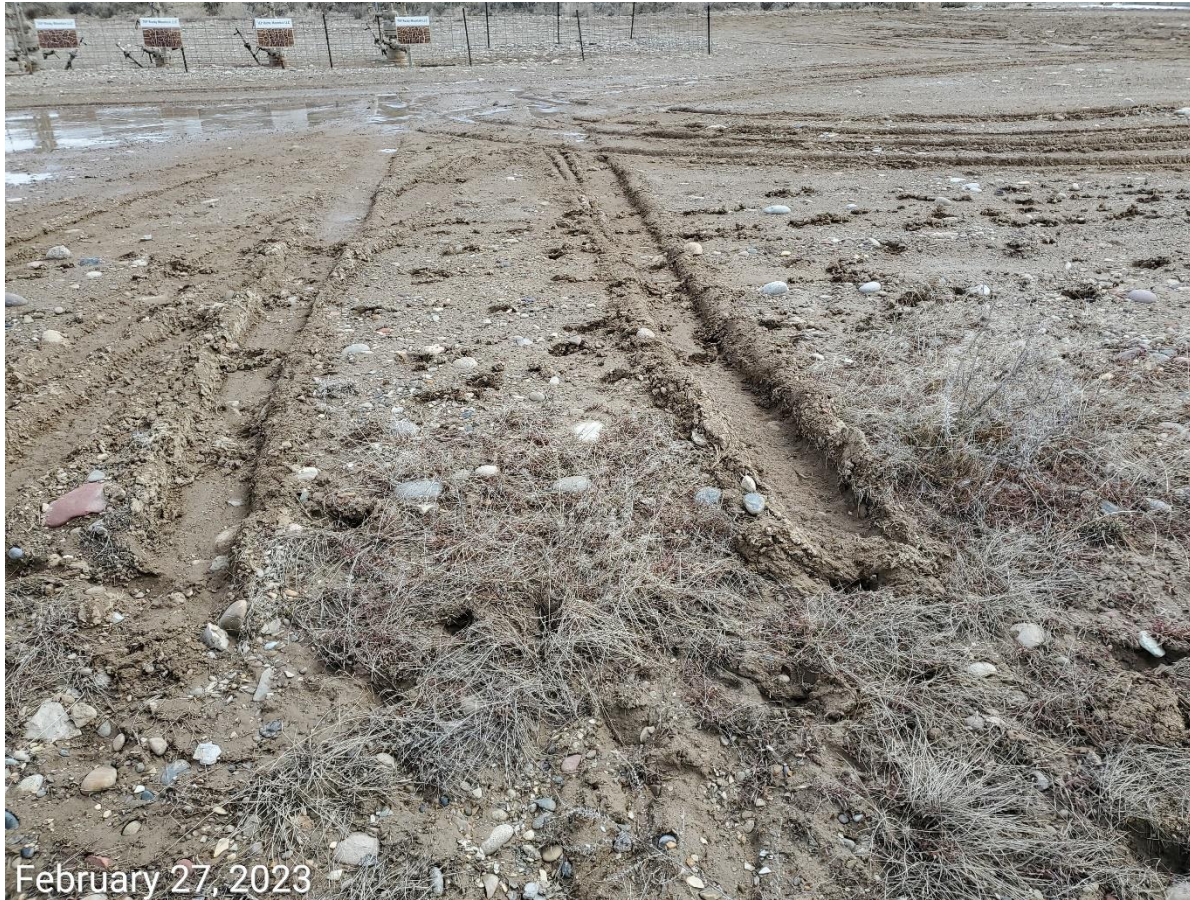
Photo 6: Photo taken from west end of the Location, facing east. Photo shows that BMPs to stabilize the Location, and to minimize degradation, tracking and sediment transport from the working pad areas remain missing or insufficient.

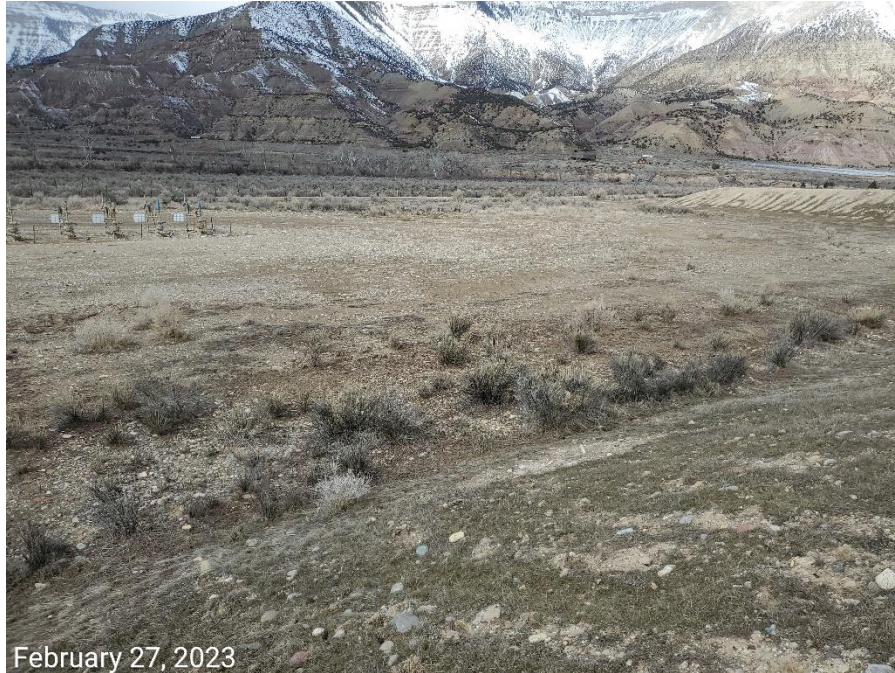
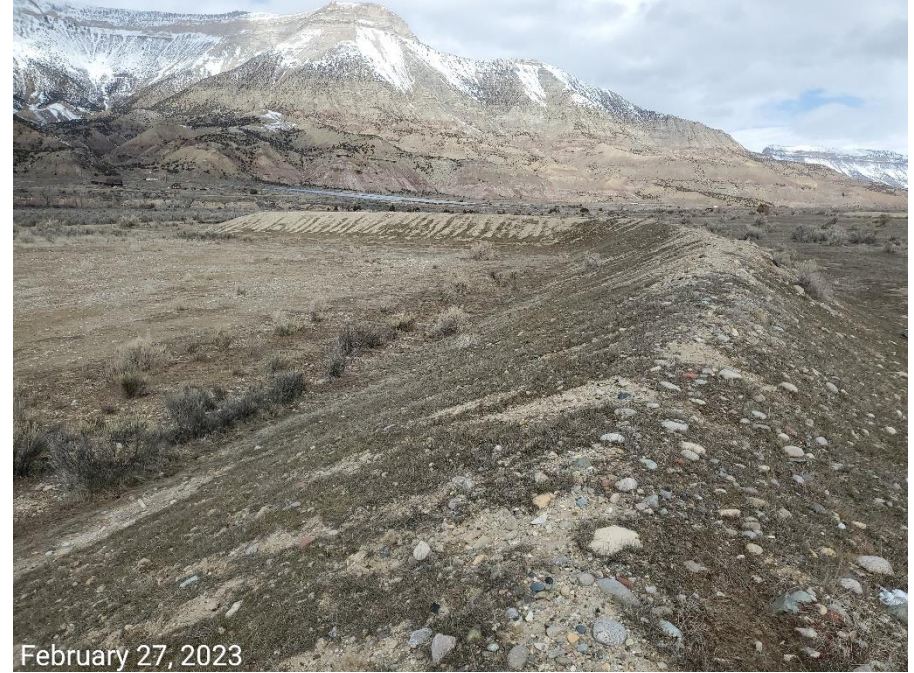
Photo 7: Photos taken from the east end of the Location, facing northwest to north. Photos examples showing areas on the north end of the Location that are not reasonably needed for production. Interim reclamation including, but not limited to, removal of gravel/road base, compaction alleviation, replacement of soils and revegetation required.

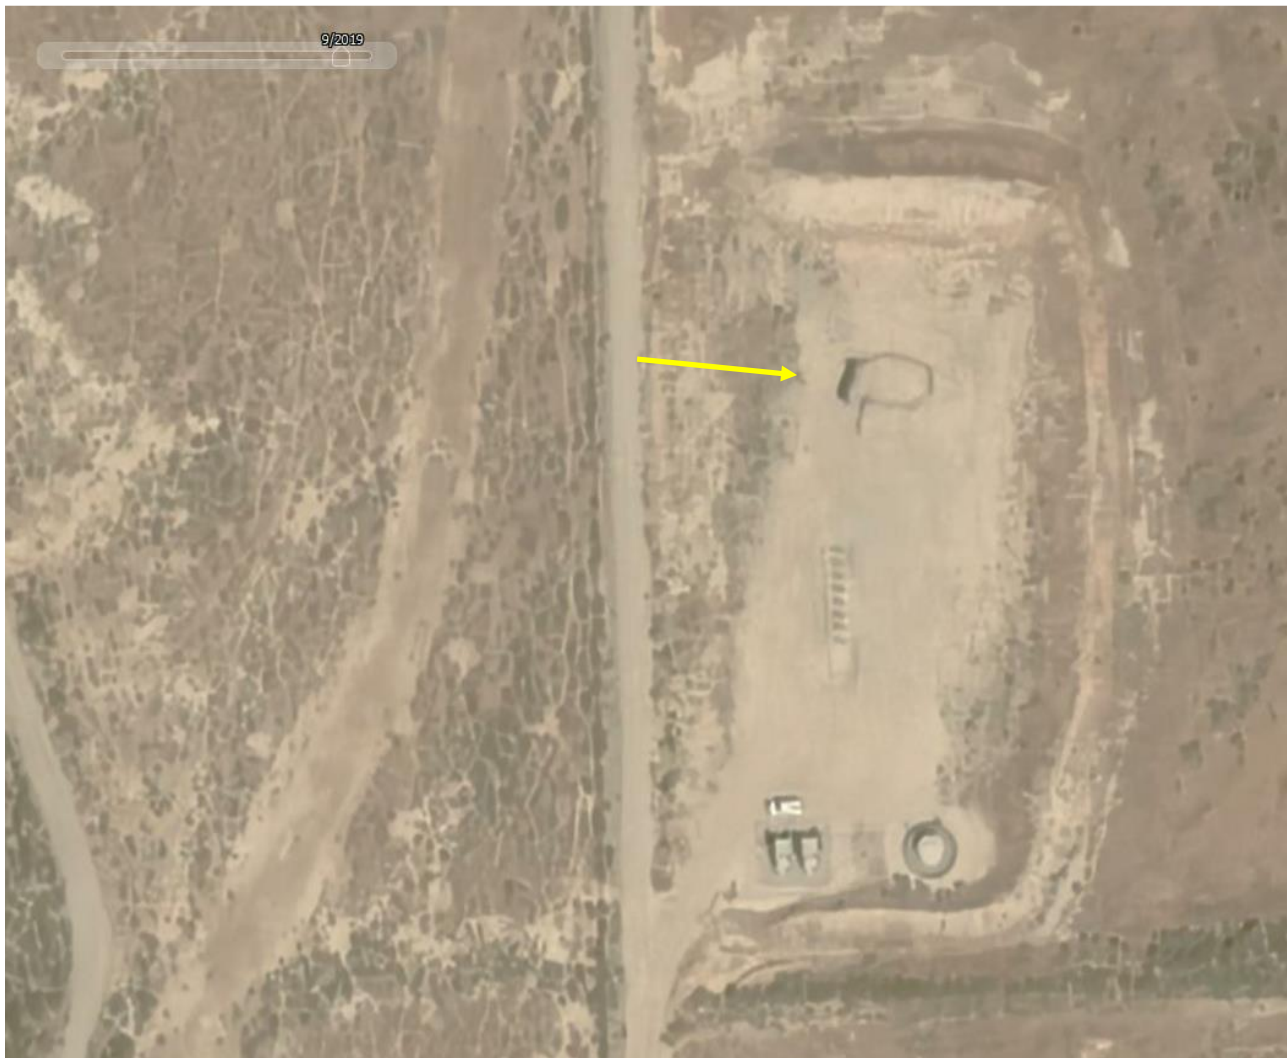
Photo 8: 2009 Google Earth aerial imagery of the Location. Arrow shows unknown equipment existing on the north end of the Location.

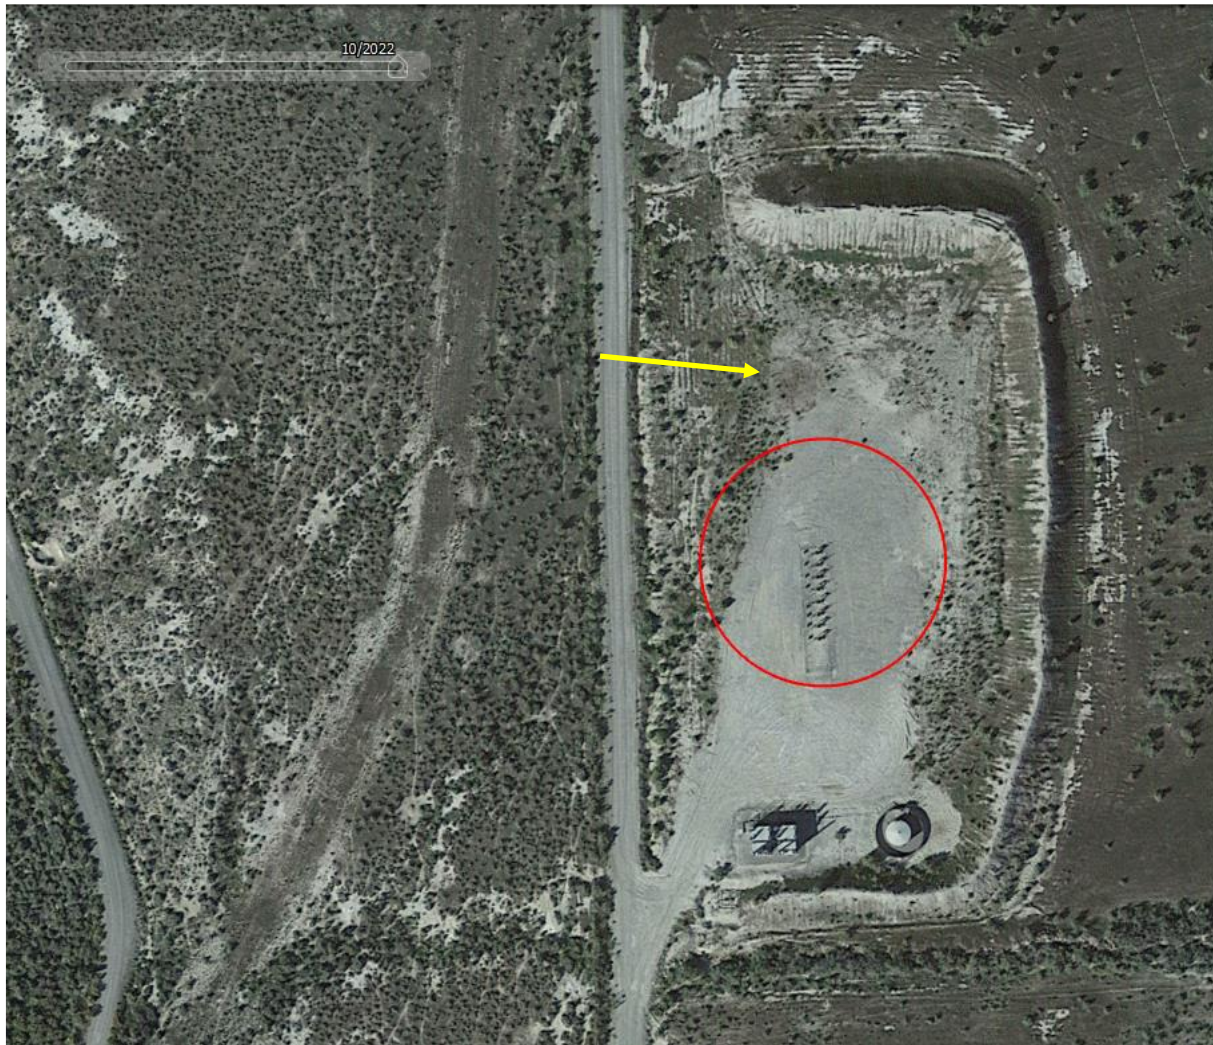
Photo 9: 2022 Google Earth Aerial imagery. Unknown equipment identified in Photo 8 has been removed. Red Polygon represents a 75' buffer around the northern-most well(s). Northern areas no longer necessary for production.

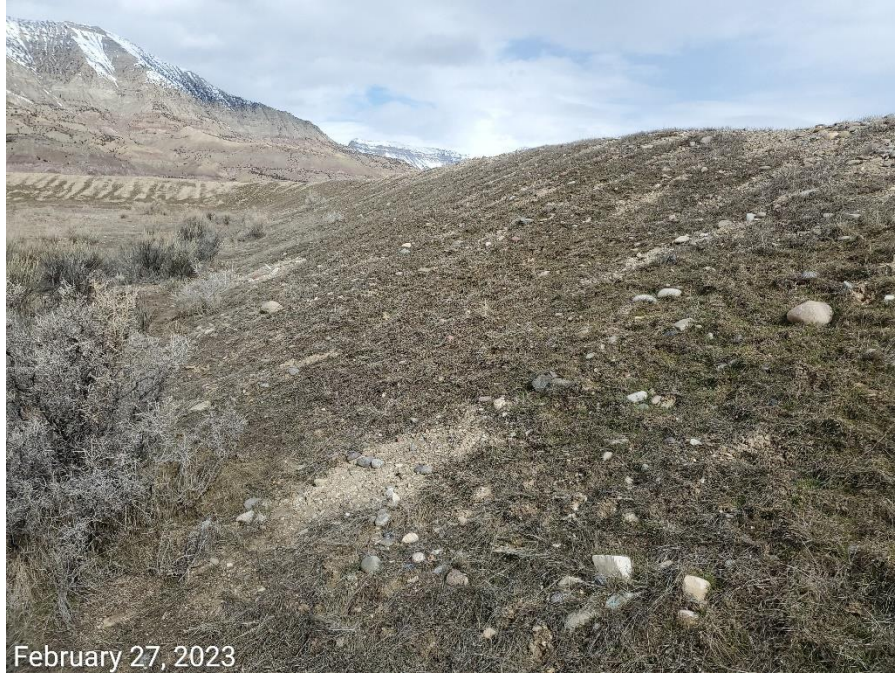
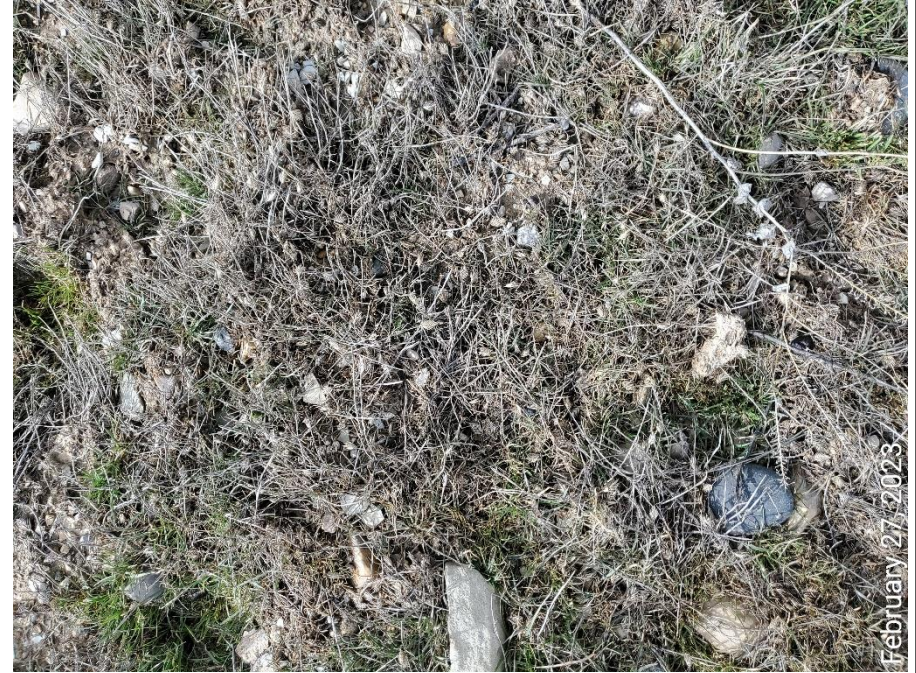
Photo 10: Photos taken from the soil stockpiles along the perimeter of the Location. Vegetation observed on the stockpiles predominantly Undesirable Plant Species such as Annual Wheatgrass, Cheatgrass. Other Undesirable Plant species observed included Halogeton.
