Inspection Photos

Operator: TEP ROCKY MOUNTAIN LLC #96850

Location #440705

Garfield County, CO

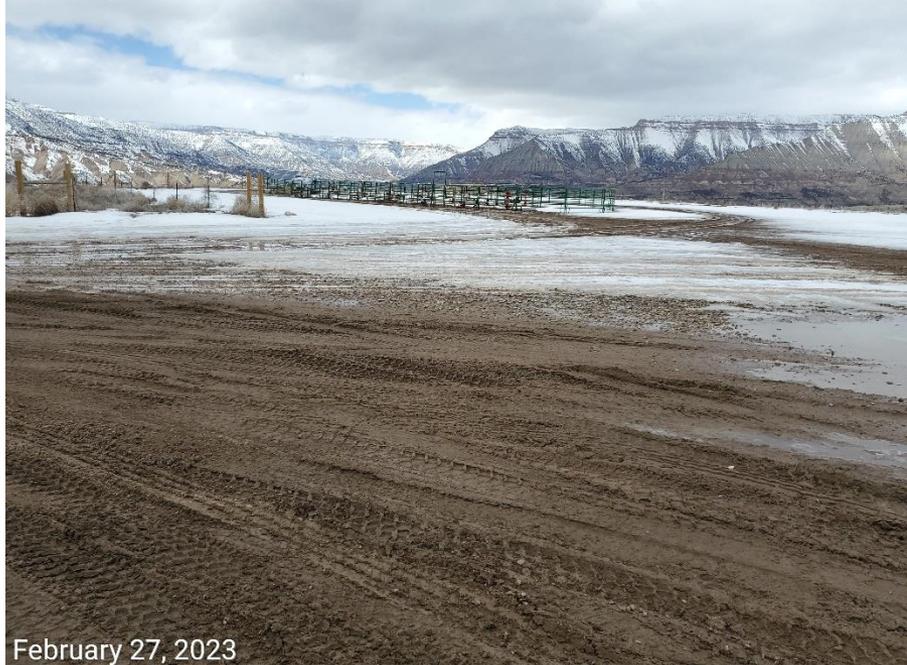
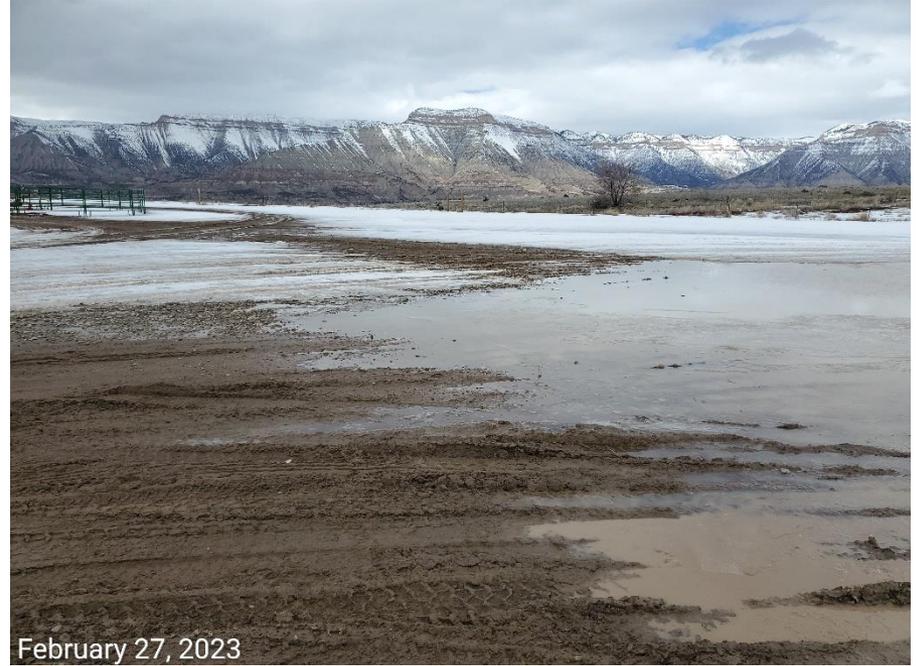
Photo 1: Photos 1-2 taken from the south end of the Location. Photos provide an overview of the Location from west, northwest, northeast to east. Photos also show areas of the Location not reasonably needed for production, requiring 1003 reclamation.

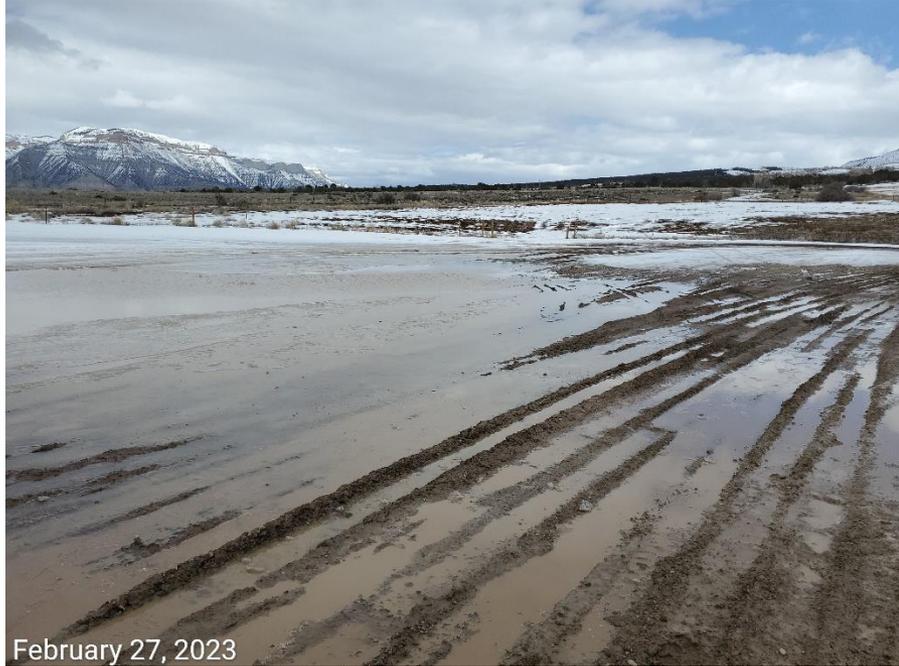
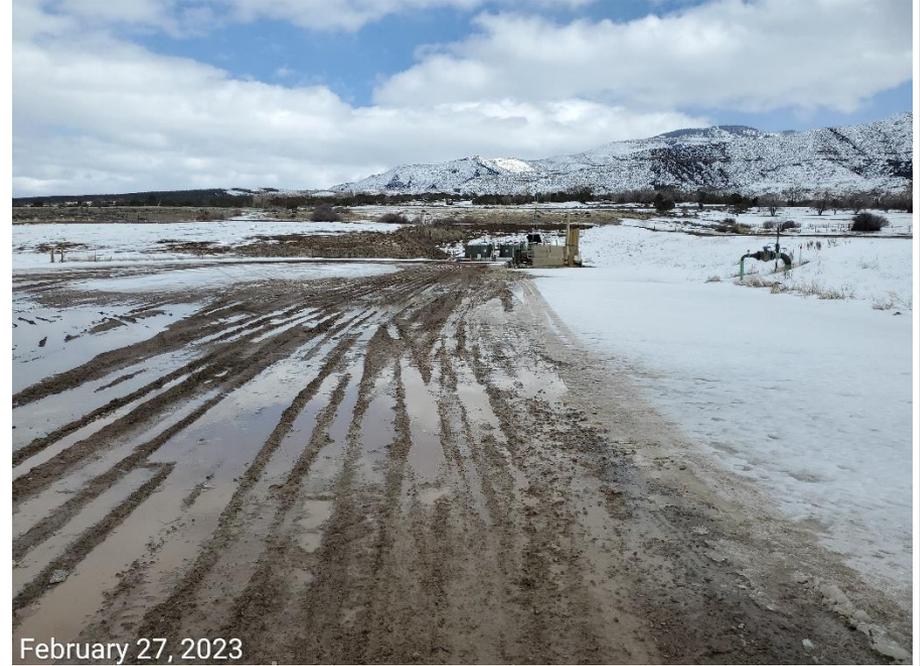
Photo 2: See comments under photo 1.

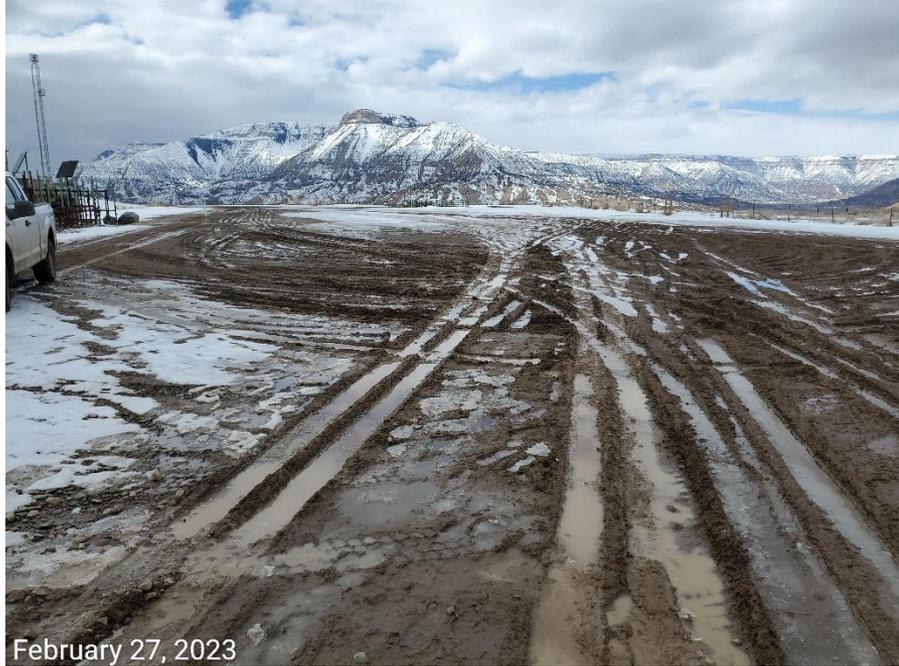
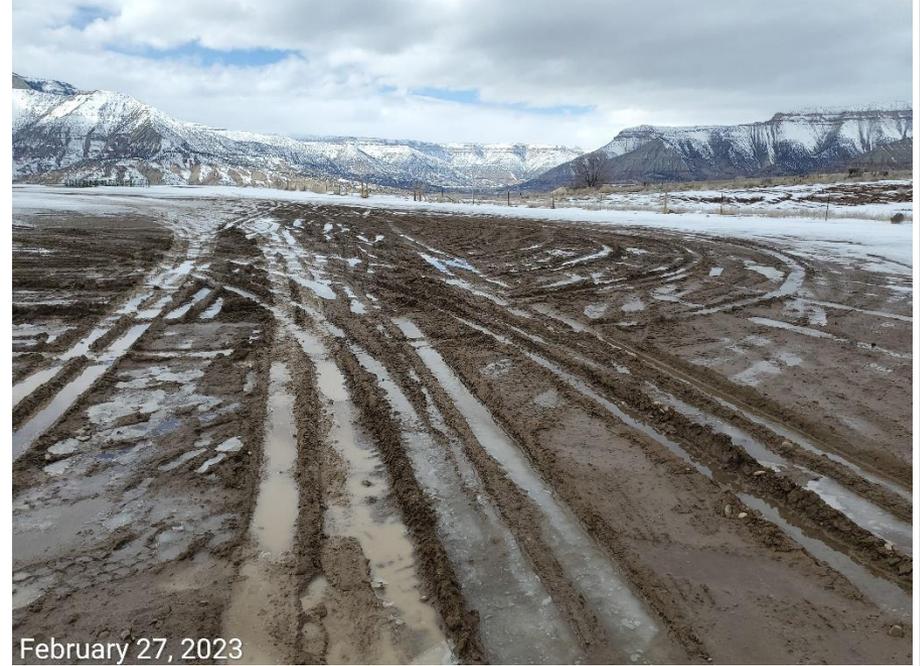
Photo 3: Photos 3-4 provide examples showing BMPs to minimize degradation, tracking and off-site sediment transport are missing or insufficient on the working pad areas of the Location.

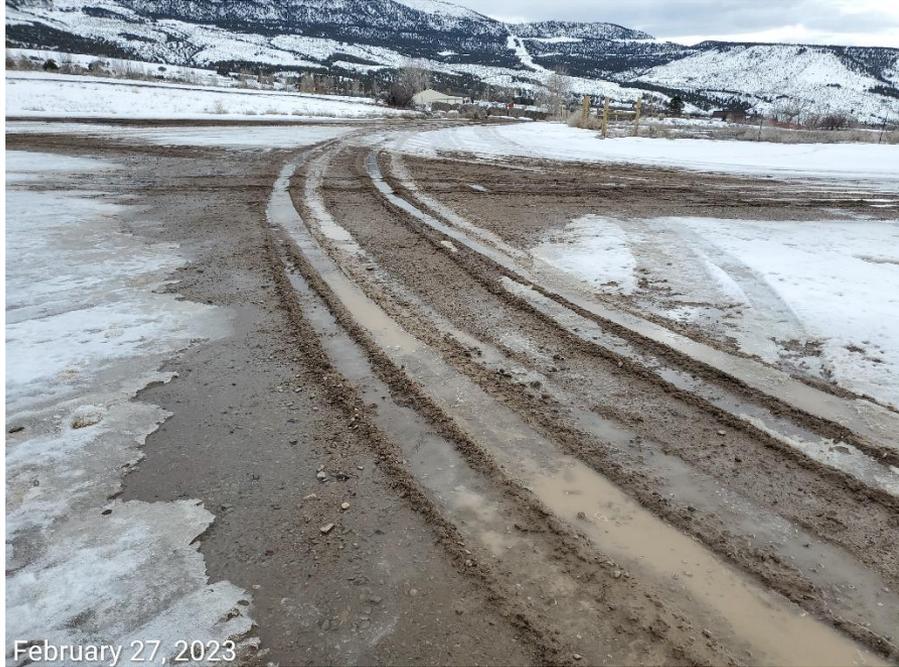
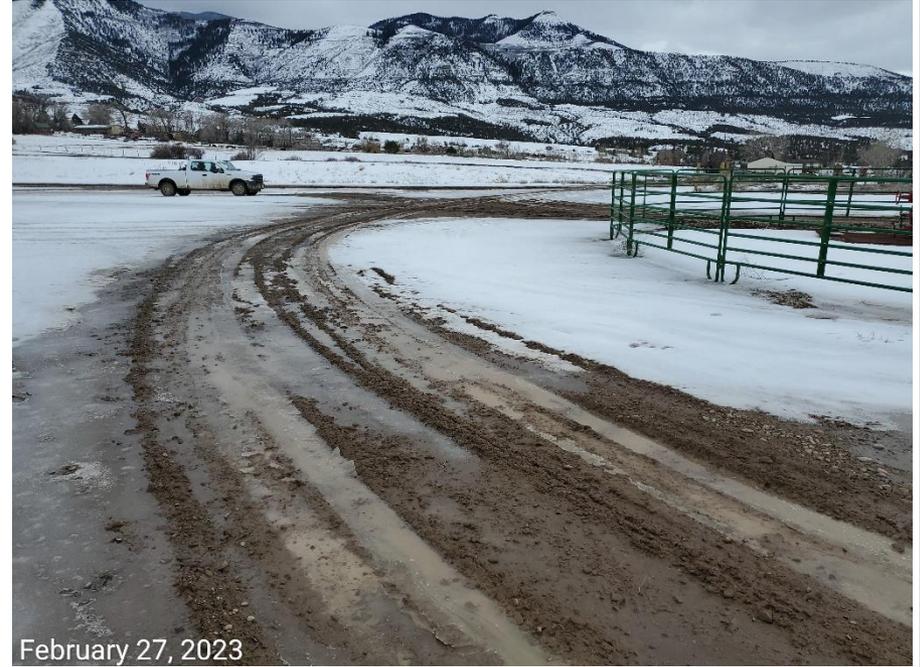
Photo 4: See comments under photo 3

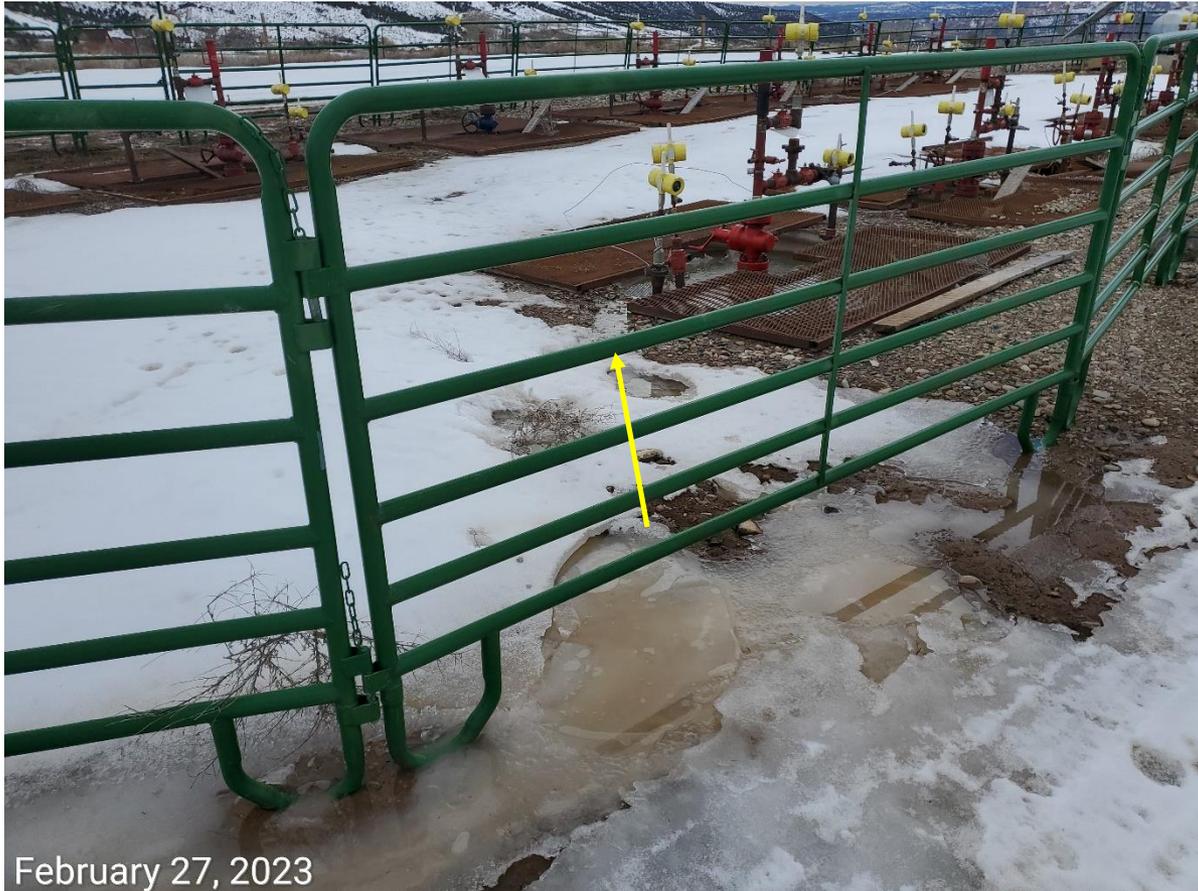
Photo 5: Photo taken from the wells. Photo shows stormwater runoff due to snowmelt flowing into the wellhead cellars on the Location. Additional BMPs to allow for proper discharge required.

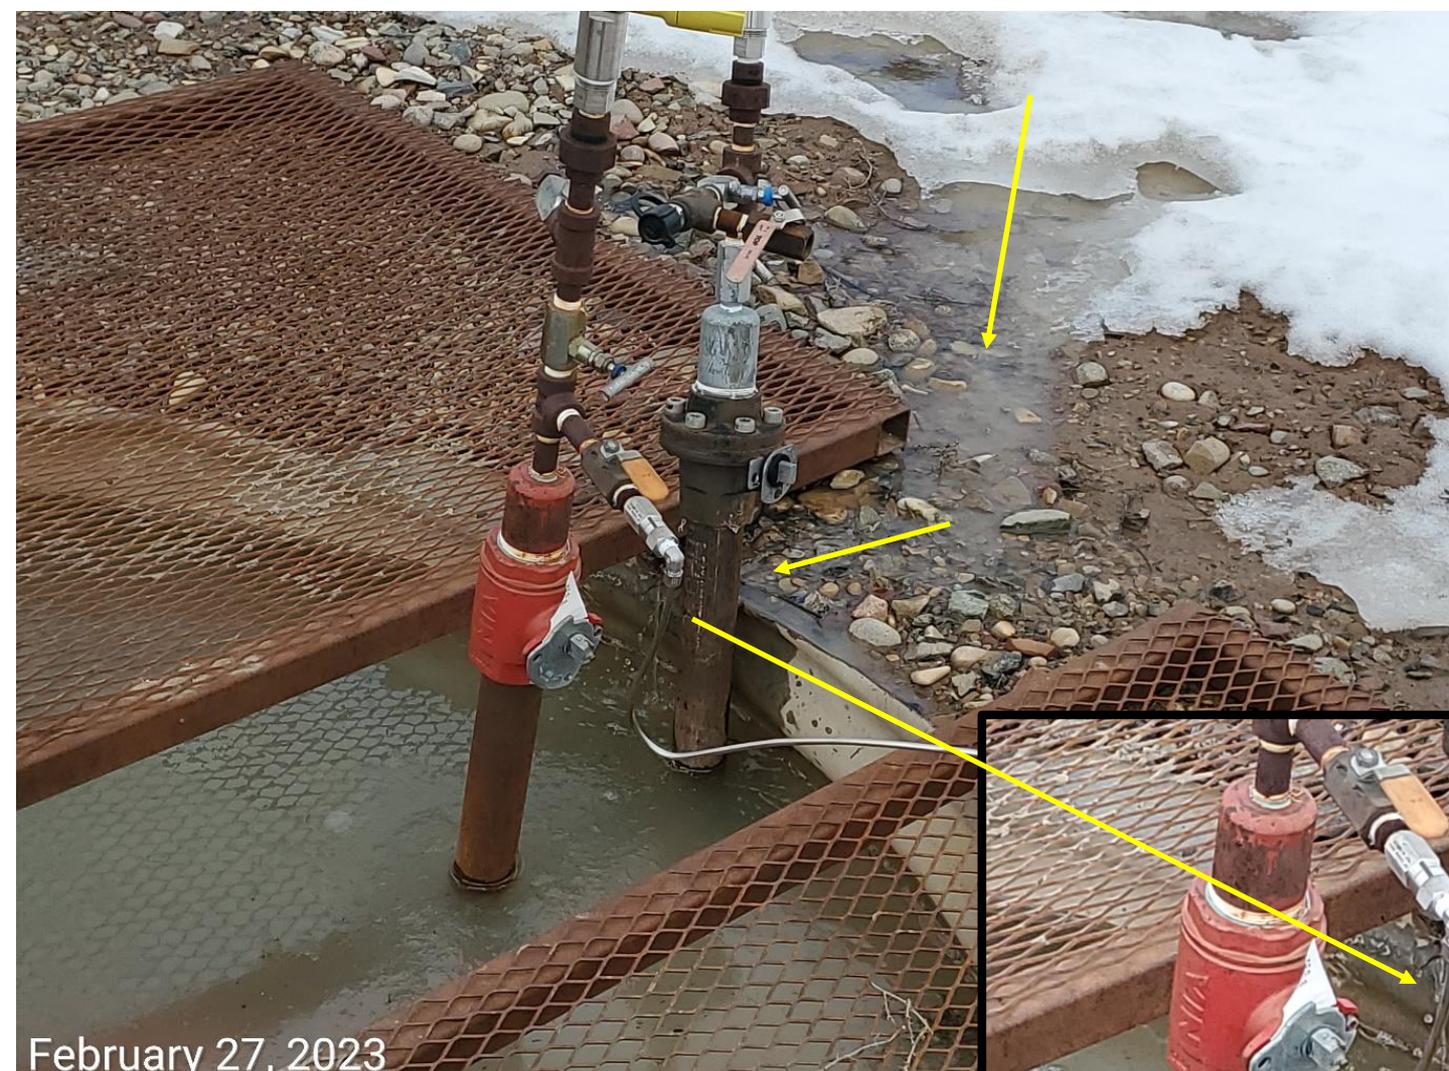
Photo 6: Photo shows stormwater runoff draining into wellhead cellar.
