Operator: BONANZA CREEK ENERGY OPERATING COMPANY

Location Name: State Antelope K-1 Pad

Loc ID: 431198

Inspection: 696304679

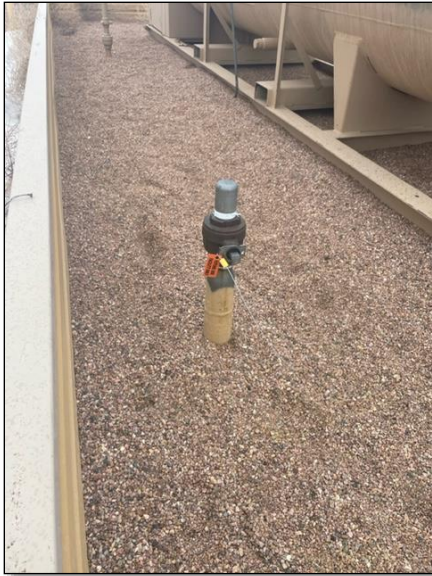
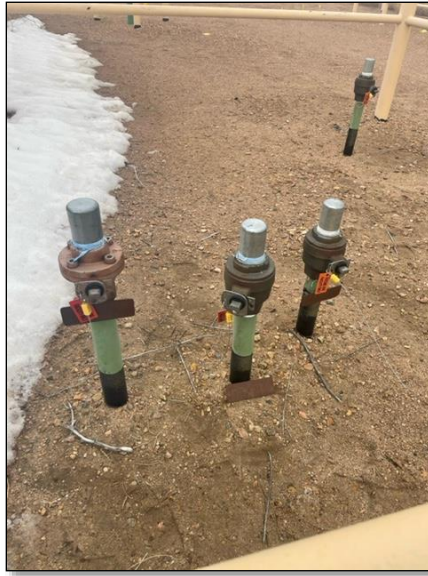
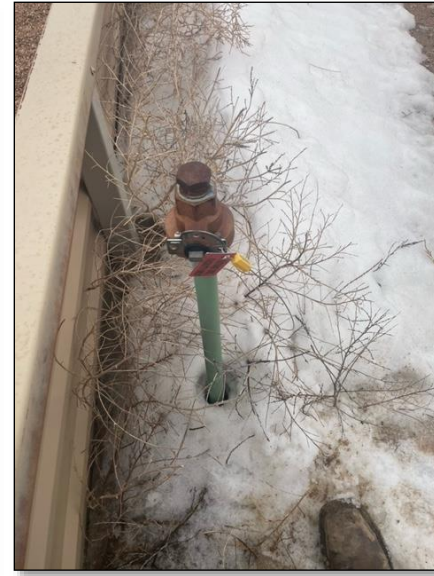
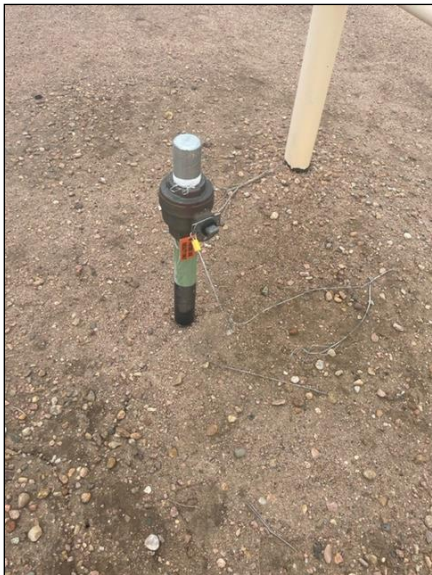
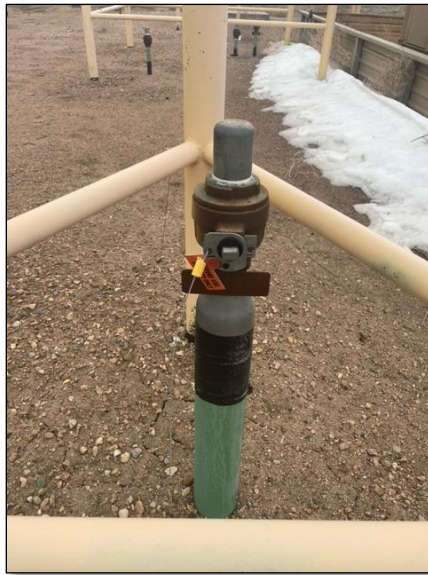
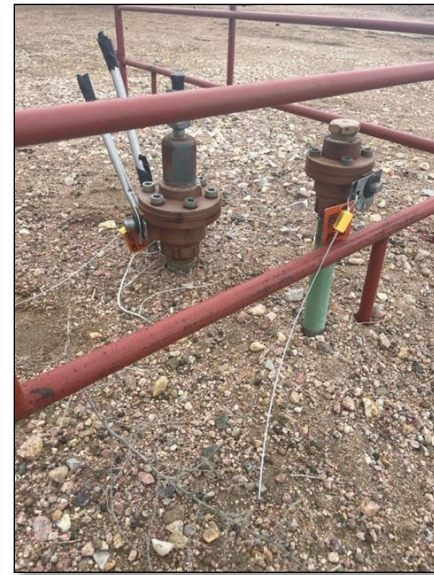
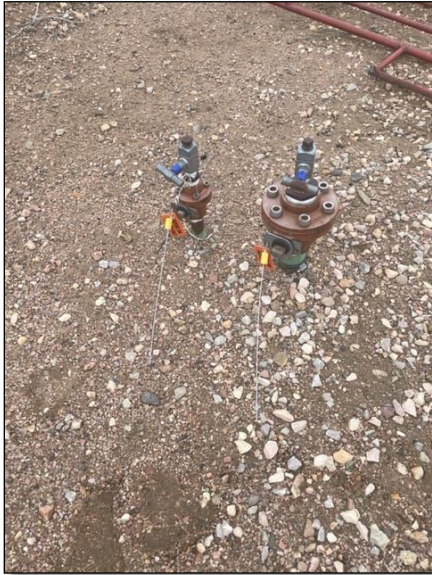
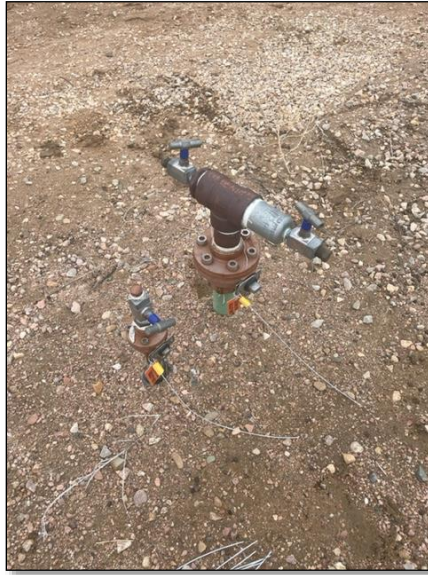
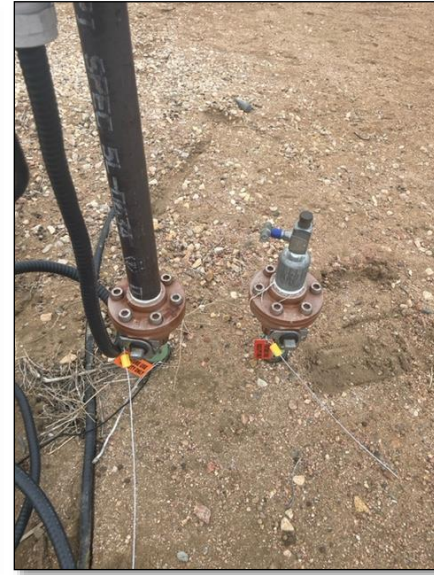
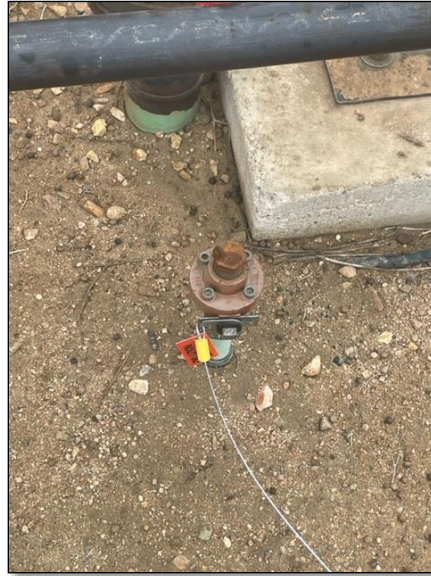
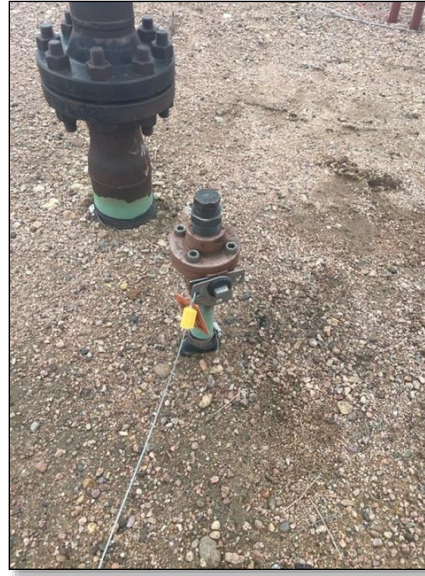
CA: Unmarked Risers at Compressor Area and North Separator; Comply with Rule 606

CA Resolution: Markers/signage have been installed to comply with Rule 606.

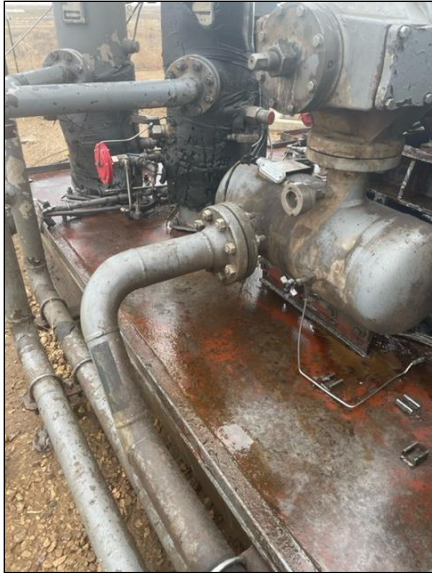
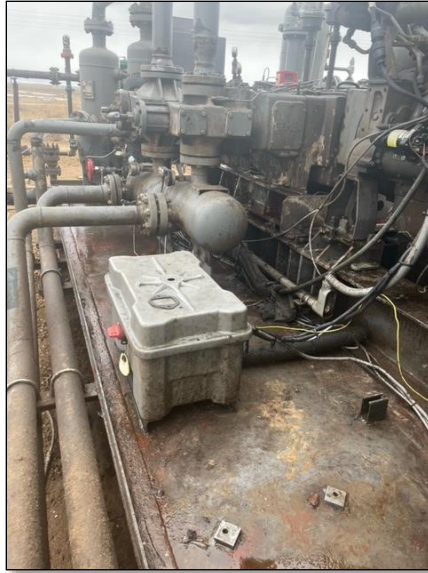
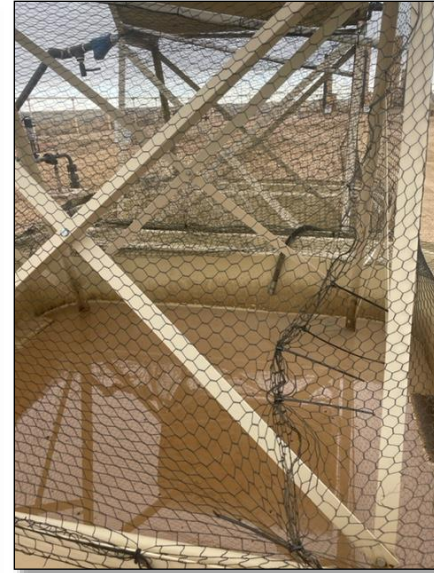
CA: Oily waste at Compressor. Wildlife Netting at West Day Tank has hole. For localized stained soils or oily waste - "Properly dispose of oily waste in accordance with 905.e." Install or repair wildlife protection equipment. Prevent any unauthorized discharge (specify condition if it is E&P waste, improper disposal, trash, etc.) Per Rule 902.b

CA Resolution: Oily waste has been properly disposed of to comply with Rule 905.e. Wildlife protection equipment has been adequately installed and measures are in place to prevent unauthorized discharge to comply with Rule 902.b.

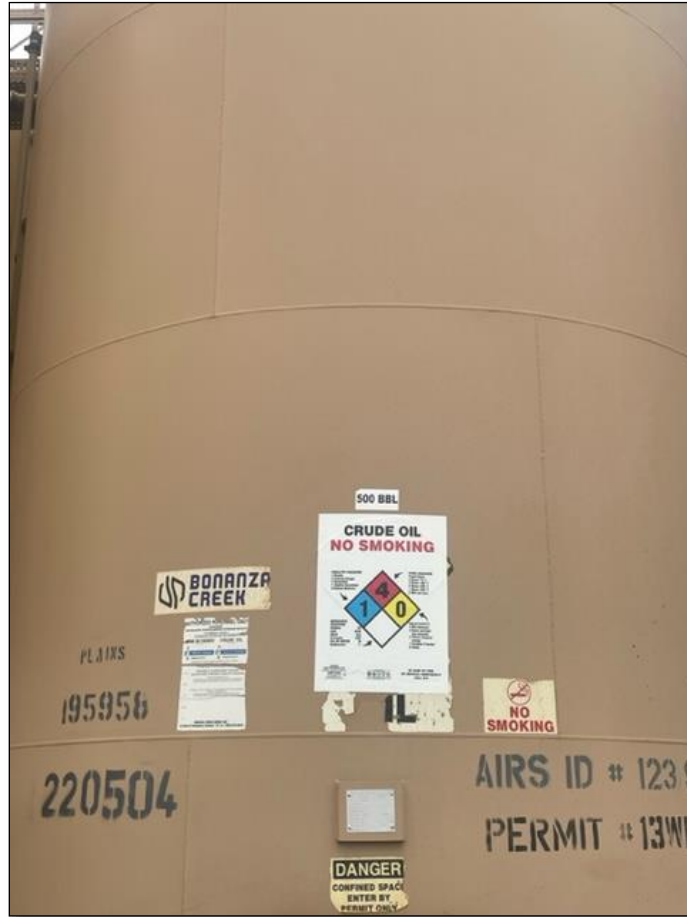
Exhibit A

CA: West Side of Tank - Tank #220504 - NFPA, Content, and Capacity Labels. Install sign to comply with Rule 605.h.

CA Resolution: Signage/labels have been installed to comply with Rule 605.h.
