Inspection Photos

Loc: 470757

Operator: WESTERN OPERATING COMPANY

Inspection Date: 3/1/2022

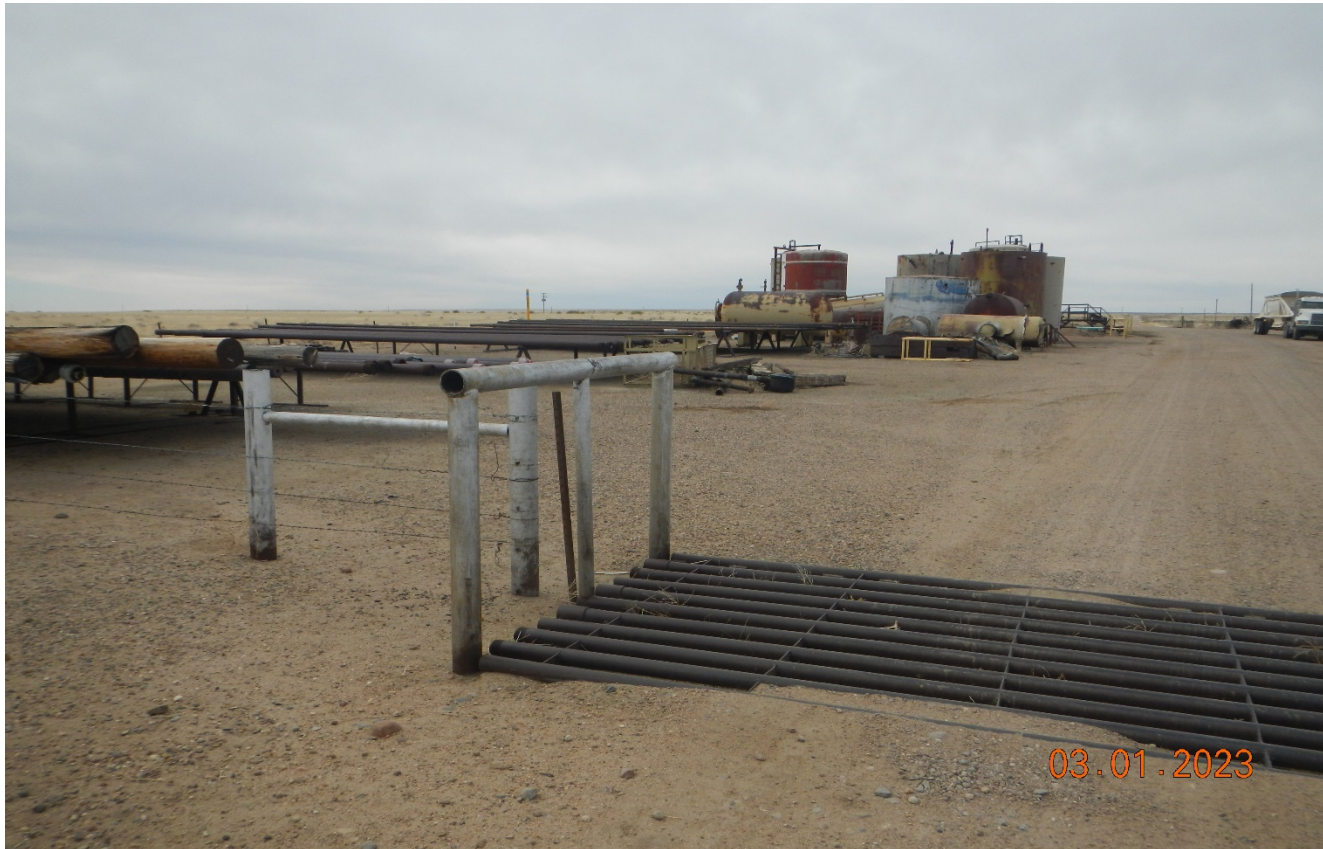
Photo 1. Facing southwest toward the PYLES offsite tank battery and storage yard.

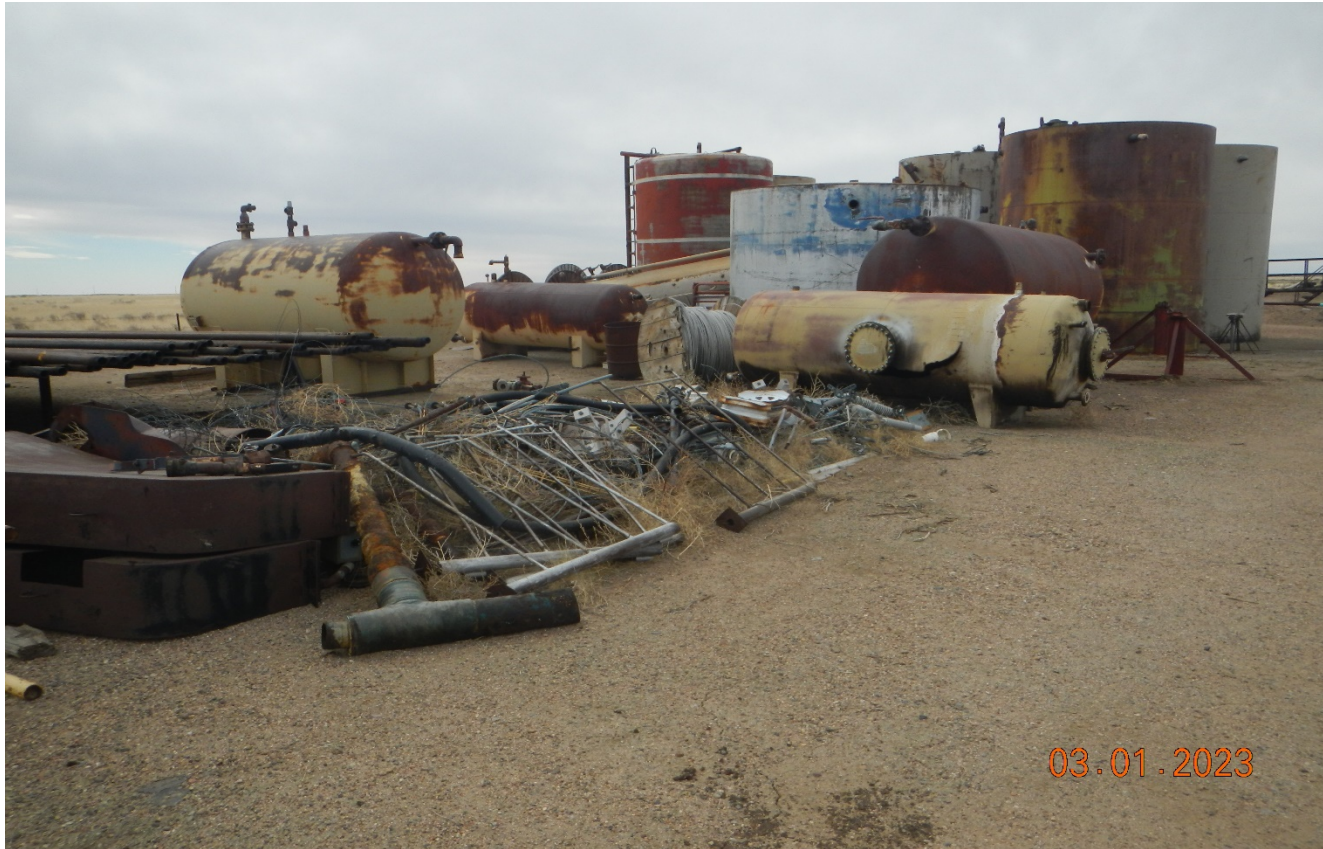
Photo 2. There is unused equipment being stored on location that needs to be removed. All equipment and supplies not necessary for use on this Oil and Gas Location is prohibited per Rule 606 and 1003.a.

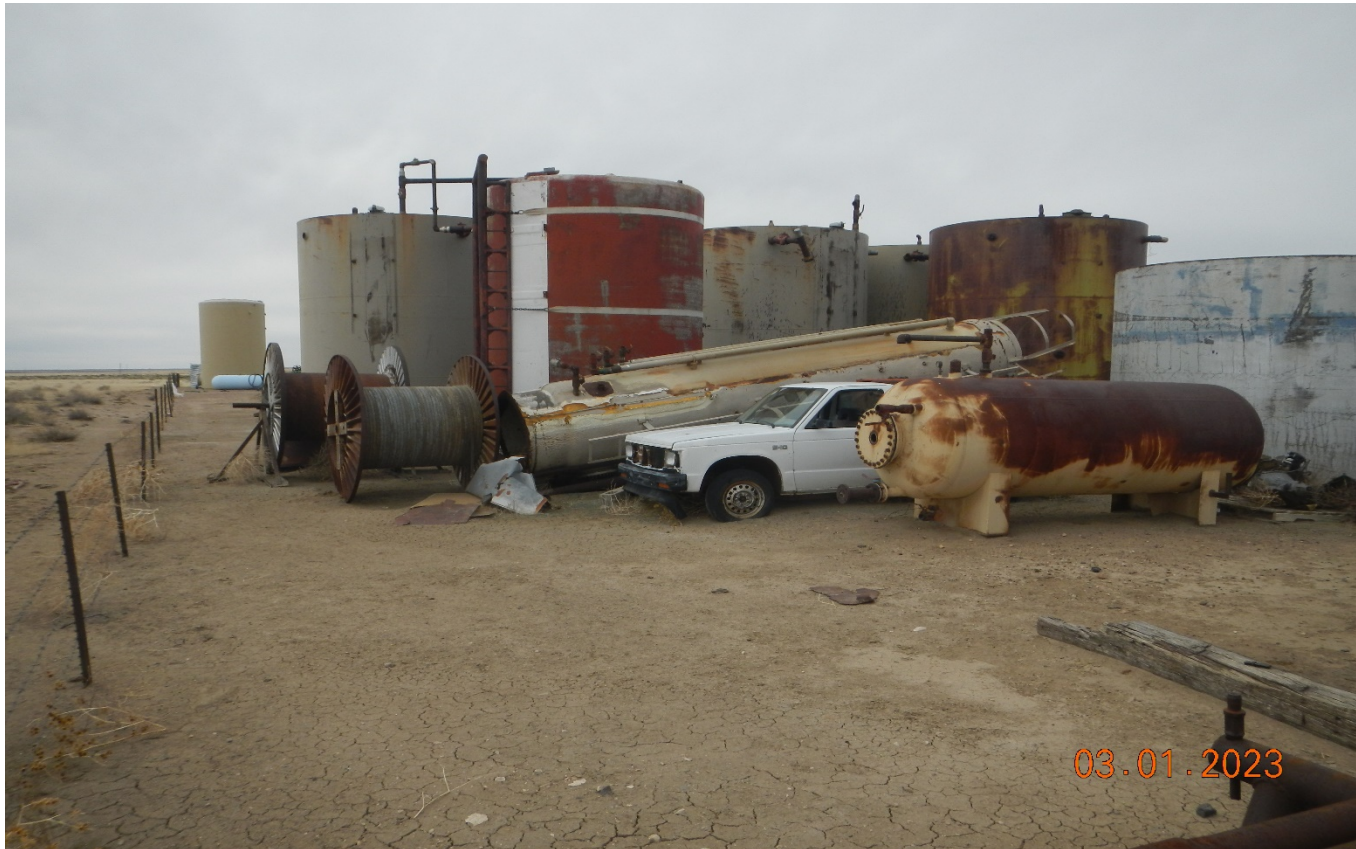
Photo 3. Facing west at the south side of the location. There is equipment and a vehicle that appears to have been sitting unused at this location for awhile.

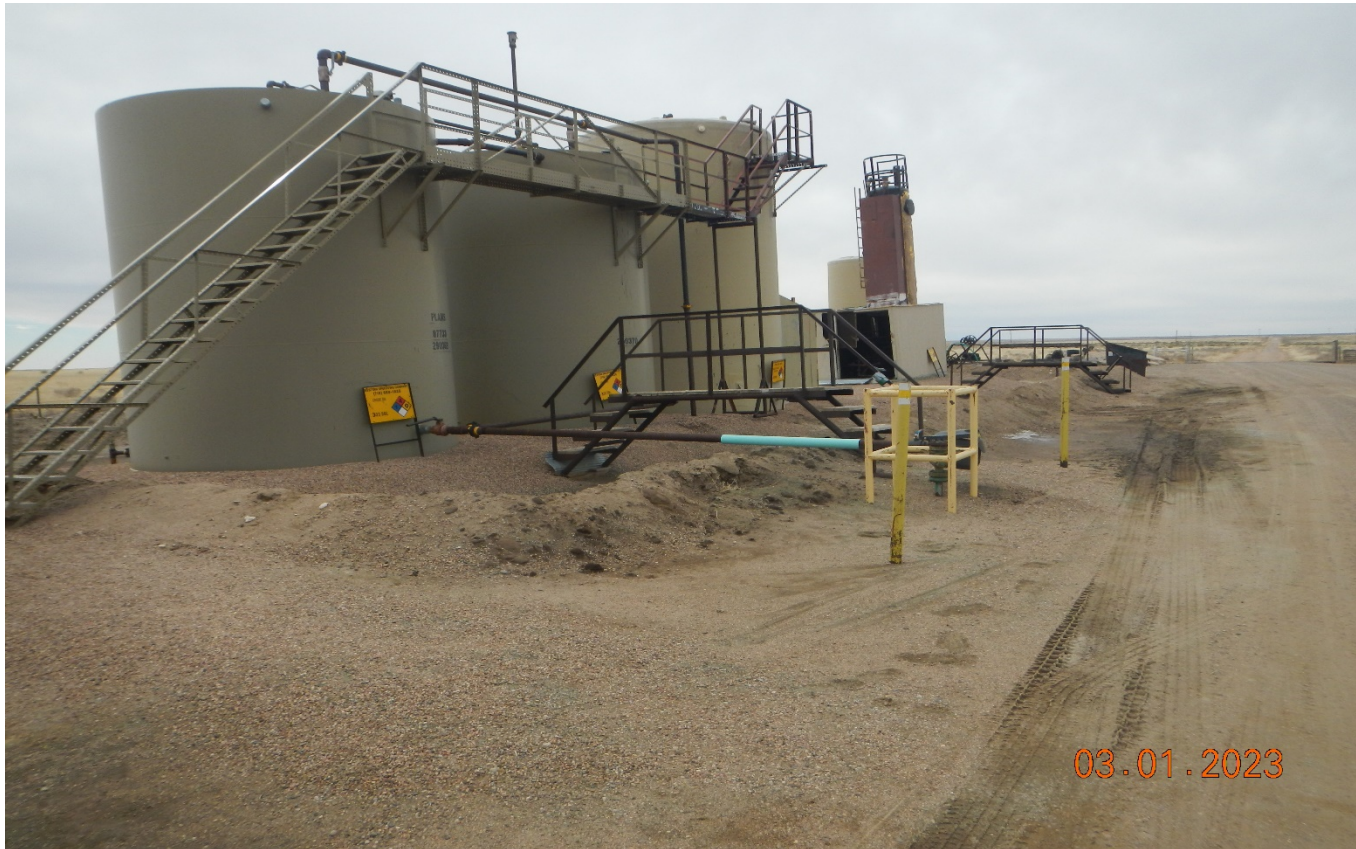
Photo 4. Facing toward the PYLES offsite tank battery at the location.

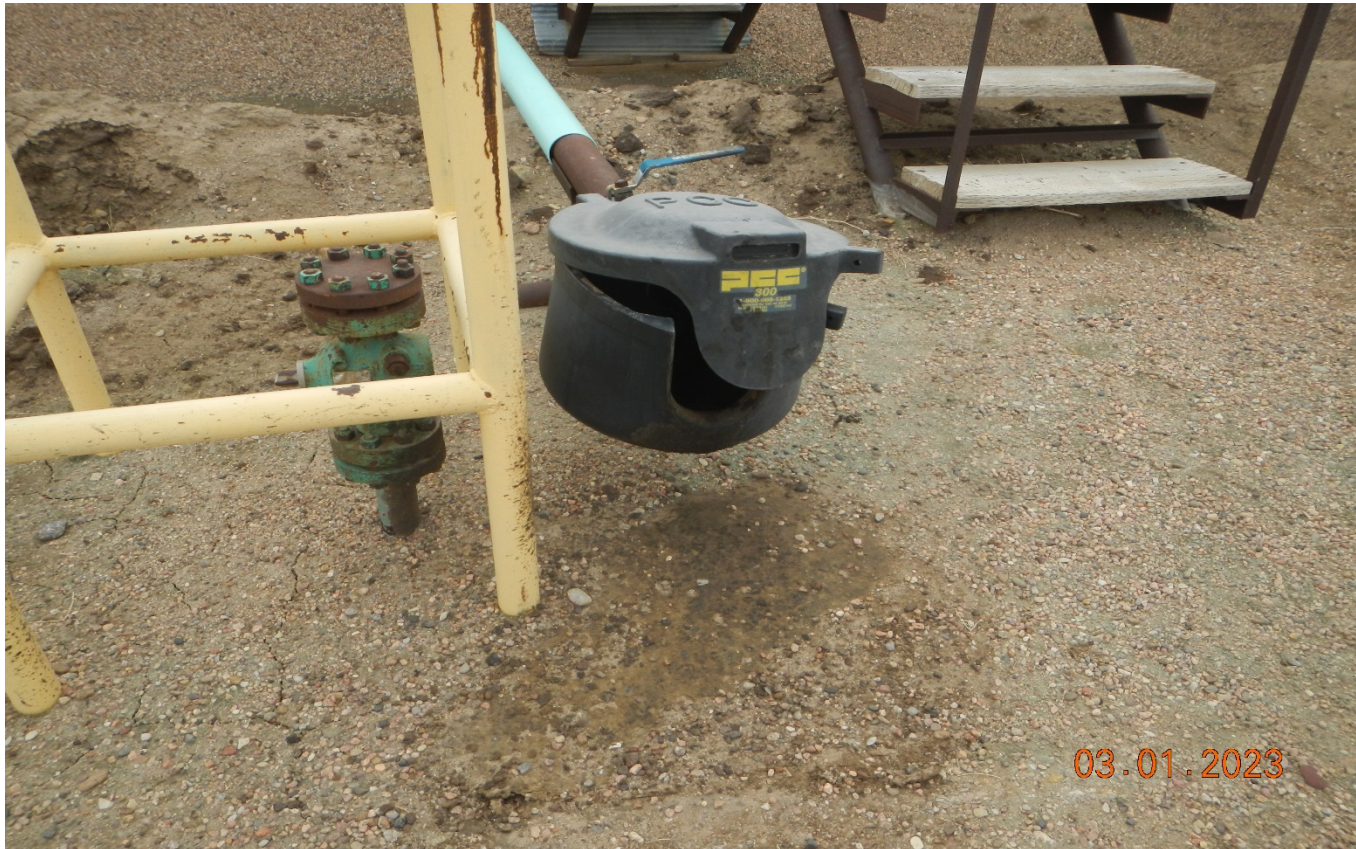
Photo 5. There is oil stained soils at the pipe outlet and oil inside the plastic containment that needs to be cleaned up.

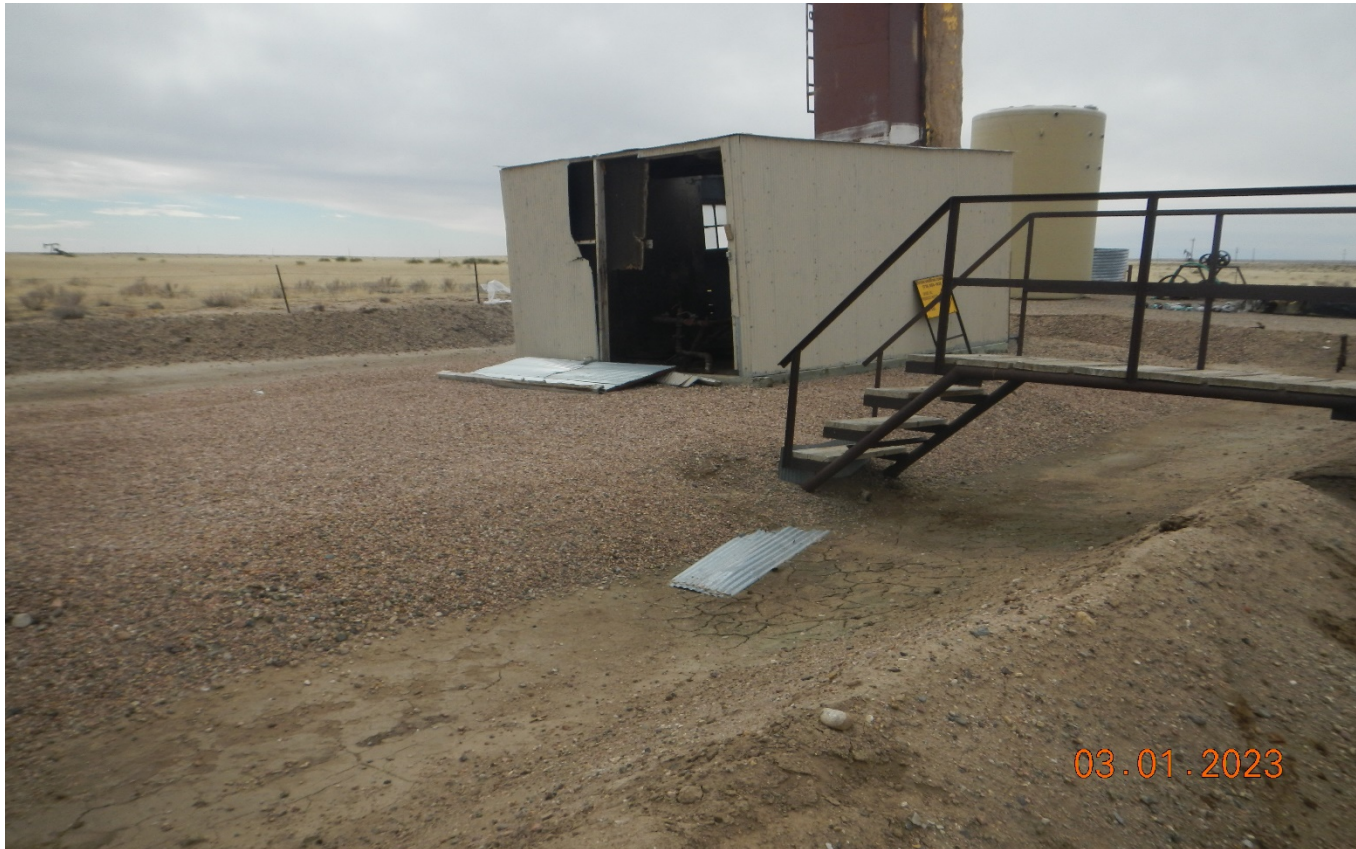
Photo 6. The shed inside the containment battery is not maintained with metal siding laying on the ground.

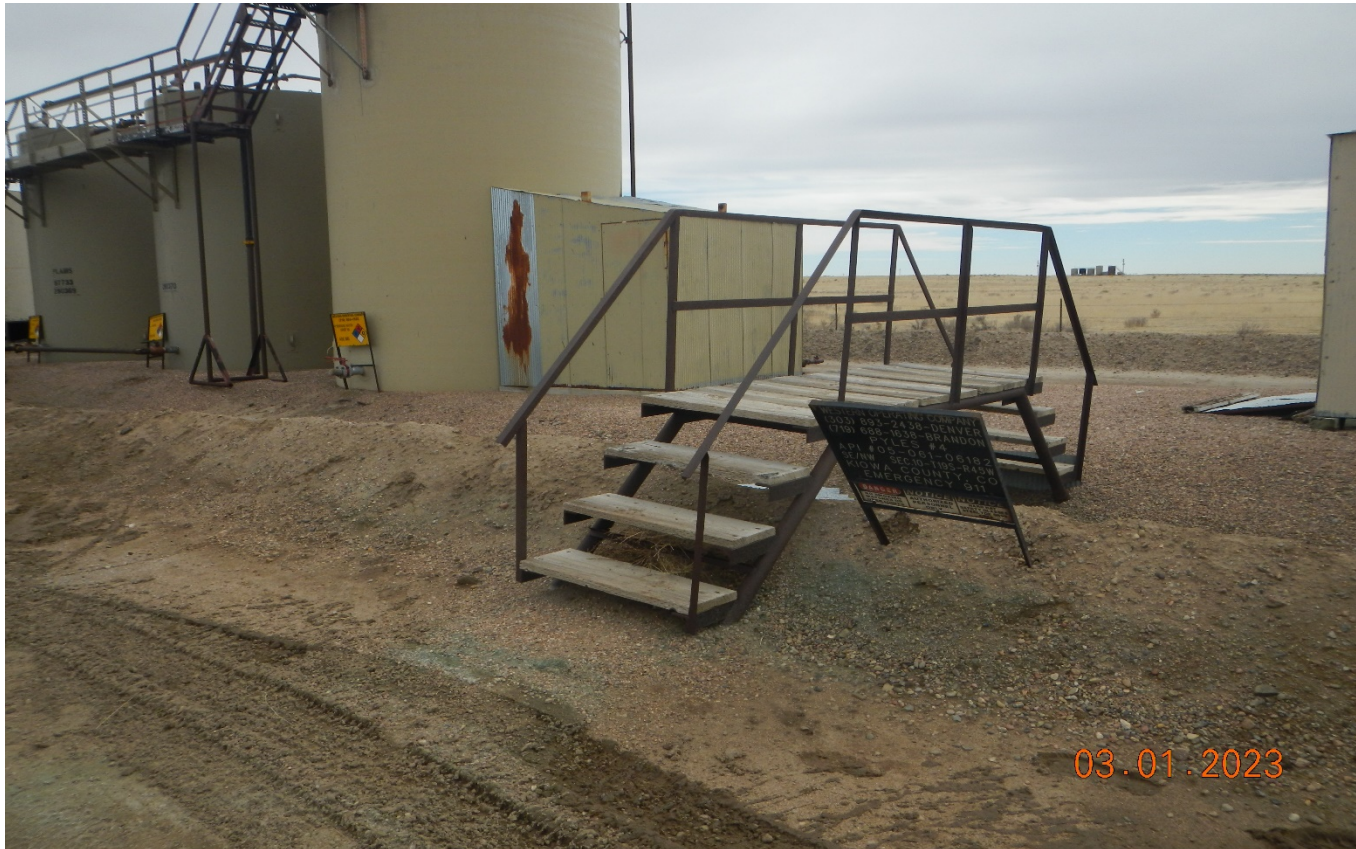
Photo 7. Facing back towards the PYLES tank battery. PYLES #5 wells sign is posted at the battery.

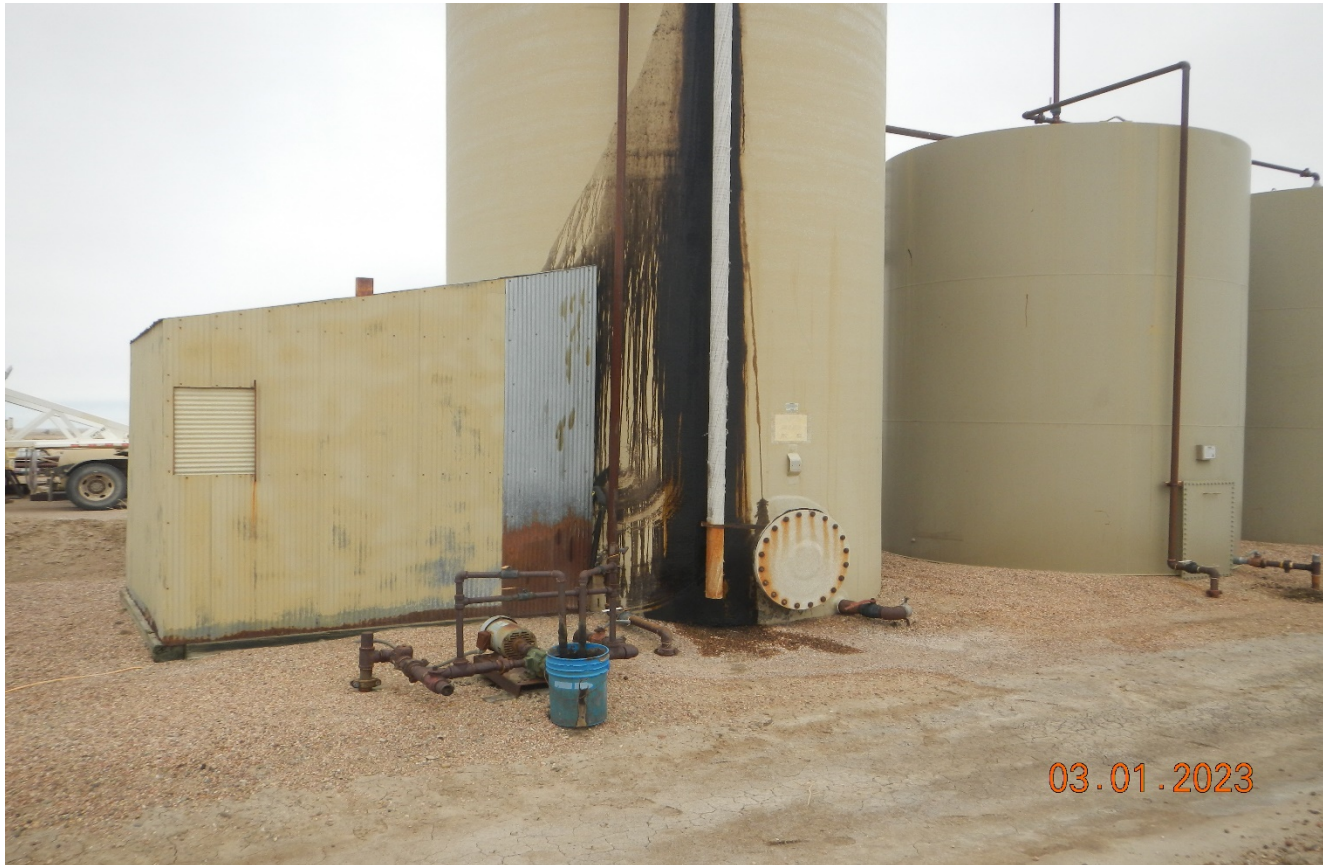
Photo 8. Facing at the back side of the tank battery. There was a spill from the tank which needs to be cleaned up. The blue bucket needs to be emptied and disposed of any oil.

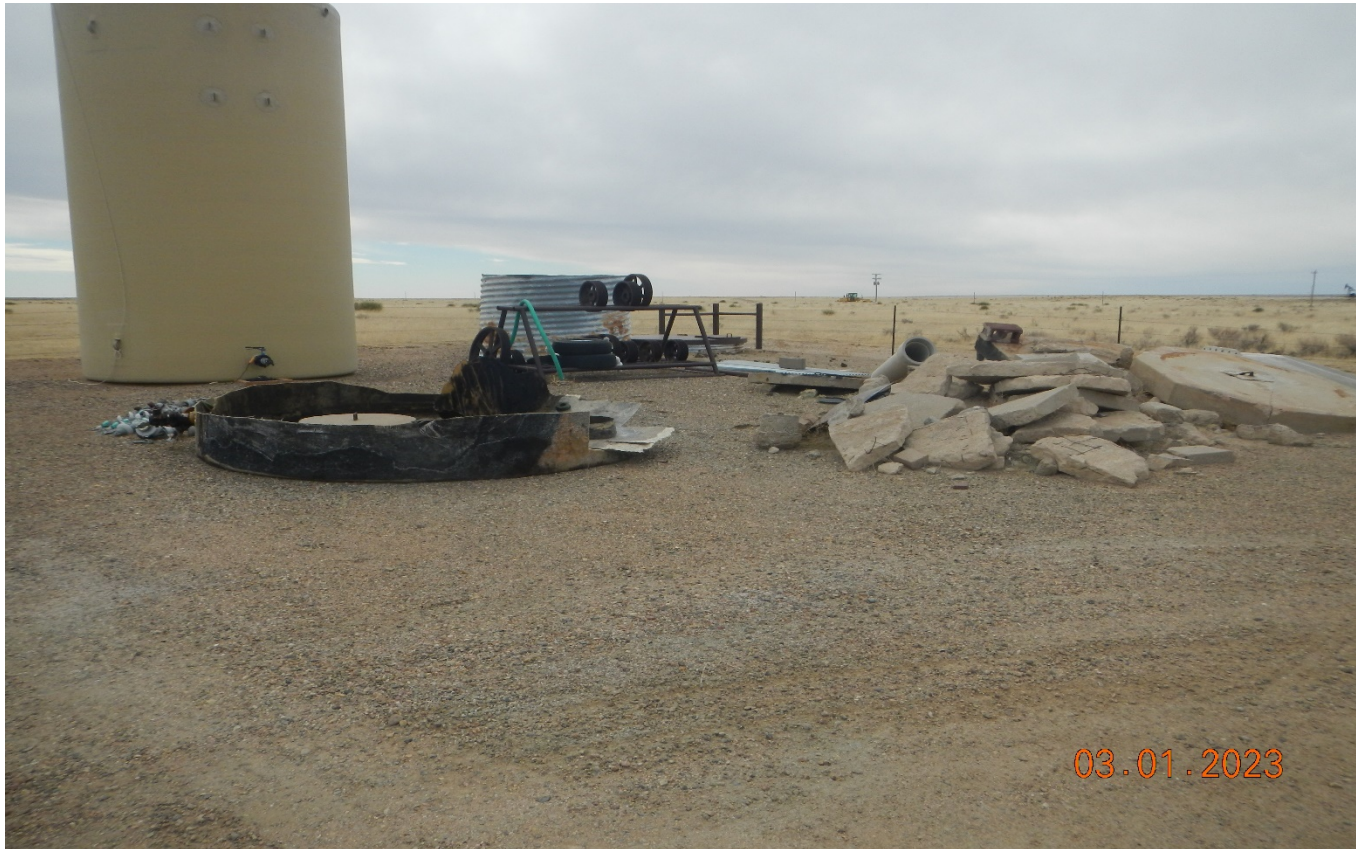
Photo 9. Facing toward the southwest side of the location. There is concrete debris and a broken bottom of a tank among other debris and equipment that must be removed per Rule 606 & 1003.a.

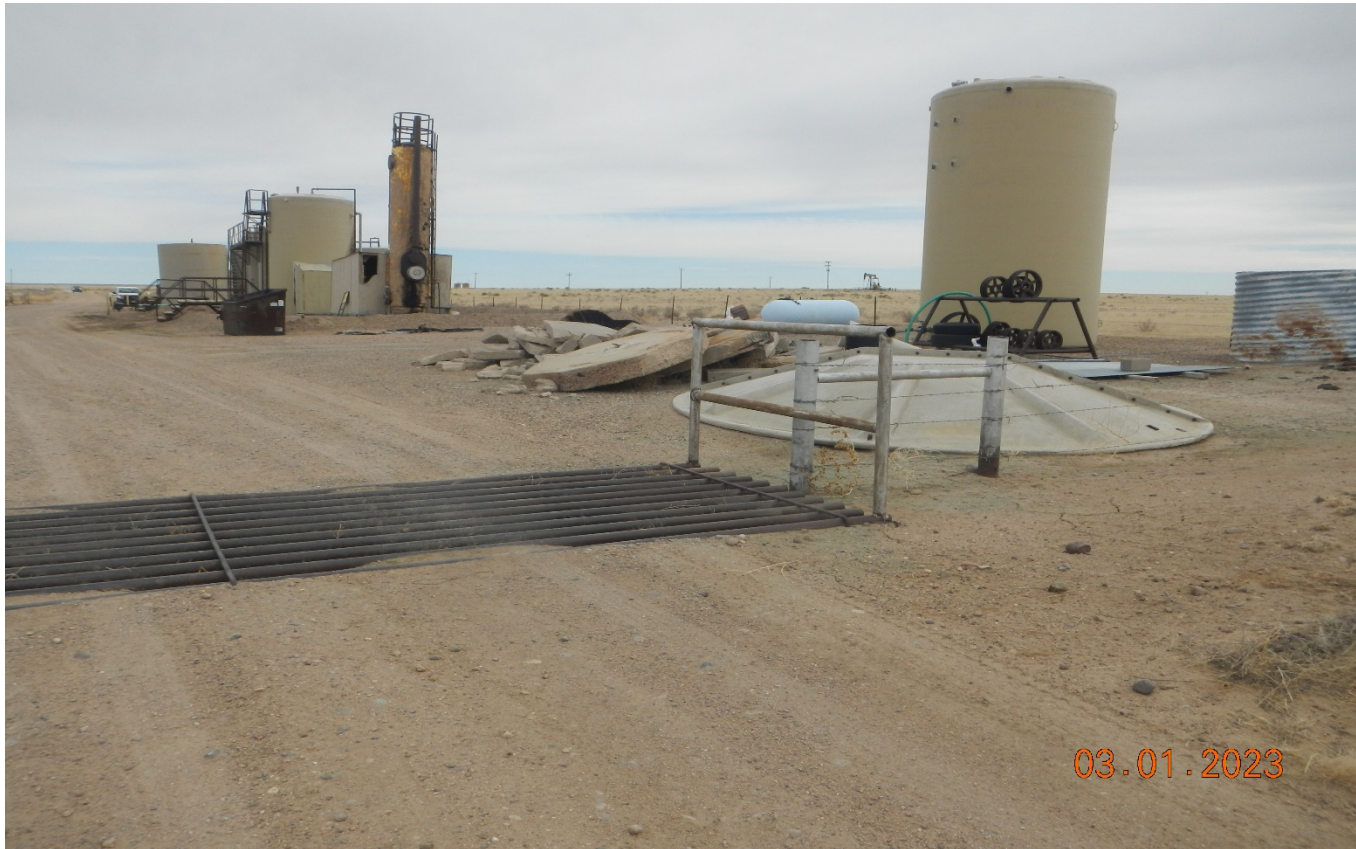
Photo 10. Facing southeast toward the PYLES offsite tank battery and storage yard. There is concrete debris and a broken bottom of a tank among other debris and equipment that must be removed per Rule 606 & 1003.a.

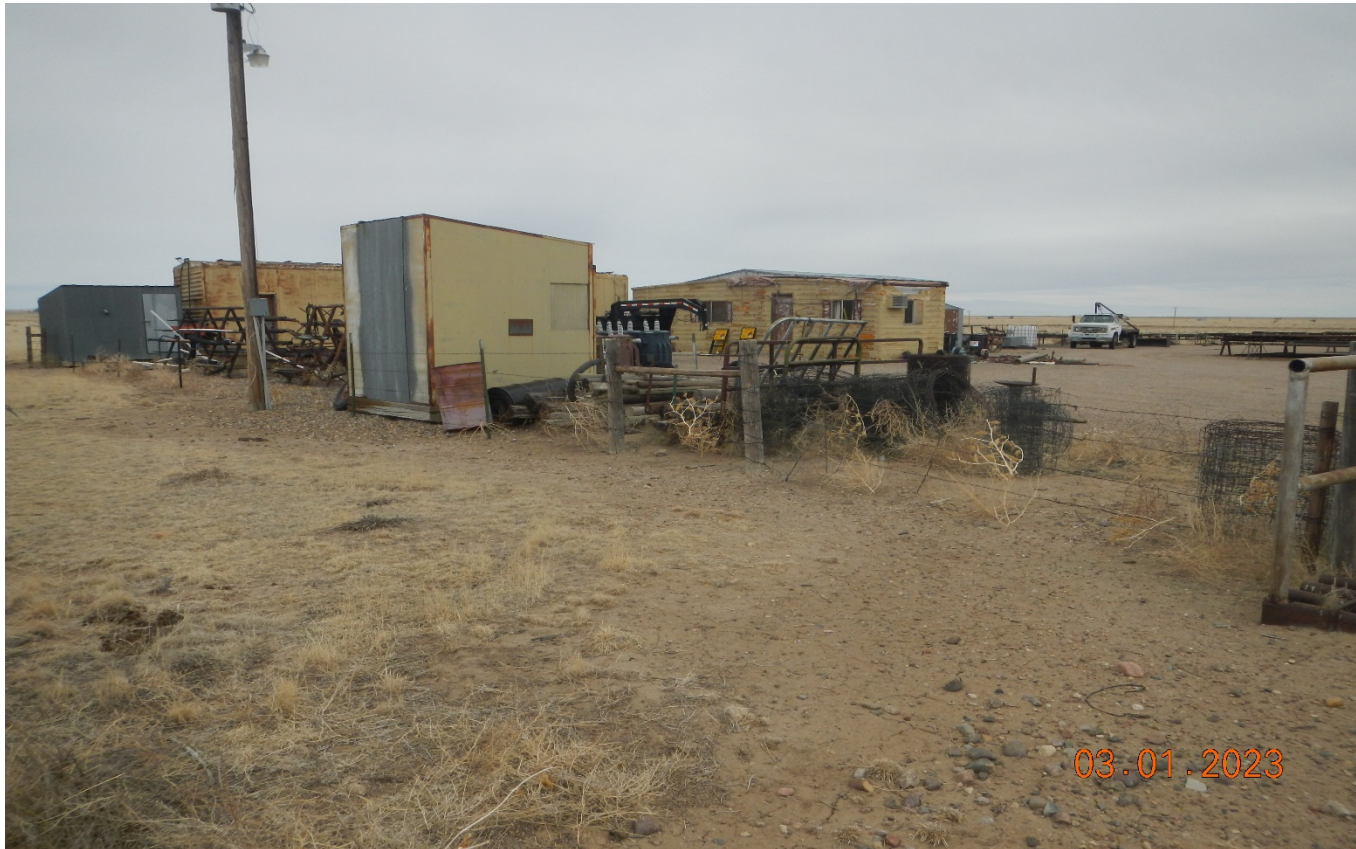
Photo 11. Facing northeast toward the PYLES offsite tank battery and storage yard.

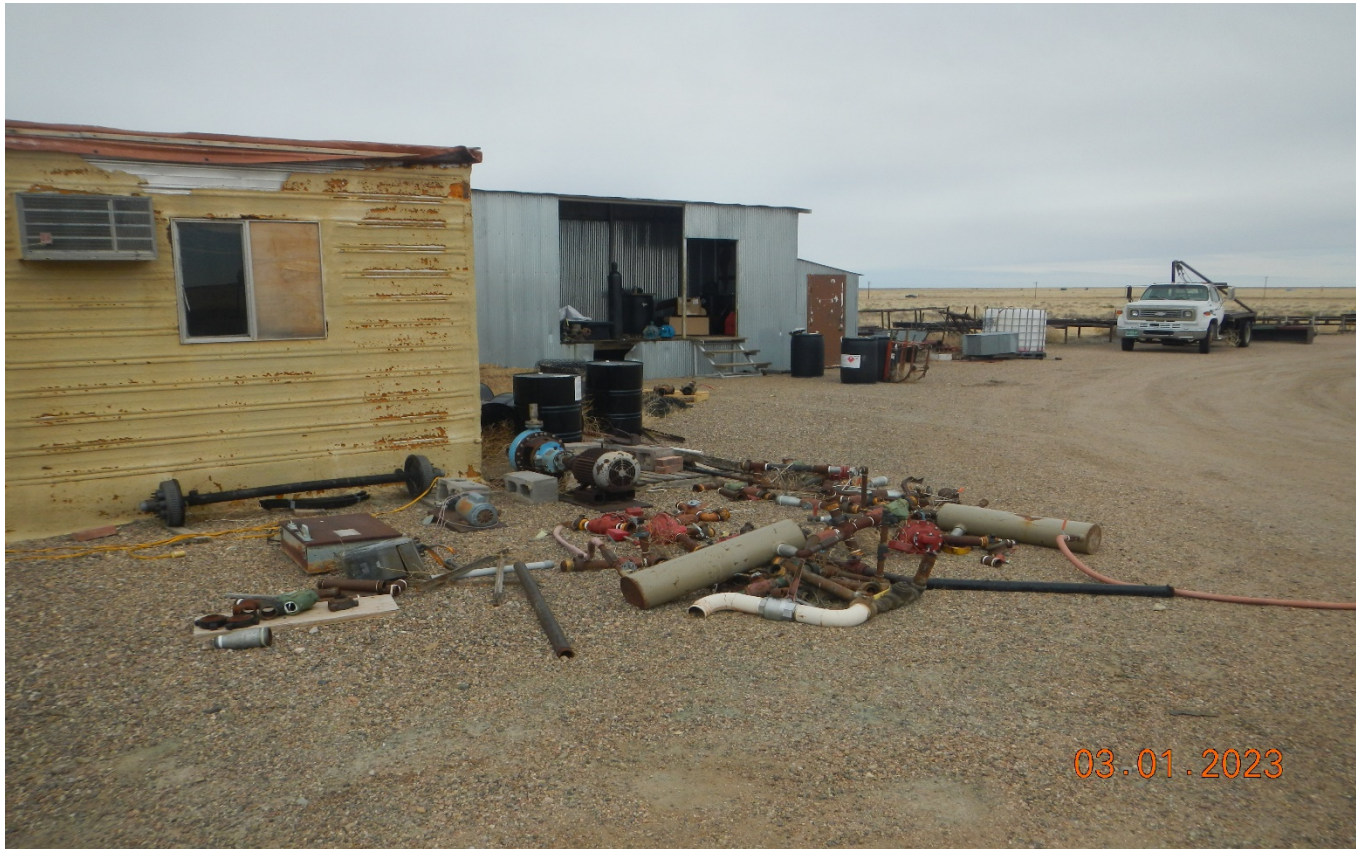
Photo 12. There is various parts and supplies being stored on location. All equipment and supplies not necessary for use on this Oil and Gas Location is prohibited per Rule 606 and 1003.a.

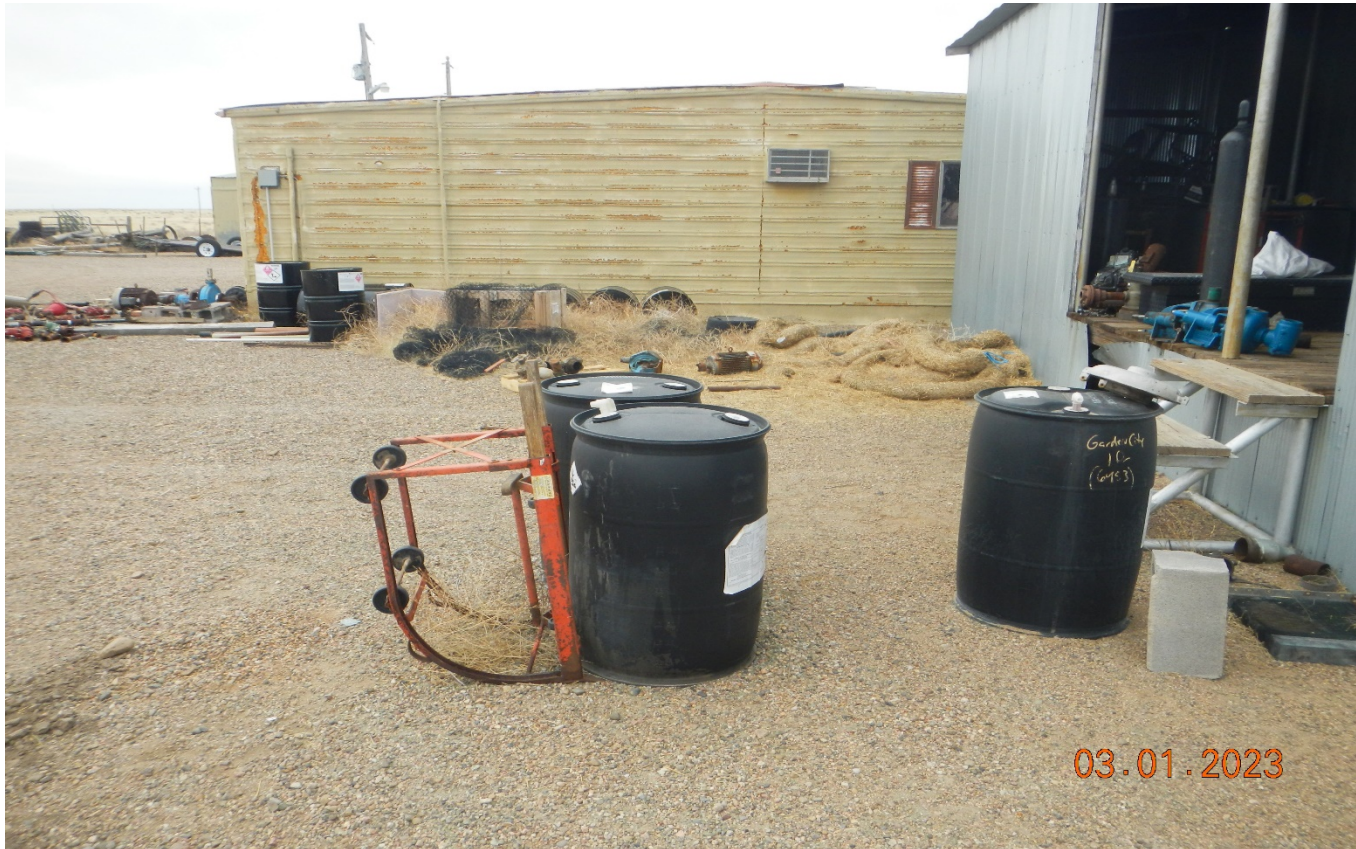
Photo 13. There are several chemical barrals on location with faded labeling and no secondary containment.

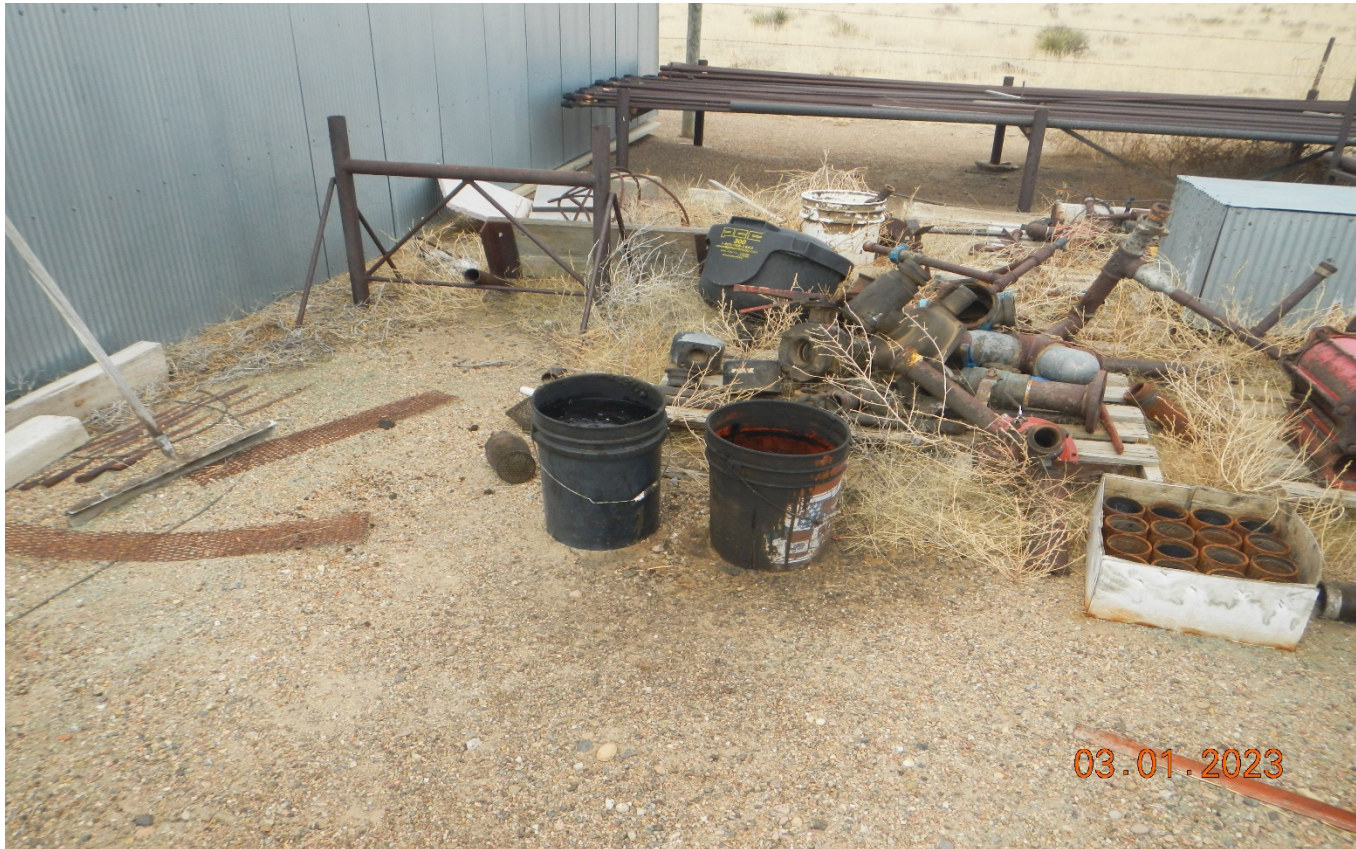
Photo 14. There are various parts and supplies and tow buckets of oil which appear to have spilled out on the ground. Buckets of oil need to be properly disposed and stained soil cleaned up.

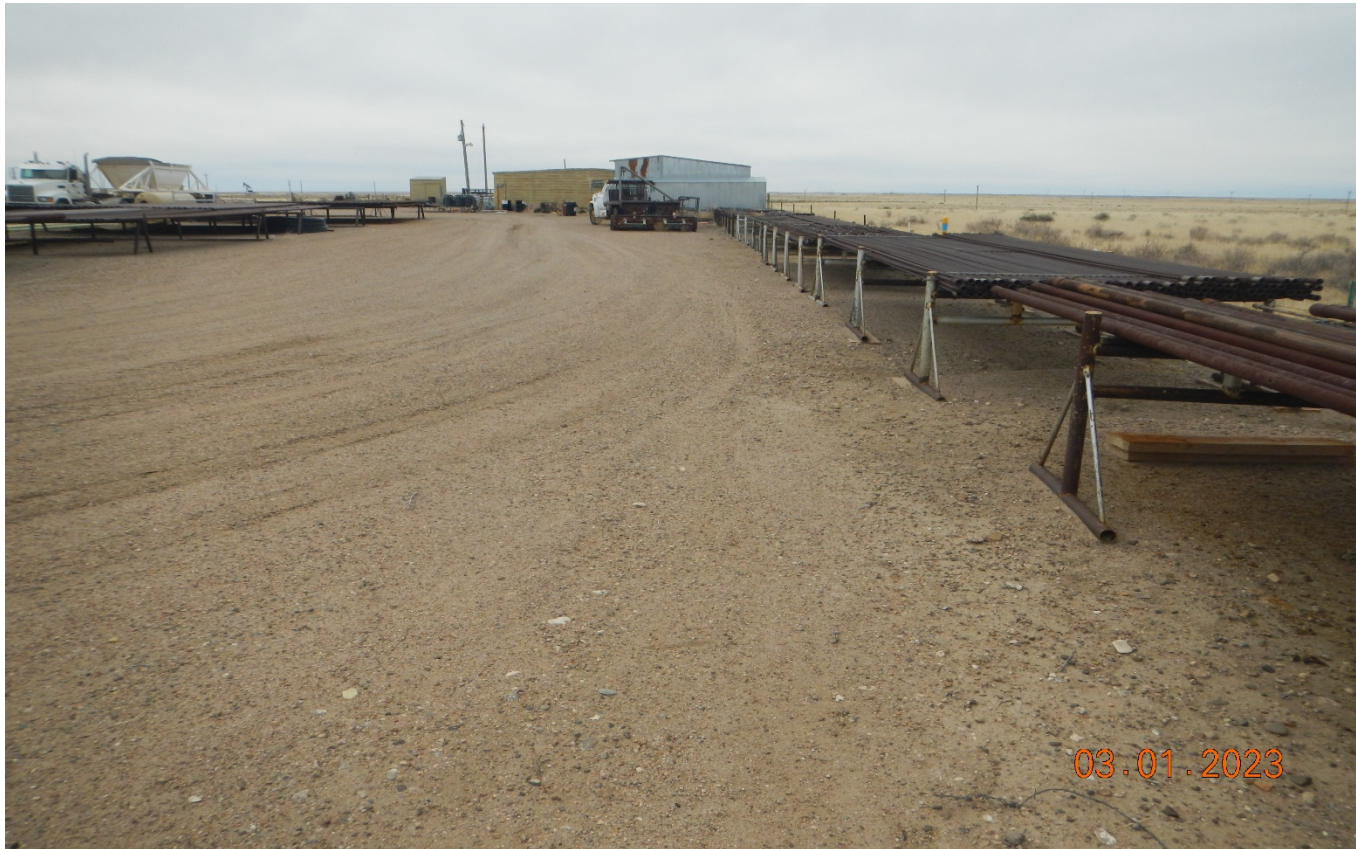
Photo 15. Facing west at the north side of the location. There is storage of unused drilling pipe at the location. All equipment and supplies not necessary for use on this Oil and Gas Location is prohibited per Rule 606 and 1003.a.

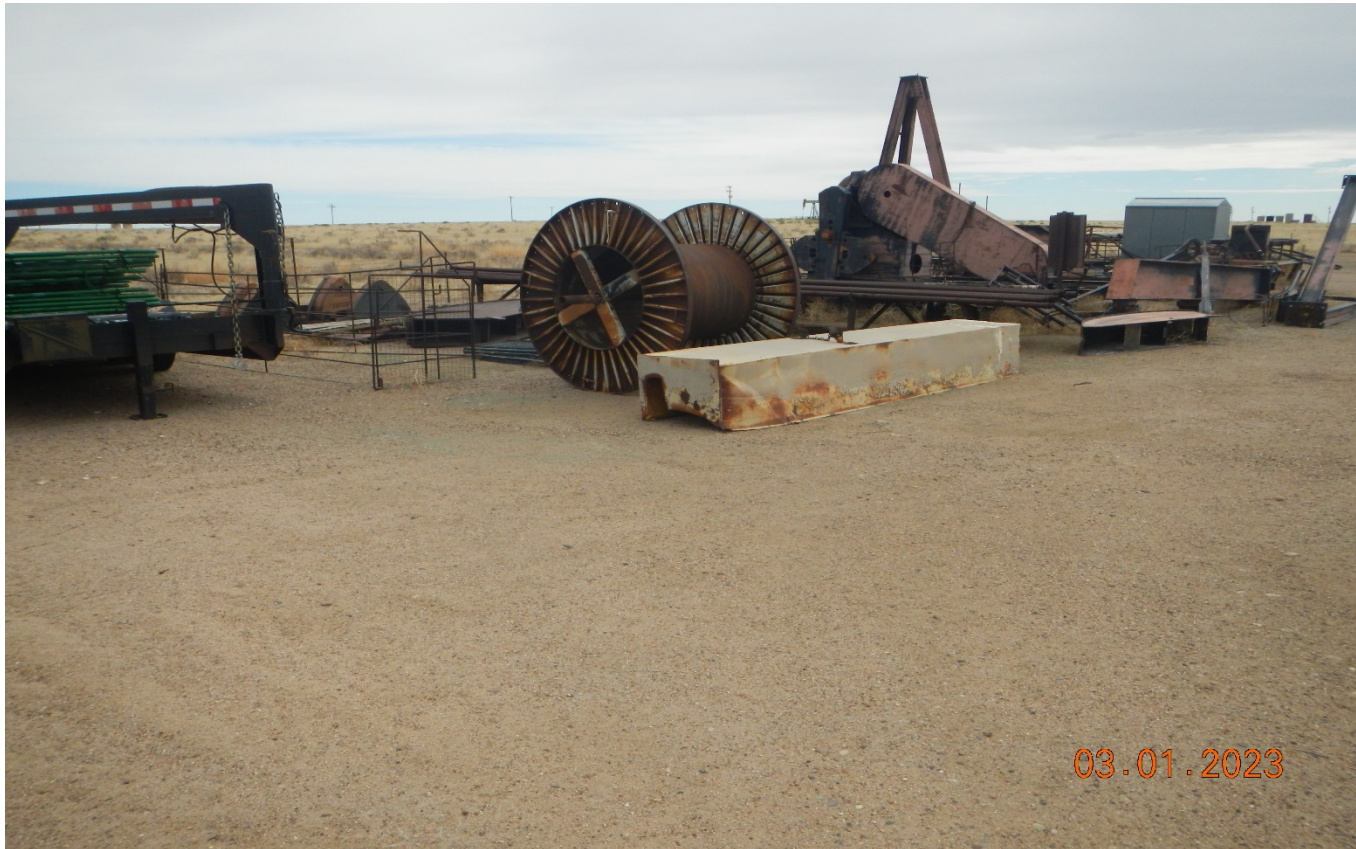
Photo 16. Facing toward the east side of the location. All equipment and supplies not necessary for use on this Oil and Gas Location is prohibited per Rule 606 and 1003.a.

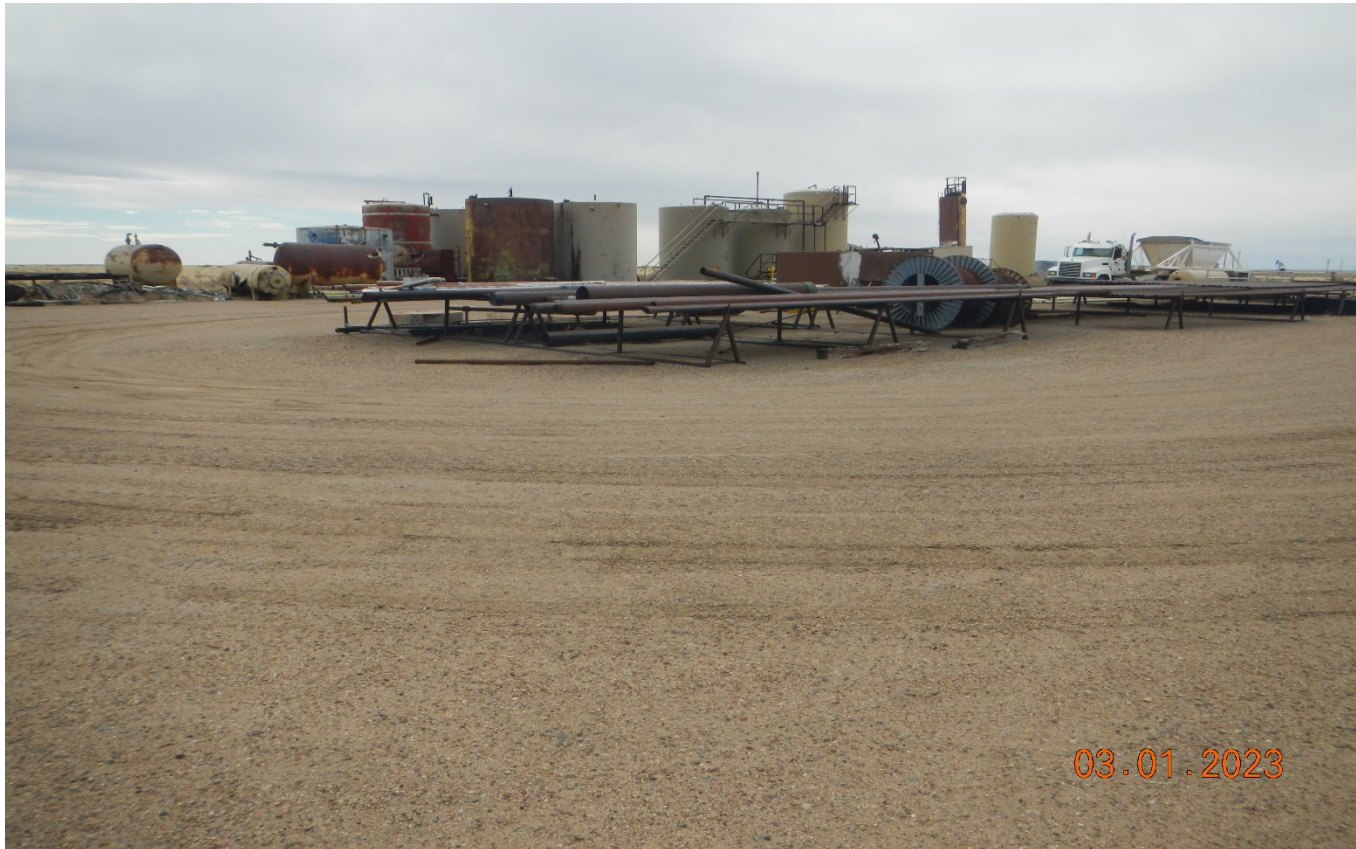
Photo 17. Facing southeast at the location PYLES offsite tank battery and storage yard. The use of this location as a storage yard is prohibited per the rules.
