Interim Reclamation and Stormwater Inspection

Operator: UPLAND EXPLORATION LLC- #10701

Location ID: 462908

Inspection Photos
Location Name: Little Lady 21/North Well Pad
Location ID: 462908

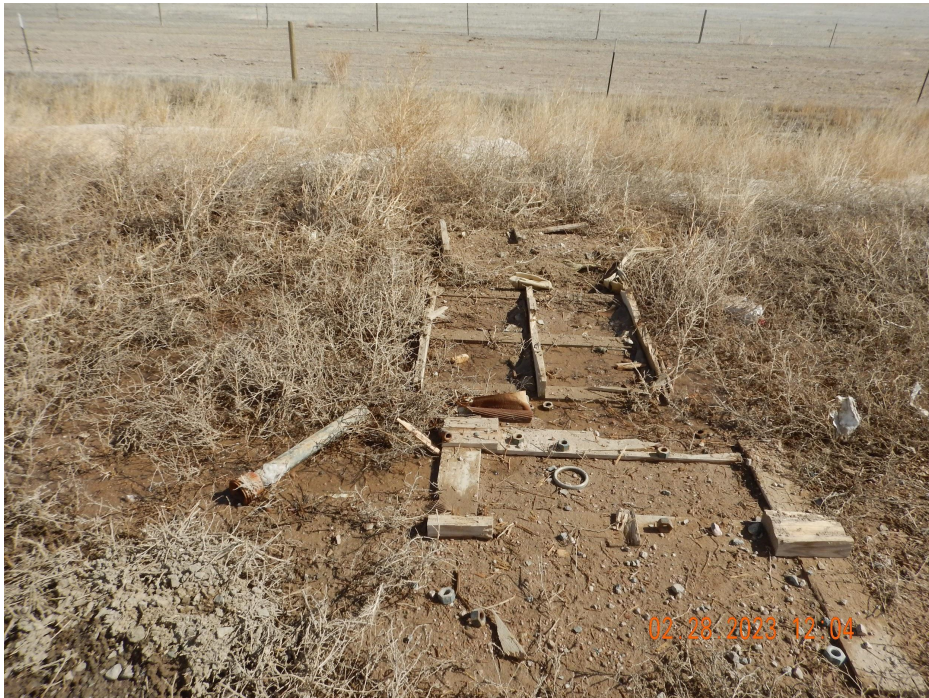
Photo 1. Photo taken from the southeastern location, facing East. Photo illustrates trash being stored on location has mostly been removed and still requires additional cleanup.

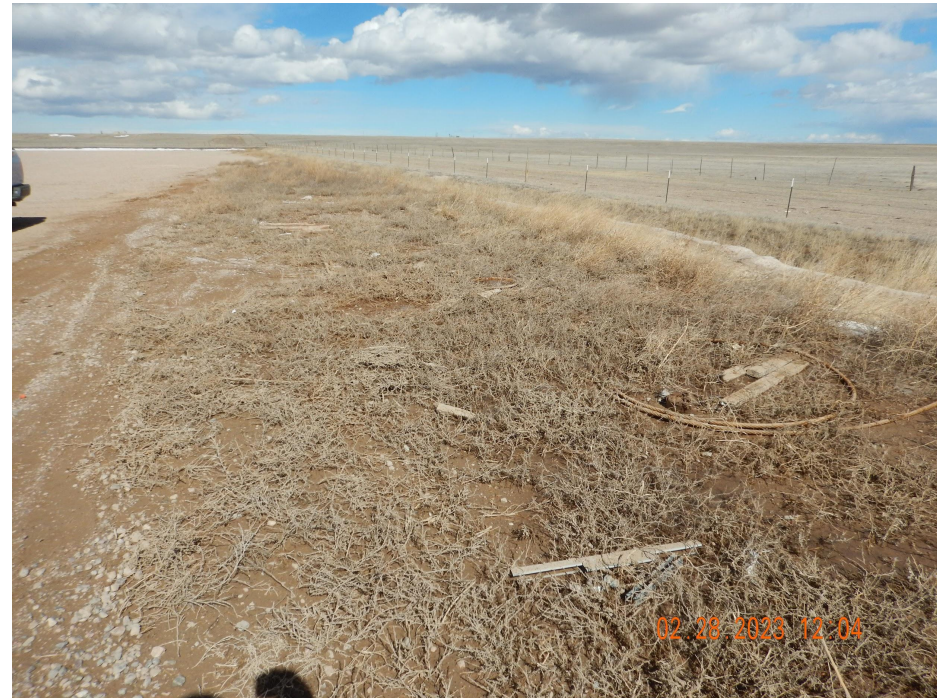
Photo 2. Photo taken from the southeastern location, facing Northeast. See comments under Photo 1.

Note- weeds were observed along the eastern perimeter of location.

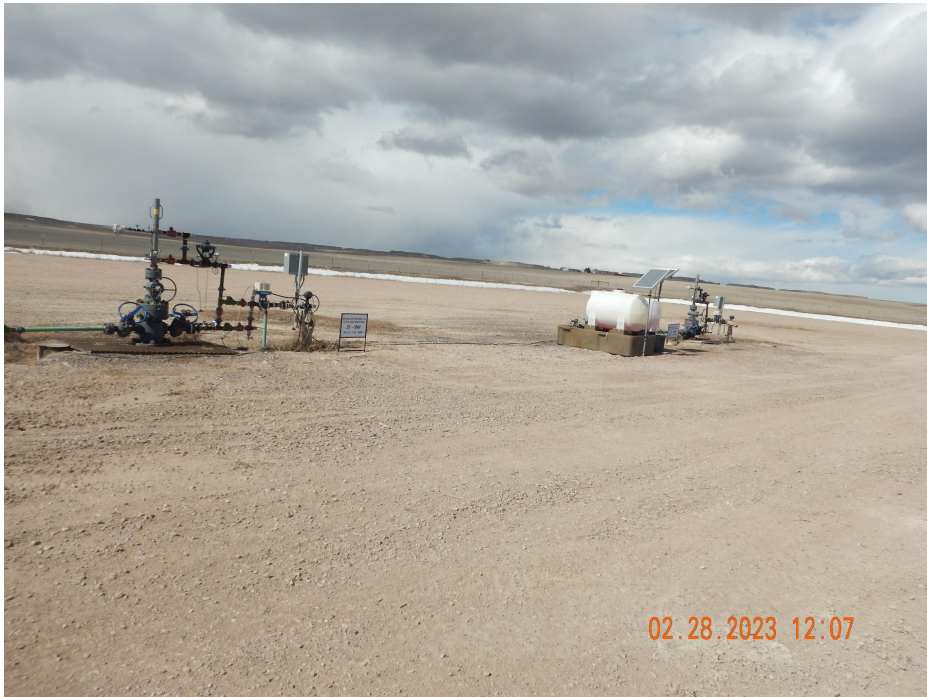
Photo 3. Photo taken from the wellheads, facing North. Photo illustrates unused equipment has been removed.

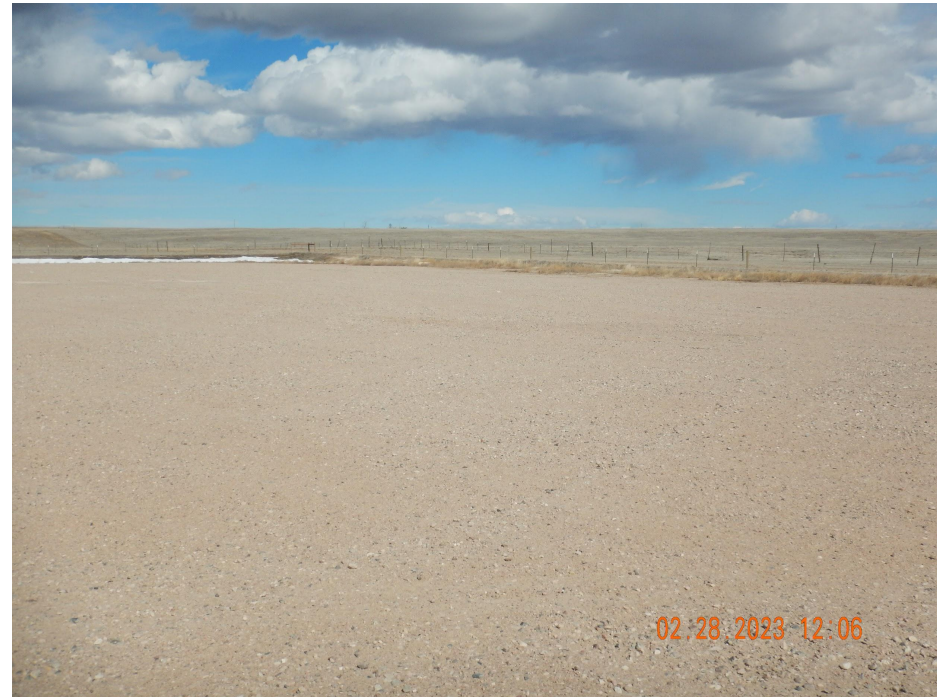
Photo 4. Photo taken of the northeastern location, facing Northeast. Photo illustrates the chemical container has been removed.

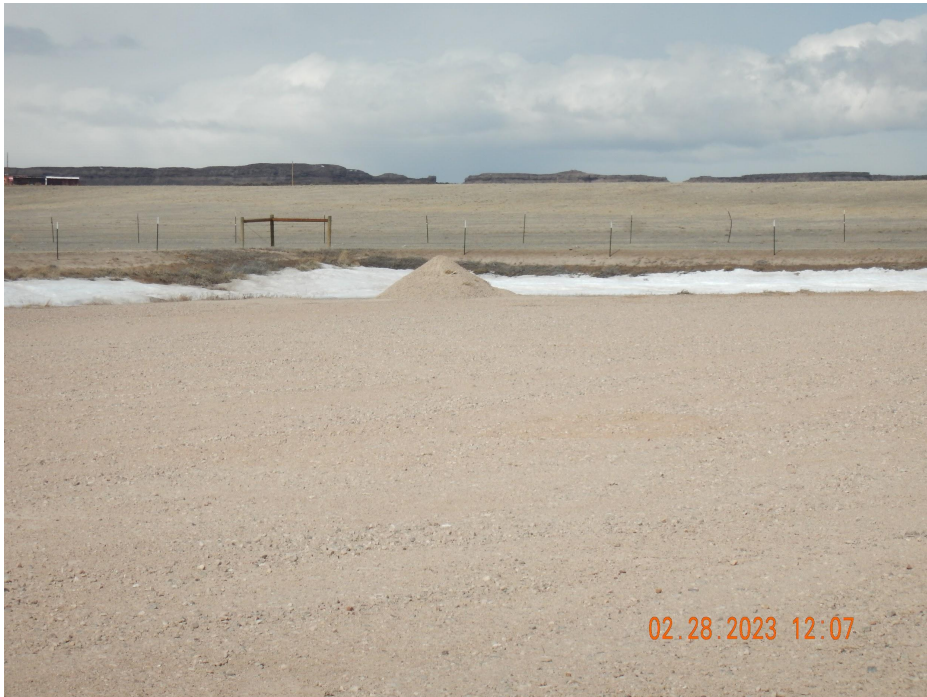
Photo 5. Photo taken from the northwestern location, facing North. See comments under Photo 4.

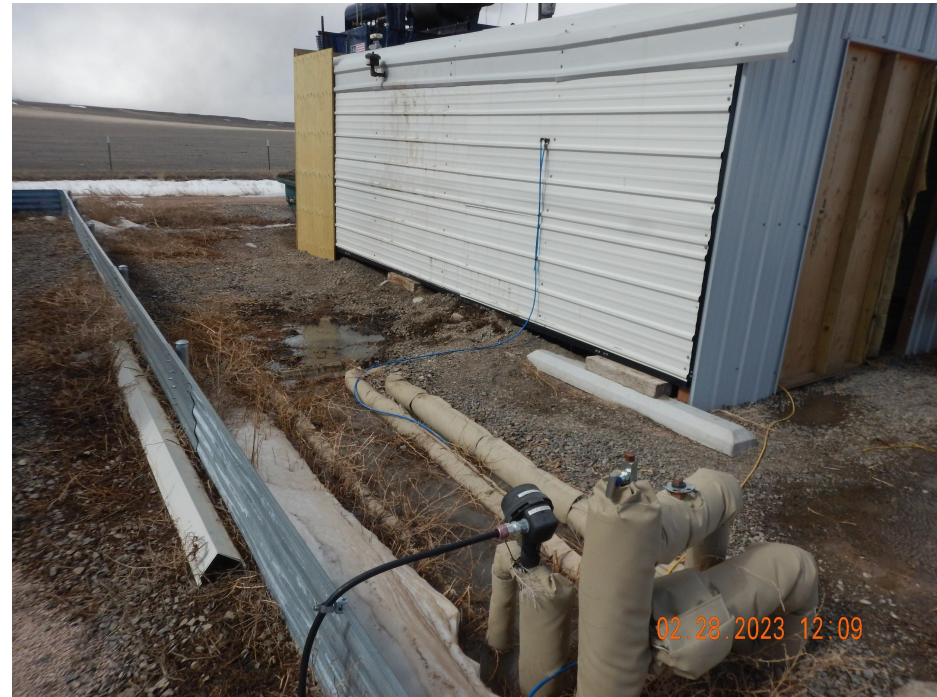
Photo 6. Photo taken from the western location, facing West. Photo illustrates stained soil/spill related to the compressor.

Note- it does not appear any action has been taken since the previous inspection.

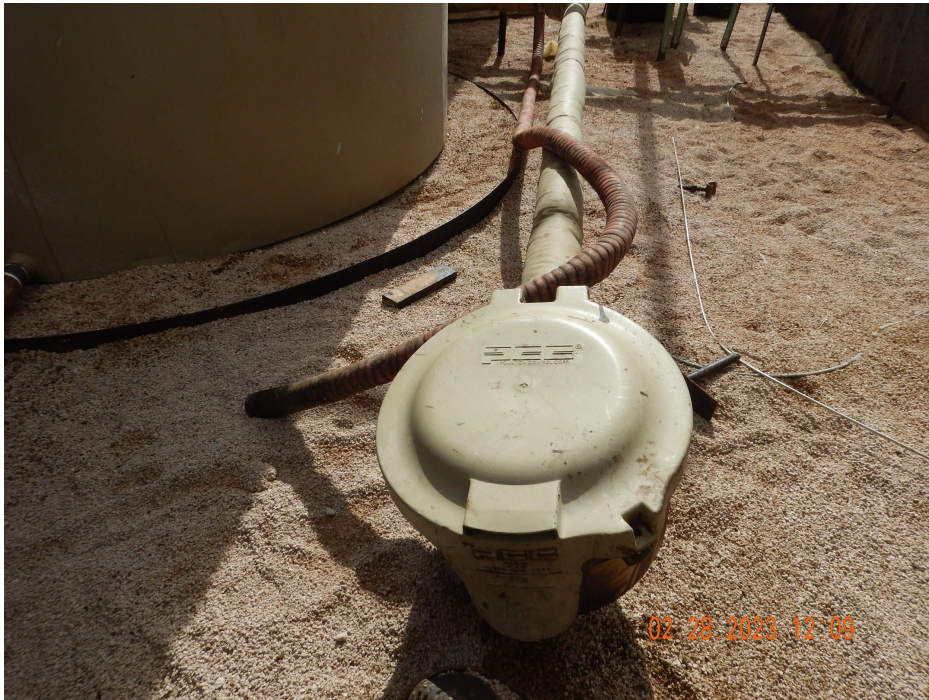
Photo 7. Photo taken from the western location. Photo illustrates a hose left hooked up has been disconnected.
