Inspection Photos

Operator: Mustang Resources LLC - #10550

Location Name: CLOUGH FEDERAL-66S94W/14SESW

Inspection Document #: 702801331

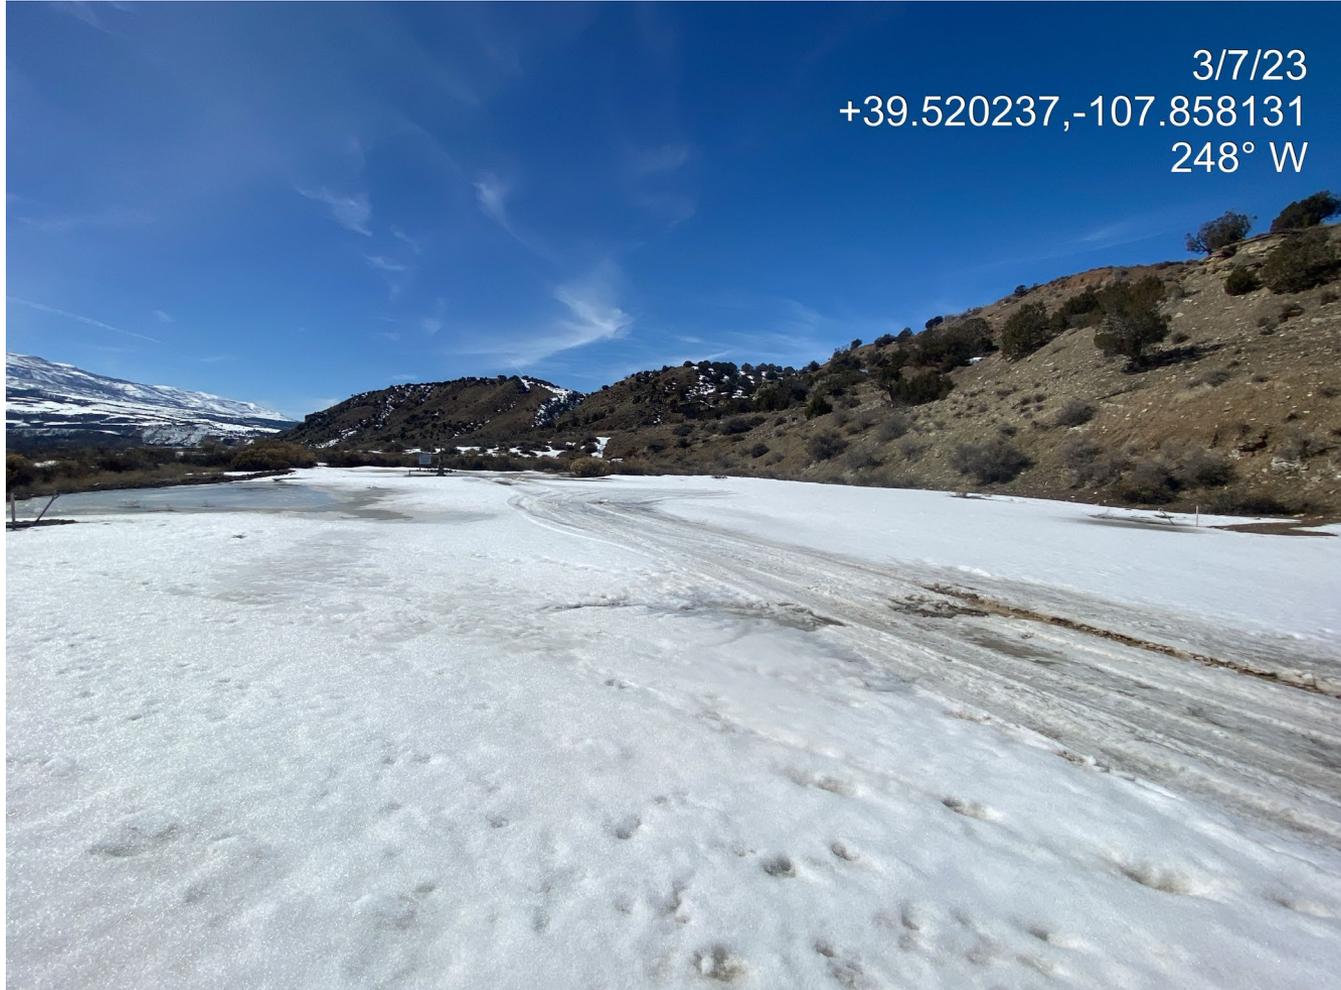
Photo 1. Photo taken from the east shows an overview of the Location.

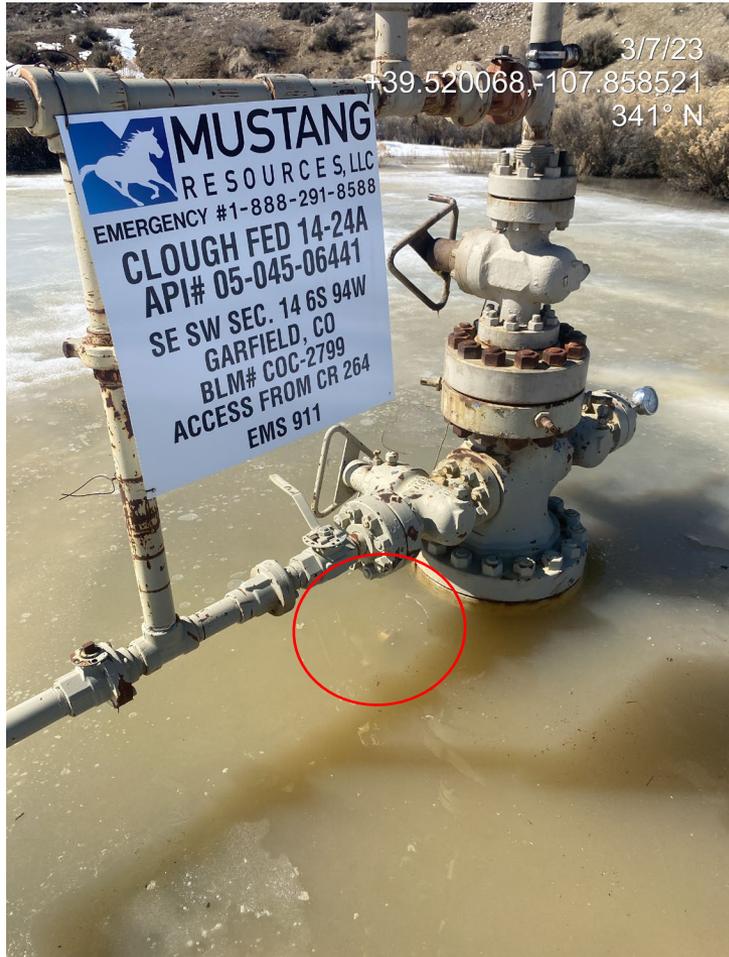
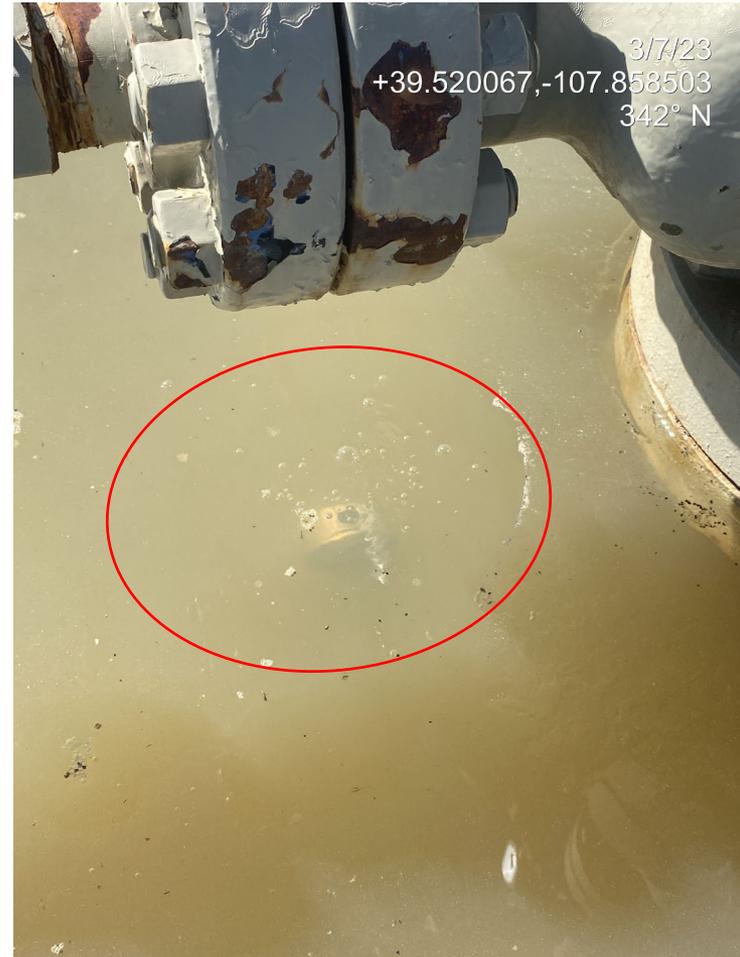
Photo 2. Photos show the area around well API # 045-06441 is inundated with stormwater. Bubbles are rising in the water indicative of a leak.

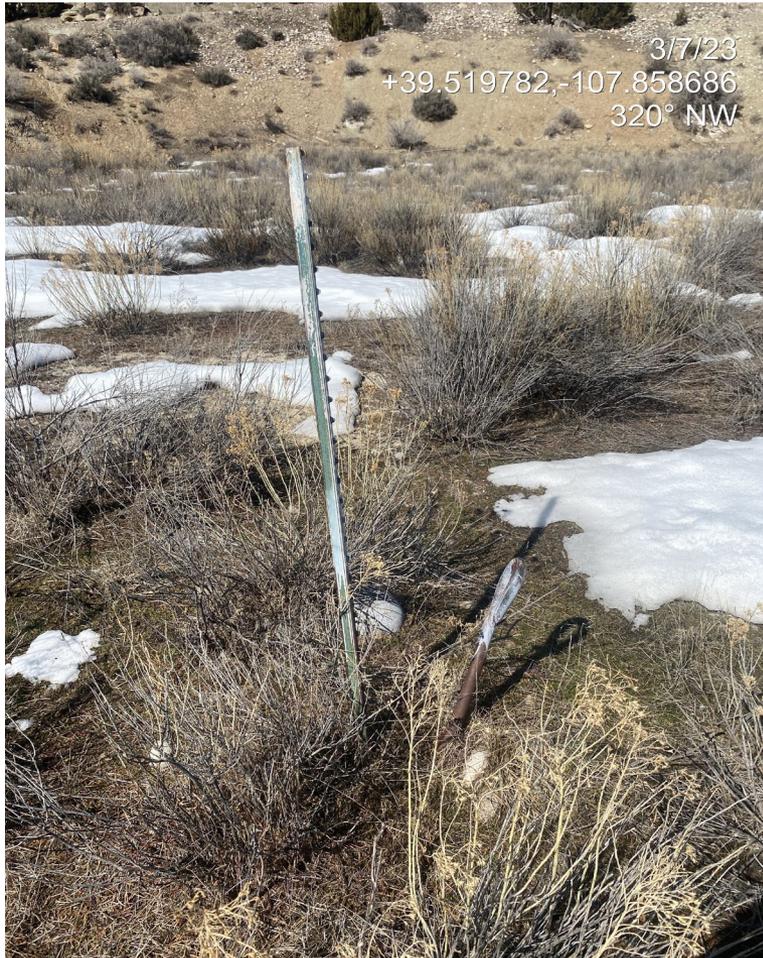
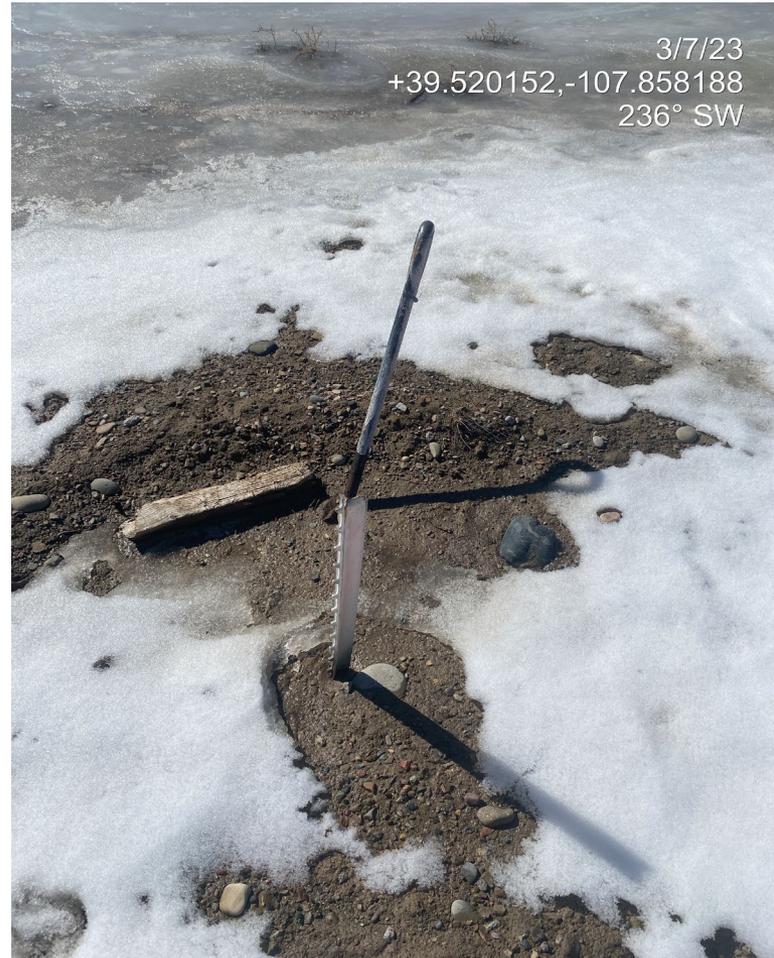
Photo 3. Photos taken from the western interim area (left) and working pad area (right) show examples of anchor markers. All anchor markers on location have faded and are no longer marked with a bright color.

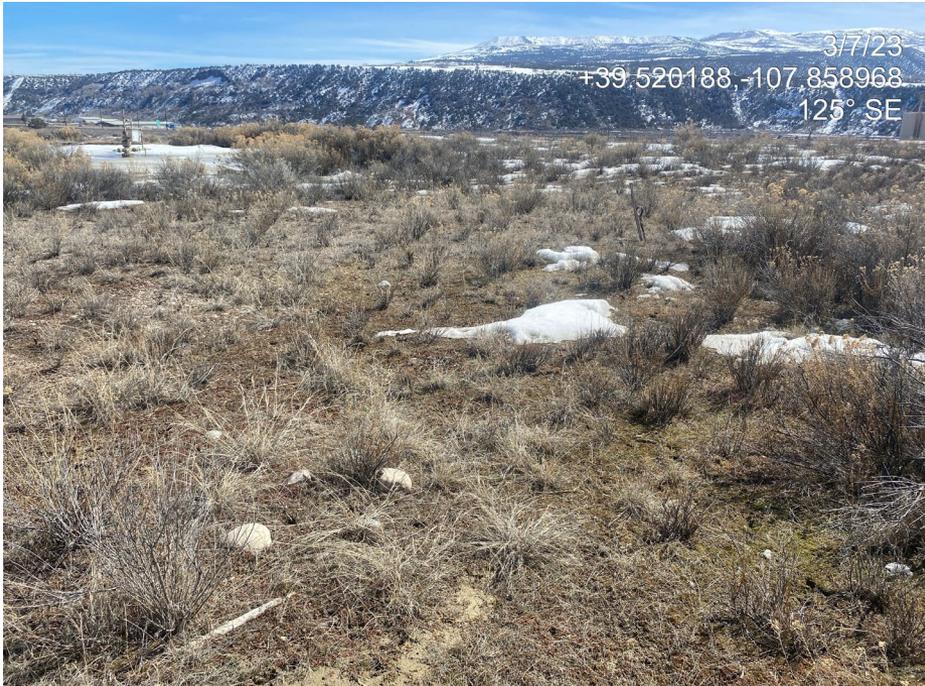
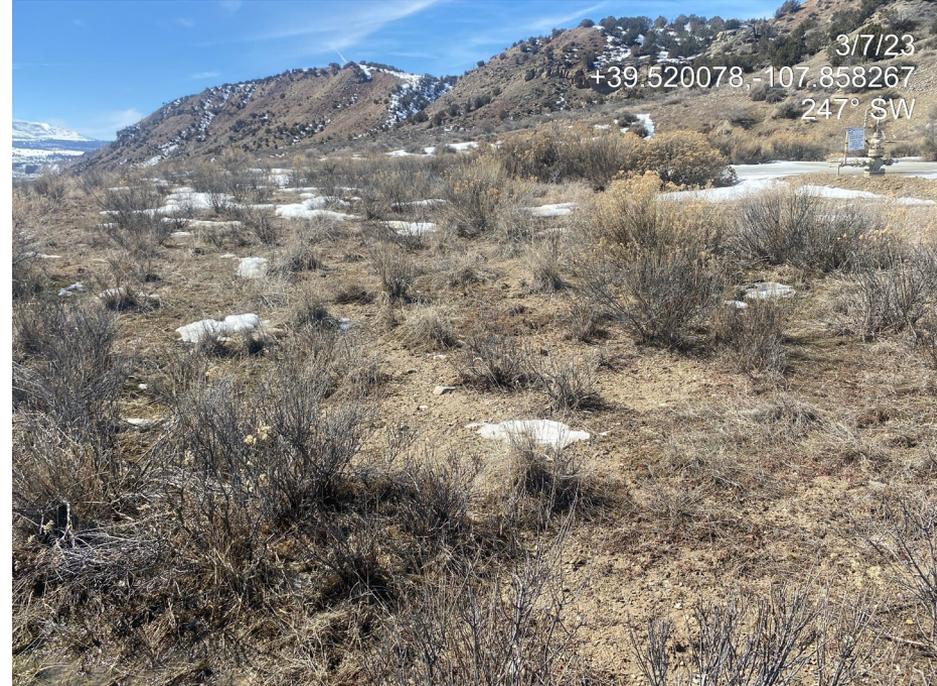
Photo 4. Photos show examples of the interim areas to the west (left) and south (right) of the location. Perennial grasses and shrubs appear established.
