Third Party Flowline Abandon in place Verification Letter

Parker 22-33 & 2-4-33

Client: Crestone Peak Resources Operating LLC

Location: Wellhead Line 33NWNW

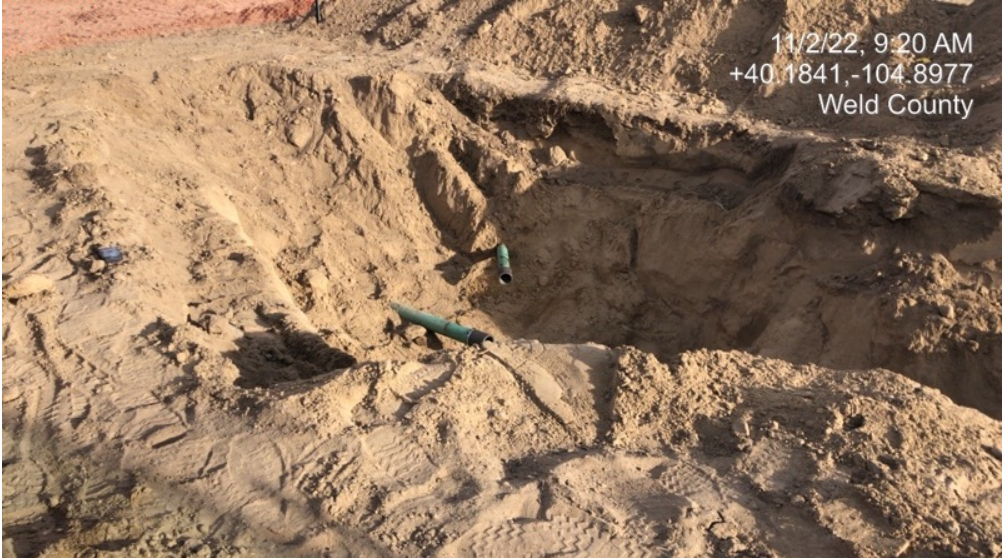
Information		Photo
Photo #: Location: Description:	1 2-4-33 & 22-3 wellhead 2-4-33 & 22-3 End A prior to flushing activity

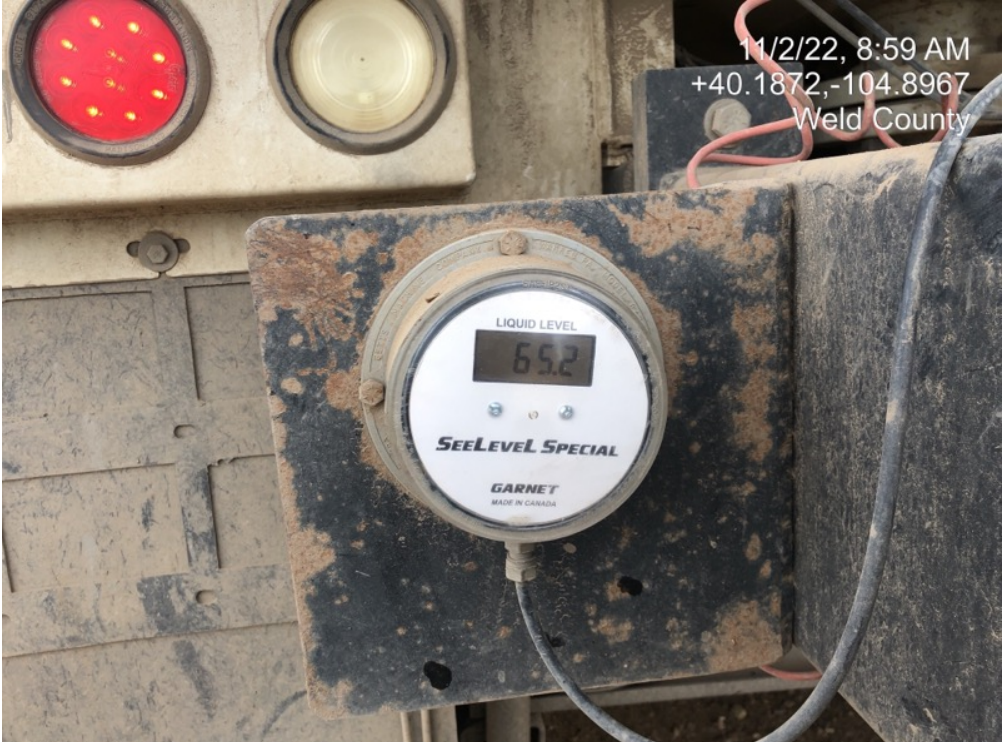
<p data-bbox="1291 388 1542 483">11/2/22, 9:20 AM +40.1841,-104.8977 Weld County</p>
Photo #: Location: Description:	2 Hydrovac truck at 2-4-33 wellhead Meter prior to flushing activity

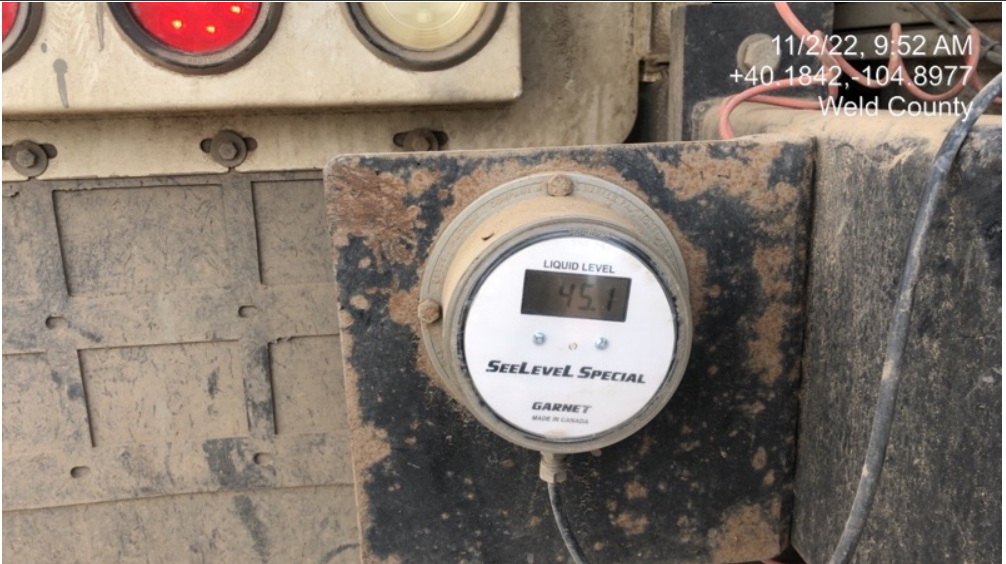
Information		Photo
Photo #: Location: Description:	3 Hydrovac truck at 2-4-33 wellhead Meter post flushing activity

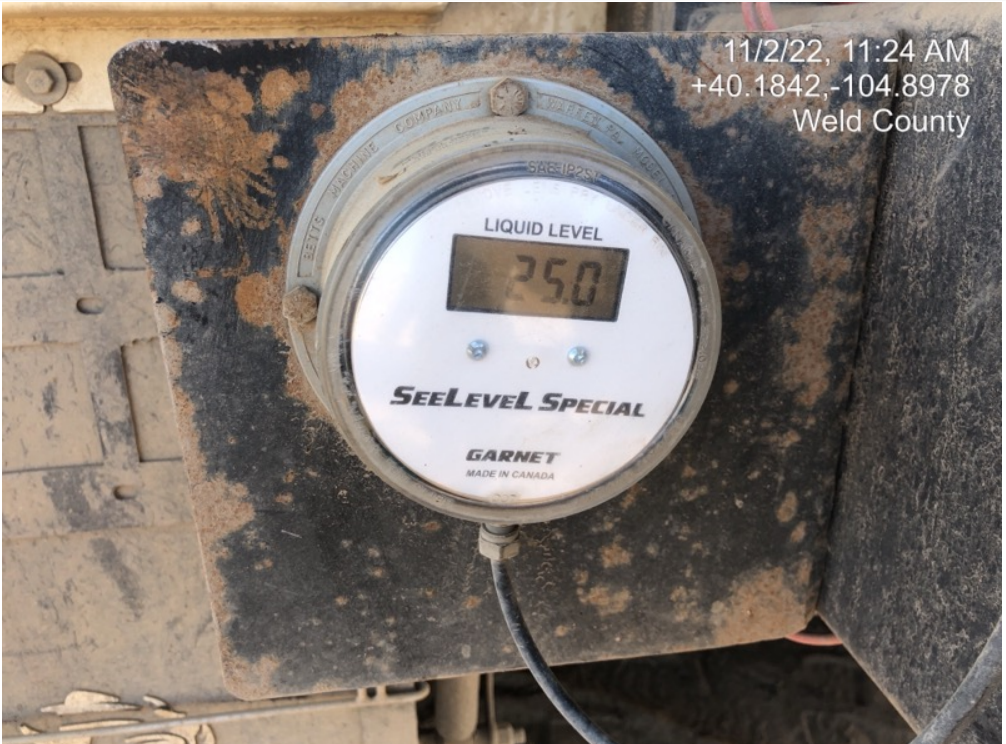
<p>11/2/22, 9:52 AM +40.1842,-104.8977 Weld County</p>
Photo #: Location: Description:	4 Vacuum truck at 22-33 wellhead Meter prior to flushing activity

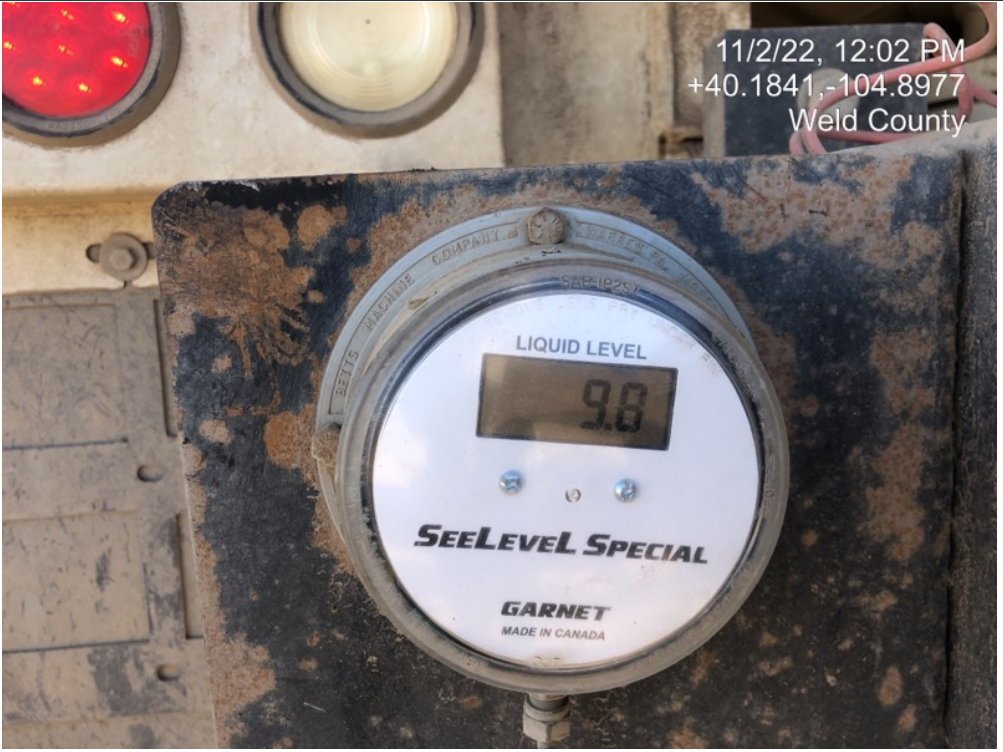
Information		Photo
Photo #: Location: Description:	5 Hydrovac truck at 22-33 wellhead Meter post flushing activity

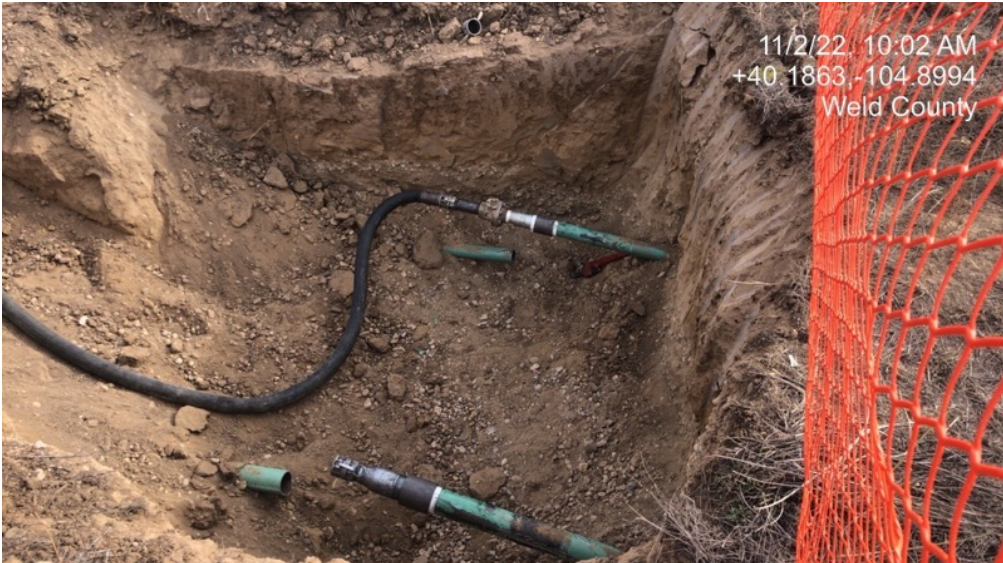
<p>11/2/22, 12:02 PM +40.1841,-104.8977 Weld County</p>
Photo #: Location: Description:	6 22-33 and 2-4-33 End B 22-33 and 2-4-33 End B
