# Interim Reclamation and Stormwater Inspection

Operator: FOUNDATION ENERGY MANAGEMENT LLC - 10112

Location ID: 429231

Inspection Photos  
Location Name: Green 1-7 Facility  
Location ID: 429231

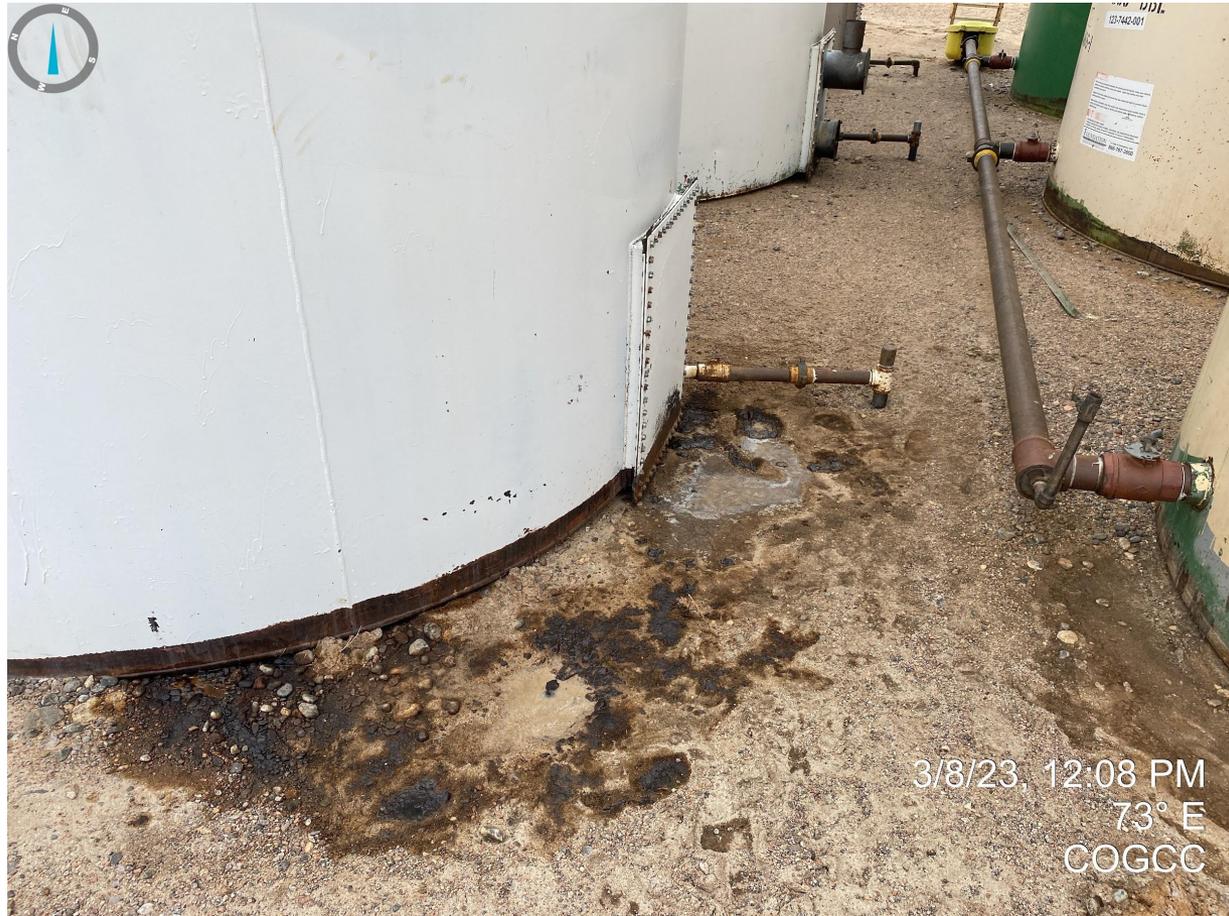
**Photo 1.** Facing east at the northwest-most tank battery. Unknown fluid observed around bottom of tank. The tank itself will need to be inspected per Rule 609.b and the stained soil will need to be disposed of per Rule 905.e.

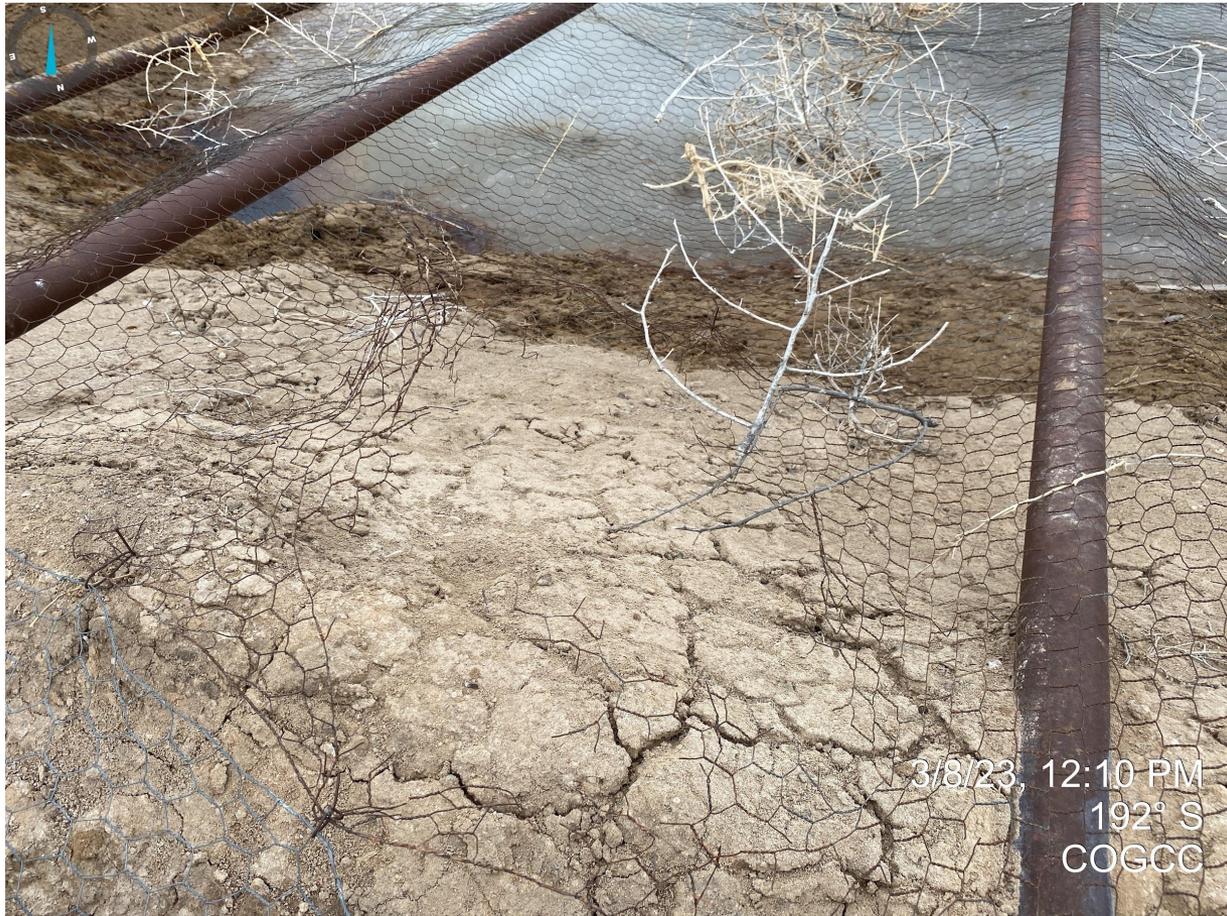
**Photo 2.** Facing south at pit. Netting is inadequate with large opening observed.

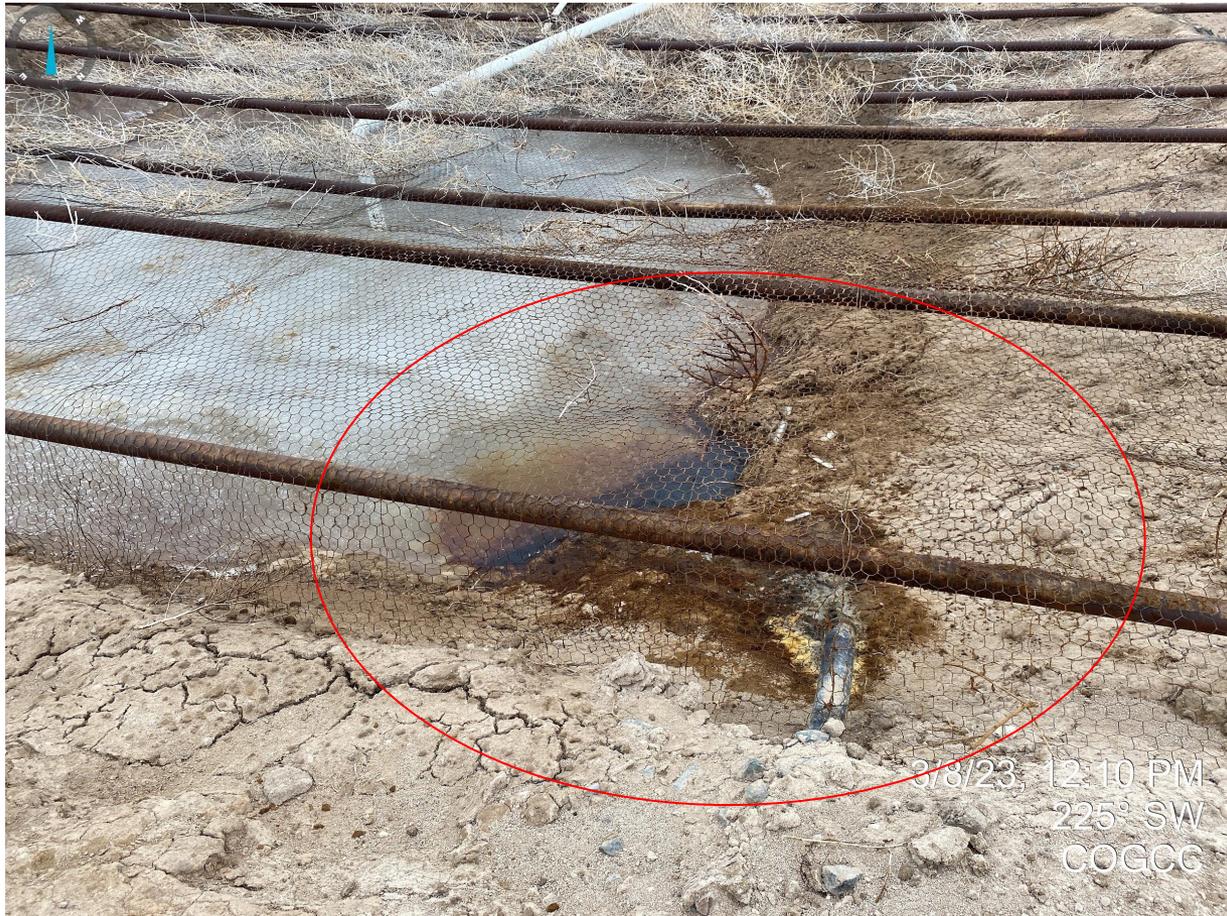
**Photo 3.** Facing southwest at pit. Hydrocarbons observed within the pit will need to be properly cleaned up and disposed of per Rule 909.d.

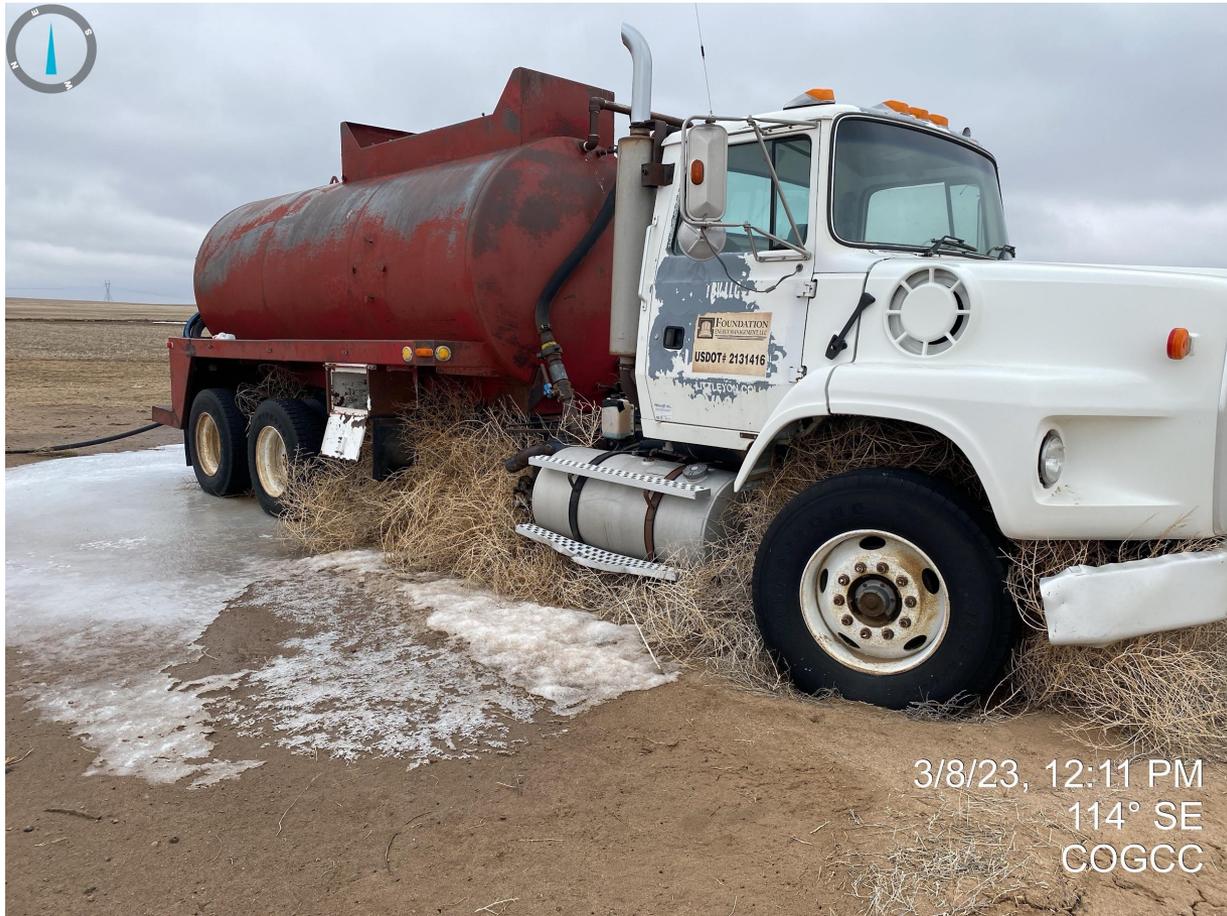
**Photo 4.** Facing southeast near pit. It appears this equipment/water truck has been parked for an extended period of time. Locations are not to be used for equipment storage.

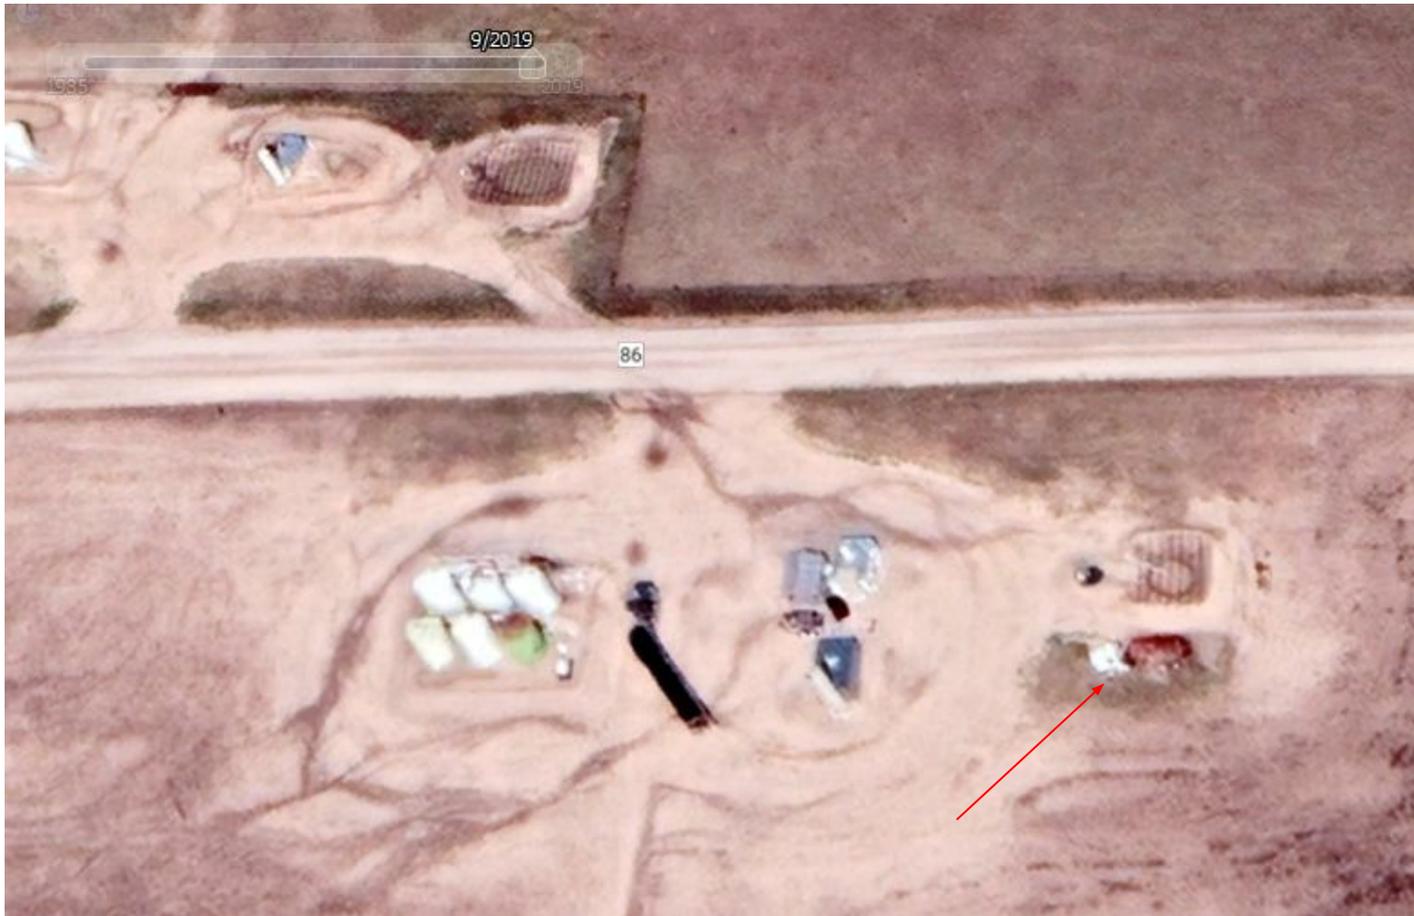
**Photo 5.** Google Earth aerial imagery taken circa 09/2019, illustrating the water truck has been parked on location for an extended period of time.
