Interim Reclamation and Stormwater Inspection

Operator: CONFLUENCE DJ LLC #10518

Location ID: 454560

Inspection Photos
Location Name: 70 Ranch/10 West
Location ID: 454560

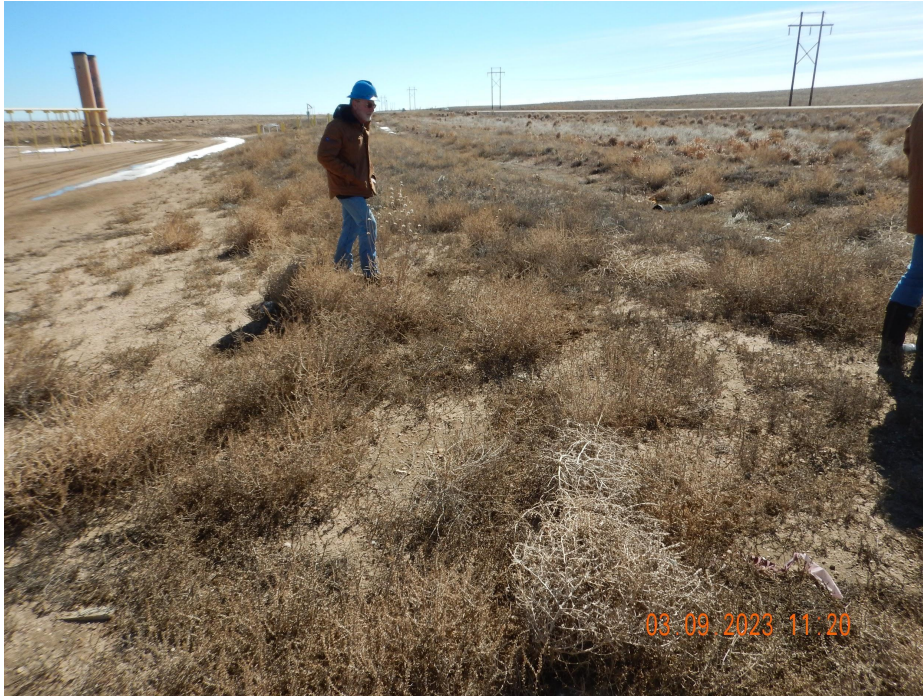
Photo 1. Photo taken from the southern location, facing East. Photo illustrates weed establishment and weed maintenance needed along the southern perimeter.

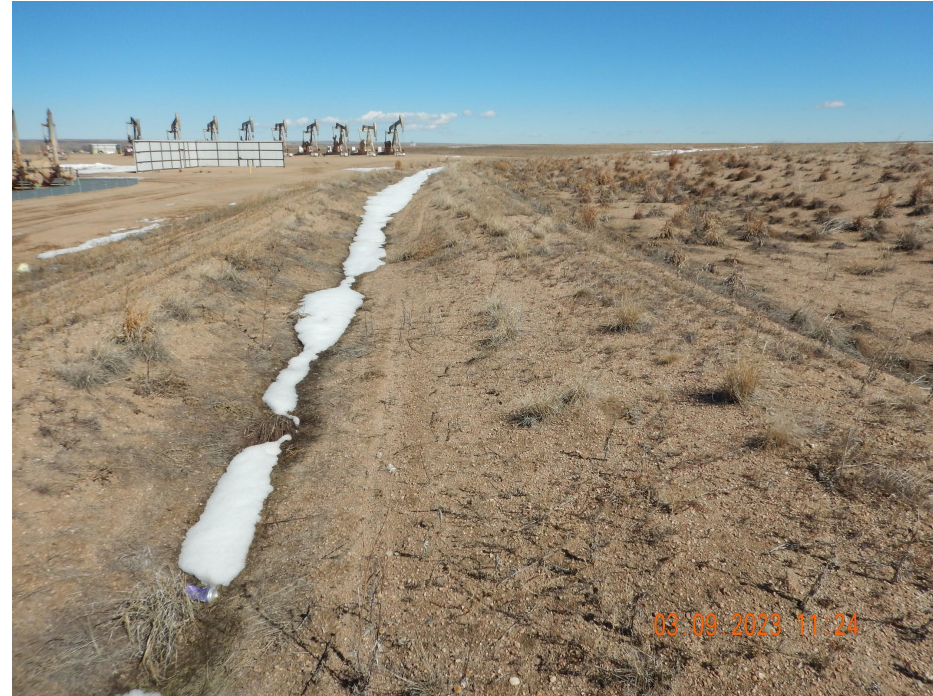
Photo 2. Photo taken from the southeastern location, facing North. Photo illustrates the Operator has seeded stormwater BMP area (berm and ditch). Desirable germination was observed and in process of establishment. See Photo 3.

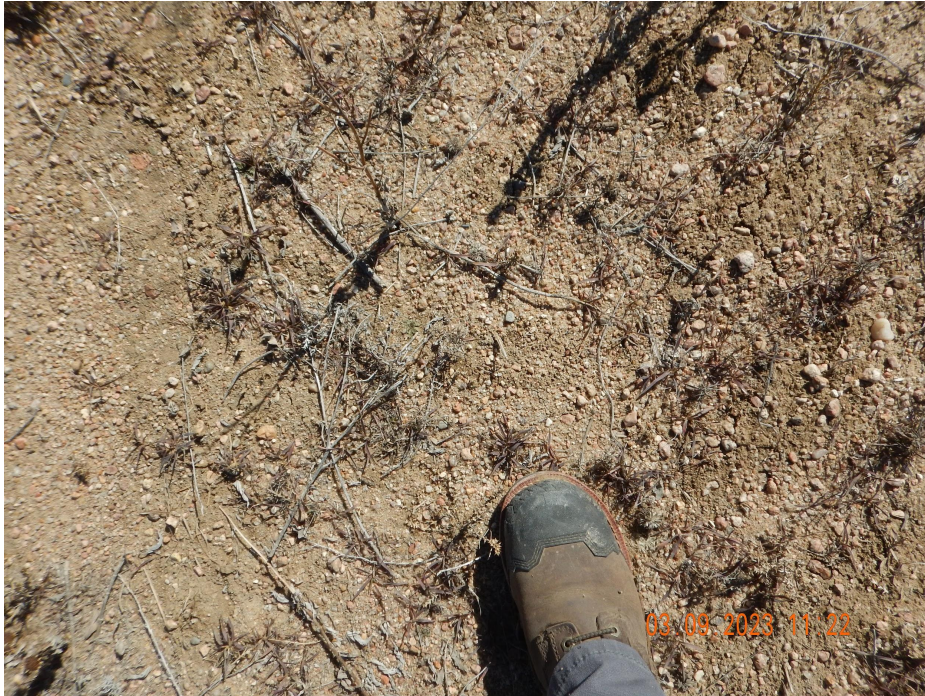
Photo 3. Close up photo illustrating desirable vegetation.

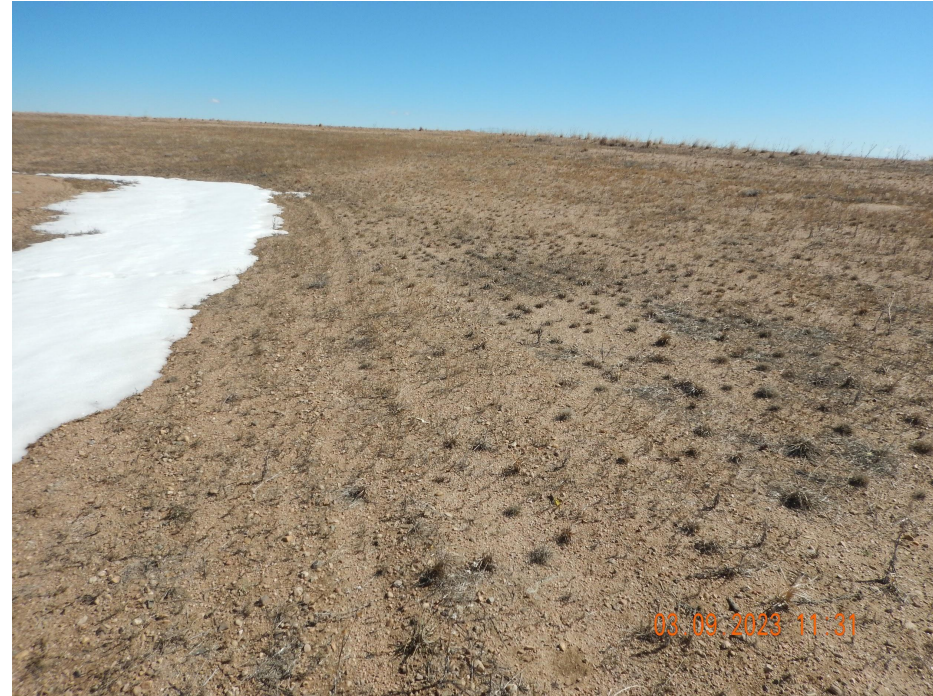
Photo 4. Photo taken from the northeastern location, facing North. Photo illustrates the Operator has performed interim reclamation. Desirable germination was observed and in process of establishment.

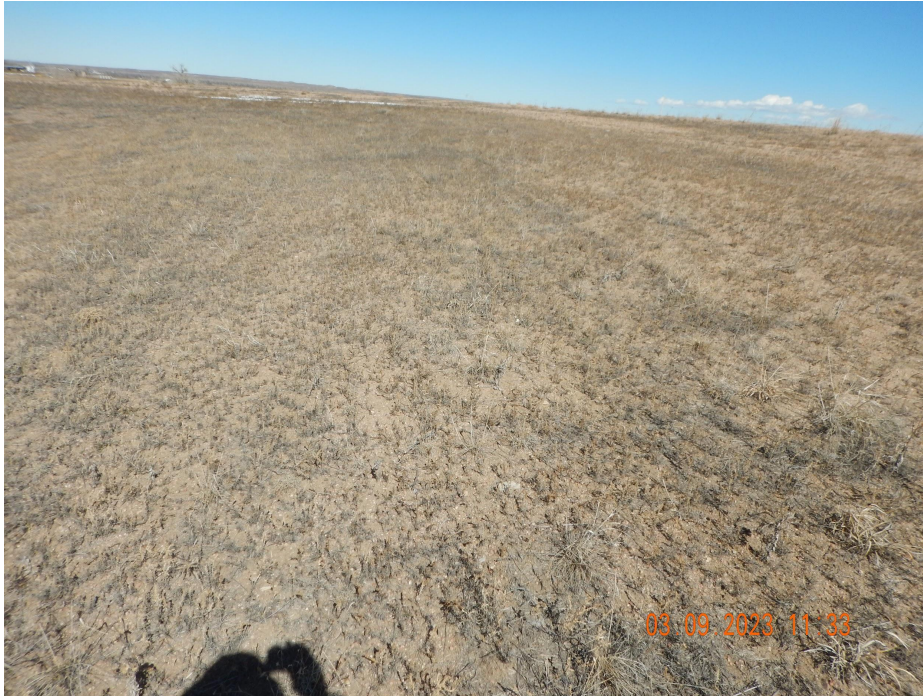
Photo 5. Photo taken from the northeastern location, facing Northwest. See comments under Photo 4.

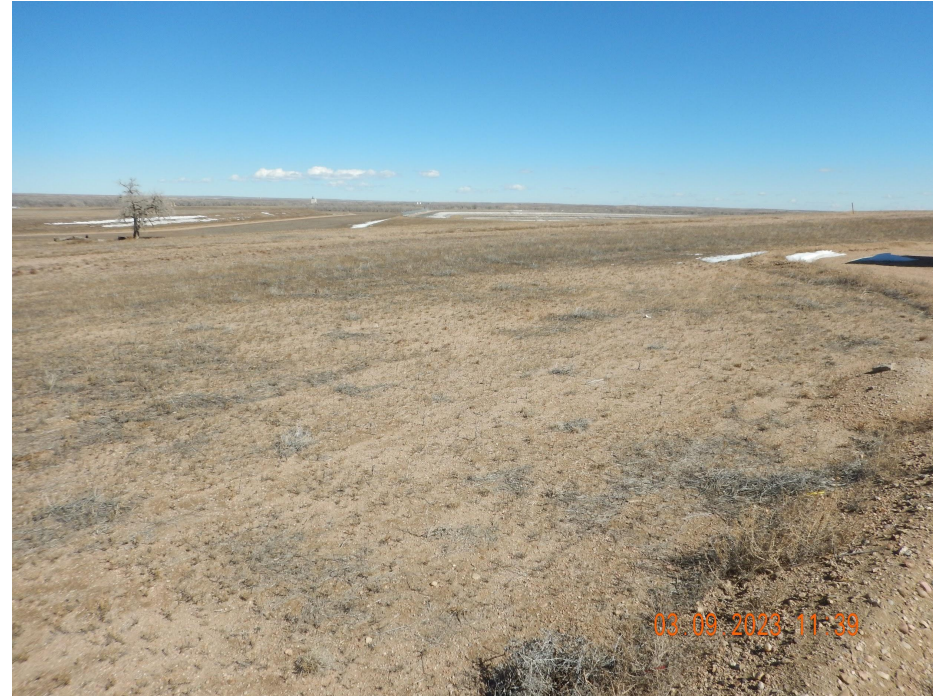
Photo 6. Photo taken from the northwestern location, facing North. See comments under Photo 4.

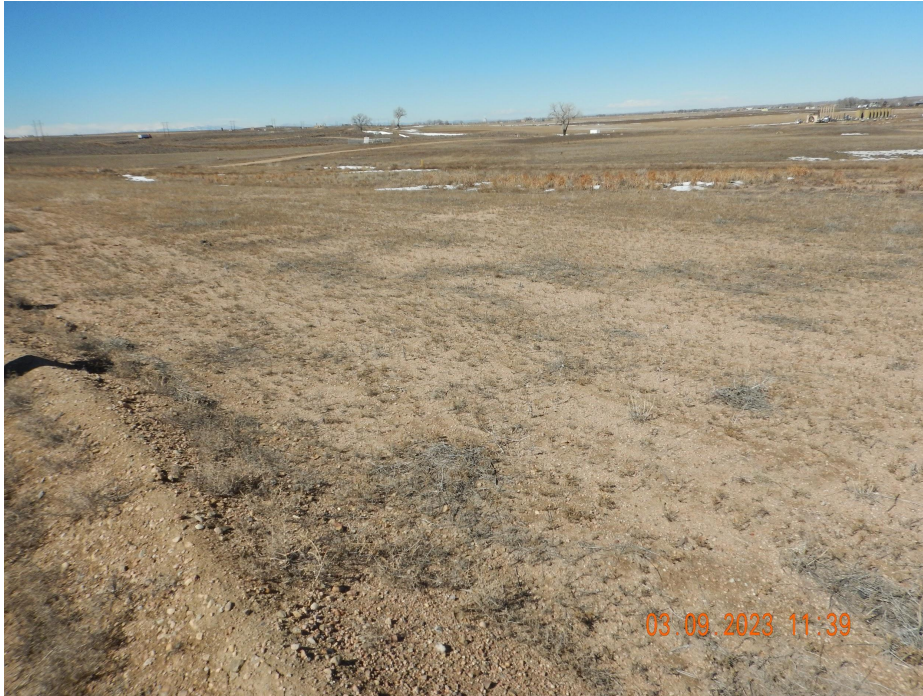
Photo 7. Photo taken from the northwestern location, facing West. See comments under Photo 4.

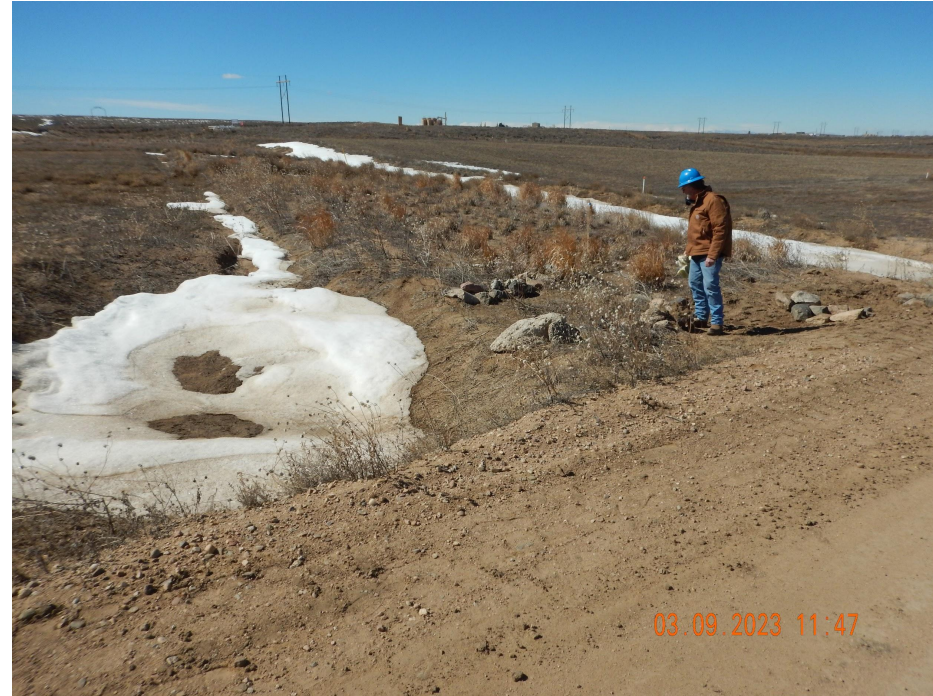
Photo 8. Photo taken from the western location, facing West. Photo illustrates concrete waste within rip rap of the culvert.

CDPHE is addressing this observation.
