Inspection Photos

Operator: CAERUS PICEANCE LLC #10456

Location #324198

Garfield County, CO

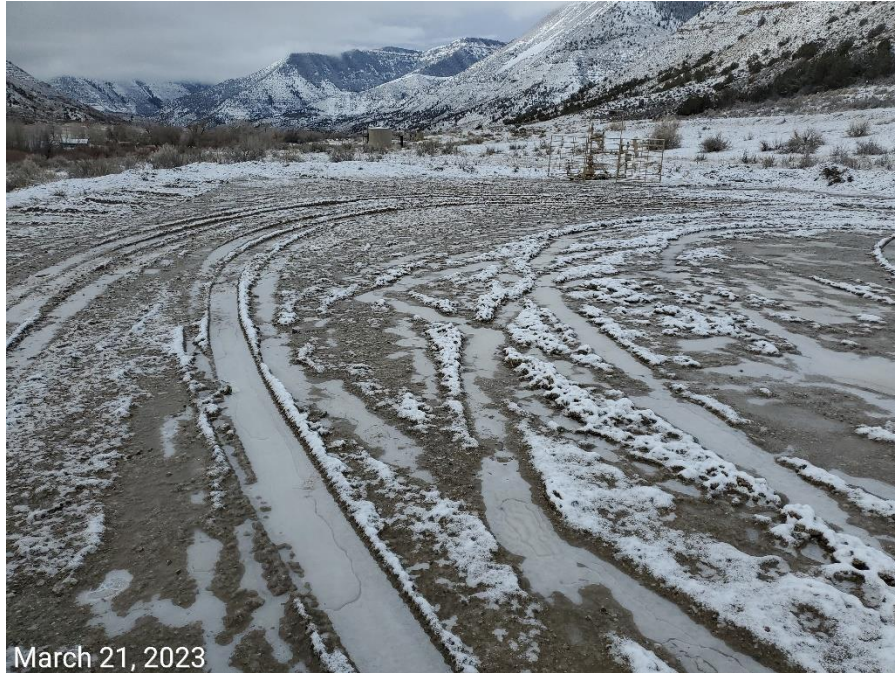
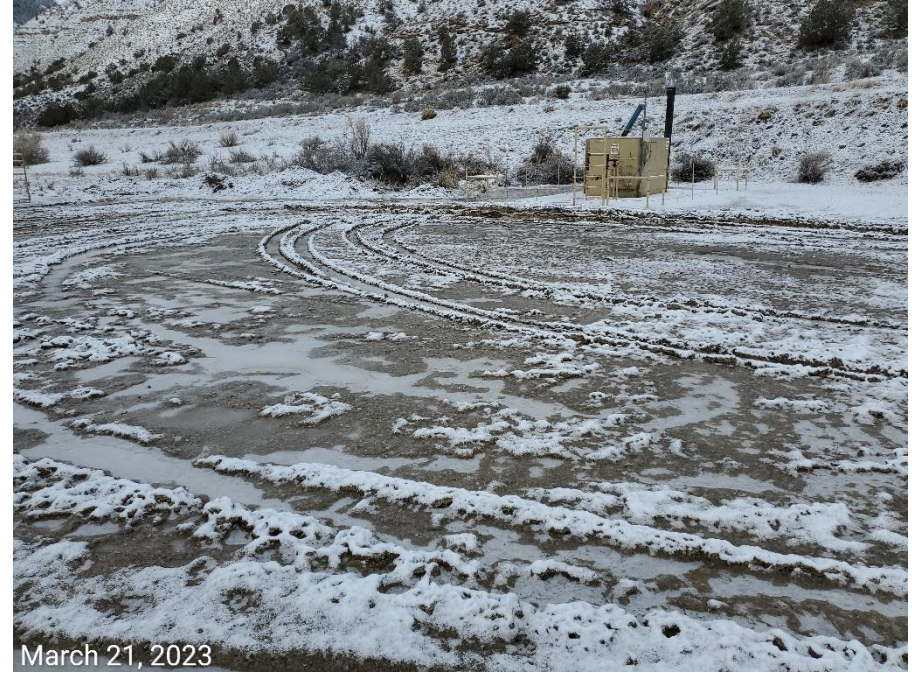
Photo 1: Photos 1-2 taken from the east end of the Location. Photos provide an overview of the working pad area from south, southwest, northwest to north. Photos 1-3 also provide examples showing BMPs, including vehicle tracking control measures, are missing or insufficient to stabilize, as well as to minimize erosion, degradation and sediment transport during wet conditions.

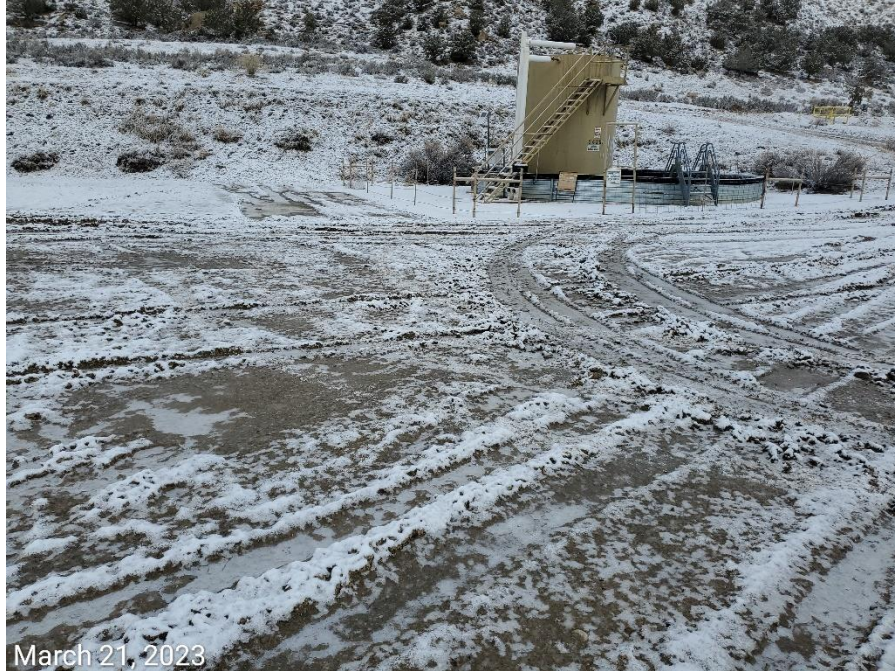
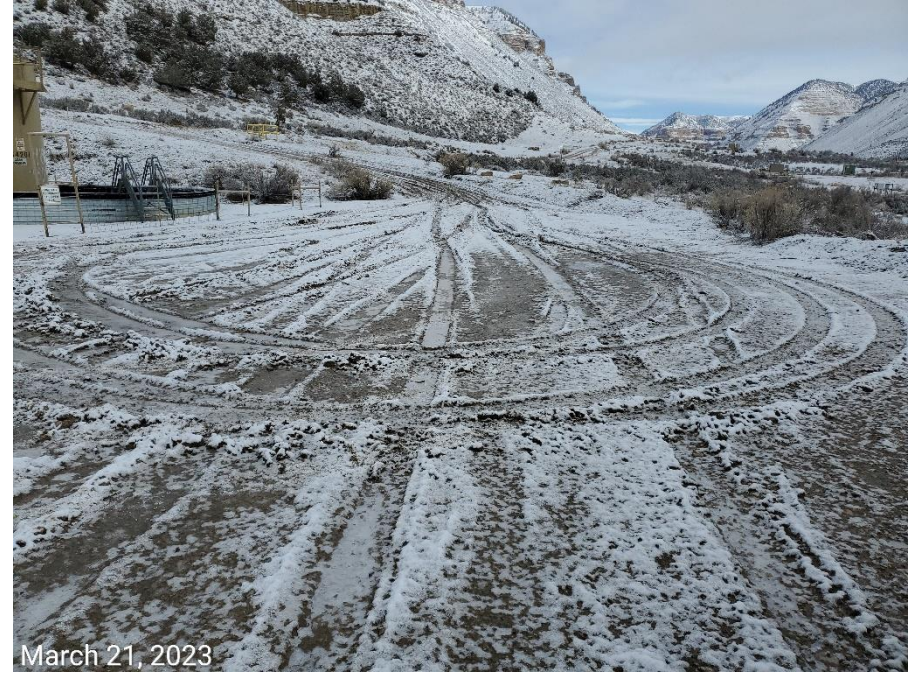
Photo 2: See comments under photo 1.

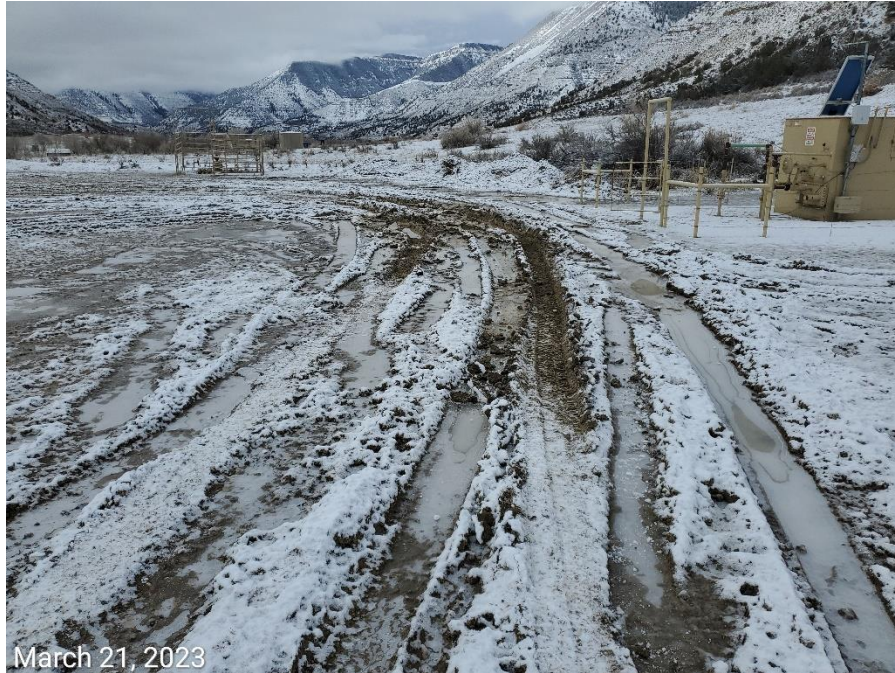
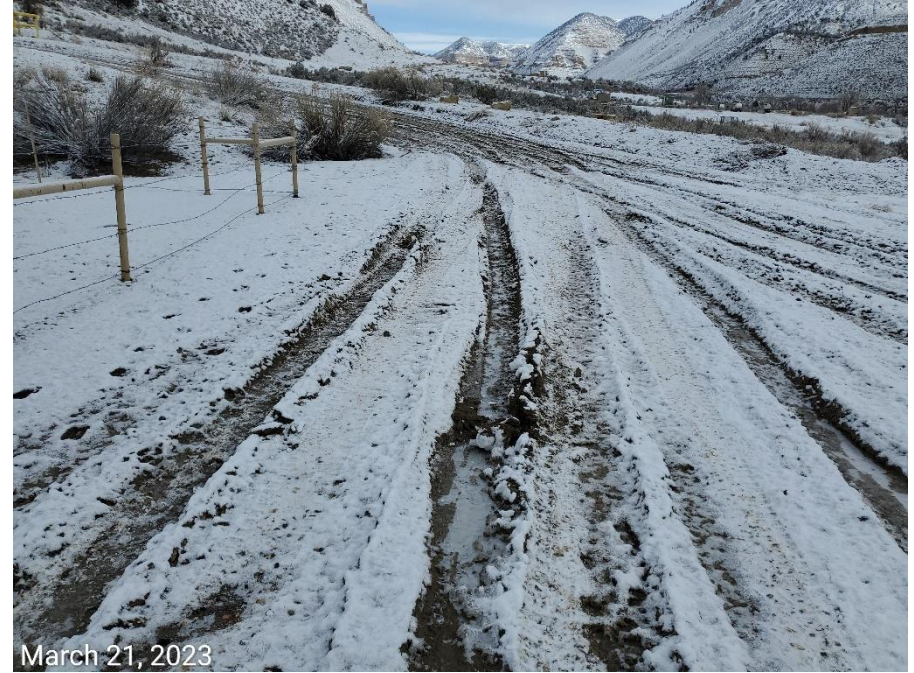
Photo 3: See comments under photo 1.

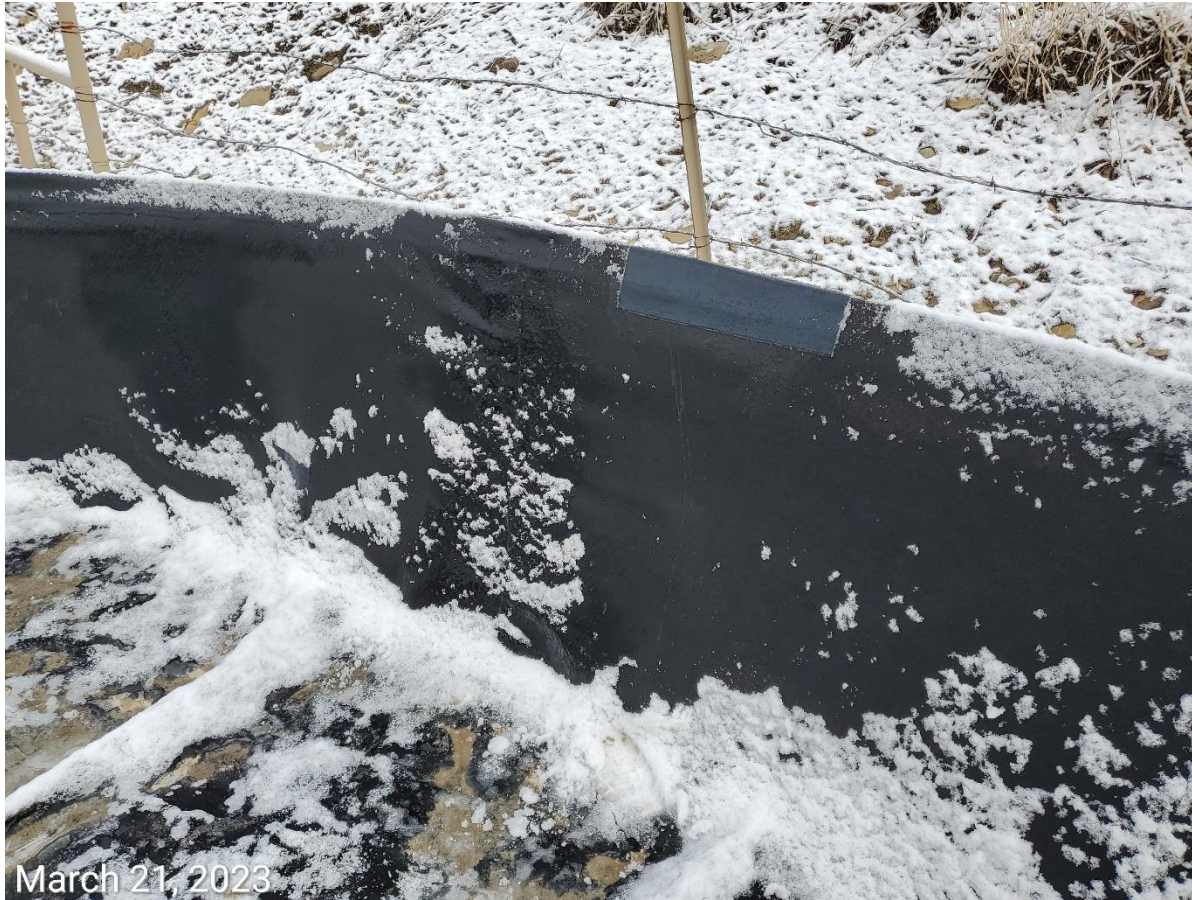
Photo 4: Photo taken from the tank battery. Photo shows repairs appear to have been made to the secondary containment liner.
