Inspection Photos

3/31/2023

Operator: LOCIN OIL CORPORATION - 51130

Location #322447

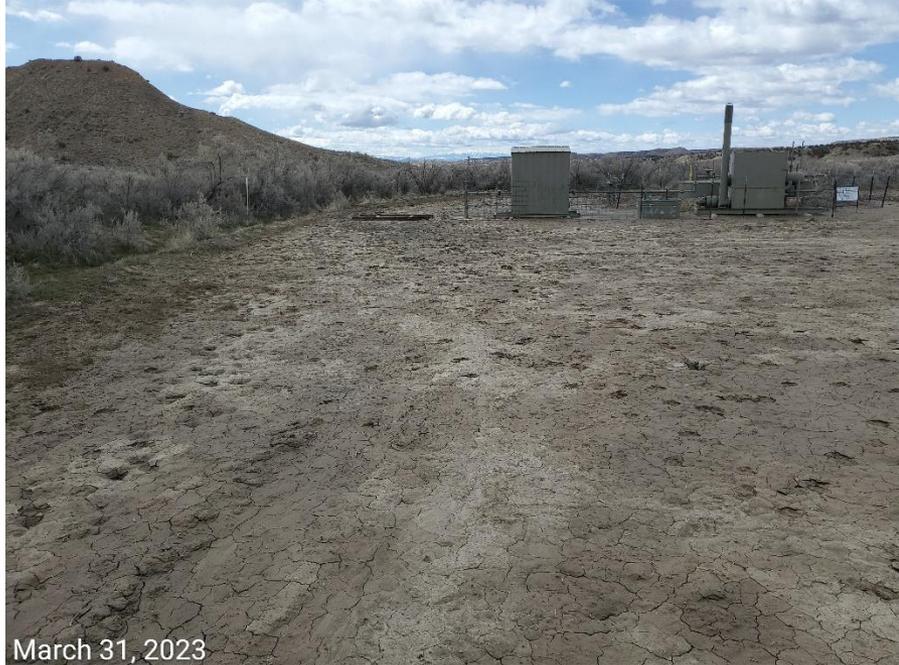
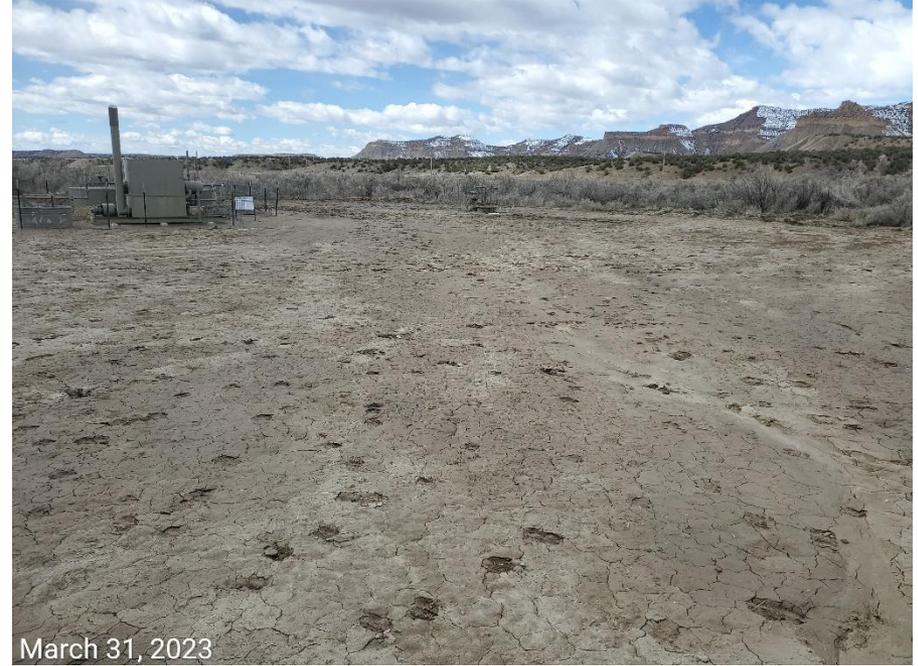
Photo 1: Photos 1-2 taken from the north end of the Location. Photos provide an overview of the Location from south, southwest, west to northwest.

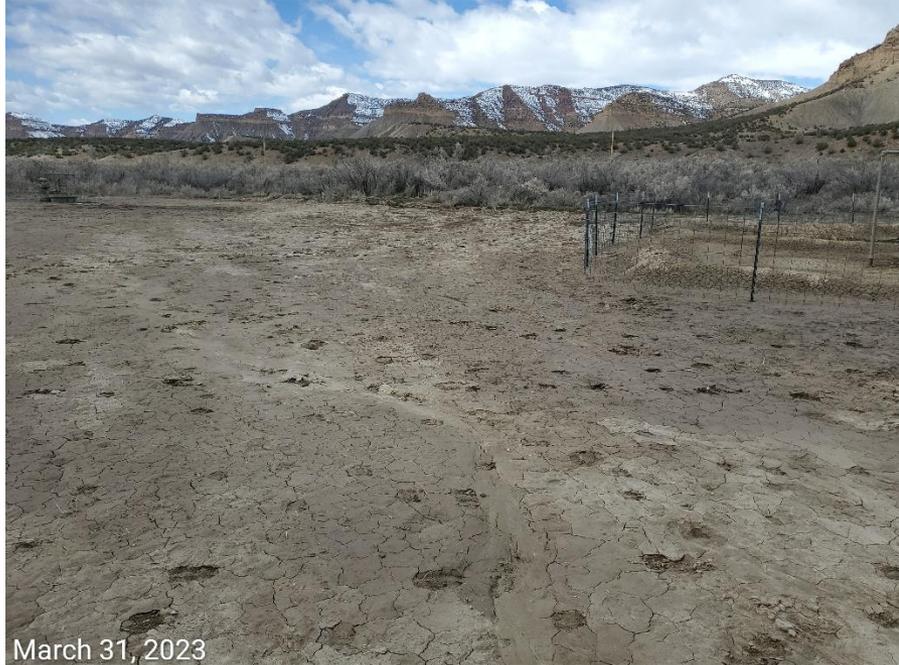
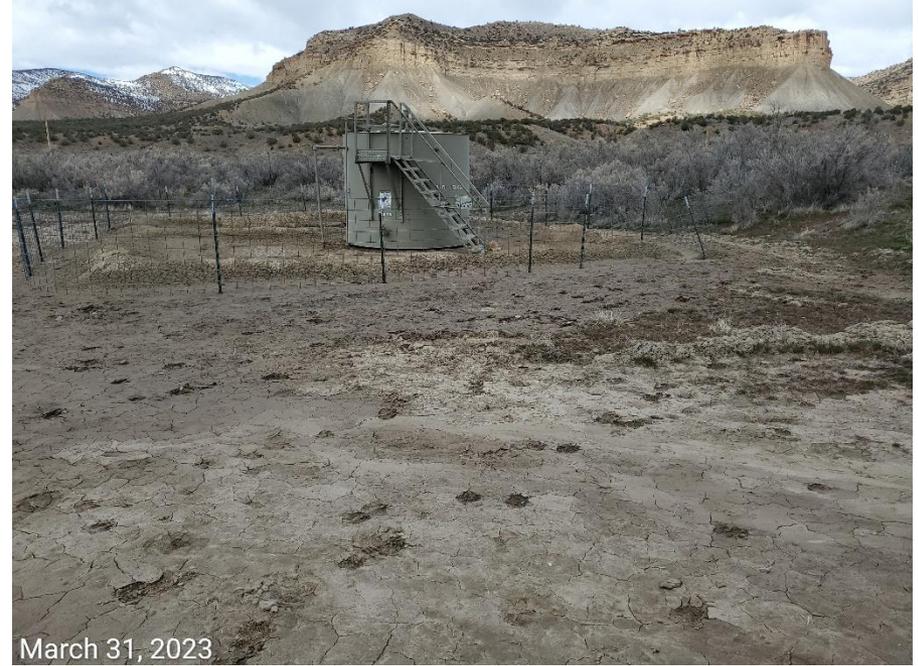
Photo 2: See comments under photo 1.

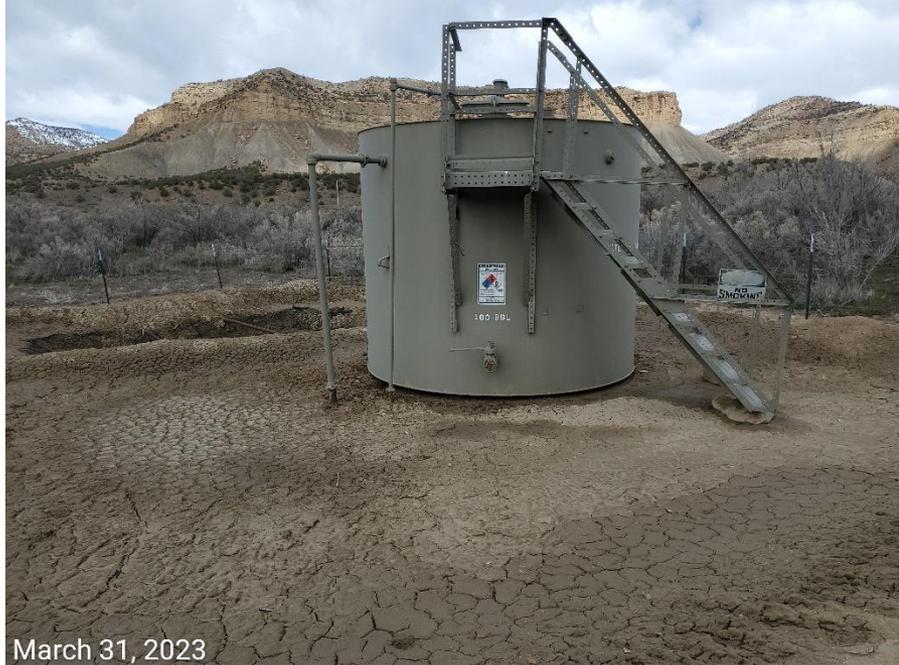
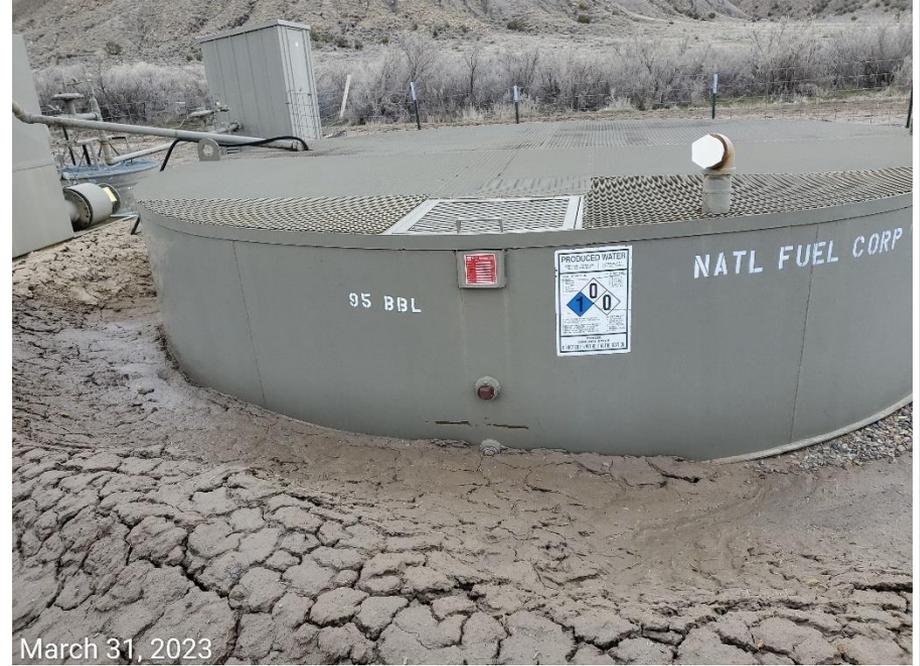
Photo 3: Tanks on Location- Labels missing required information per Rule 605.h.

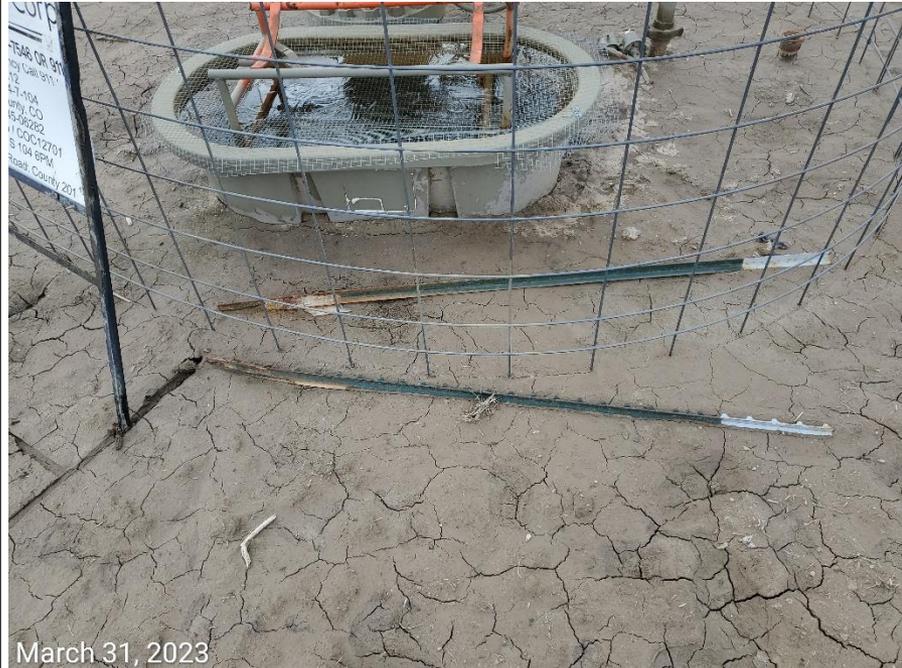
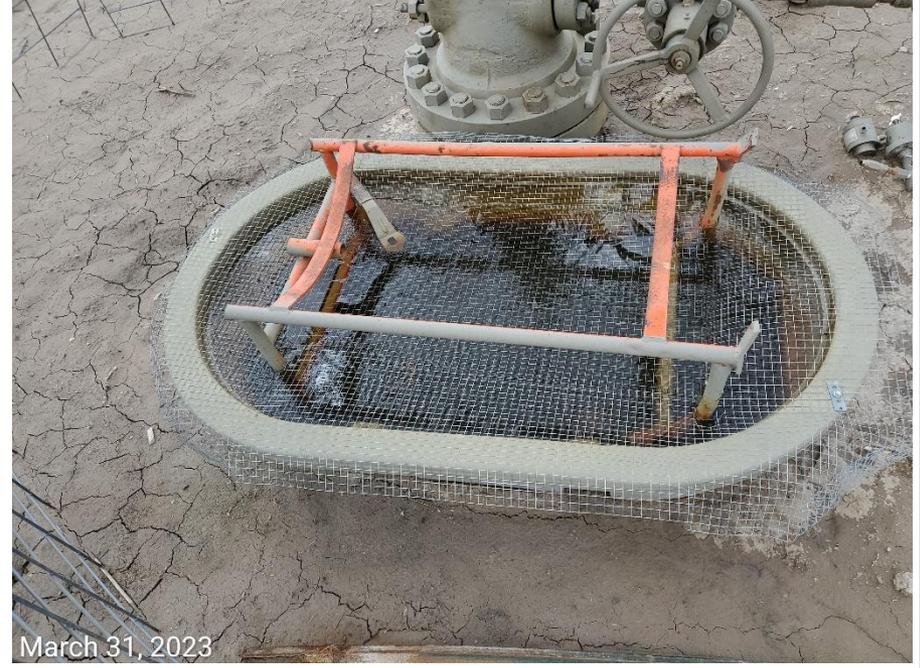
Photo 4: Unused equipment (T-post, containment BMP). The storage of equipment not necessary for use/production on a Location is prohibited.

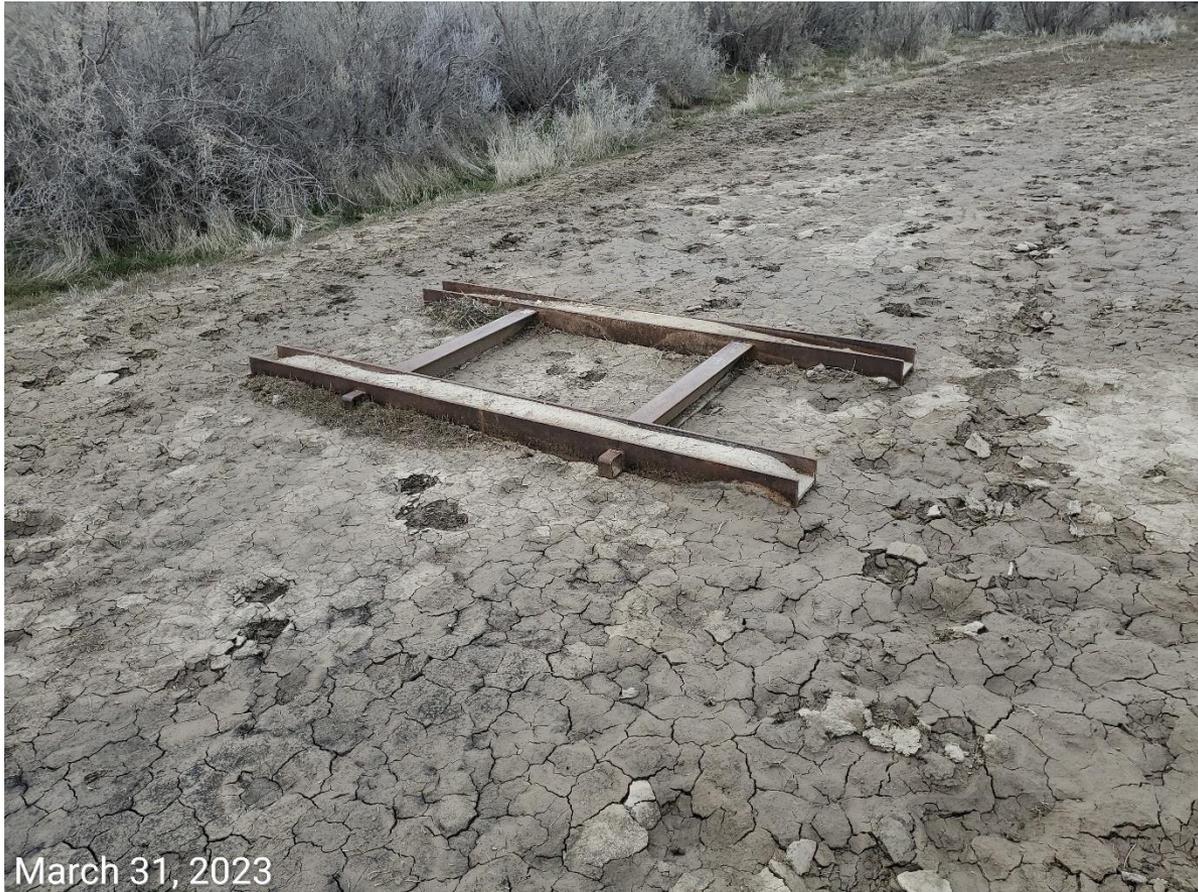
Photo 5: Unused equipment. The storage of equipment not necessary for use/production on a Location is prohibited.

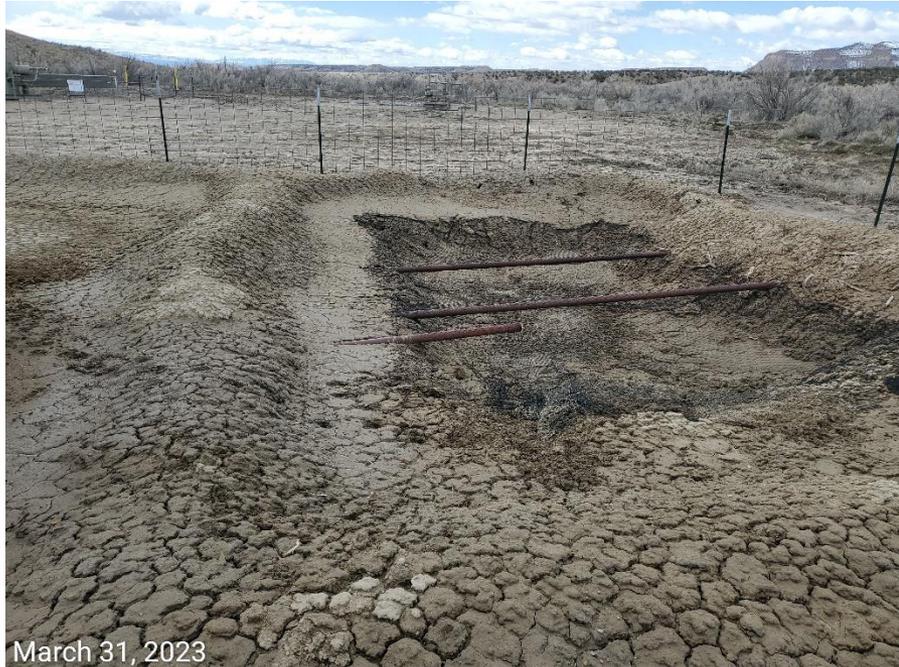
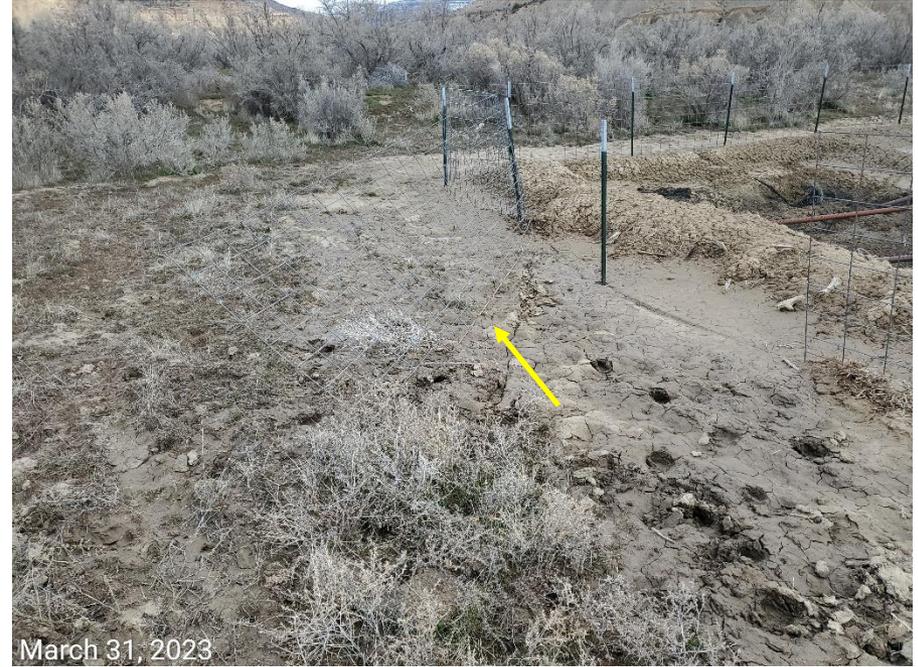
Photo 6: Photo left shows netting at pit in disrepair. Photo right shows fencing at pit/tank battery in disrepair.

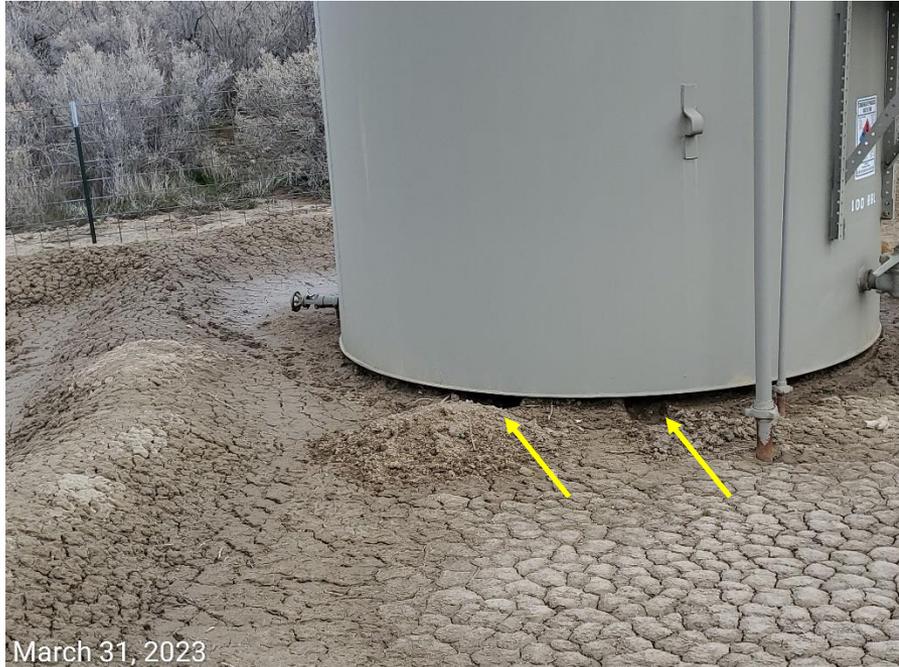
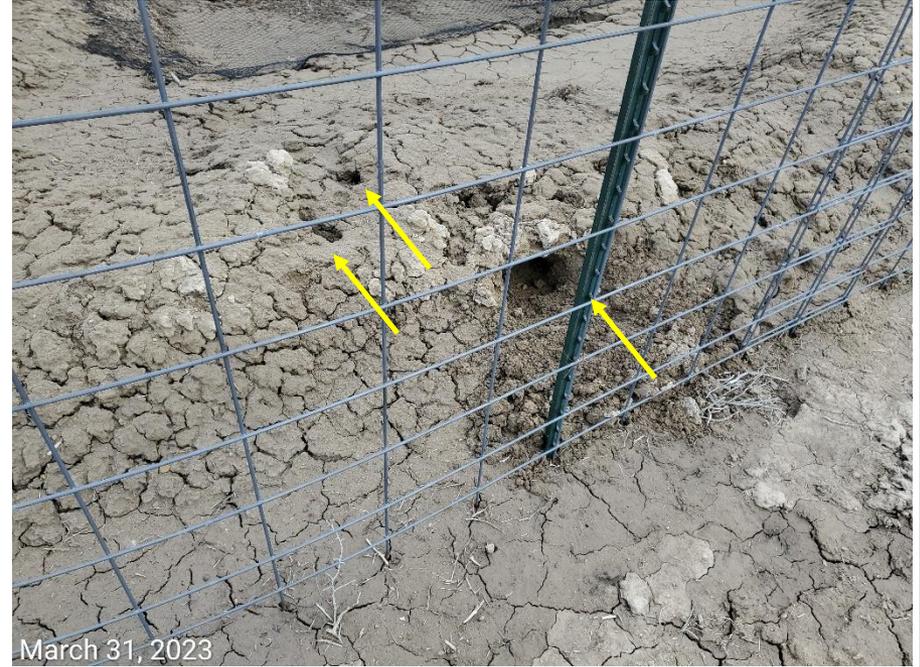
Photo 7: Photos examples showing the secondary containment BMP at the tank battery/pit is no longer sufficiently impervious to contain spilled or released materials; wildlife appears to have burrowed into the berms, as well as the base of the containment, and beneath the tank.

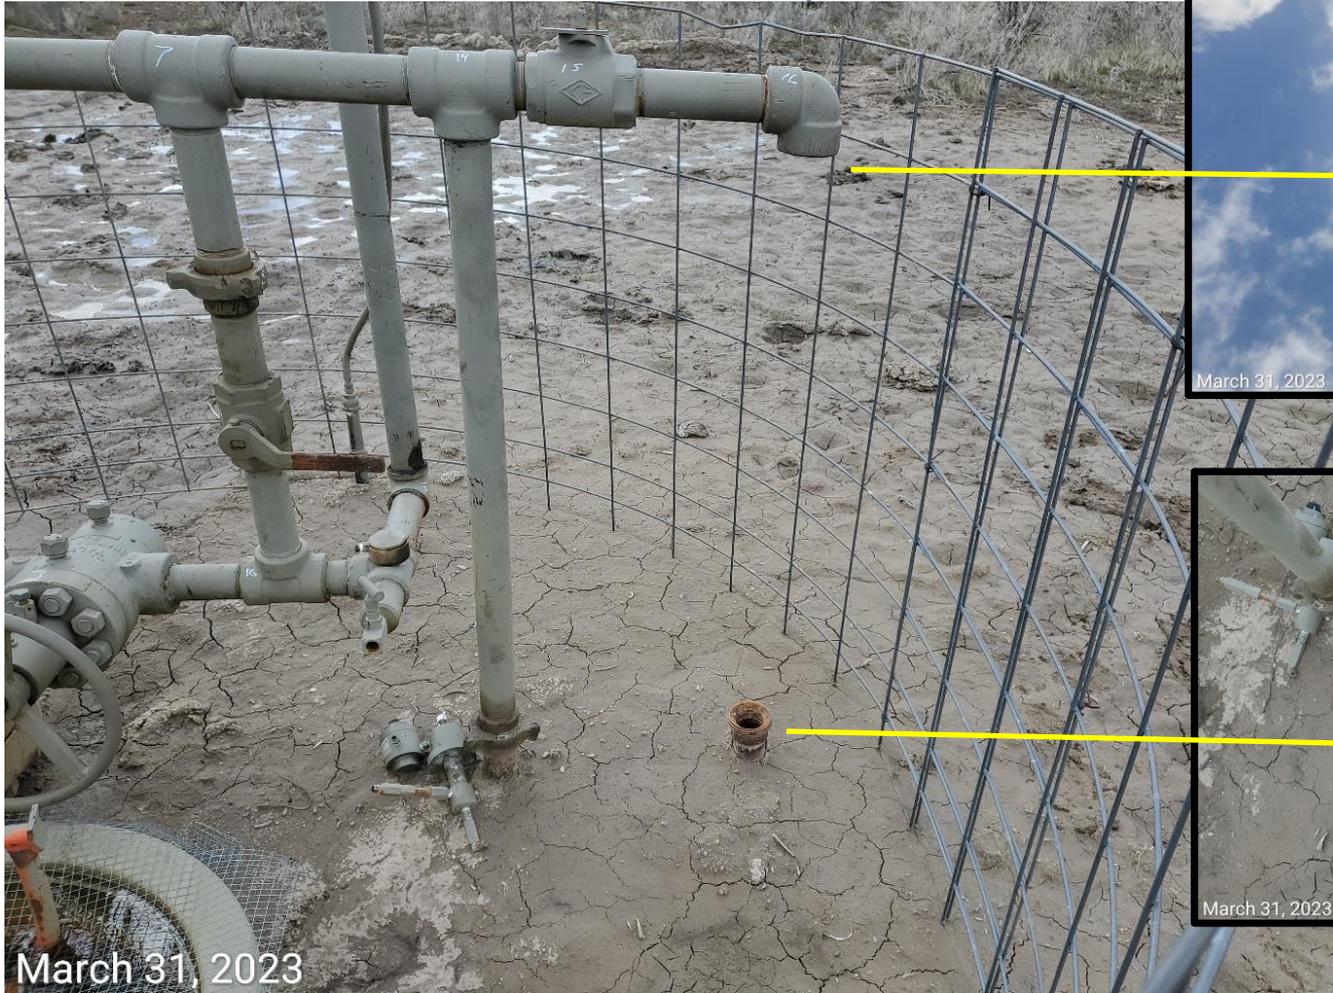
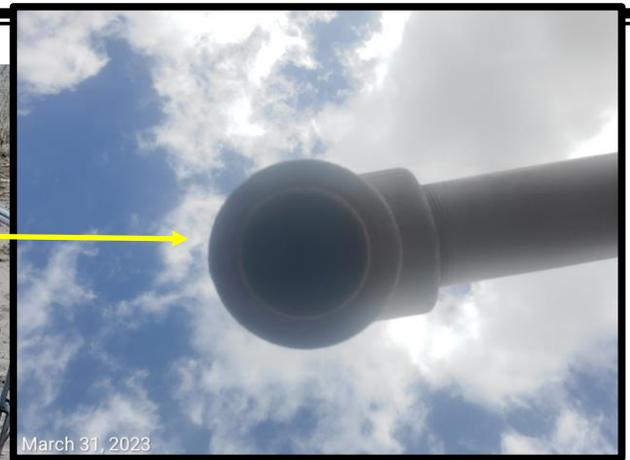
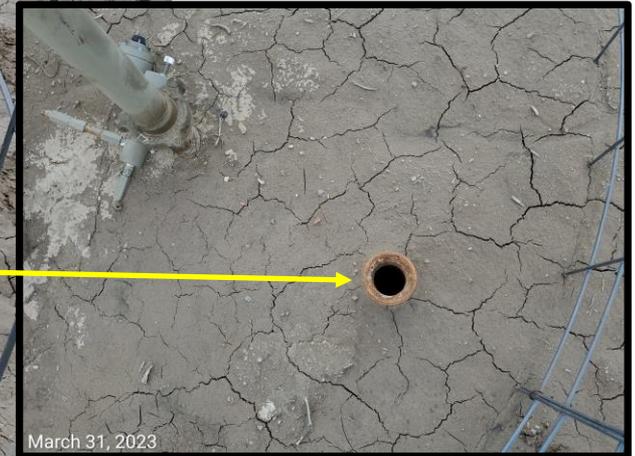
Photo 8: Photo shows section of pipe that has been removed from the well, leaving open/exposed wellhead and riser pipe; lines require capping, OOSLAT.
