# Interim Reclamation and Stormwater Inspection

Date: 03/31/2023

Operator: NOBLE ENERGY INC - 100322

Location ID: 421847

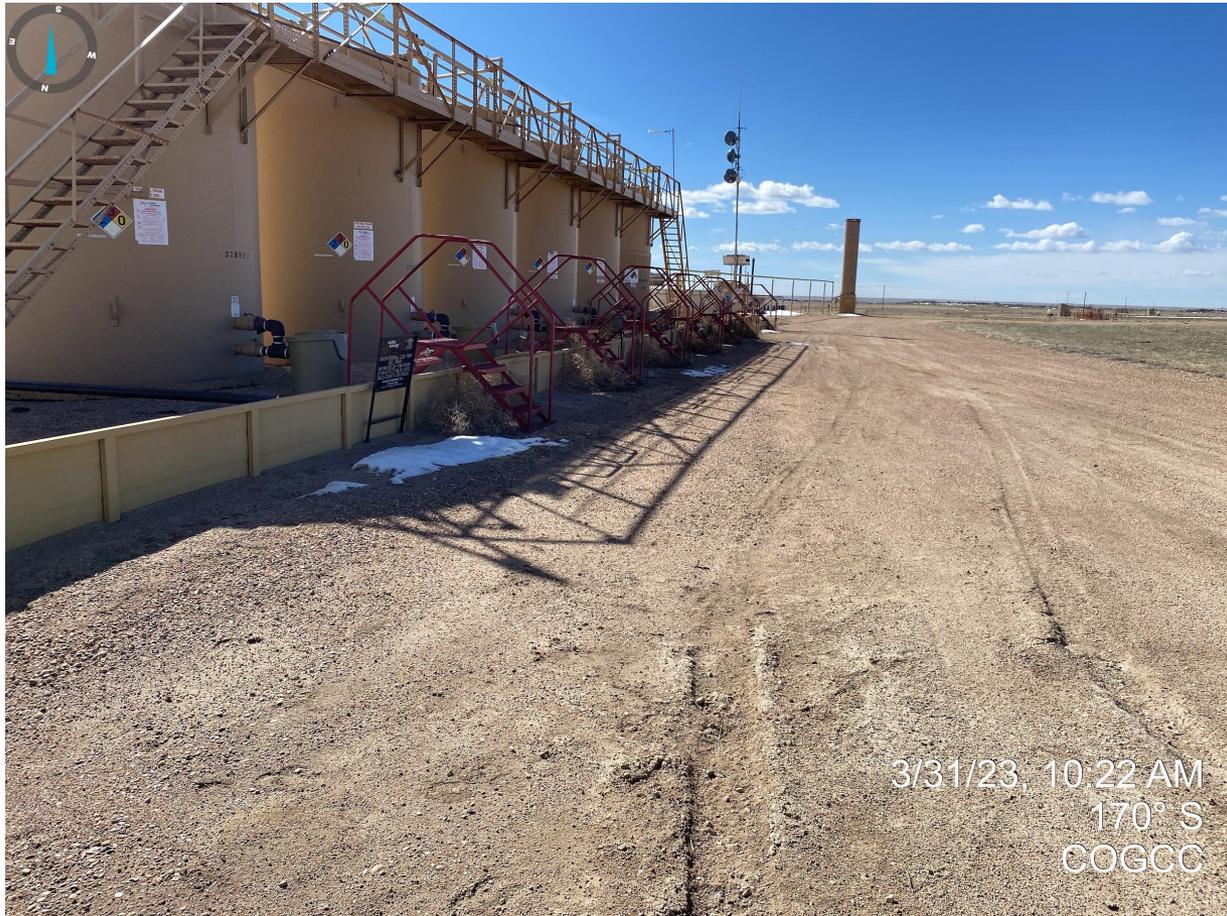
**Photo 1.** Facing south at tank battery. Operator submitted photo documentation showing that tumbleweed debris was removed from location. However, during this inspection high winds lead to additional tumbleweed accumulations that will need to be managed for in the future.

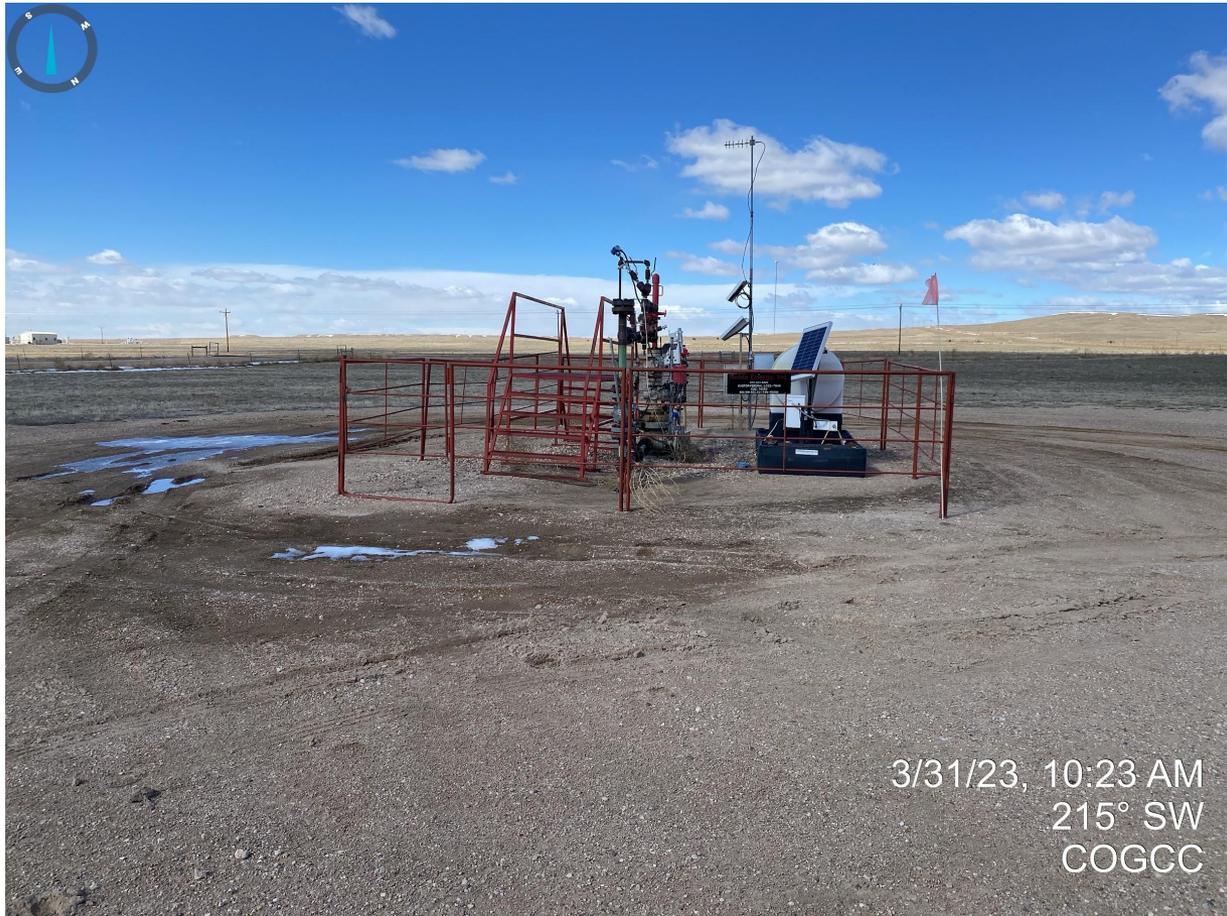
**Photo 2.** Facing southwest at wellhead; see comments in Photo 1.

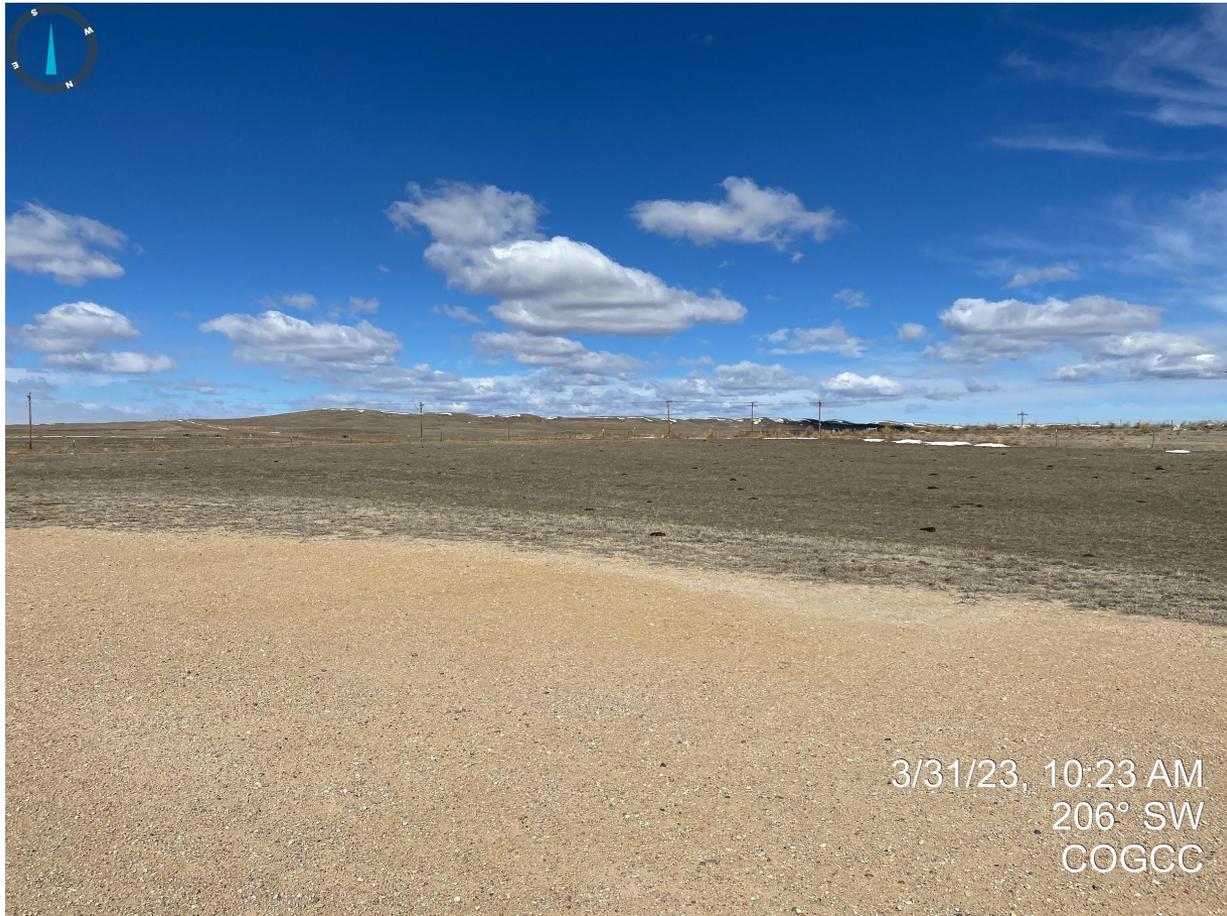
**Photo 3.** Facing southwest near the wellhead. It appears the operator has managed the interim areas (e.g. mowed) for undesirable vegetation. Note: evidence of livestock (e.g. cow pies) was observed throughout the location and interim areas.

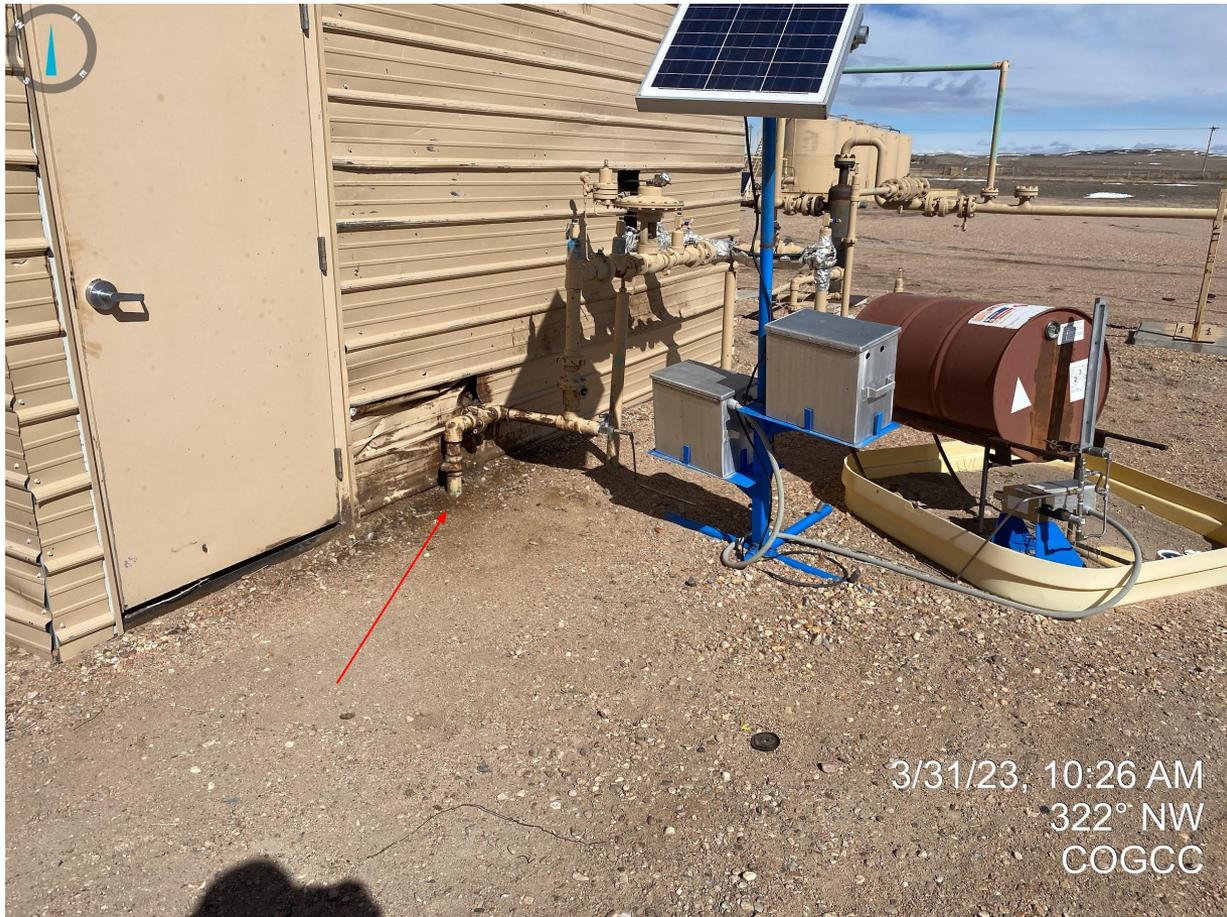
**Photo 4.** Facing northwest at engine shed. It appears the unused tin has been installed. Stained soil (red arrow) observed in the previous inspection does not appear to have been cleaned up per Rule 905.e.

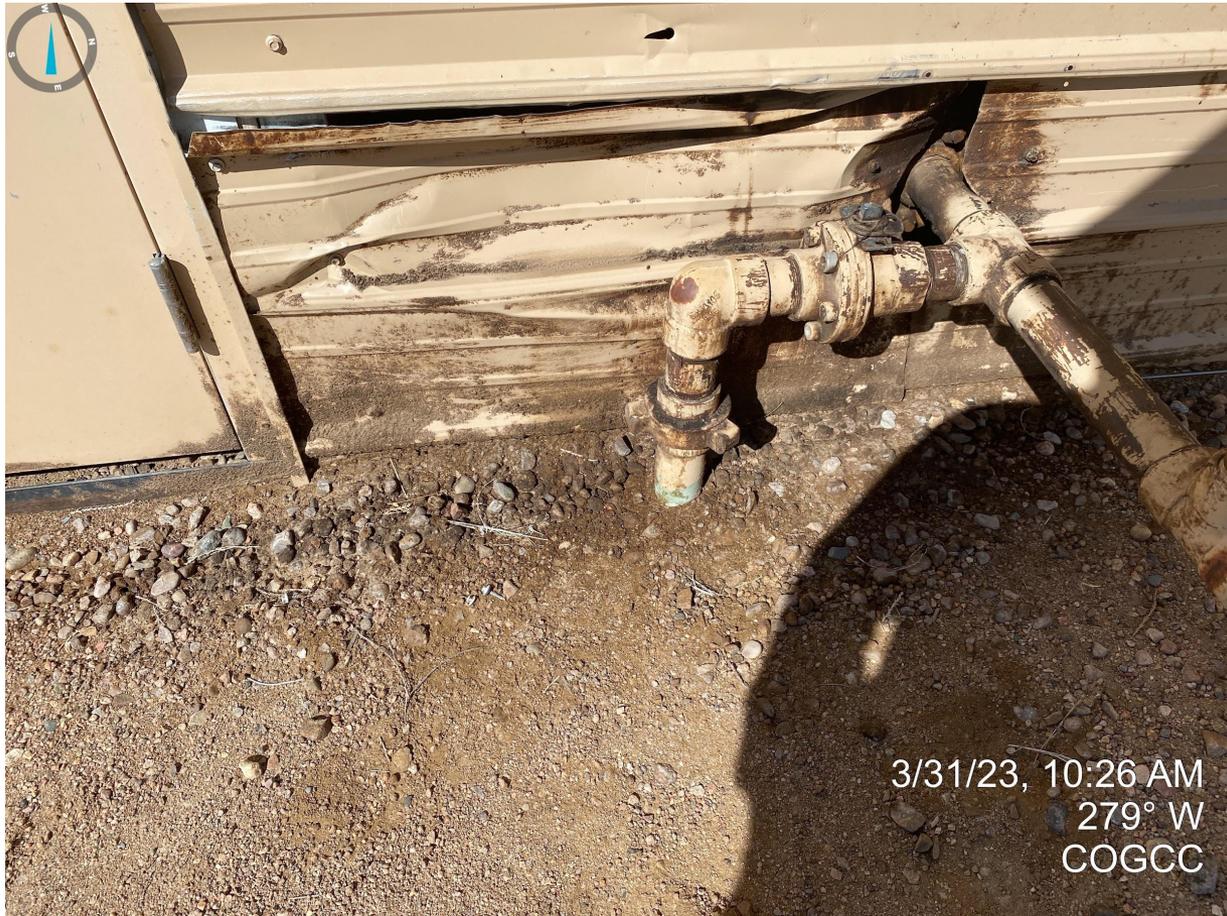
**Photo 5.** See comments in Photo 4.

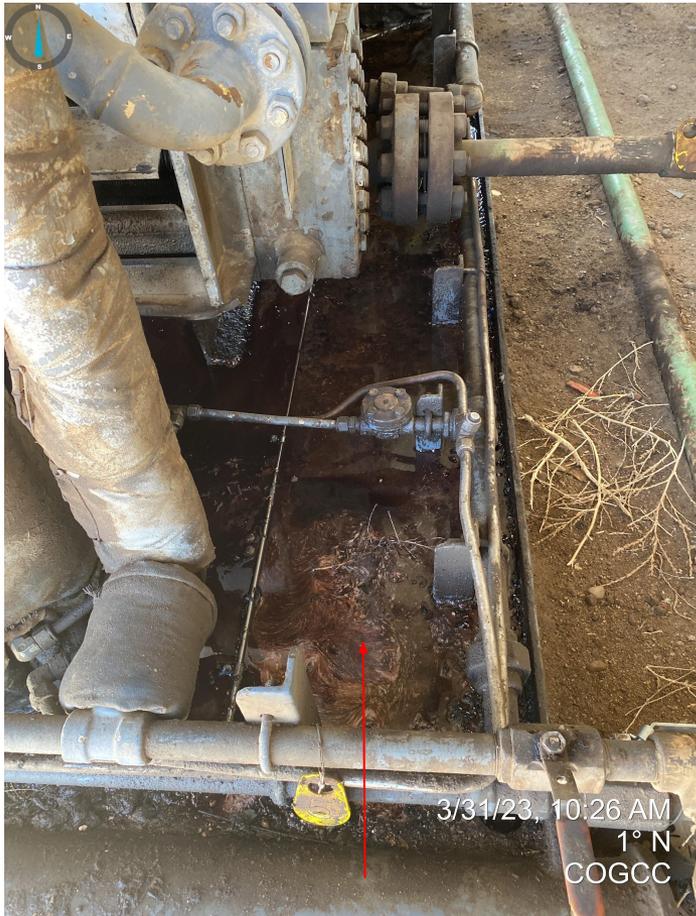
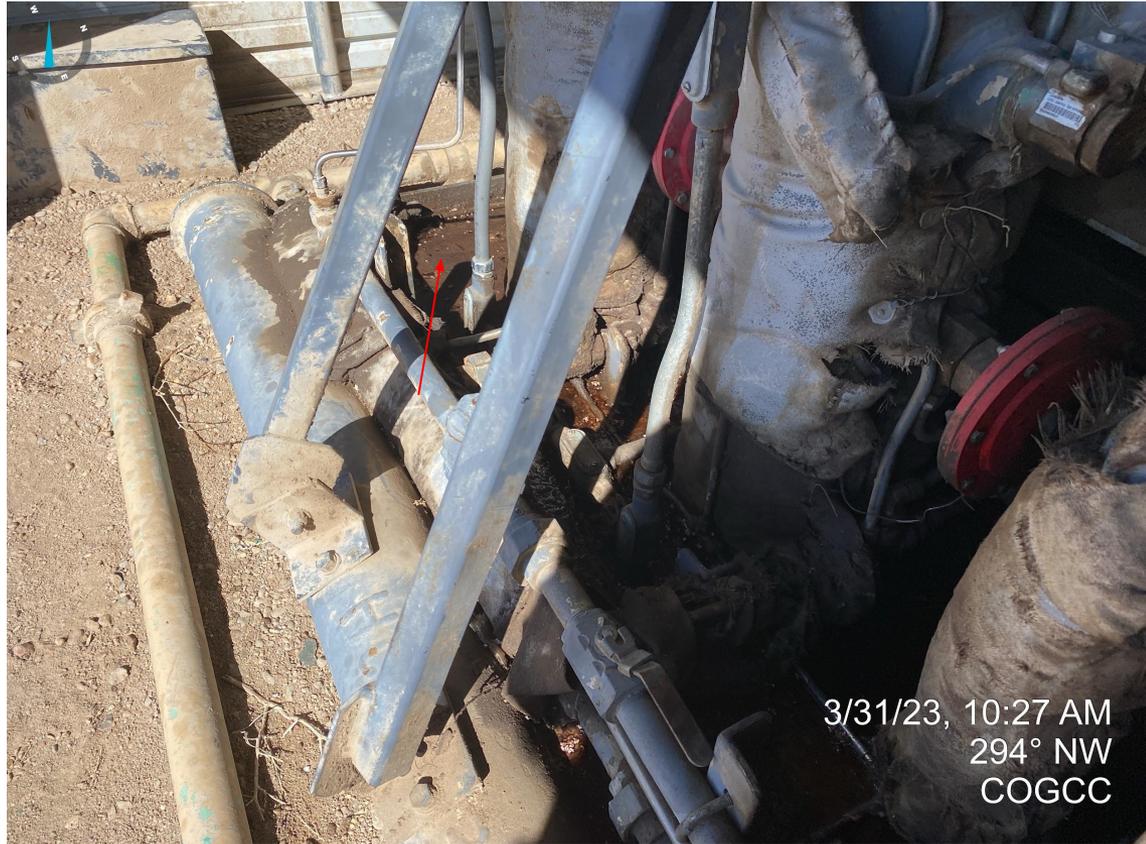
**Photos 6 & 7.** Unknown fluid/material observed within containment of engine skid. This will need to be properly cleaned up per Rule 1002.f.(2)D and machine maintenance may be necessary to prevent further accumulations of material.

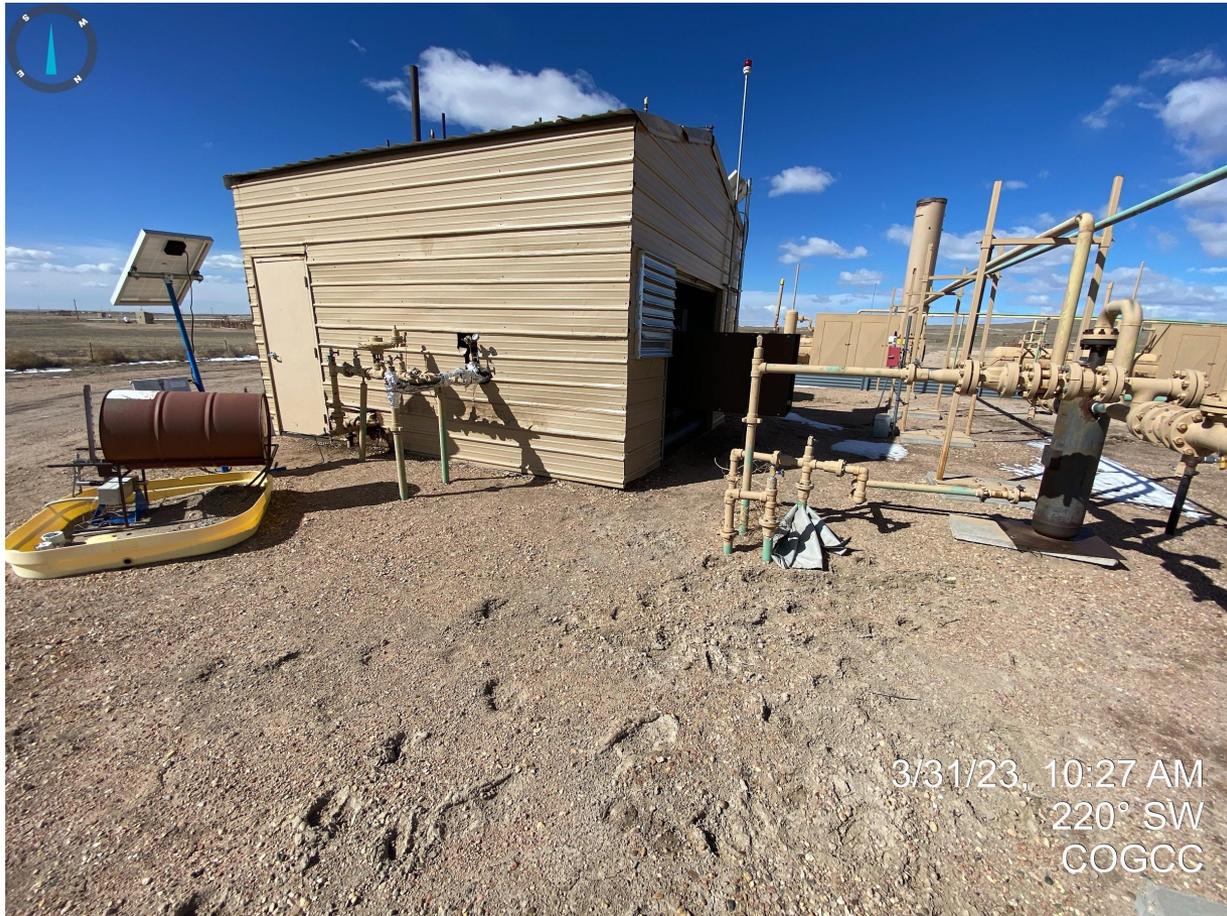
**Photo 8.** Overview of shed with tin reinstalled.

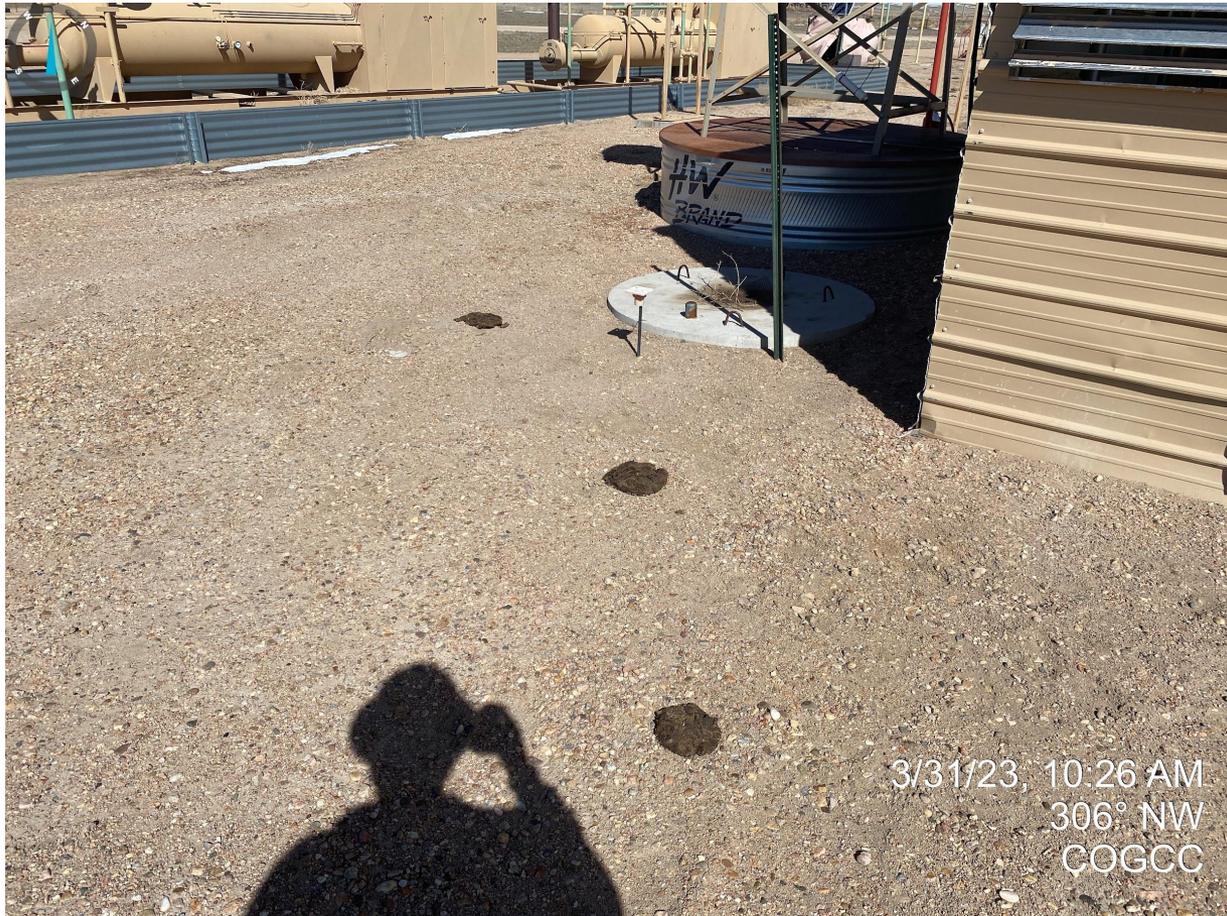
**Photo 9.** Evidence of livestock within/on location. This is being entered to notify operator of field observations during this inspection.
