Interim Reclamation and Stormwater Inspection

Operator: VERDAD RESOURCES LLC - 10651

Location ID: 432694

Inspection Photos
Location Name: Shull 1-35-9-60 Pad
Location ID: 432694

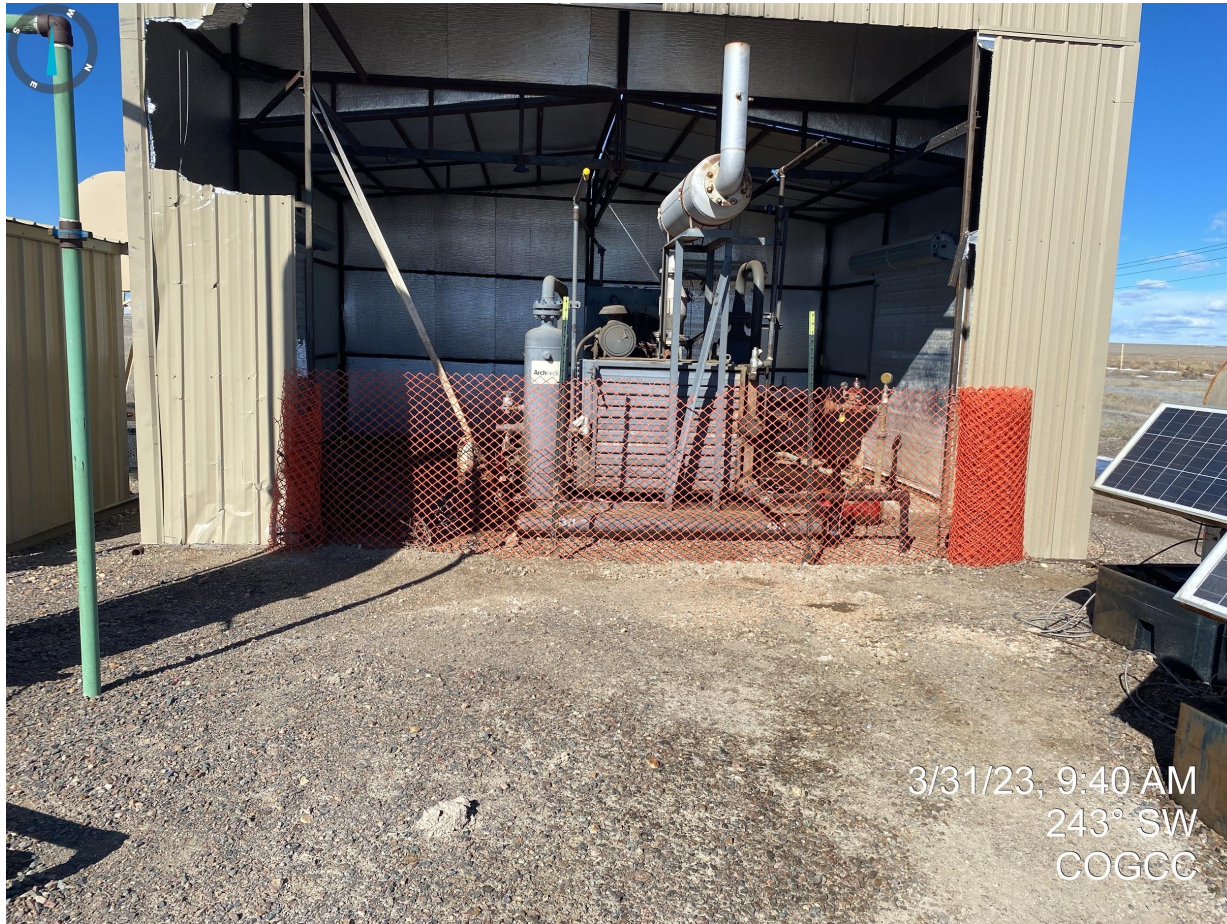
Photo 1. It appears the Operator has performed the corrective action and installed wildlife exclusion device at the entrance of the compressor shed.

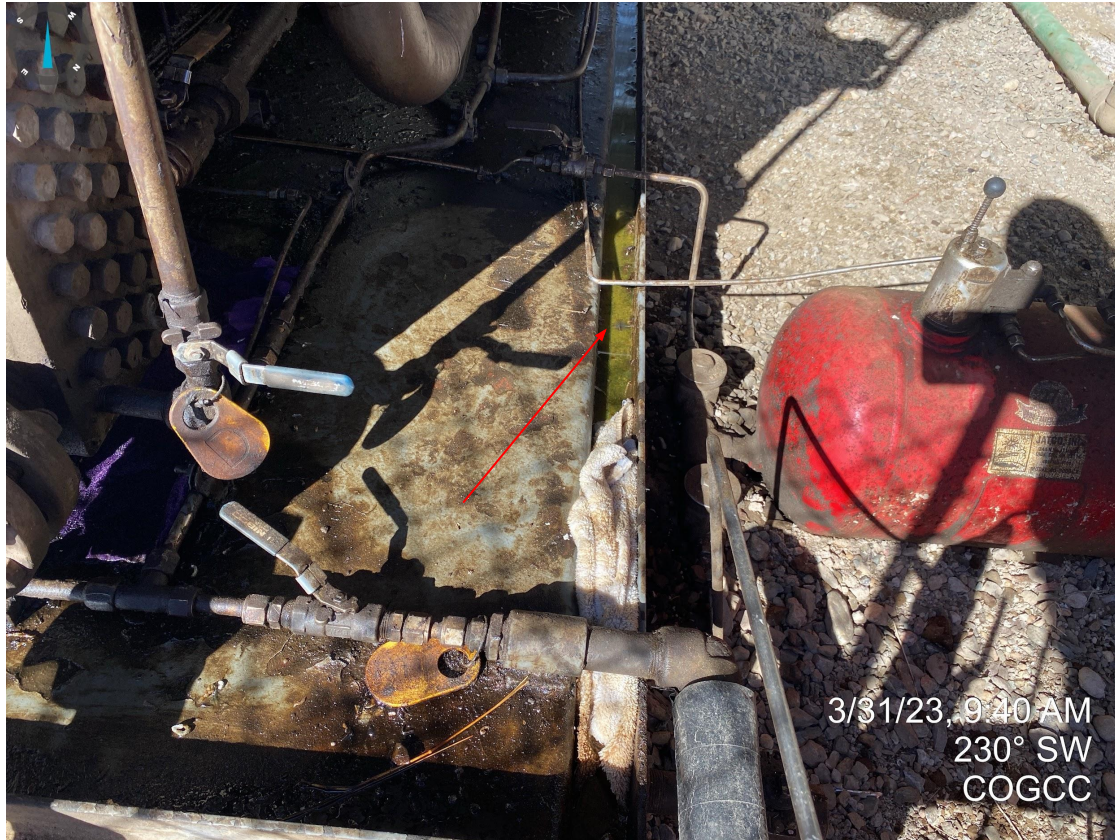
Photo 2. Close-up photo of residual antifreeze observed within containment of engine skid. Based on Operator submitted FIRR, the Operator cleaned up the free antifreeze and placed rags within the containment to soak up any remaining fluids to perform the corrective action. At the time of this inspection, some residual fluid was discovered and appears to be diluted. The Operator is being required to inspect the equipment and remove any remaining fluid to prevent further occurrences.

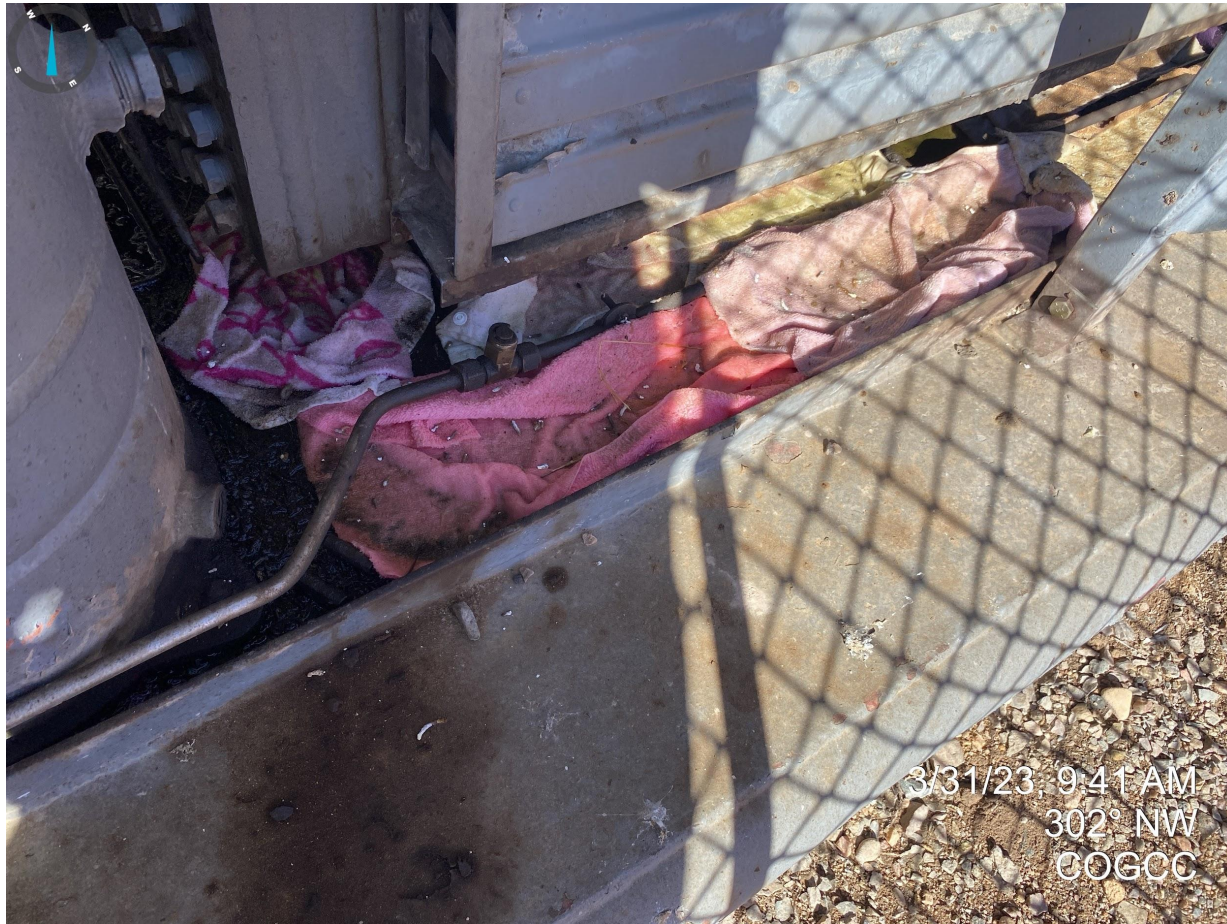
Photo 3. See comments in Photo 2.

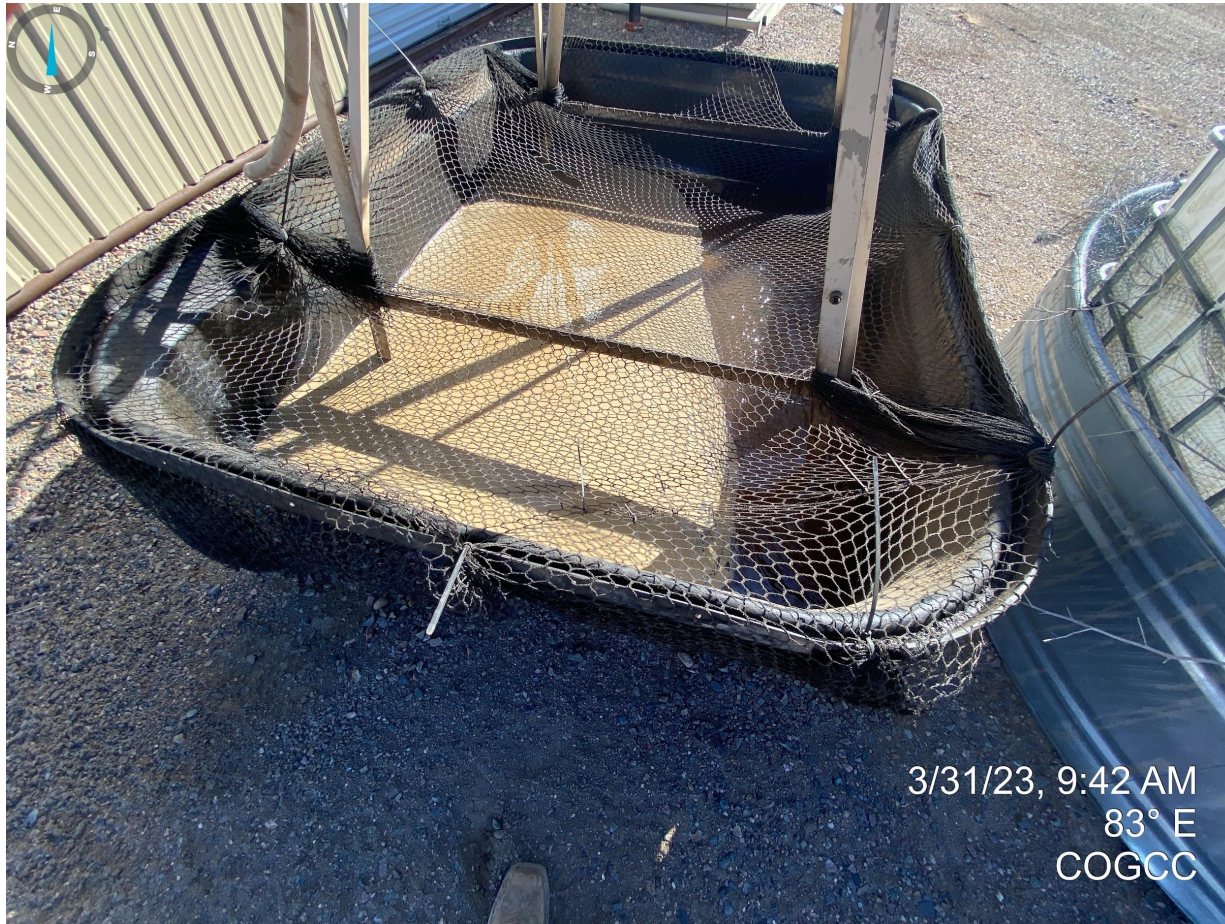
Photo 4. Facing east at raised tank and secondary containment. During this inspection, Staff observed a milky /unknown fluid within the secondary containment that will need to be properly disposed of.
