Inspection Photos

4/05/2023

Operator: TEP ROCKY MOUNTAIN LLC - 96850

Location #334359

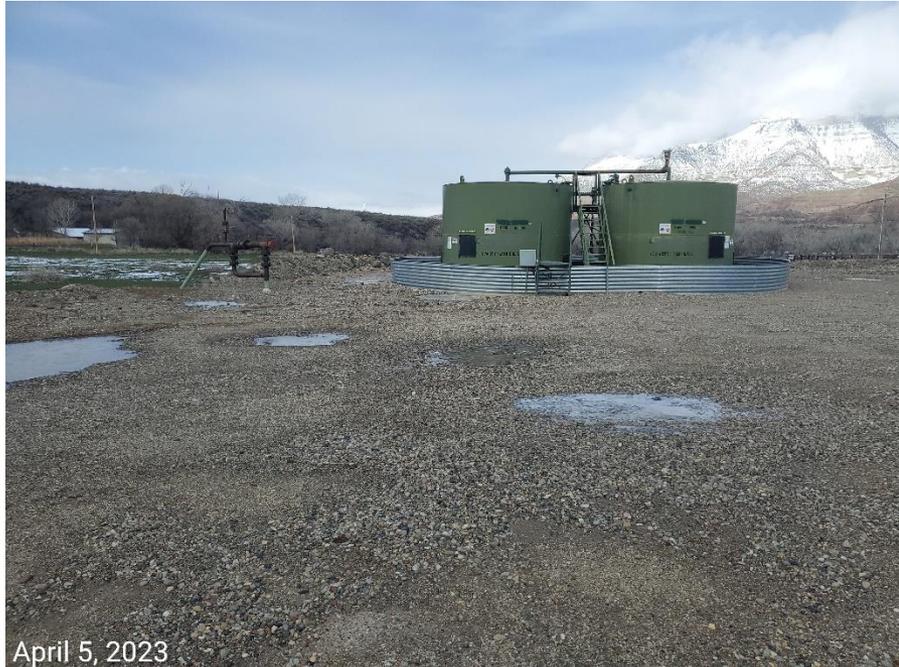
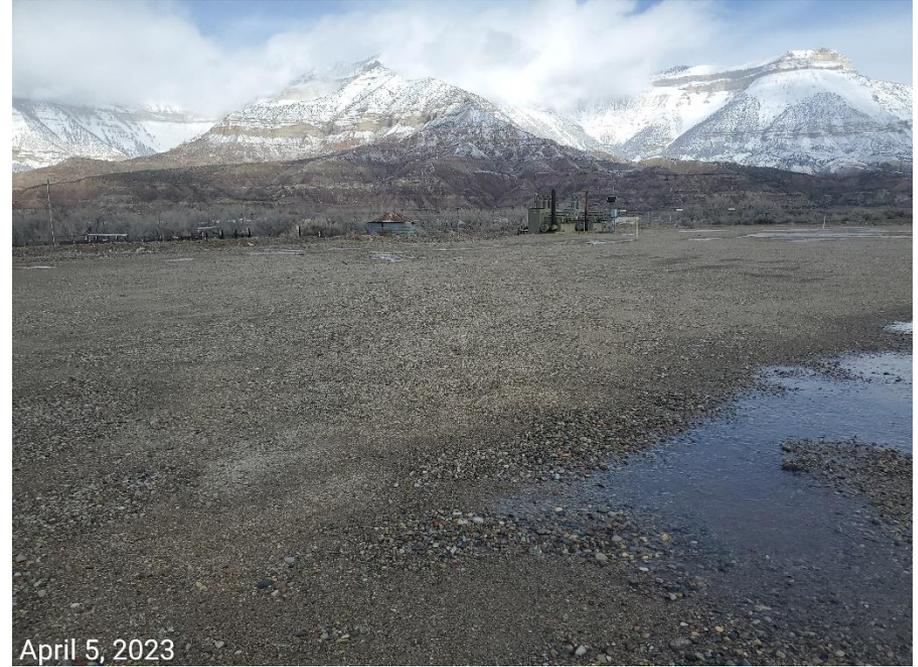
Photo 1: Photos 1-2 taken from the south end of the Location. Photos provide an overview of the Location from west, northwest, northeast to east.

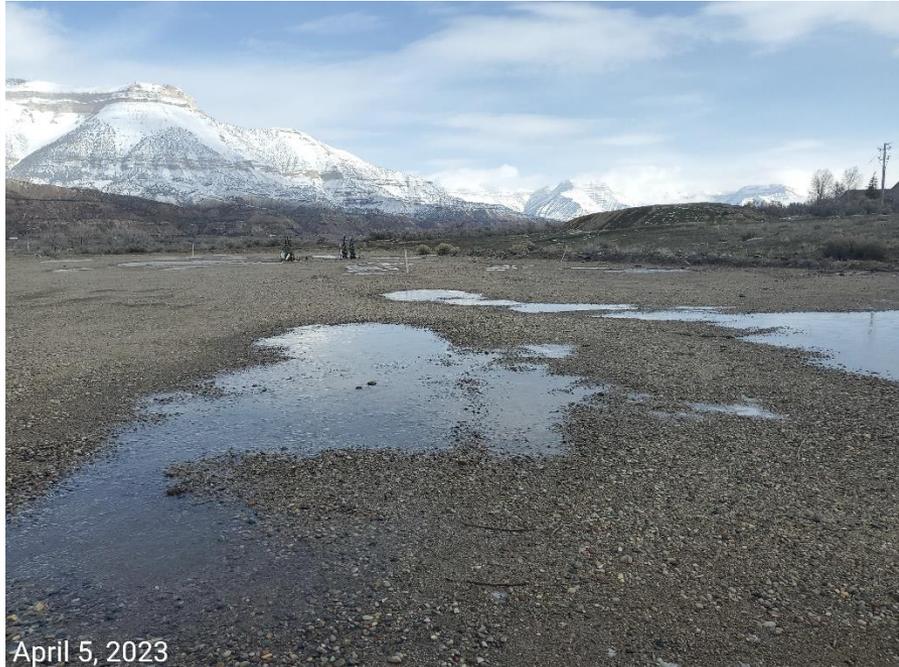
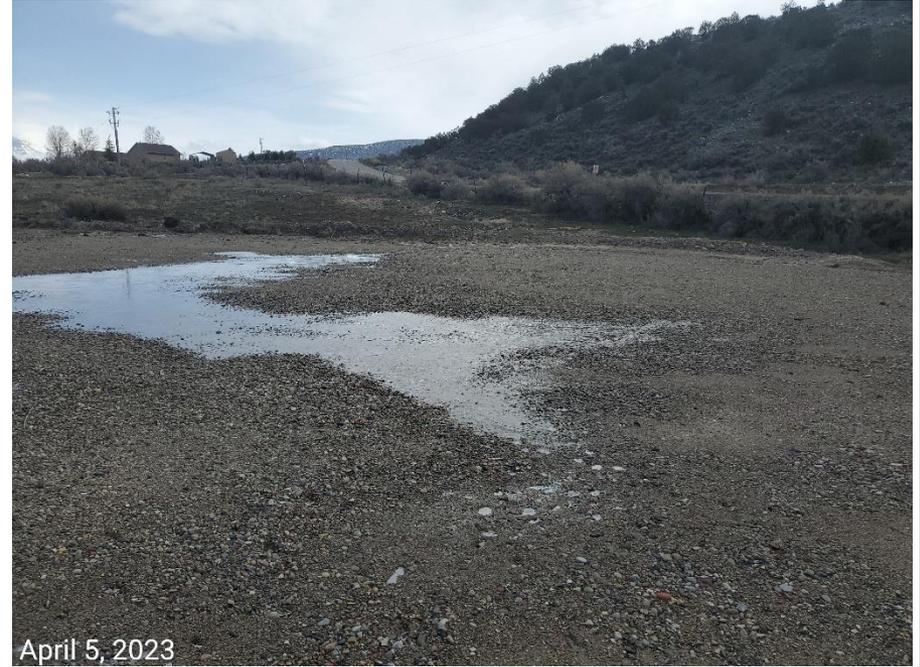
Photo 2: See comments under photo 1.

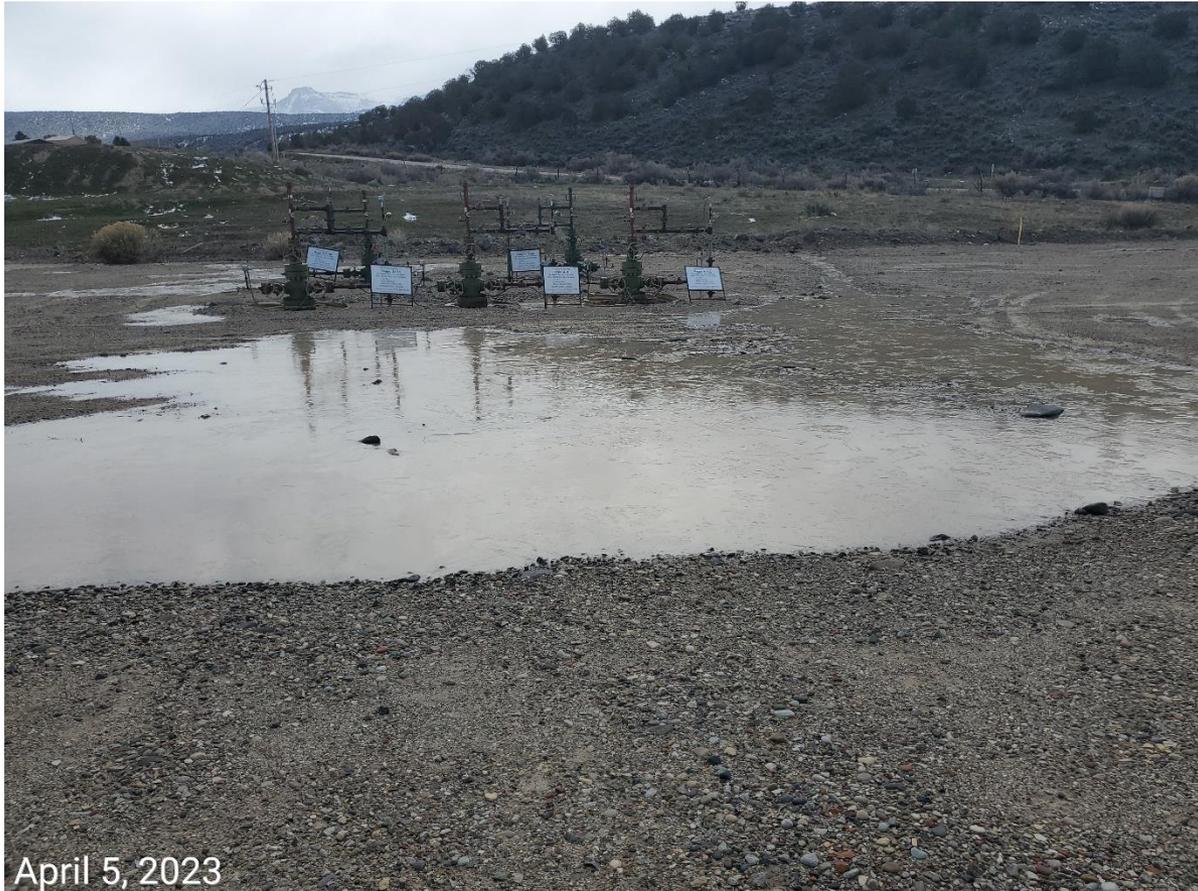
Photo 3: Photo shows stormwater ponding on the Location. BMPs inadequate to allow for proper stormwater discharge. Photo shows conditions/BMPs appear to remain unchanged since prior inspections, and appear to discharge runoff onto the working pad, rather than from.
