Inspection Photos

Operator: TEP ROCKY MOUNTAIN LLC - 96850

Location #334138

Garfield County, CO

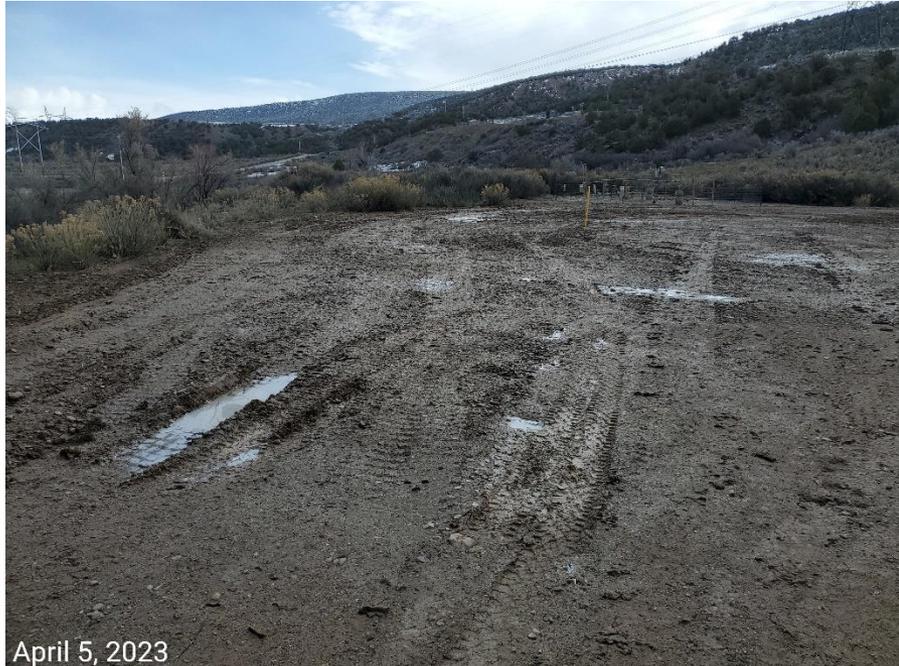
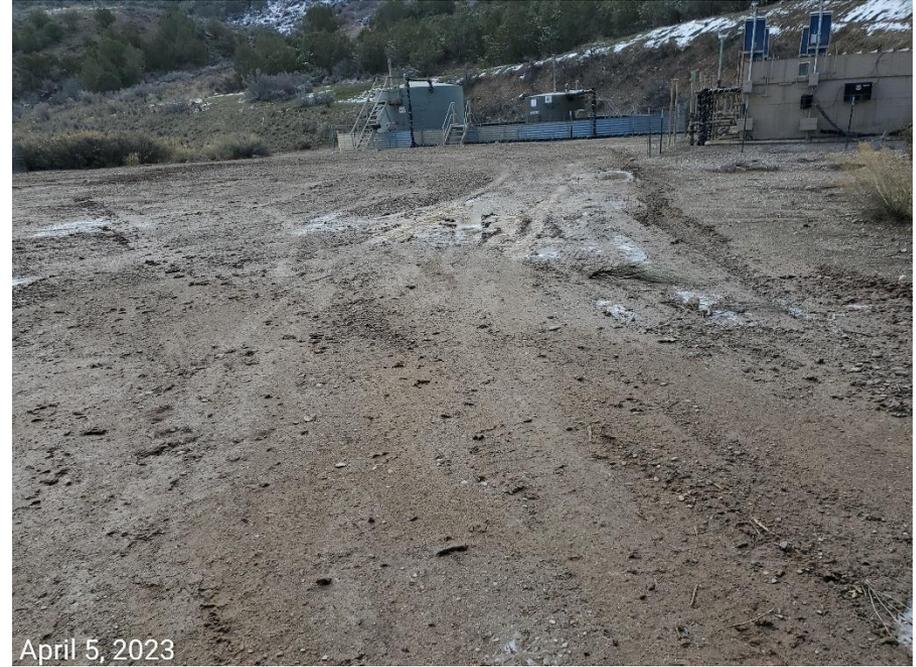
Photo 1: Photos taken from the Location entrance. Photo shows Operator appears to have re-graded the working pad- regrading alone is inadequate to provide long-term stabilization, minimization of degradation, tracking and off-site sediment transport, and is considered a temporary repair measure.

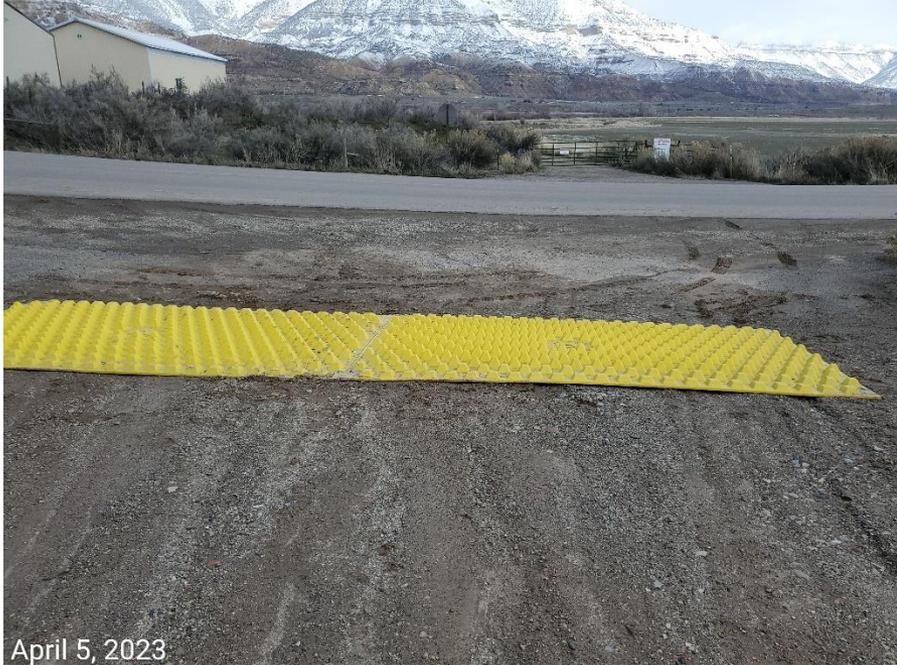
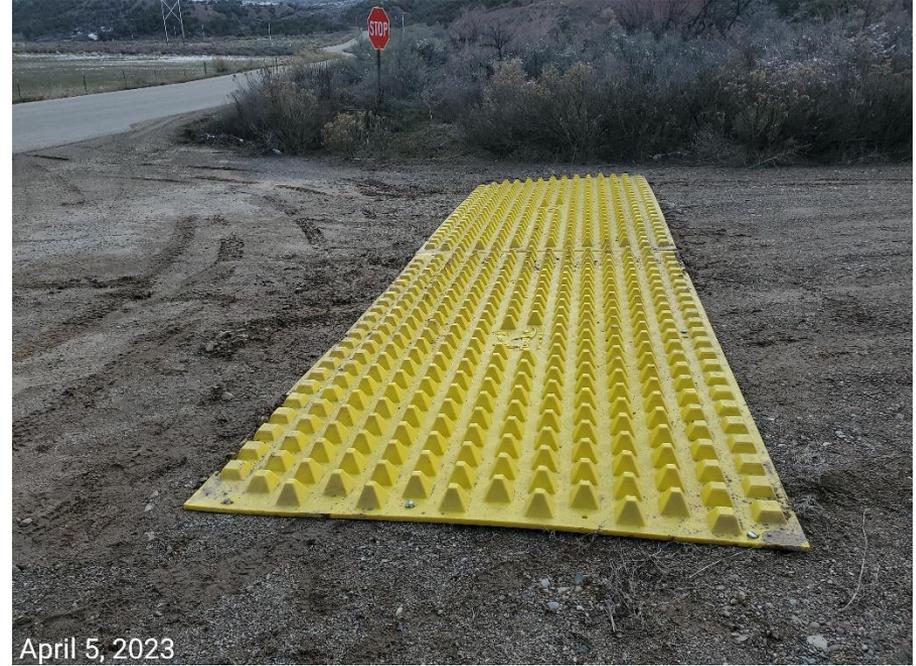
Photo 2: Photo taken from the access road entrance. Photo shows Operator has implemented a single row of “reusable trackout control mats”. BMP is not per good engineering practices, and is inadequate in length to allow for at least an entire tire rotation for most off-highway, or industrial vehicle tires used in O&G.
