# Inspection Photos

Operator: TEP ROCKY MOUNTAIN LLC - 96850

Location #334393

Garfield County, CO

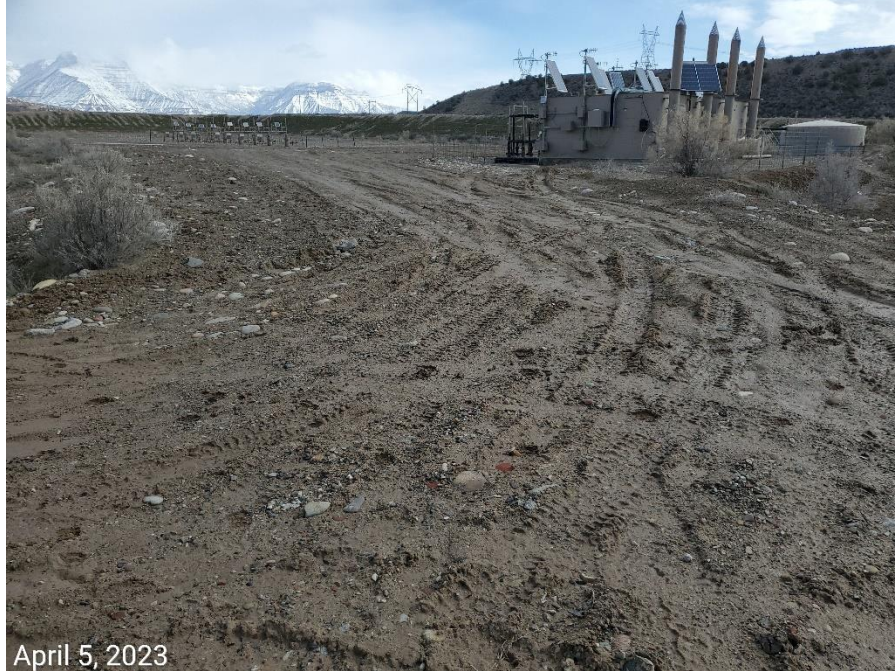
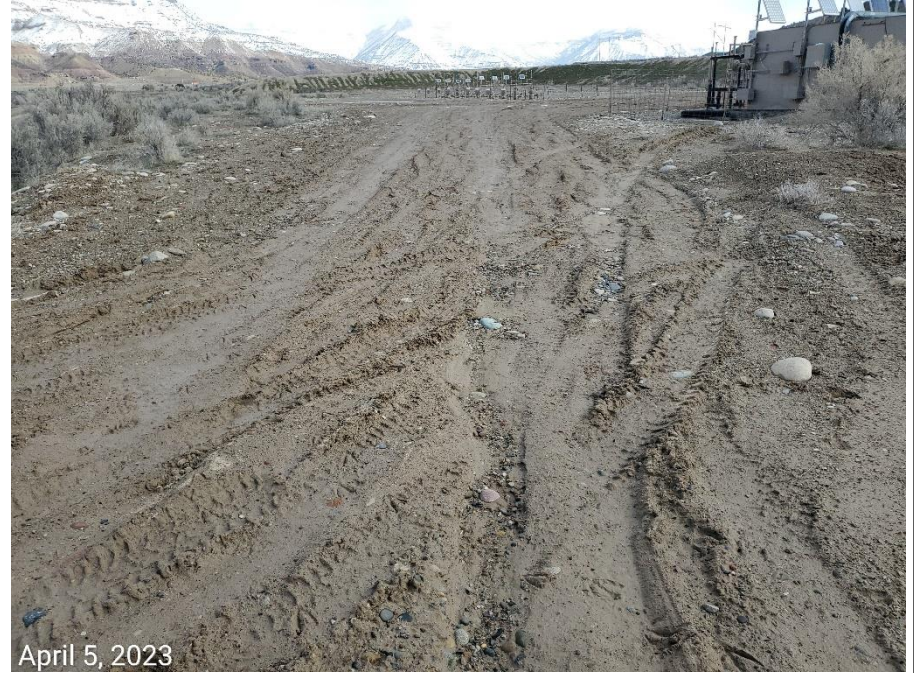
**Photo 1:** Photos 1-3 taken from the Location. Photos show BMPs to stabilization the Location, and to minimize erosion, degradation and off-site sediment transport remain missing or insufficient.

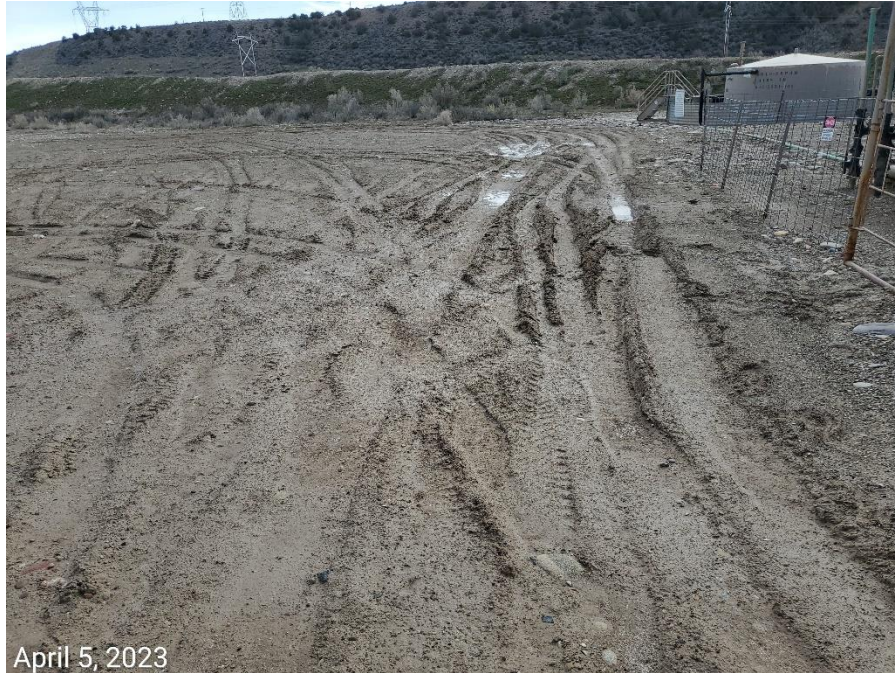
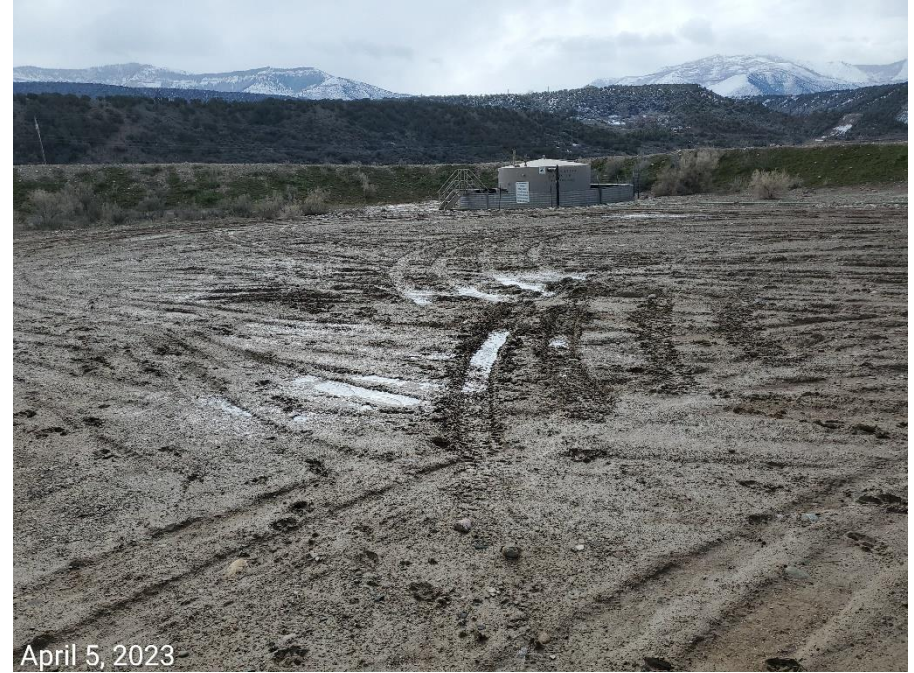
**Photo 2:** See comments under photo 1.

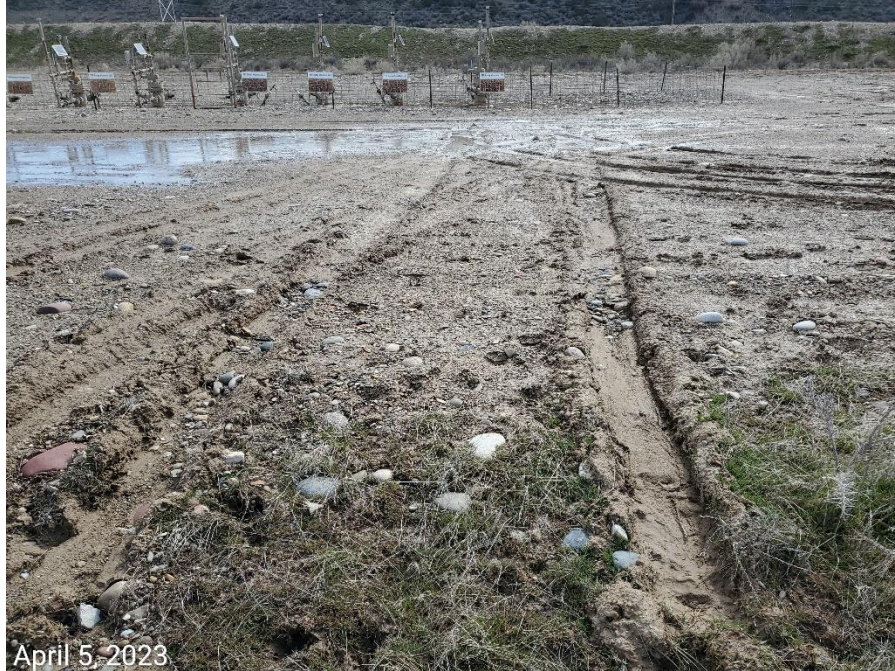
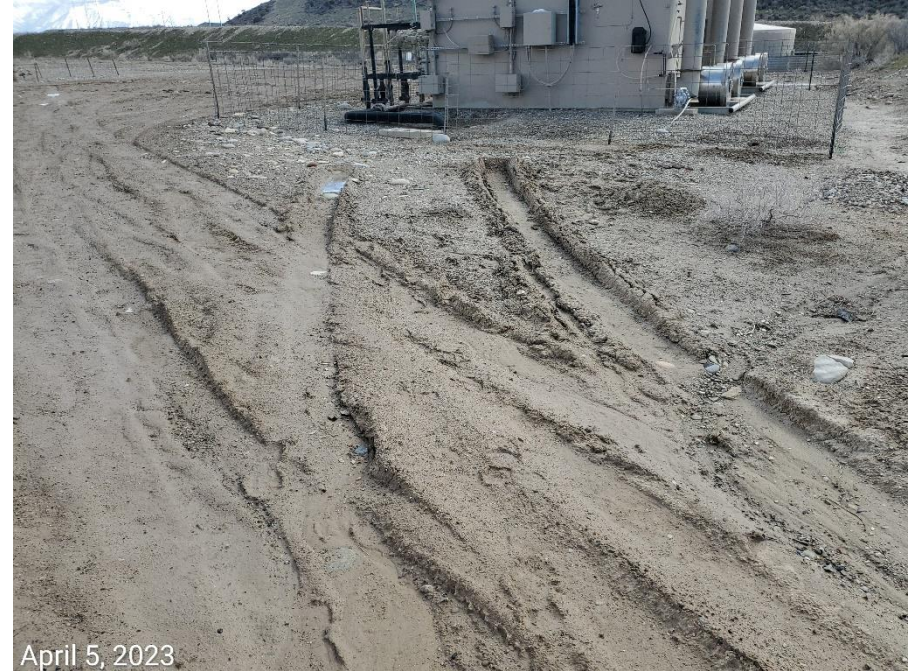
**Photo 3:** See comments under photo 1.

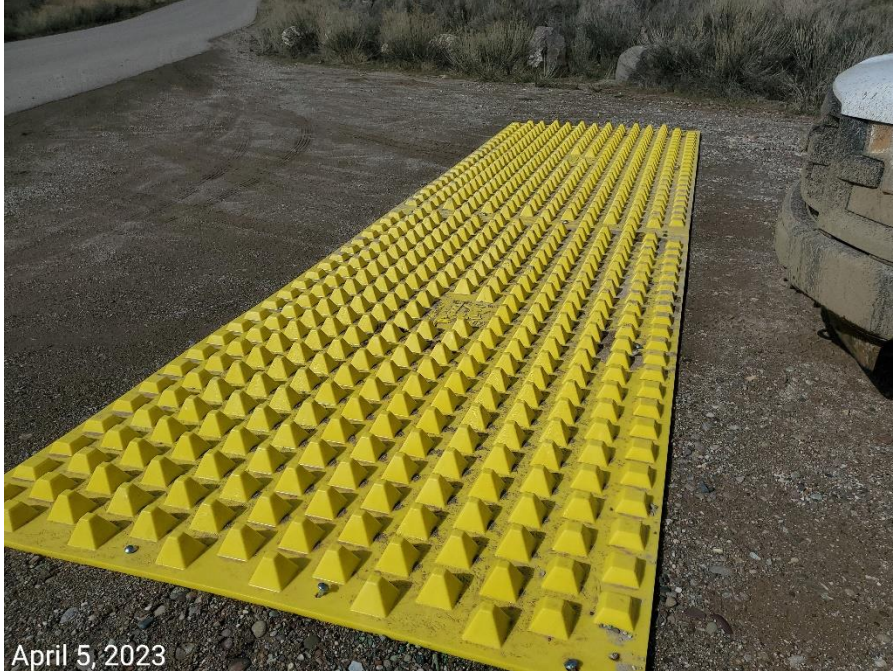
**Photo 4:** Photo taken from the access road entrance ~1/2 south of the Location. Photo shows Operator has implemented a single row of “reusable trackout control mats”. BMP is not per good engineering practices, and is inadequate in length to allow for at least an entire tire rotation for most off-highway, or industrial vehicle tires used in O&G.
