Inspection Photos

Operator: TEP ROCKY MOUNTAIN LLC - 96850

Location #334745

Garfield County, CO

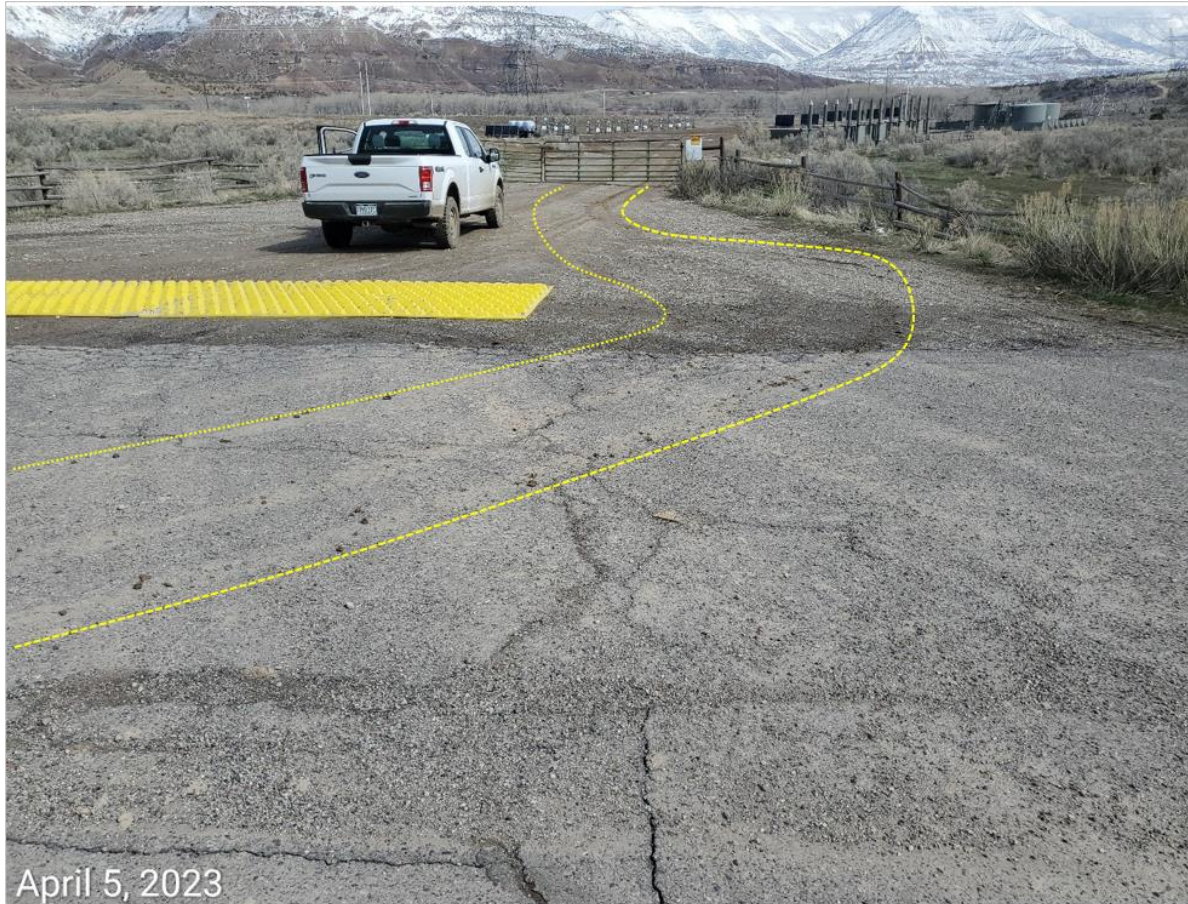
Photo 1: Photos 1-3 taken from the access road entrance and Stone Quarry Road. Photo shows Operator has implemented a single row of “reusable trackout control mats”. BMP is not per good engineering practices, and is inadequate in length to allow for at least an entire tire rotation for most off-highway, or industrial vehicle tires used in O&G. Photo also shows that Operator is traveling around the VTC (yellow dotted lines), resulting in continued sediment transport onto the public roadway.

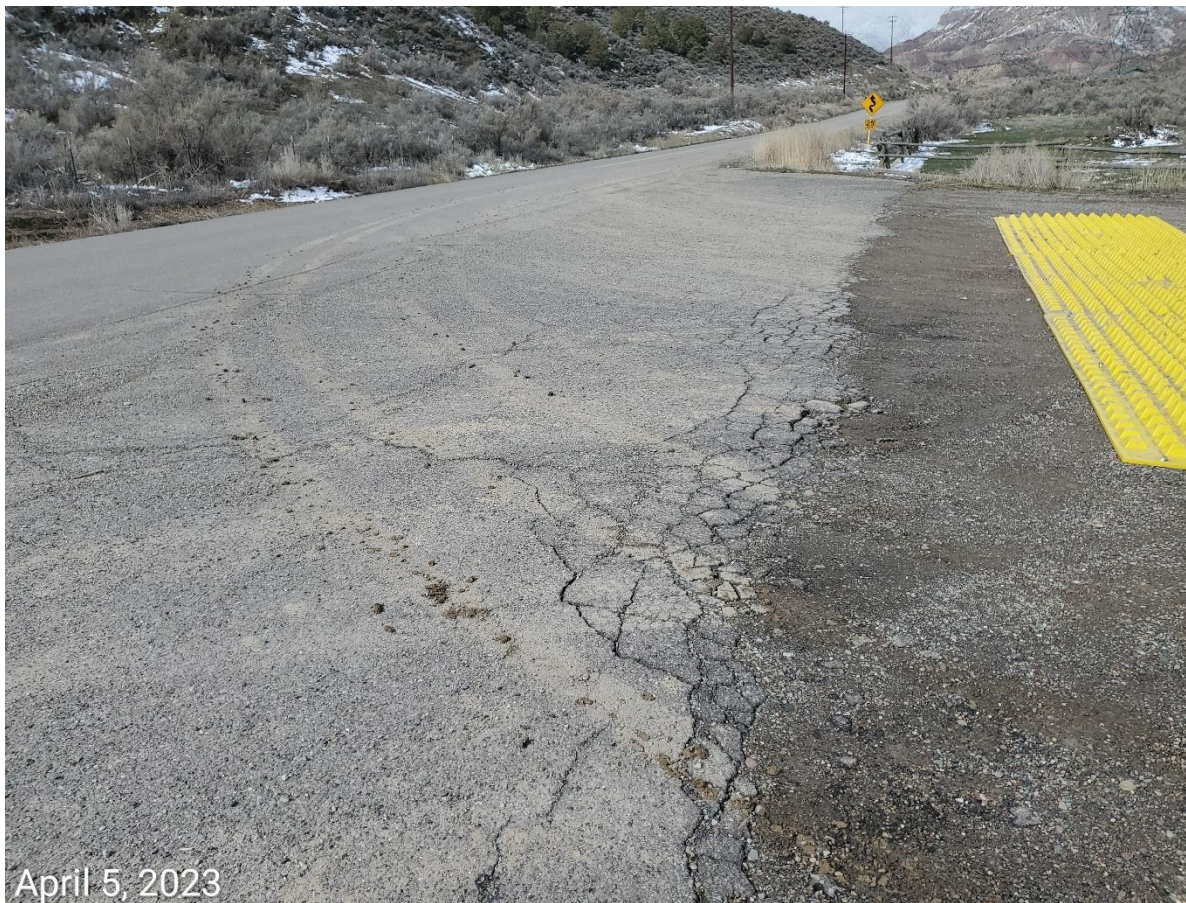
Photo 2: See comments under photo 1. Photo shows sediment transport from the Location onto the public roadway has persisted.

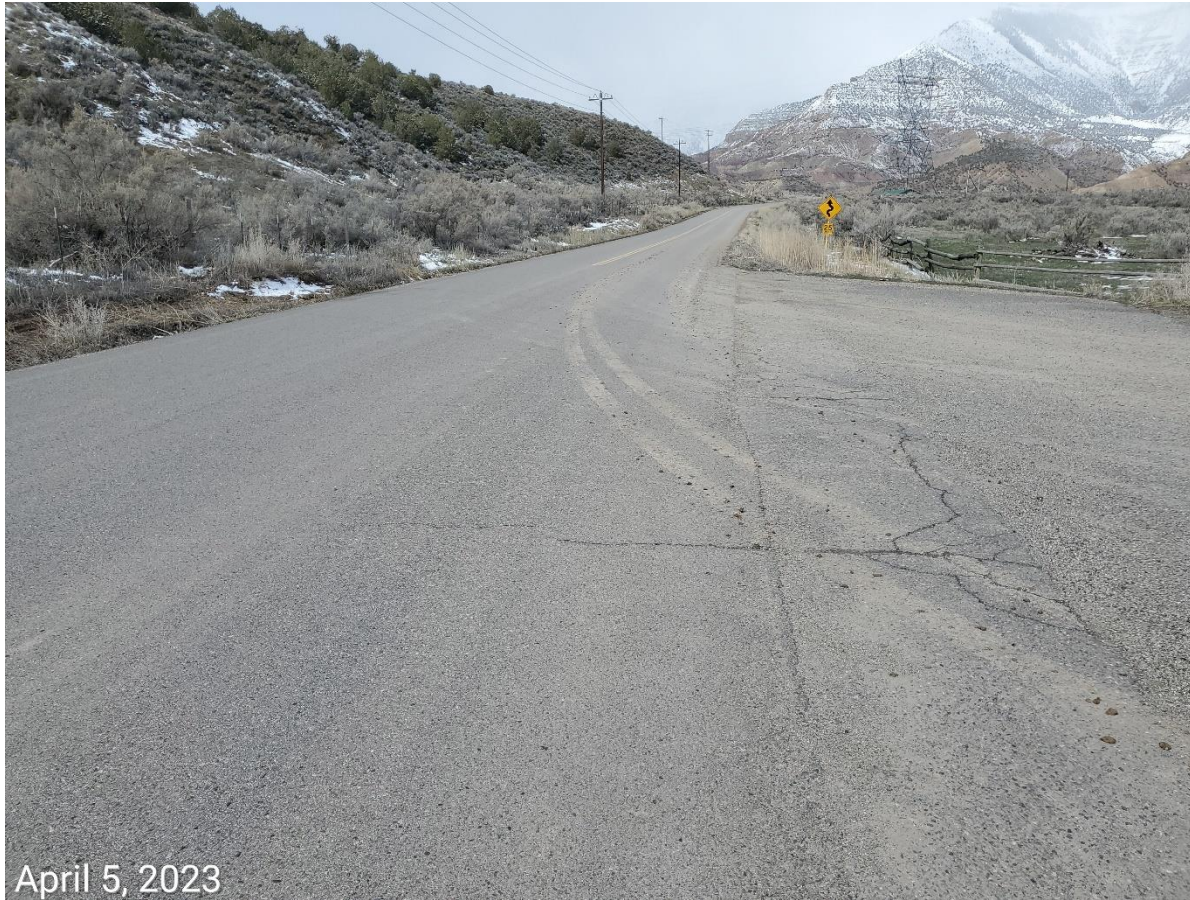
Photo 3: See comments under photo 1. Photo shows sediment transport from the Location onto the public roadway has persisted.

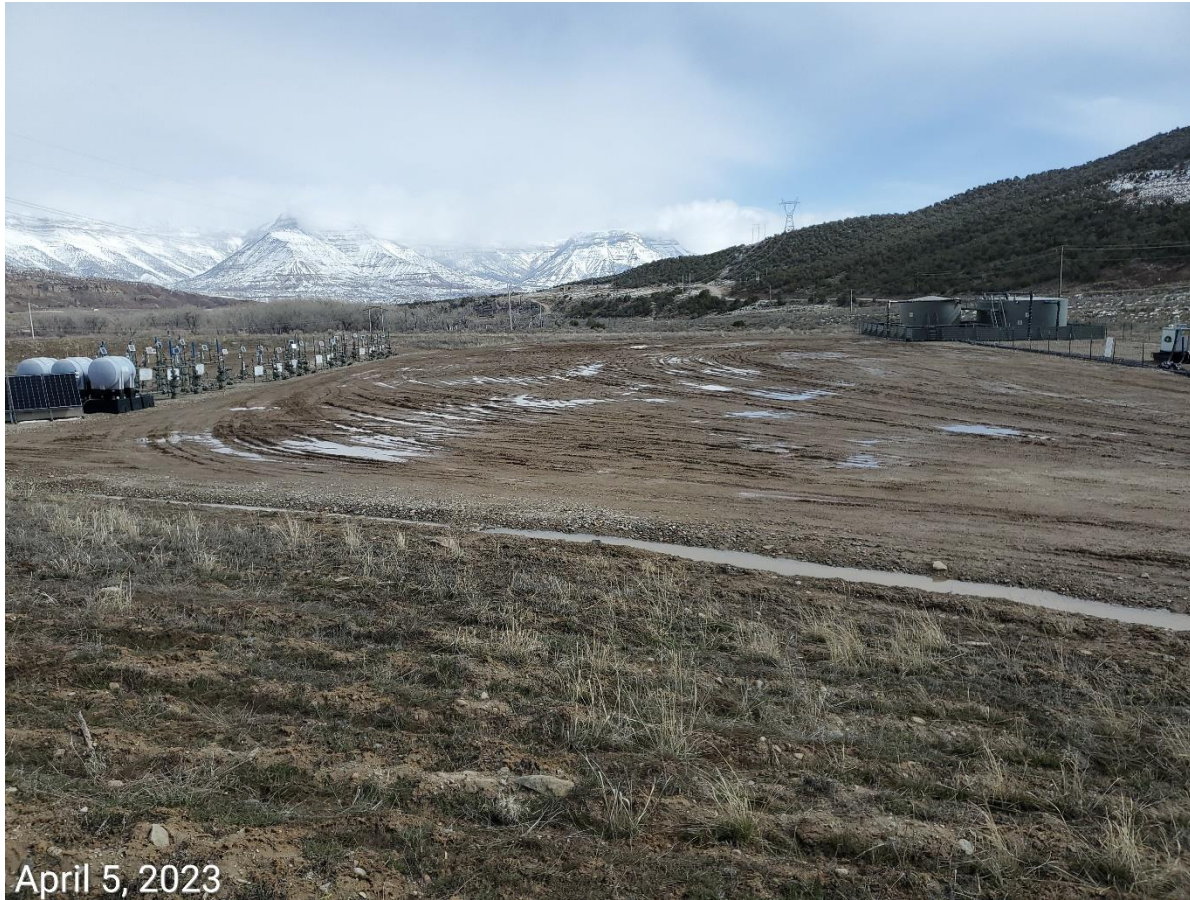
Photo 4: Photos 4-5 show BMPs to stabilize the Location, and to minimize erosion, degradation and off-site sediment transport remain missing or insufficient; pad lacks stabilization.

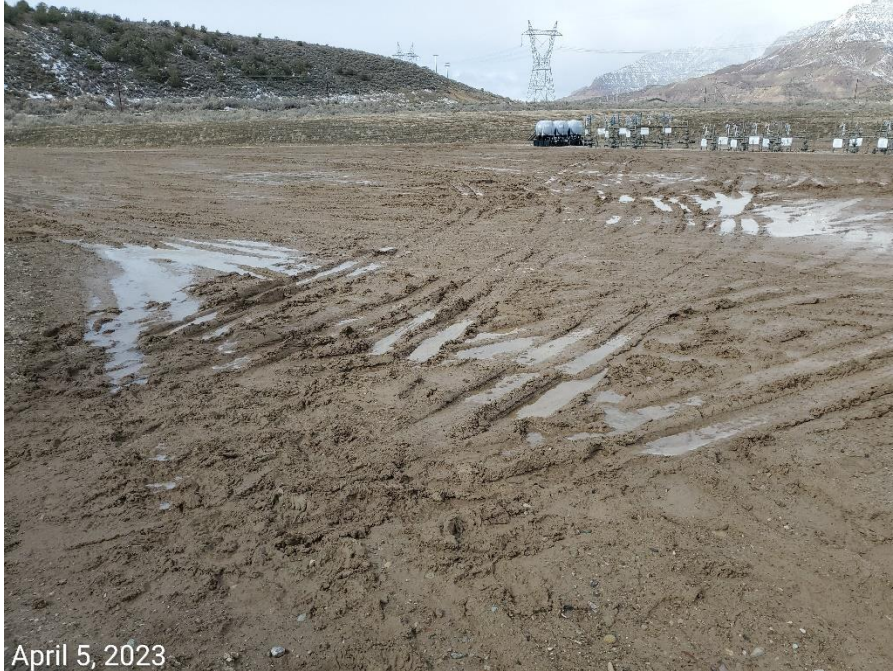
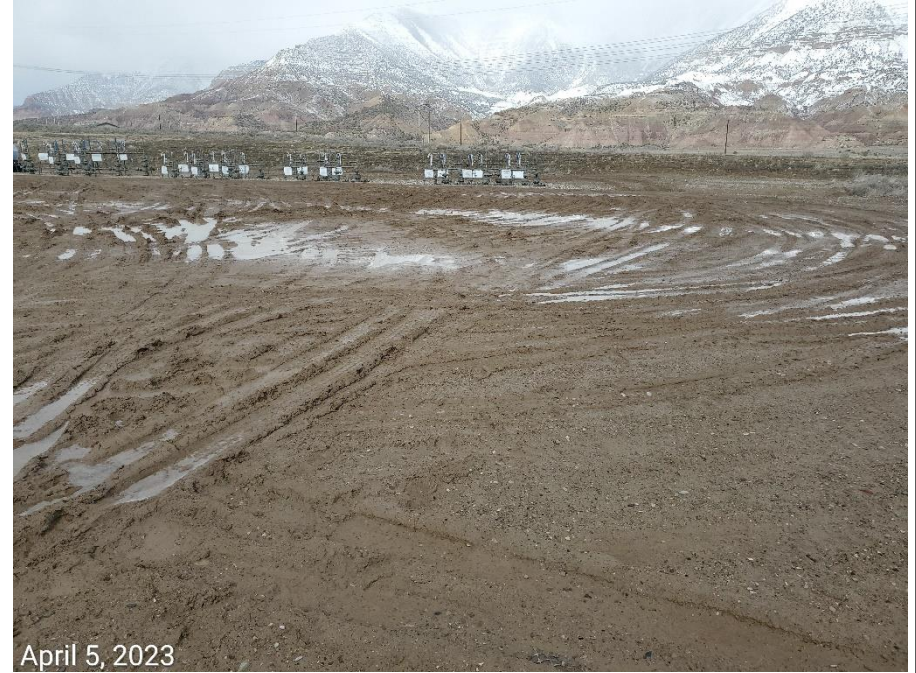
Photo 5: See comments under photo 4.

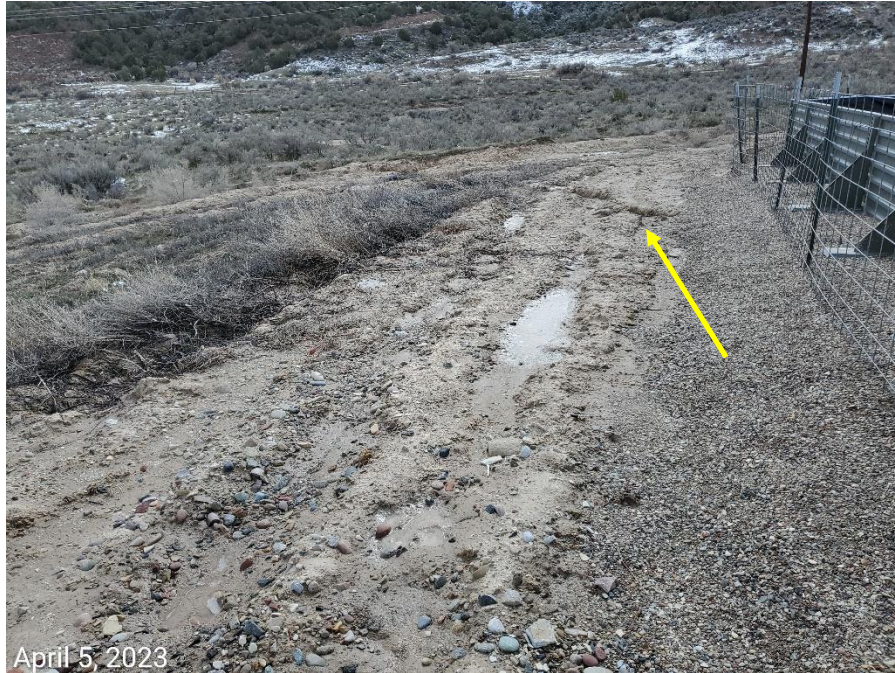
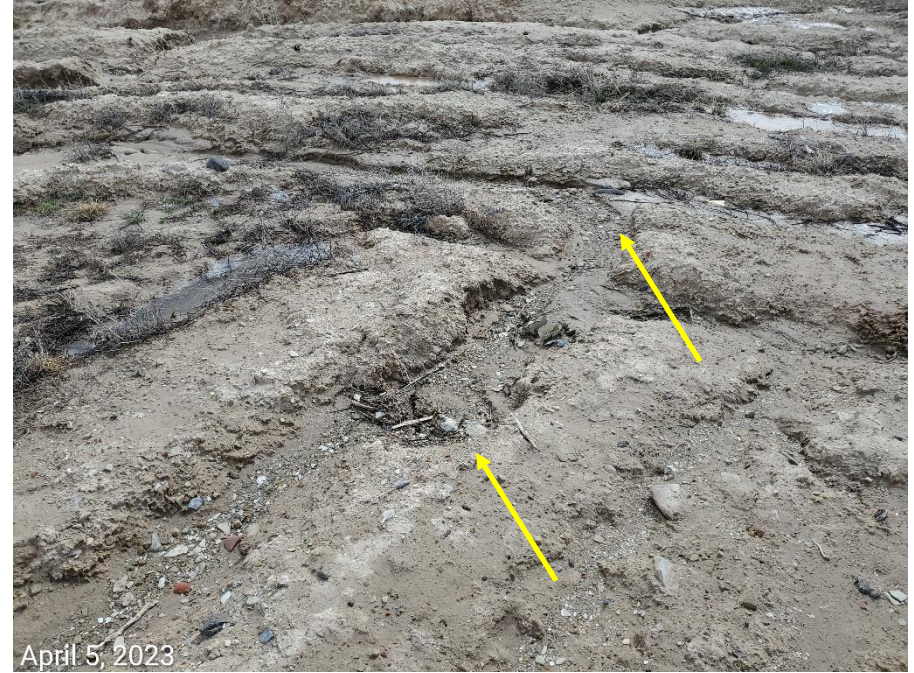
Photo 6: Photos taken from the northeast end of the Location. Photo shows erosion degradation on the interim areas of the Location, due to runoff from the working pad; BMPs to manage runoff from the working pad remain missing or insufficient;

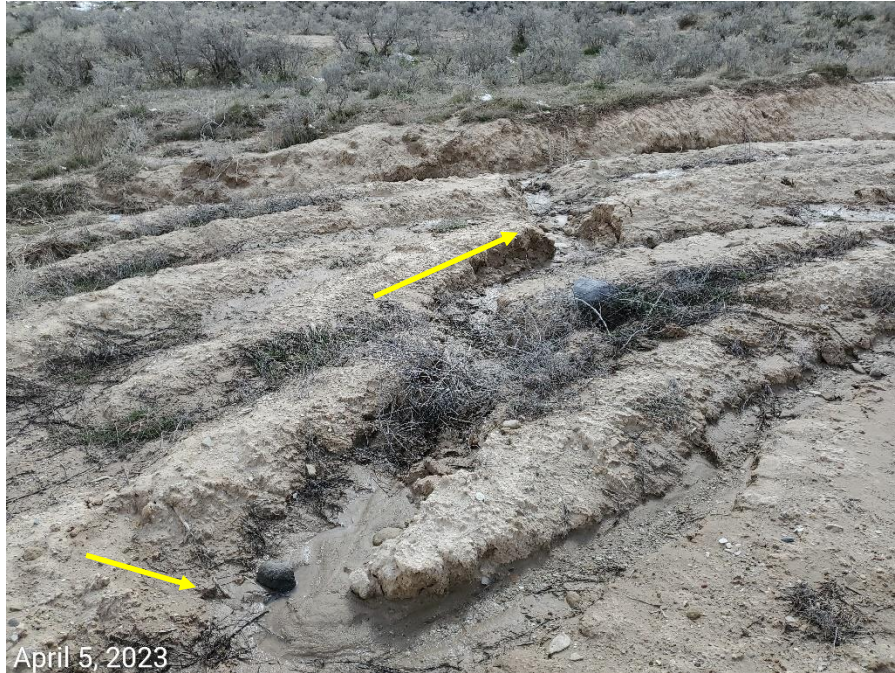
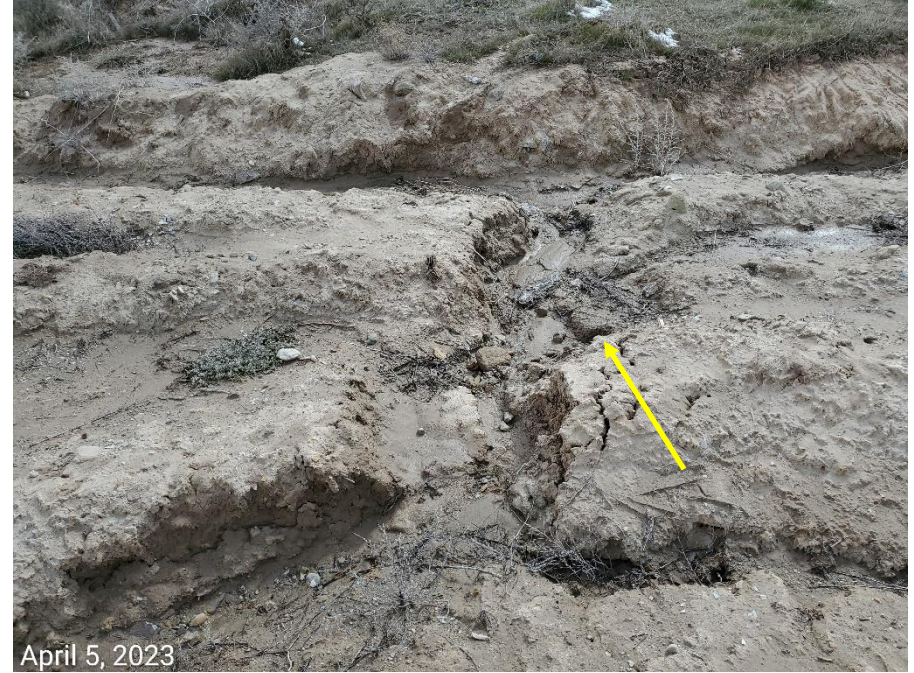
Photo 7: See comments under photo 4.
