# Inspection Photos

4/05/2023

Operator: TEP ROCKY MOUNTAIN LLC #96850

Location #440705

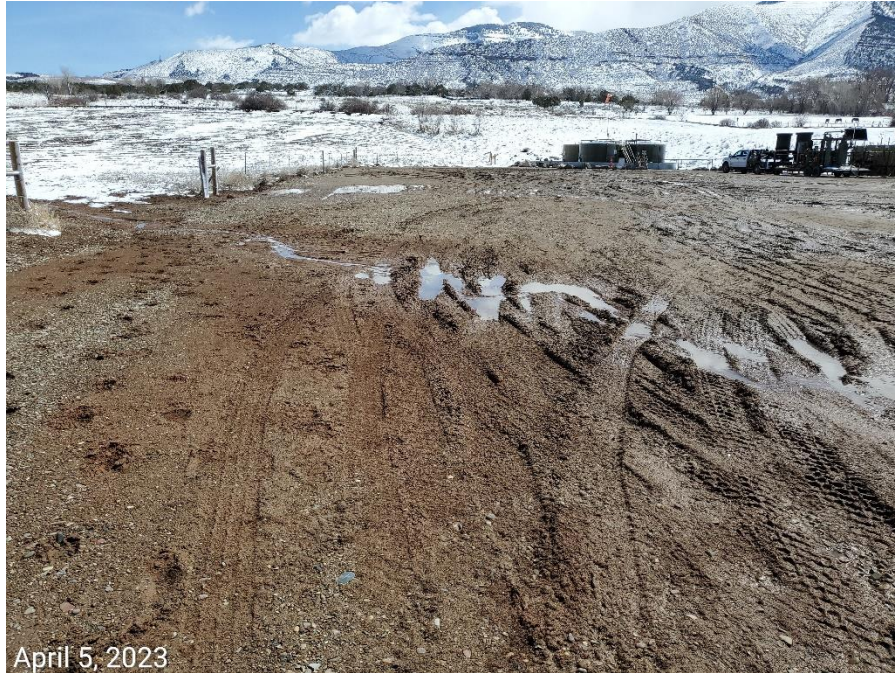
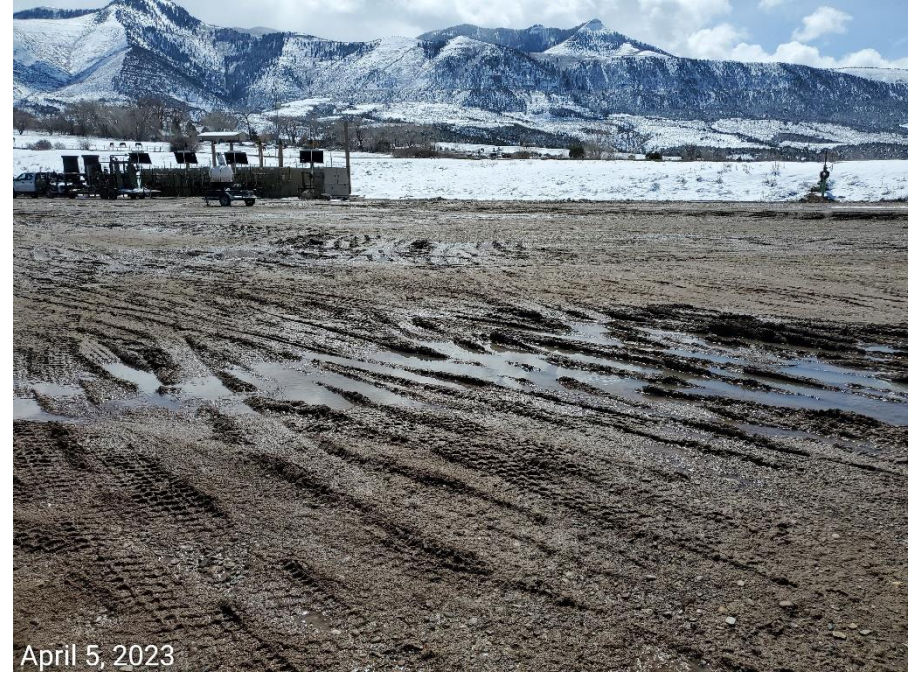
**Photo 1:** Photos 1-2 taken from the current productions areas on the north end of the Location. Photos provide an overview of the Location from east, southeast, southwest to west. Photos also show areas not reasonable needed for production remain. Areas of the working pad continue to lack stabilization.

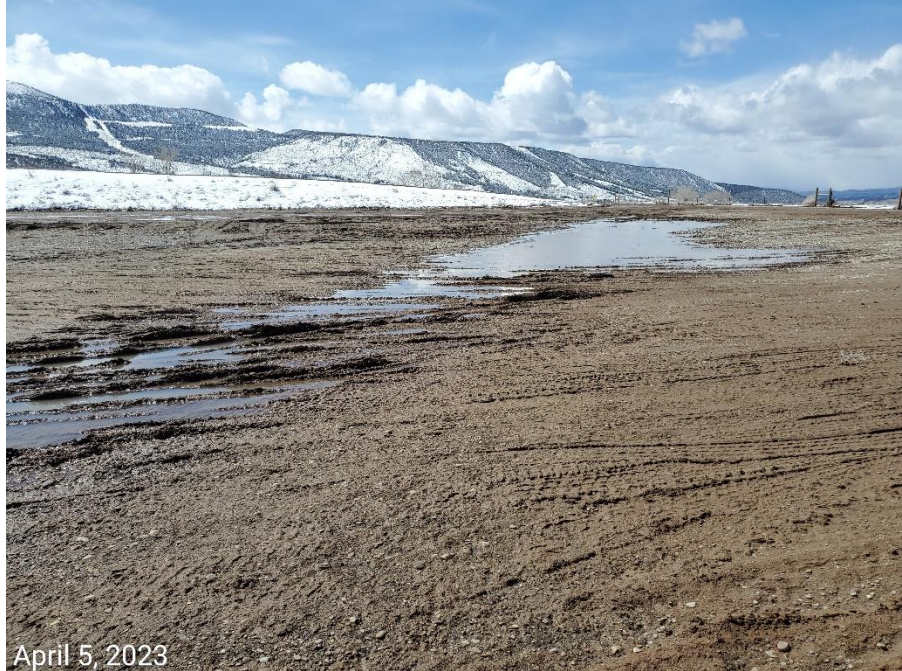
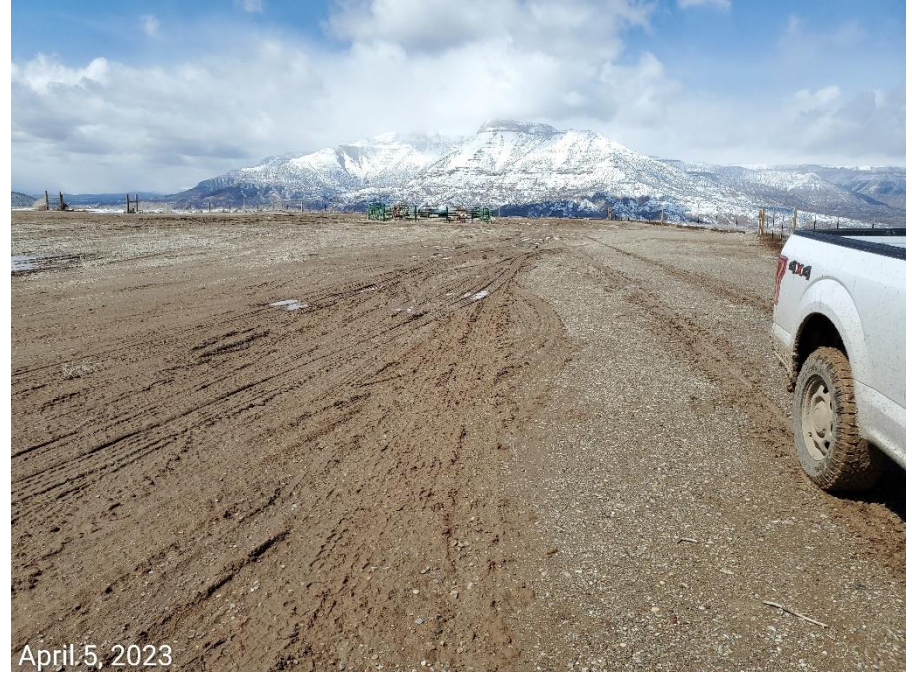
**Photo 2:** See comments under photo 1.

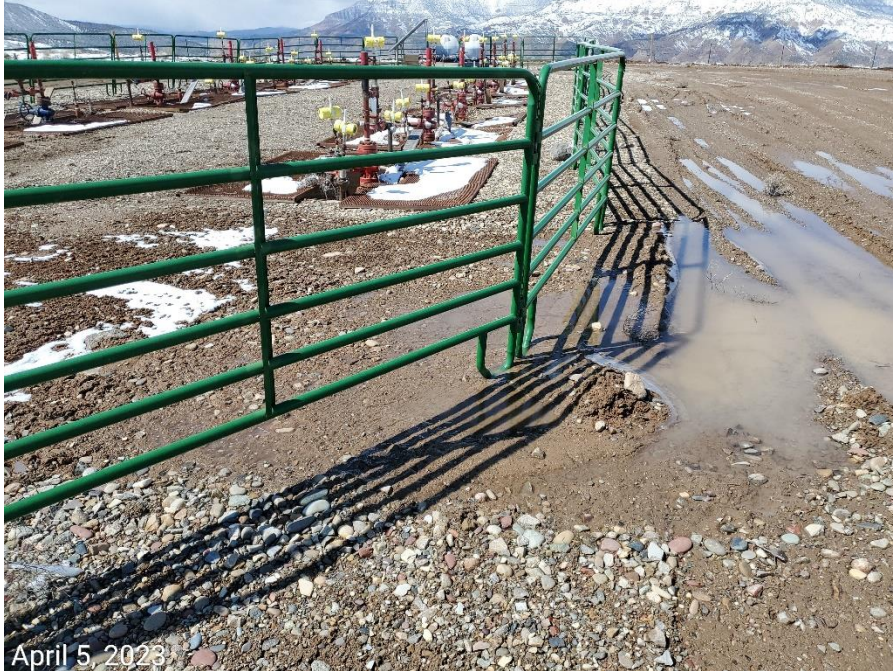
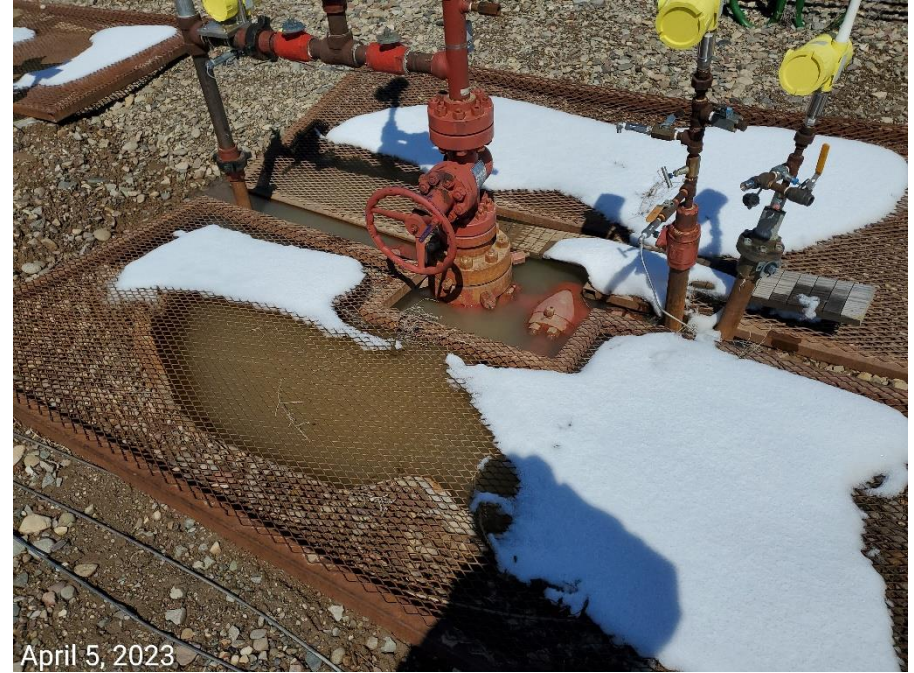
**Photo 3:** Photos taken from the wells. Unable to find evidence that stormwater BMPs to allow for proper stormwater discharge from the Location and/or BMPs to prevent potential pollution impacts due to contact with production equipment, has been installed or maintained; stormwater appears to have continued to fill cellars at the wells.

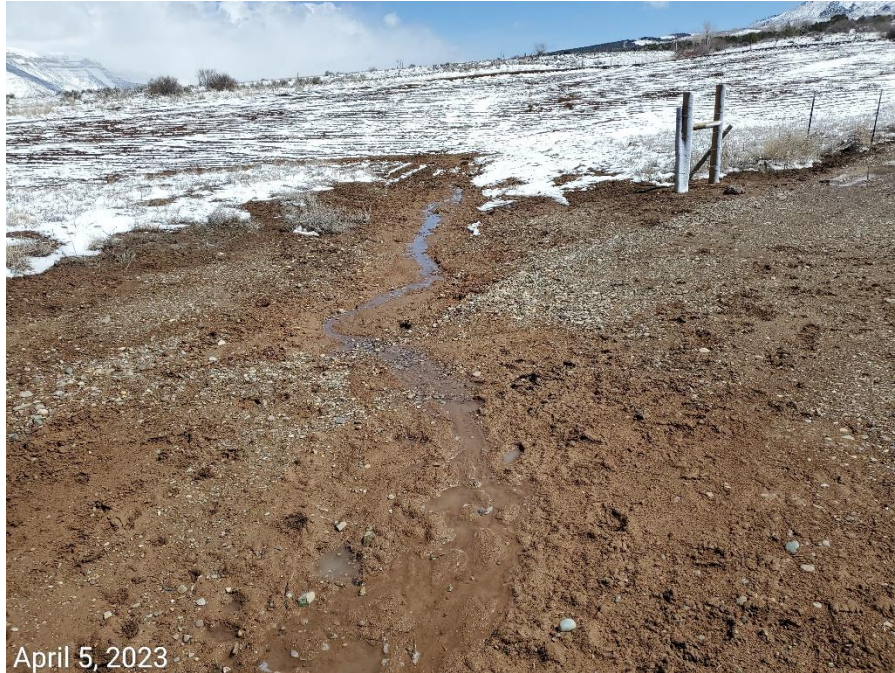
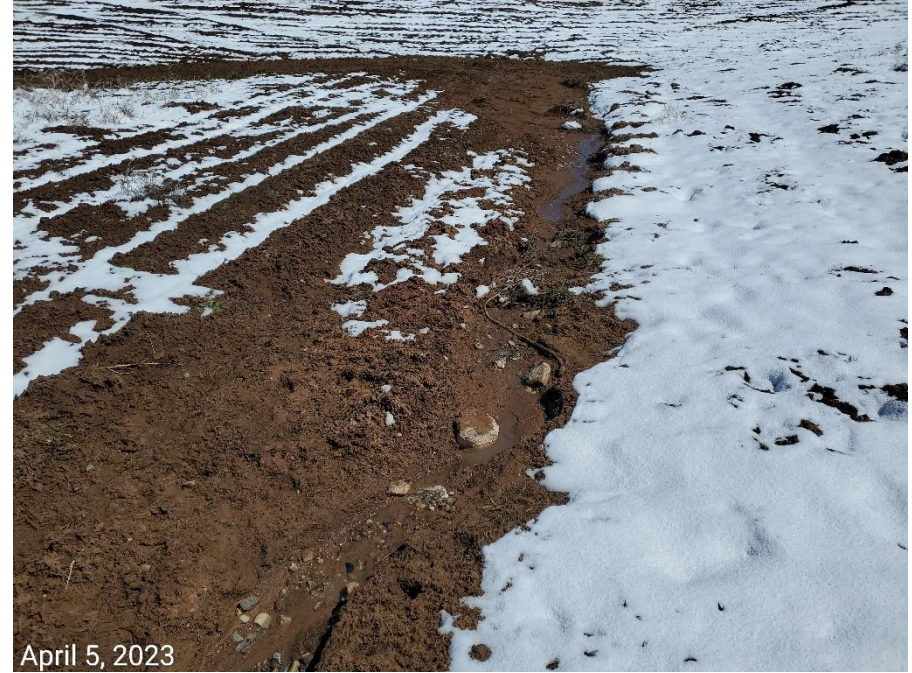
**Photo 4:** Photos 4-5 taken from the north end of the Location. Photos show Location has not been constructed with a properly engineered outlet; stormwater runoff from the current working pad has resulted in erosion degradation to the interim areas of the Location.

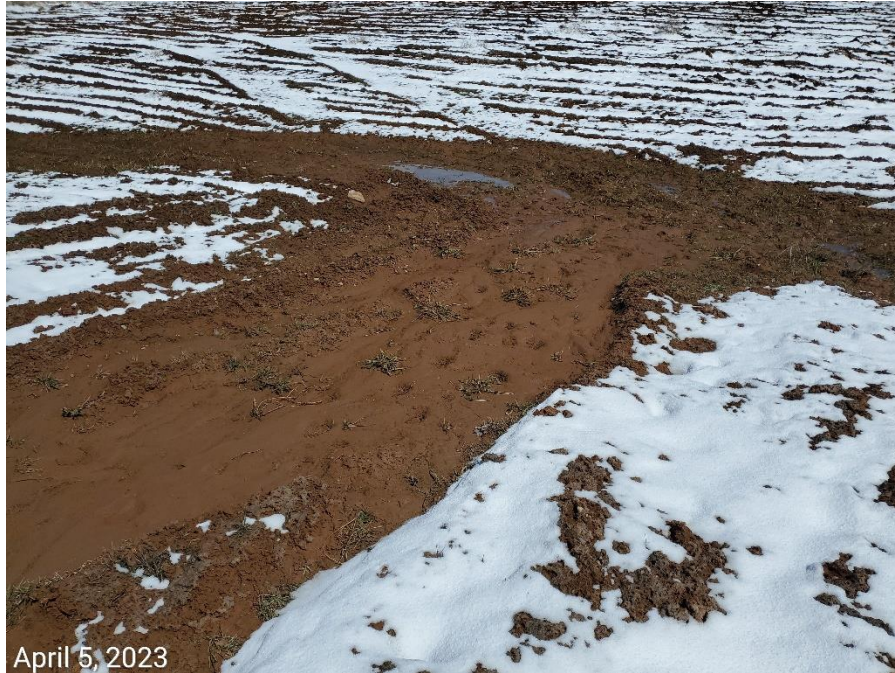
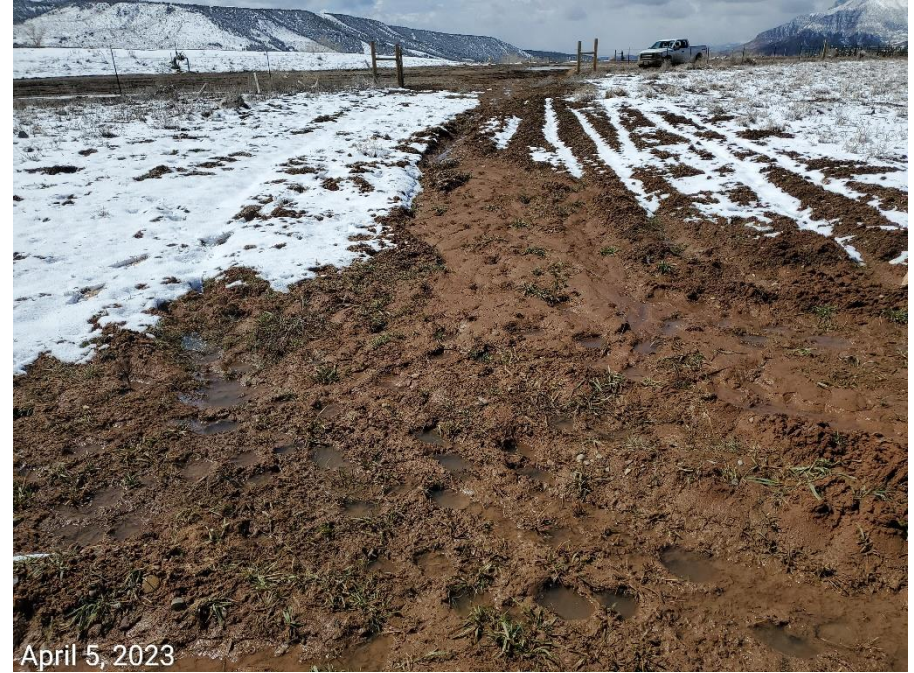
**Photo 5:** See comments under photo 4. Photos also show sediment deposition/degradation due to stormwater runoff from the working pad.
