Interim Reclamation and Stormwater Inspection

Location ID: 310566

Inspection Document #: 708200093

Inspection Photos
Location Name: Green 1-1
Location ID: 310566

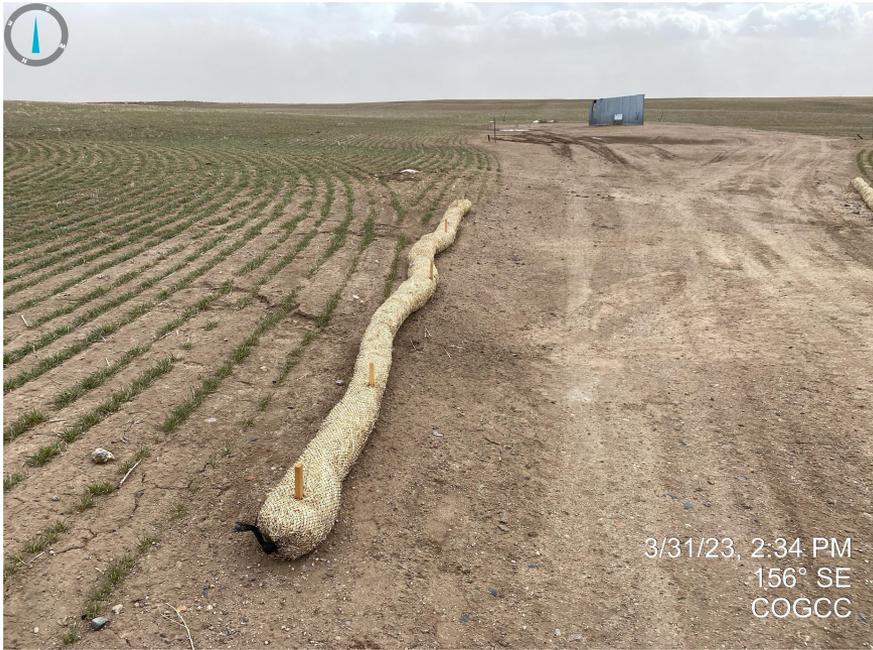
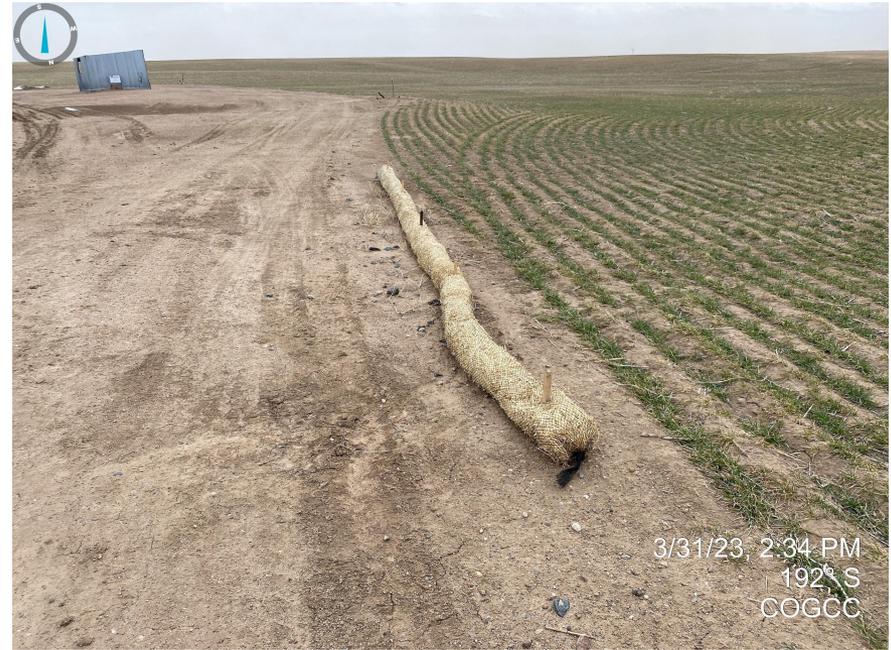
Photos 1 & 2. It appears the Operator has addressed the stormwater corrective action by installing straw wattles and backfilling rill erosion areas. However, it does not appear the BMPs were installed per good engineering practices as they were not trenched in.

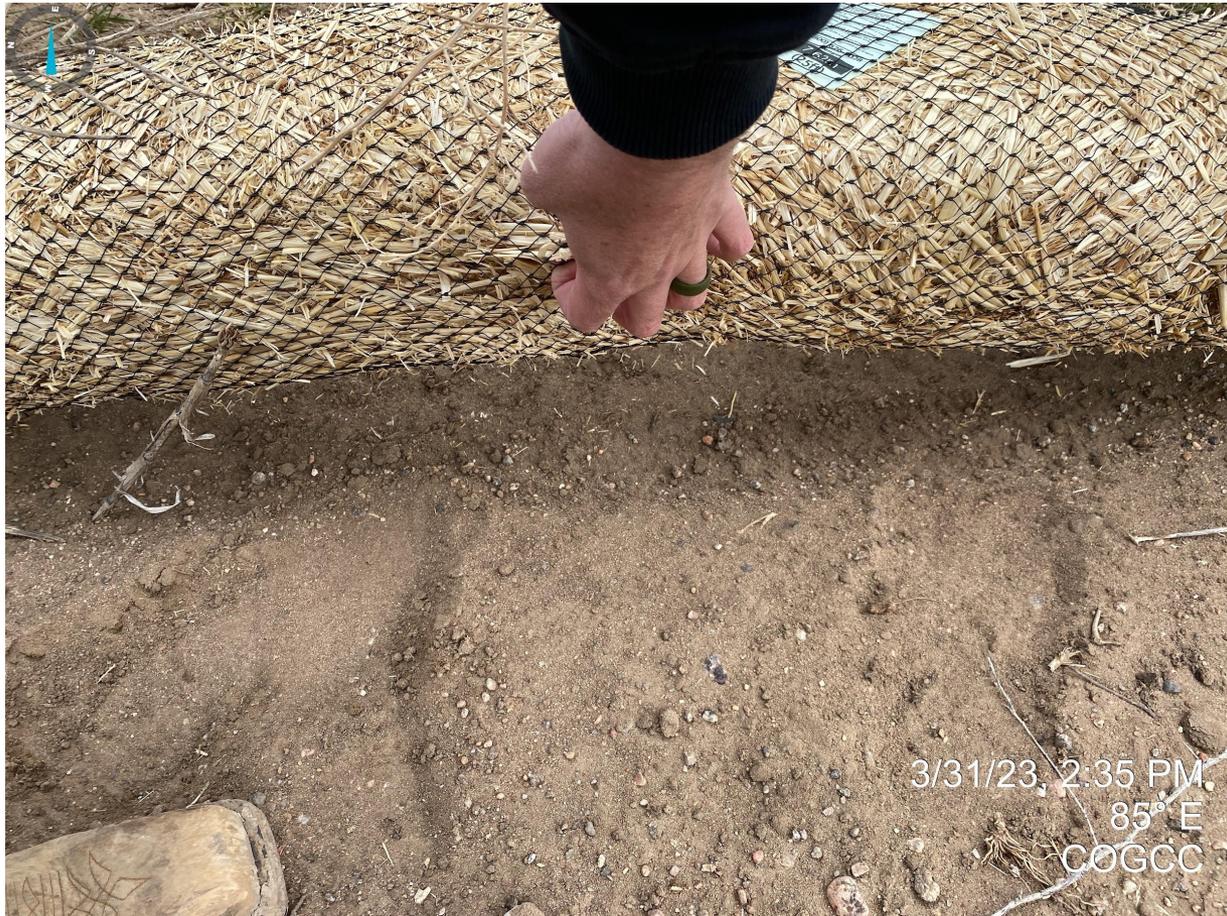
Photo 3. Close up photo illustrating that the straw wattles have not been trenched in per good engineering practices.

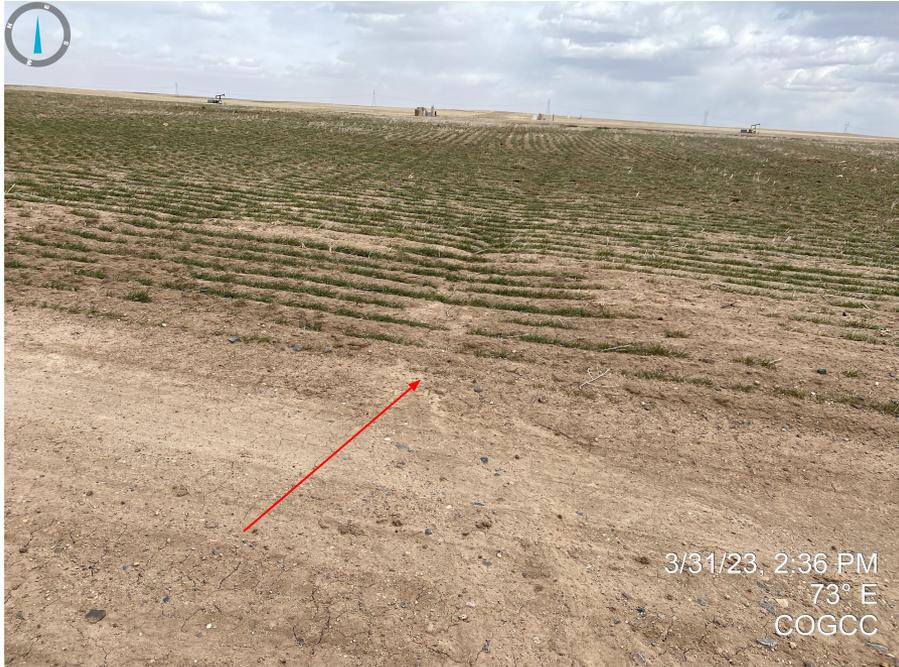
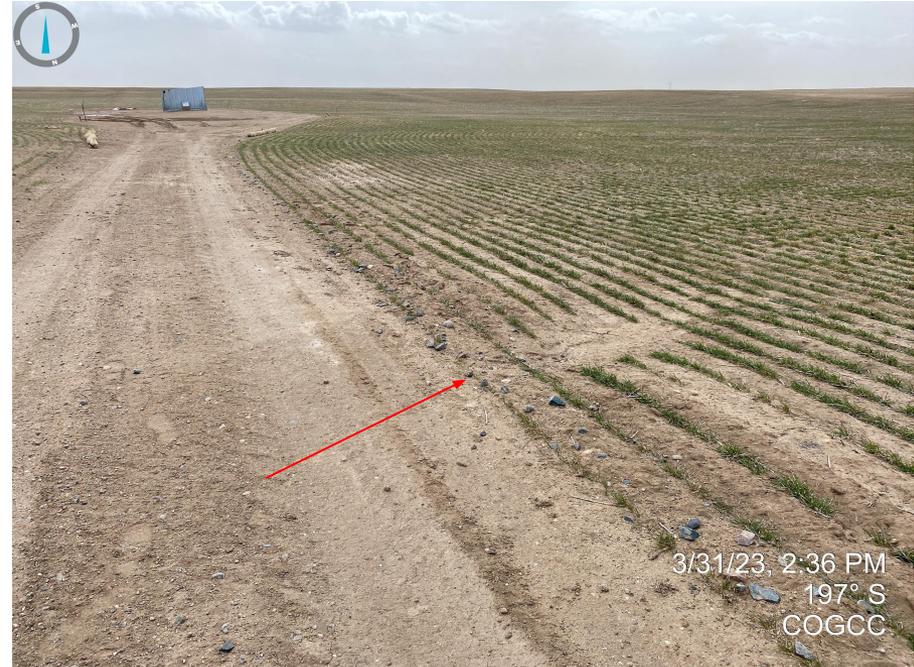
Photos 4 & 5. Rill erosion evident (red arrows) with no stormwater BMPs identified.

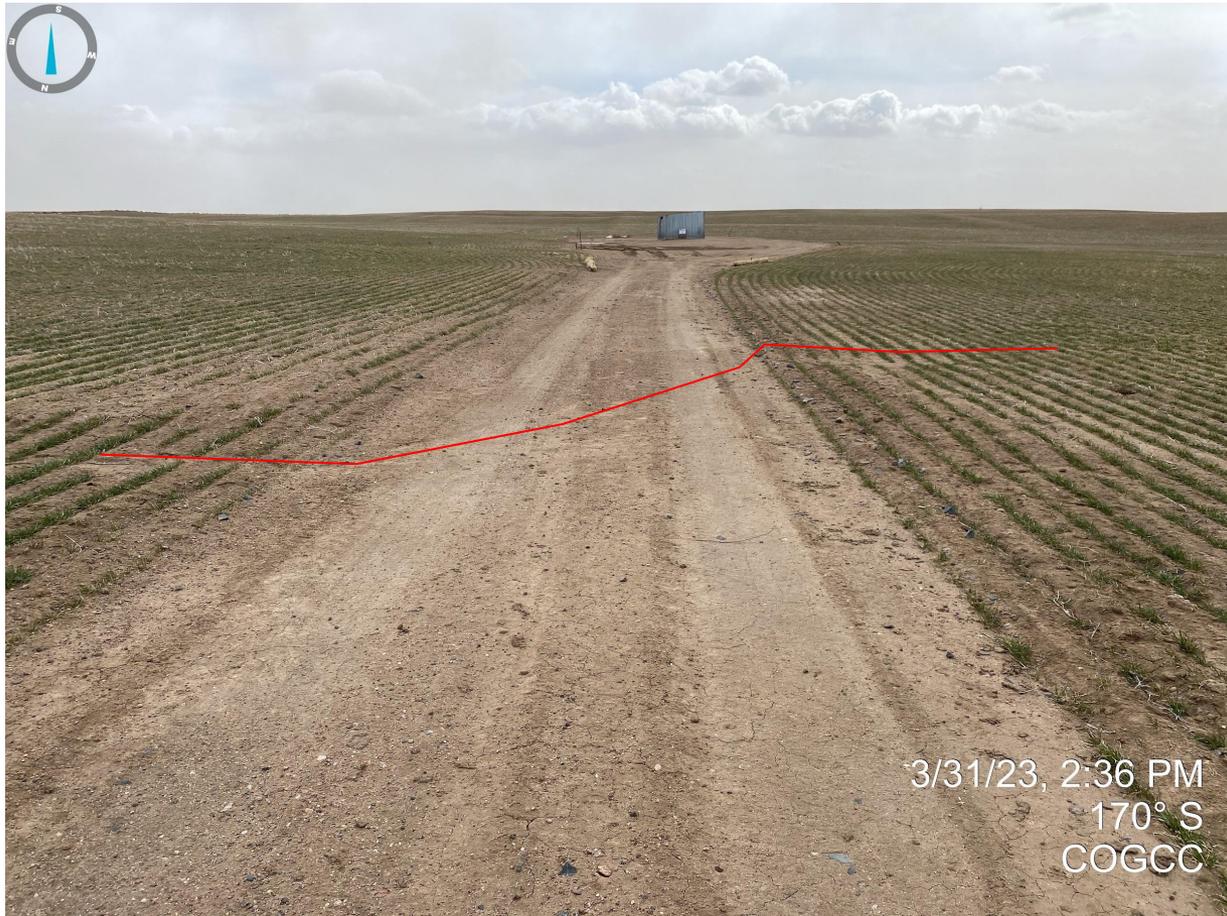
Photo 6. Overview illustrating rill erosion and path of stormwater. This area will need additional stormwater BMPs to prevent further erosion and degradation to adjacent lands.
