# Inspection Photos

API: 071-09178

Operator: EVERGREEN NATURAL RESOURCES

Inspection Date: 4/4/2023

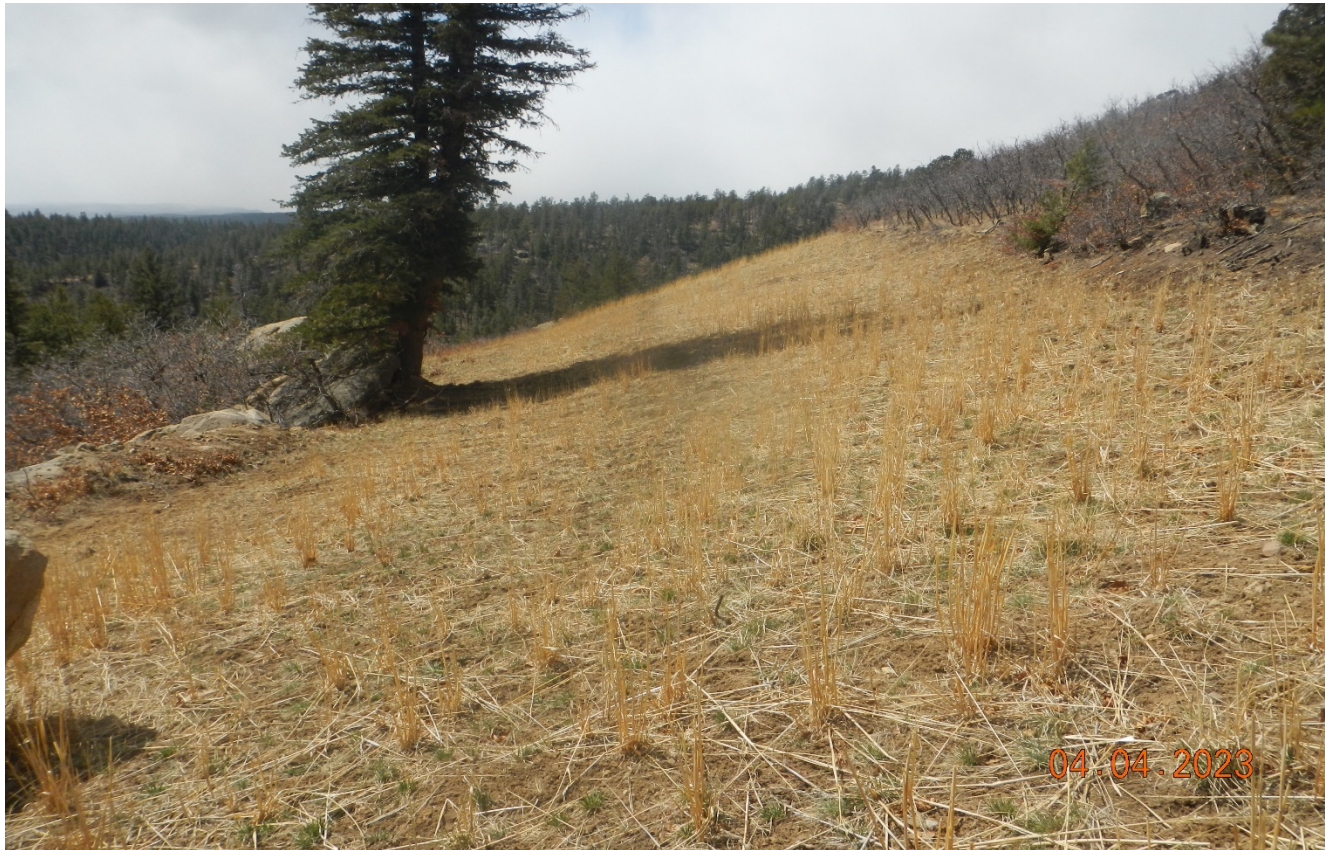
**Photo 1.** Facing southwest at the beginning of the reclaimed access road. The perennial vegetation appears to be establishing along the reclaimed road.

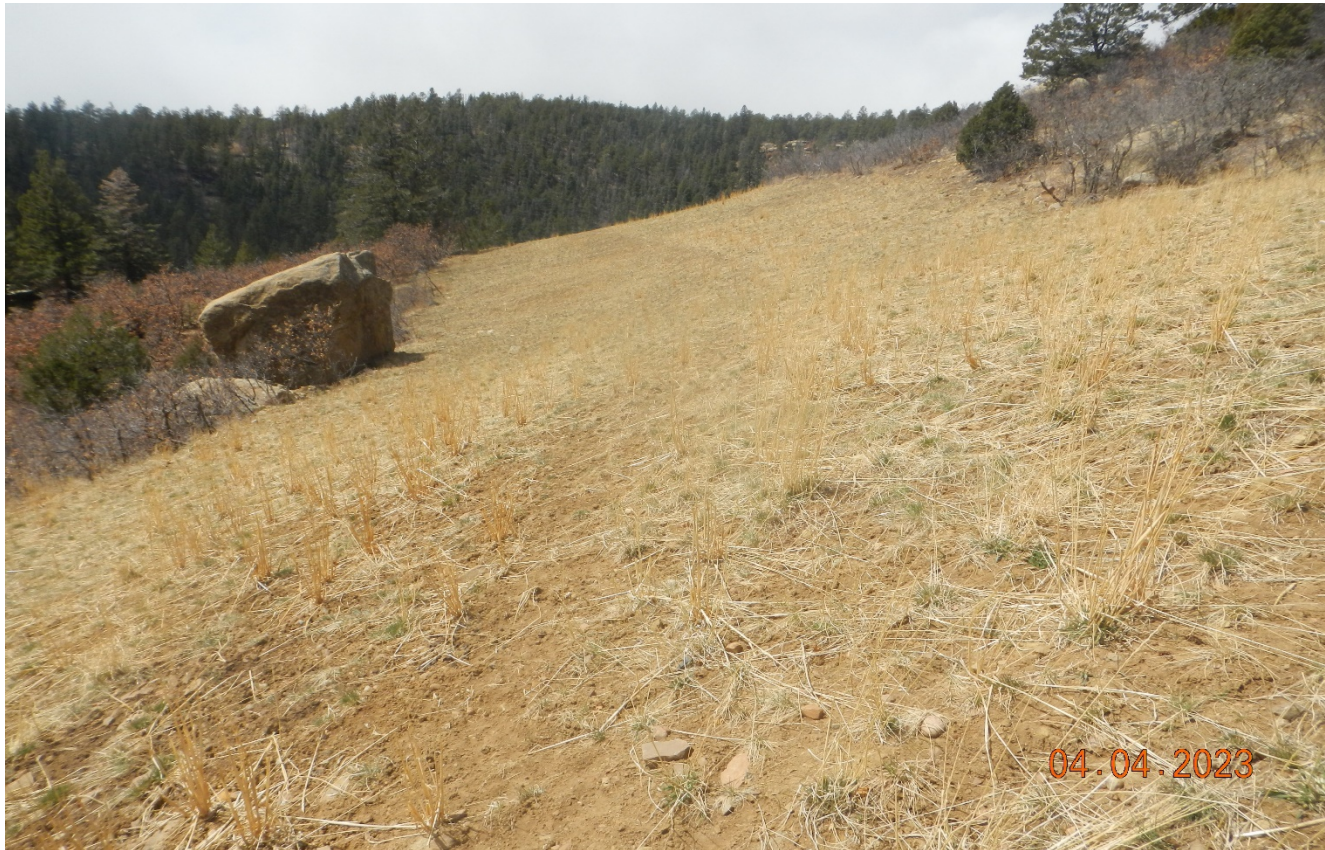
**Photo 2.** Facing southwest at the beginning of the reclaimed access road. The perennial vegetation appears to be establishing along the reclaimed road.

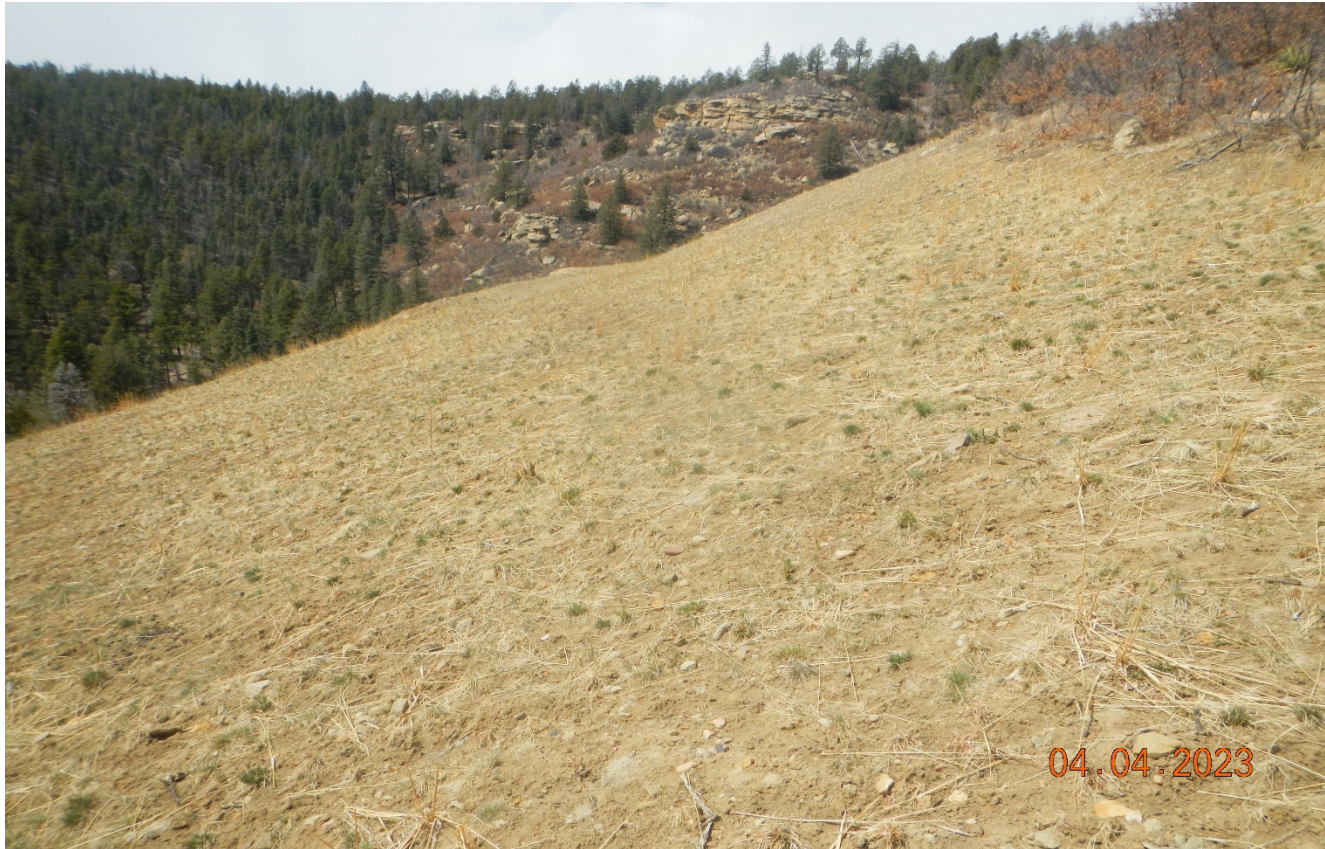
**Photo 3.** Facing west towards the location.

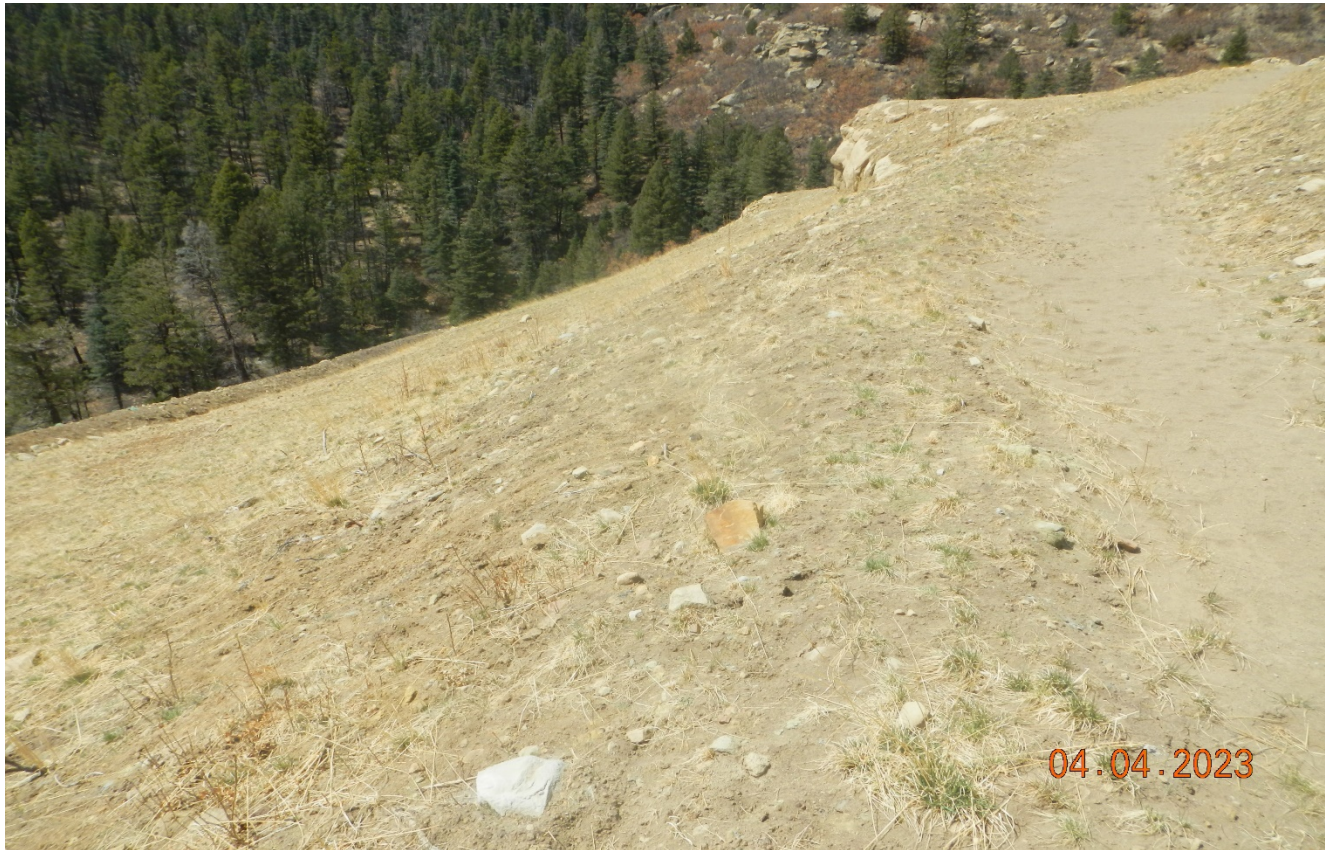
**Photo 4.** Facing southwest down to the lower portion of the location.

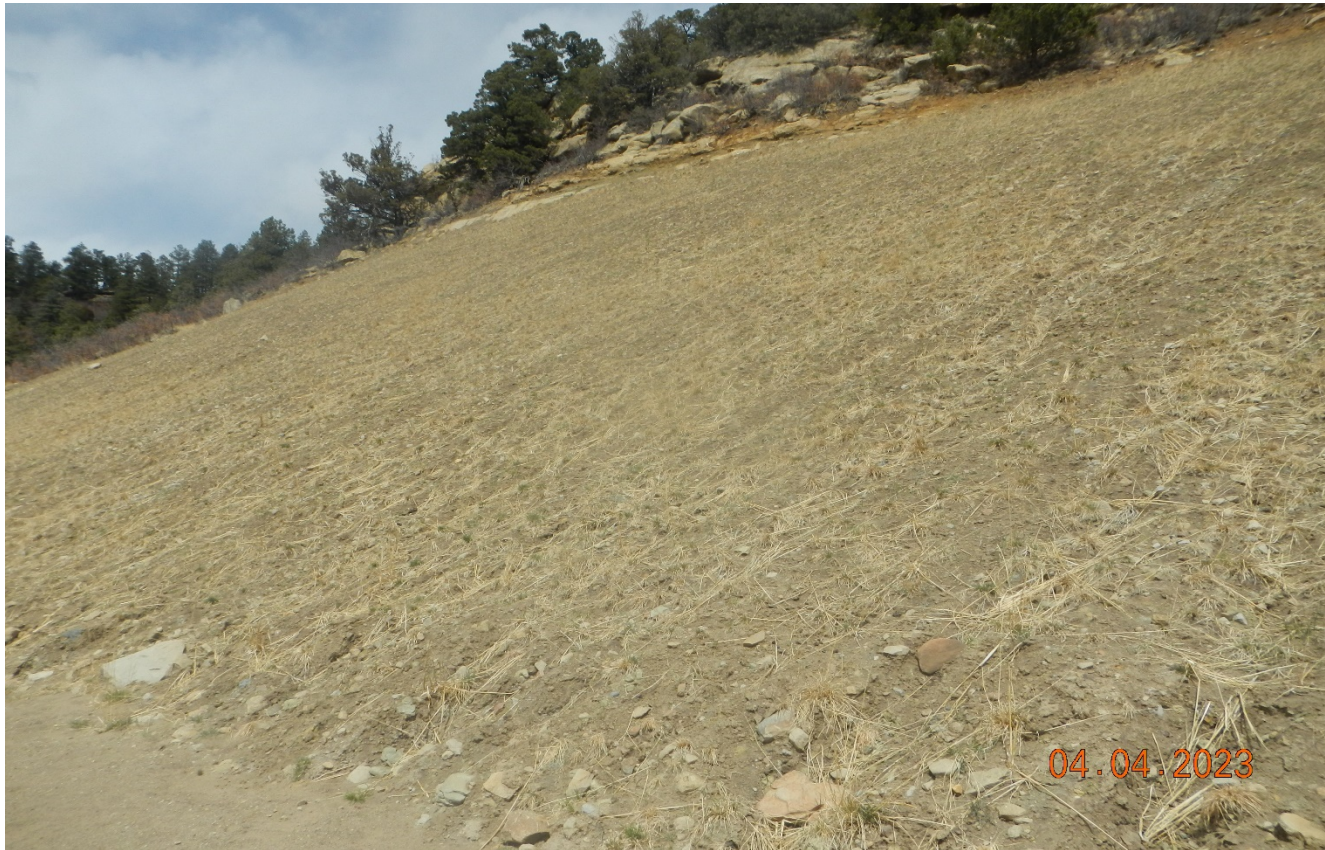
**Photo 5.** Facing northwest toward the upper portion of the location.

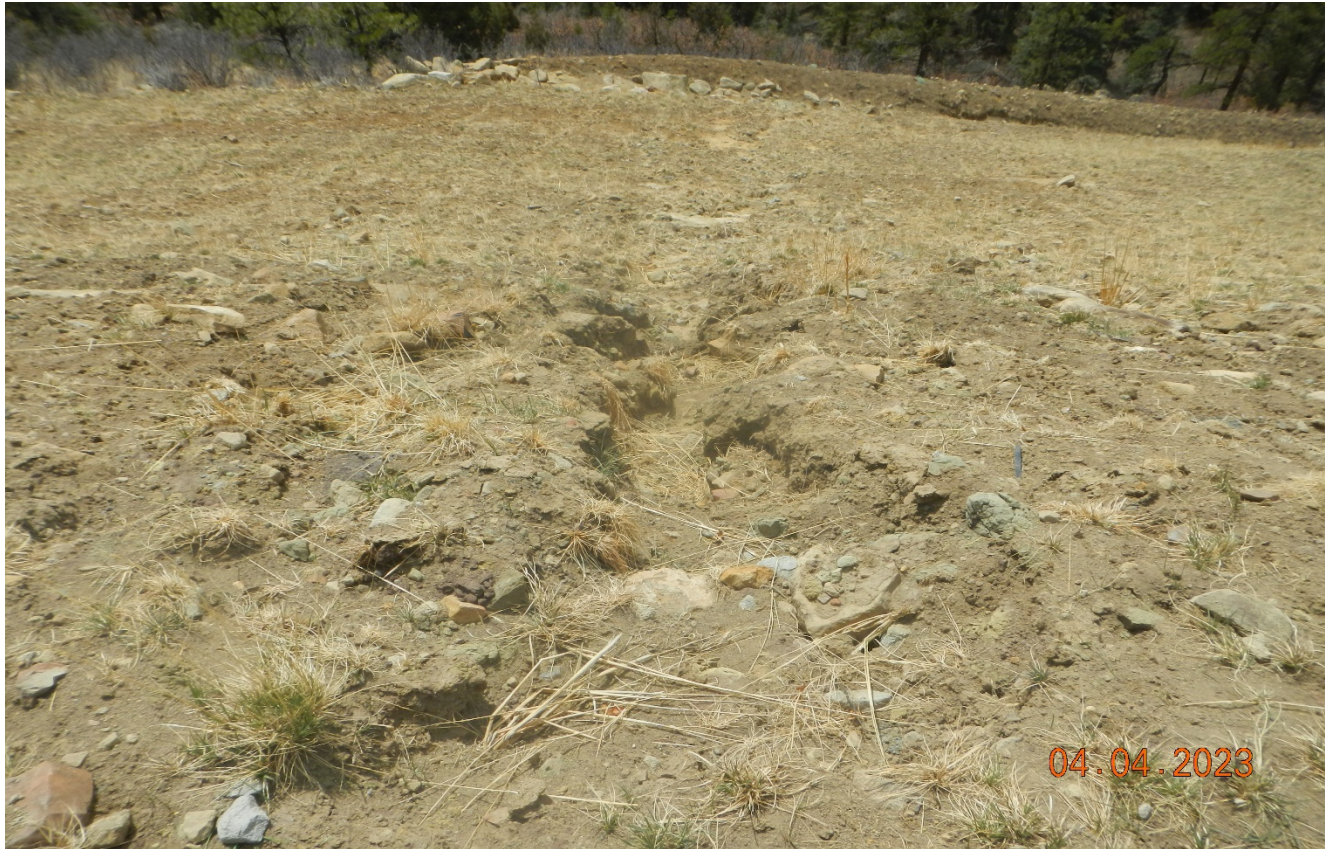
**Photo 6.** There are some areas of erosion that should be repaired with BMP's to control further erosion.

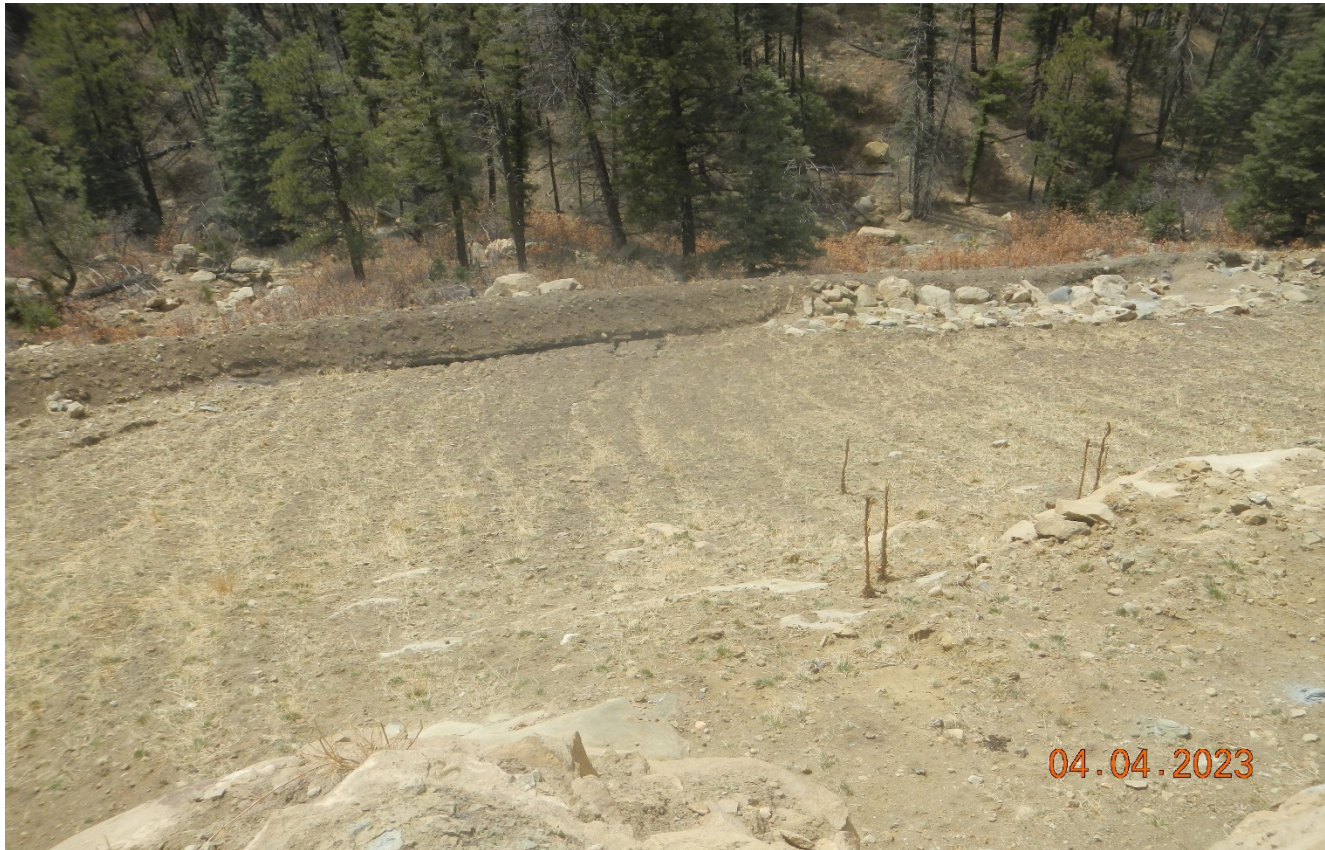
**Photo 7.** Facing down toward the bottom of the location. The berm at the bottom appears to need some maintenance due to erosion.

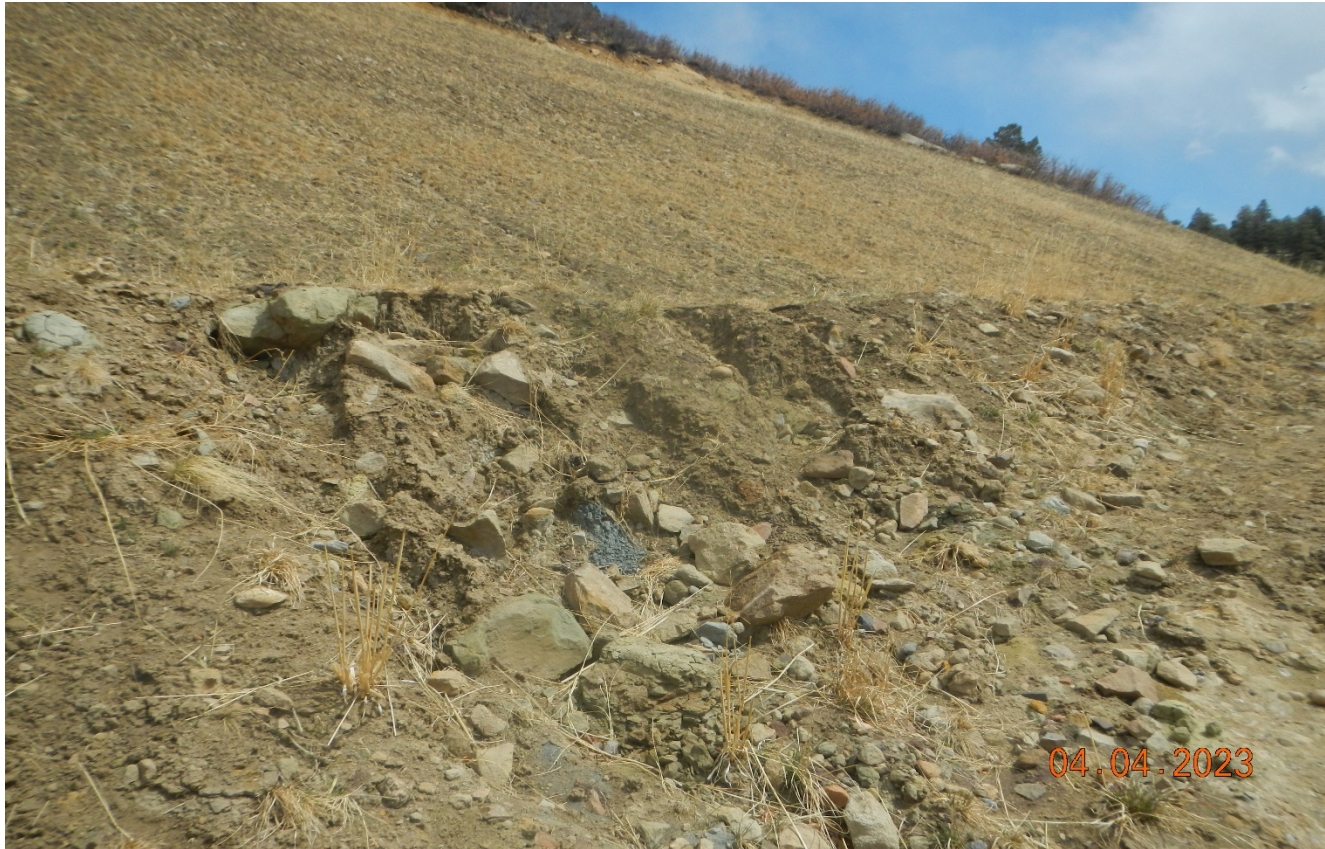
**Photo 8.** Facing northeast at west side of the location. There are some areas of erosion that should be repaired with BMP's to control further erosion.

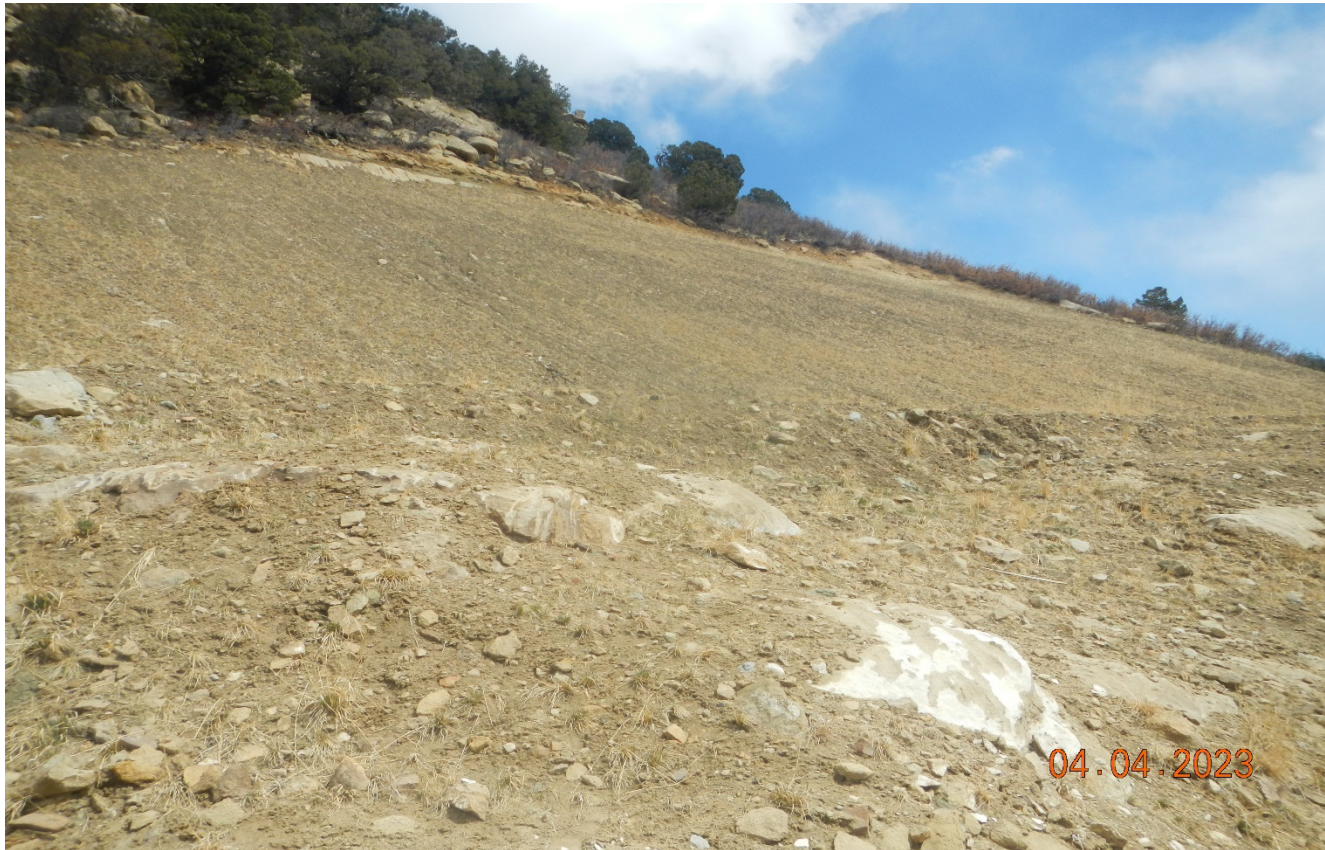
**Photo 9.** Facing northwest toward the recontoured location. The perennial vegetation appears to be establishing but will need to be monitored to ensure vegetation fully establishes.
