Stormwater Inspection

Operator: CCRP OPERATING INC - #10665

Inspection Document #: 697504593

Location Name: Wagner #11-65 11-1H

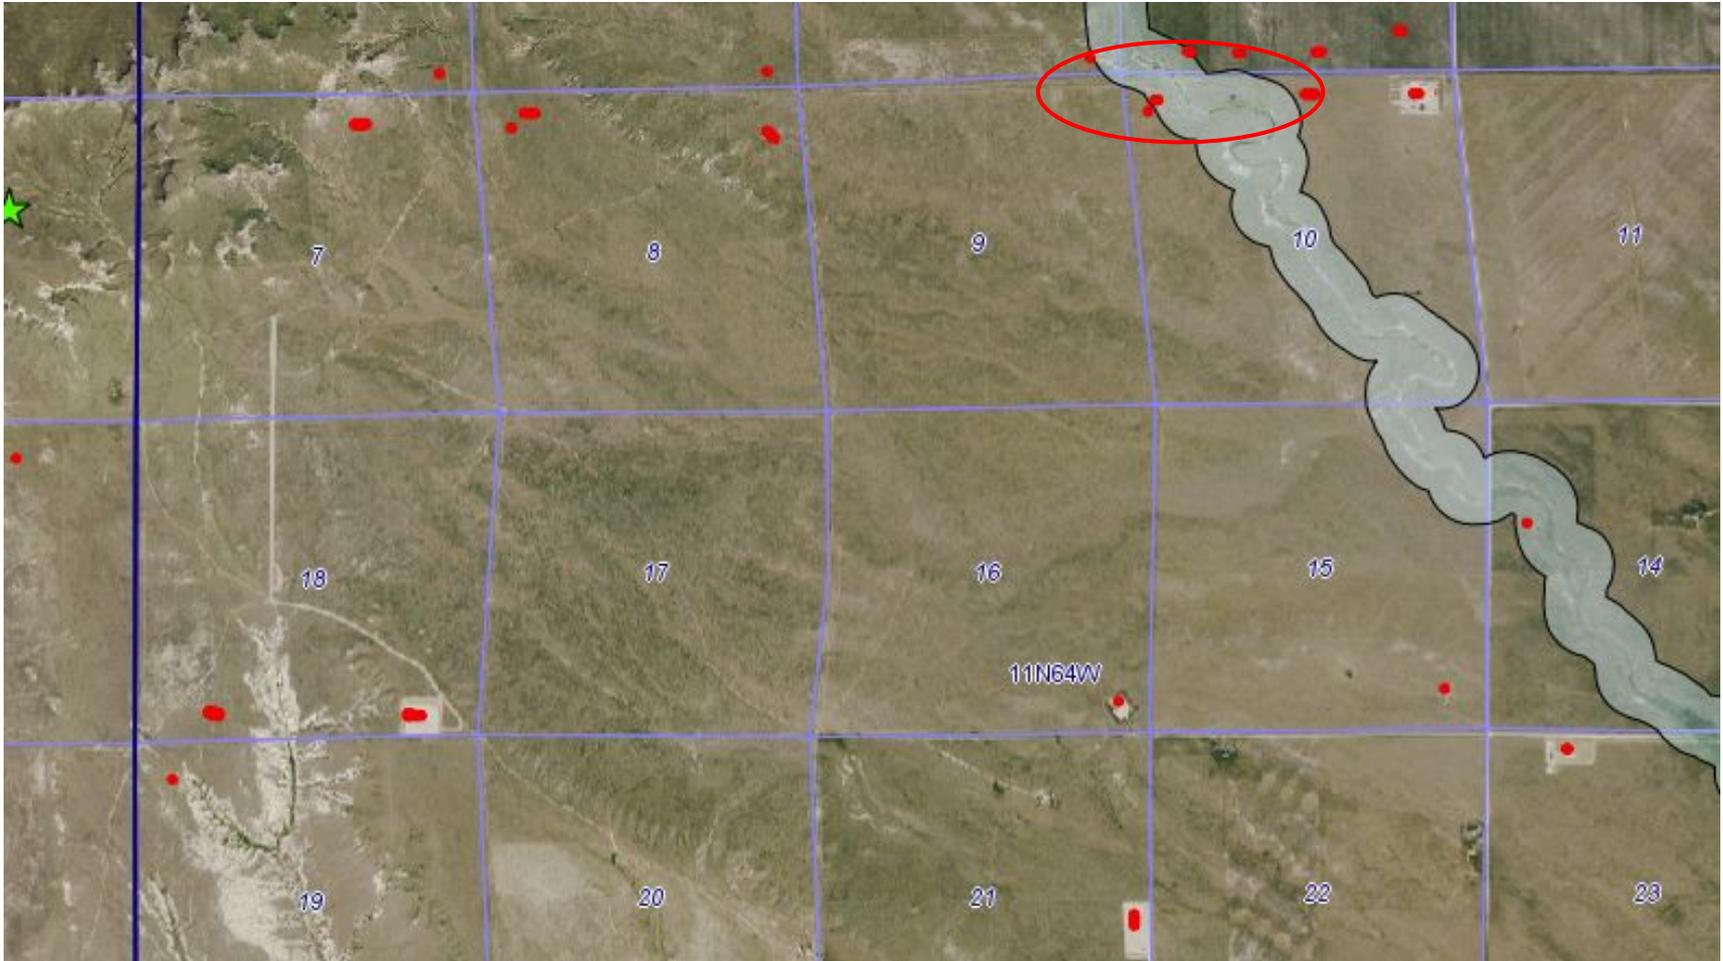
Photo 1. Photo illustrates a portion of the access road crosses a High Priority Habitat (Aquatic Native Species Conservation Waters) at Gearly Creek. Operator has failed to prevent sediment discharge into Gearly Creek- refer to the photos 2.

Note- this is a shared access road with Upland Exploration.

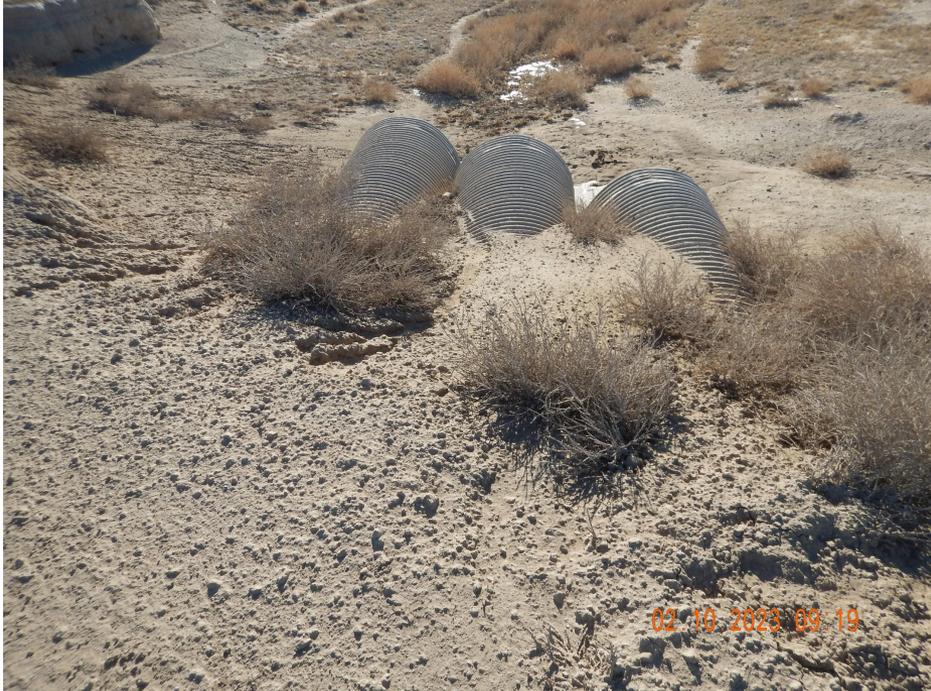
Photo 2. Photo taken from intersection of the access road and Geary Creek, facing South. Photo illustrates sediment discharge into Geary Creek without stormwater BMPs.

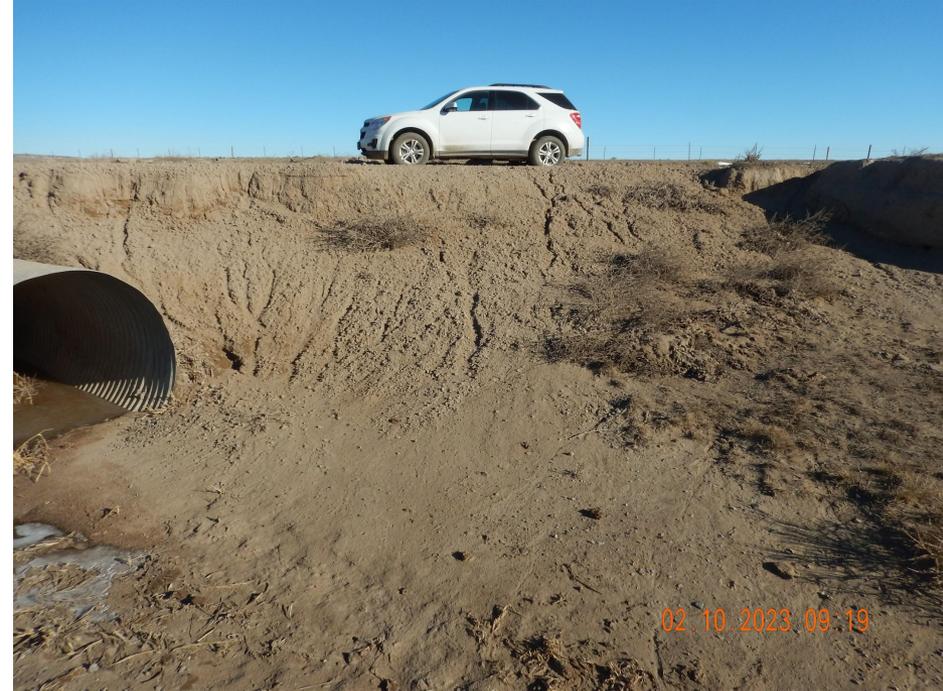
Photo 3. Photo taken from Geary Creek, facing North. See comments under Photo 2.

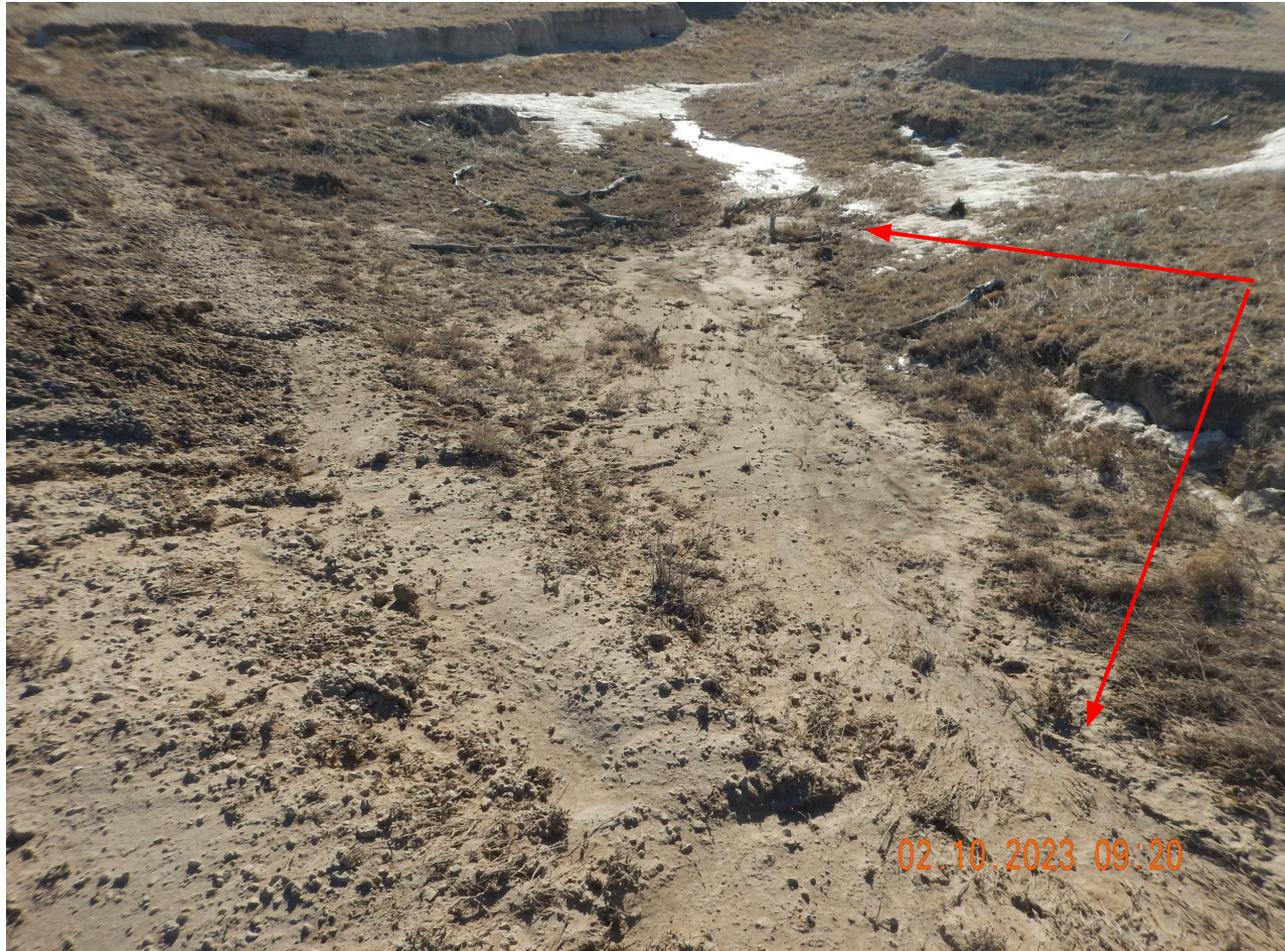
Photo 4. Photo taken from Geary Creek, facing South. Photo illustrates sediment discharge into Geary Creek.
