# Interim Reclamation and Stormwater Inspection

Operator: UPLAND EXPLORATION LLC- #10701

Location ID: 462919

**Inspection Photos**  
**Location Name: Little Lady 21/South Well Pad**  
**Location ID: 462919**

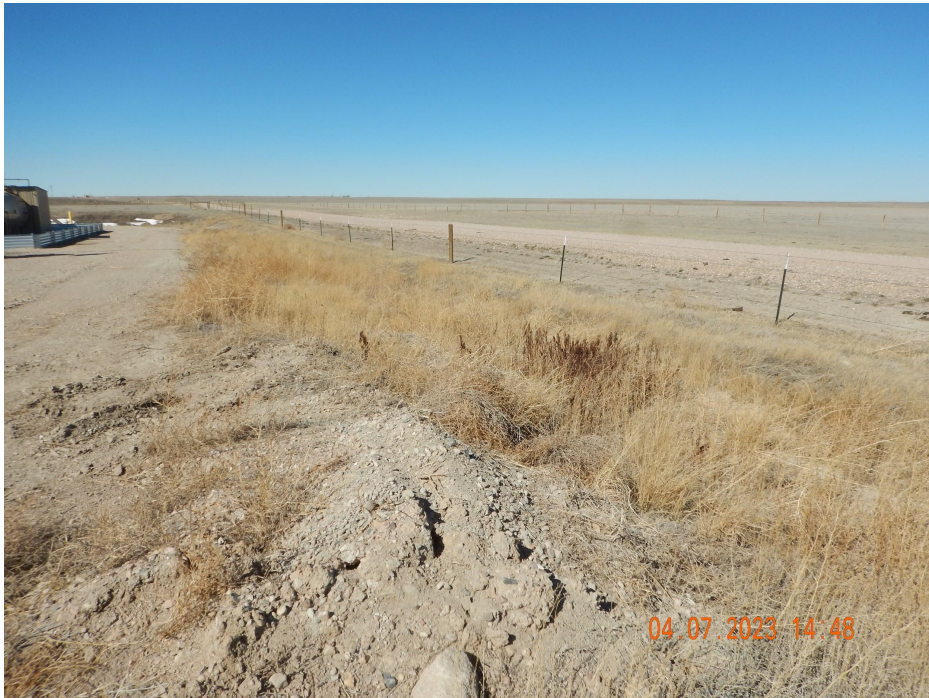
**Photo 1.** Photo taken from the eastern location, facing Northeast. Photo illustrates all unused equipment has been removed.

Note- weeds were observed along the eastern perimeter of location, which still need to be addressed. Also, interim reclamation remains out of compliance.

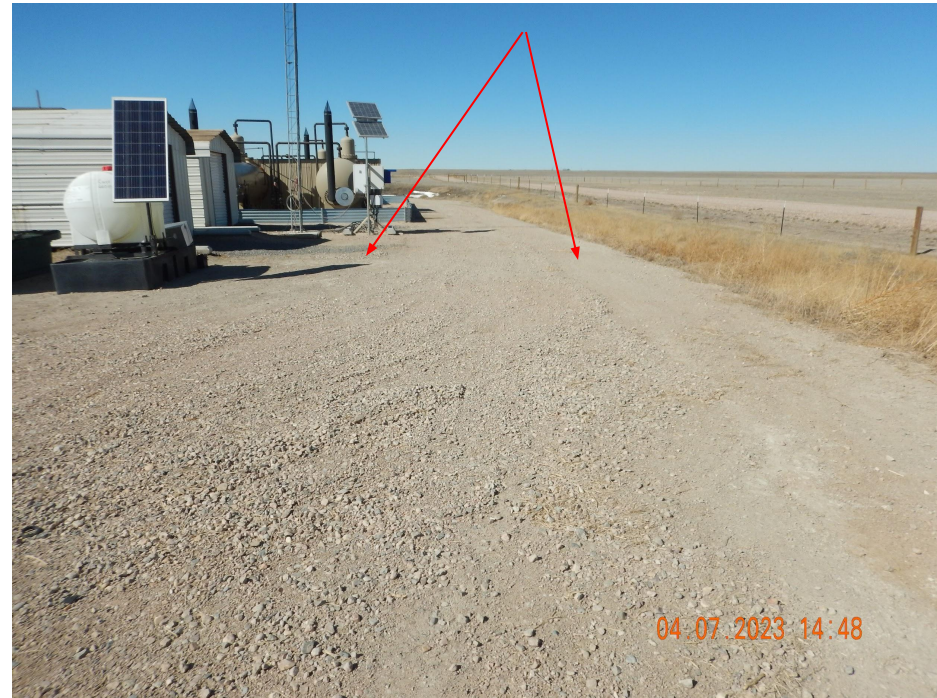
**Photo 2.** Photo taken from the eastern location, facing North. Photo illustrates a spill from non-E&P exempt waste previously believed to be from a Mobil Pegasus SAE 40 container but was related to the compressor has been cleaned up.

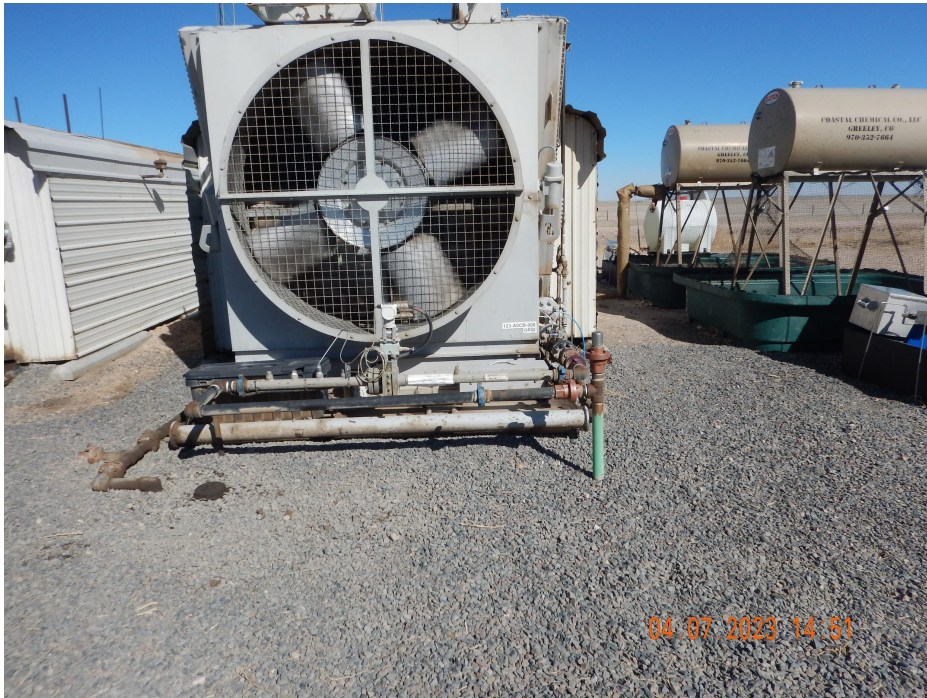
**Photo 3.** Photo taken from the eastern location, facing East. Photo illustrates stained soil/spill related to the compressor has been cleaned up and additional gravel imported.

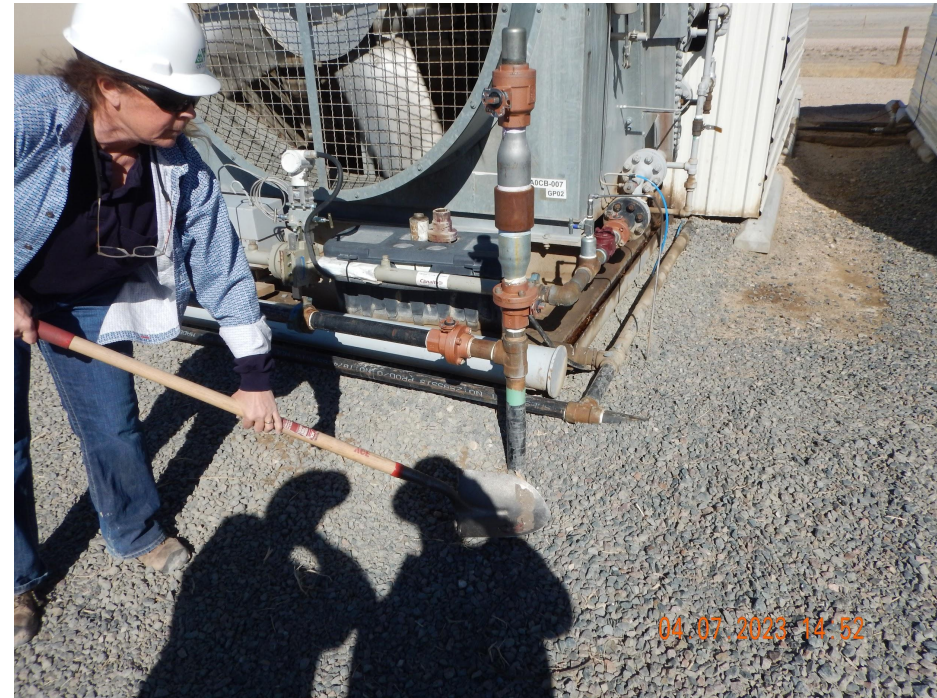
**Photo 4.** Photo taken from the eastern location, facing East. Photo illustrates COGCC staff checking to ensure stained soil/spill was cleaned up.

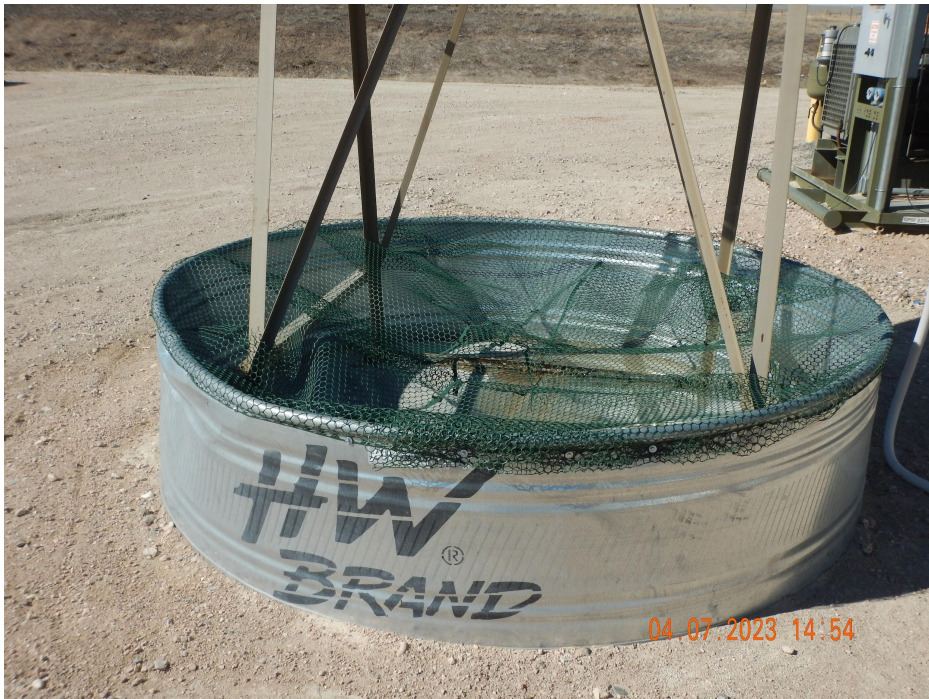
**Photo 5.** Photo taken from the eastern location, facing North.  
Photo illustrates netting has been repaired.

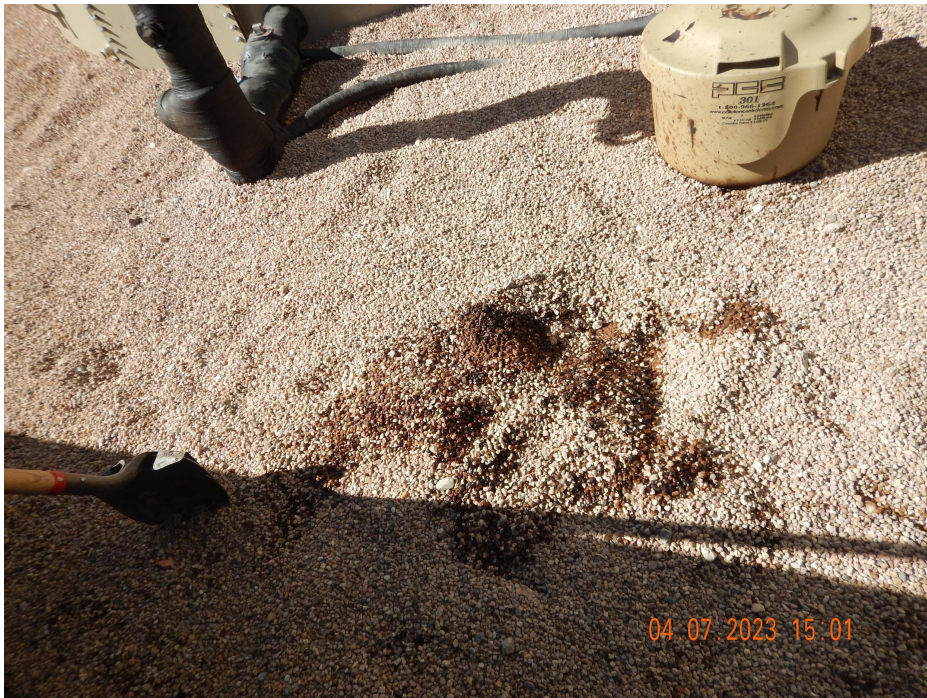
**Photo 7.** Photo taken from within the secondary containment, illustrating oily waste. Remove and properly dispose fluids from within the secondary containment.

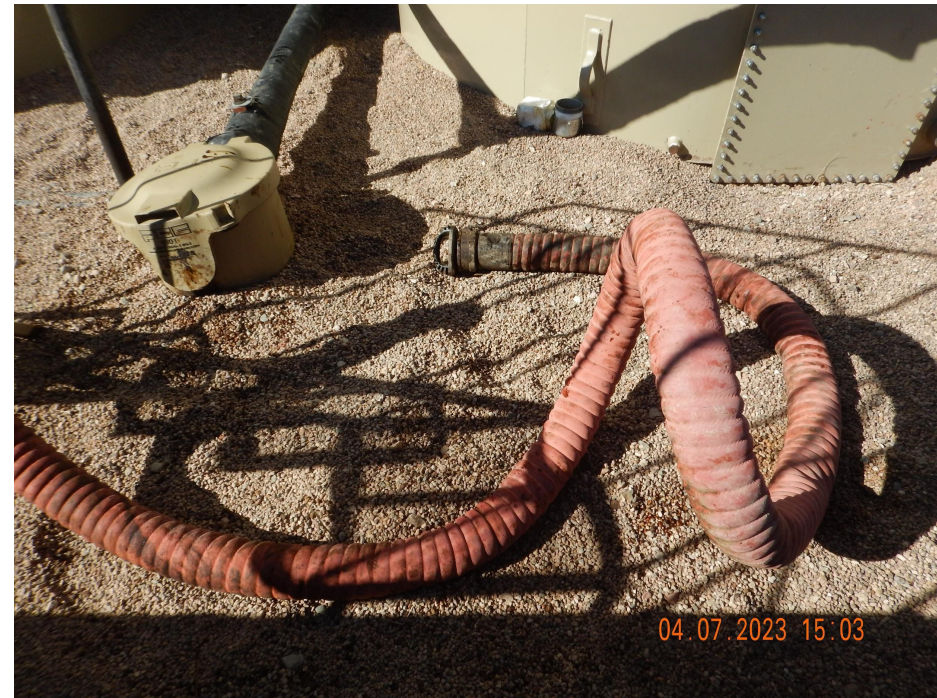
**Photo 8.** Photo taken from within the secondary containment, illustrating a hose being stored within secondary containment. COGCC staff communicated that this is considered unused equipment and needs to be removed.
