Interim Reclamation and Stormwater Inspection

Operator: EDGE ENERGY II LLC- #10671

Location ID: 456286

Inspection Photos
Location Name: Deporter /29-A Pad
Location ID: 456286

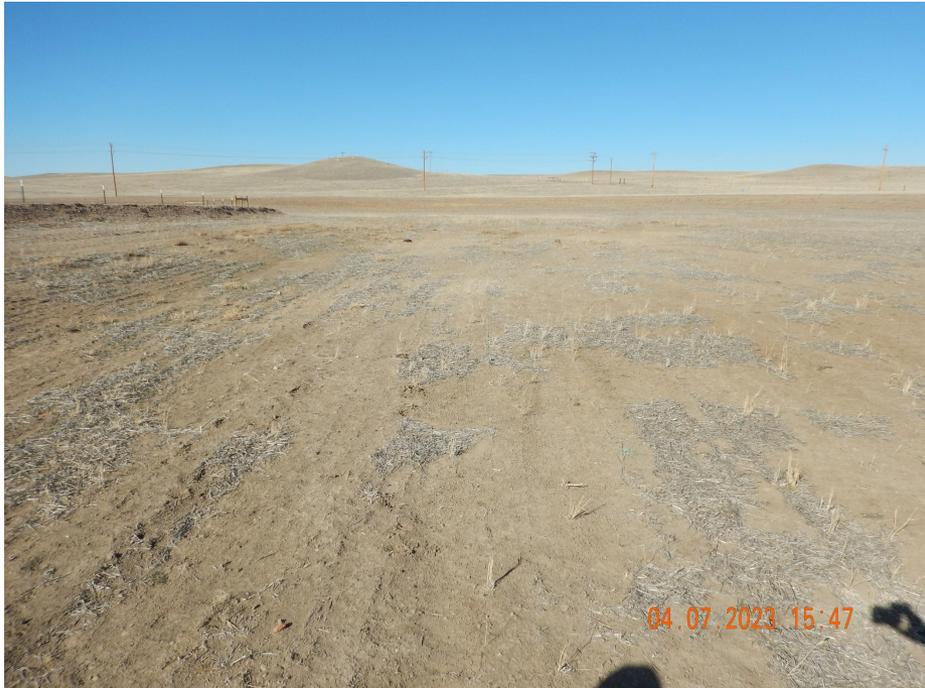
Photo 1. Photo taken along a portion of the southern interim reclamation area, facing North. Photo illustrates Cereal rye that appears to have gone to seed throughout the eastern and southern interim reclamation areas. Operator indicated that additional seeding would be performed within the next week.

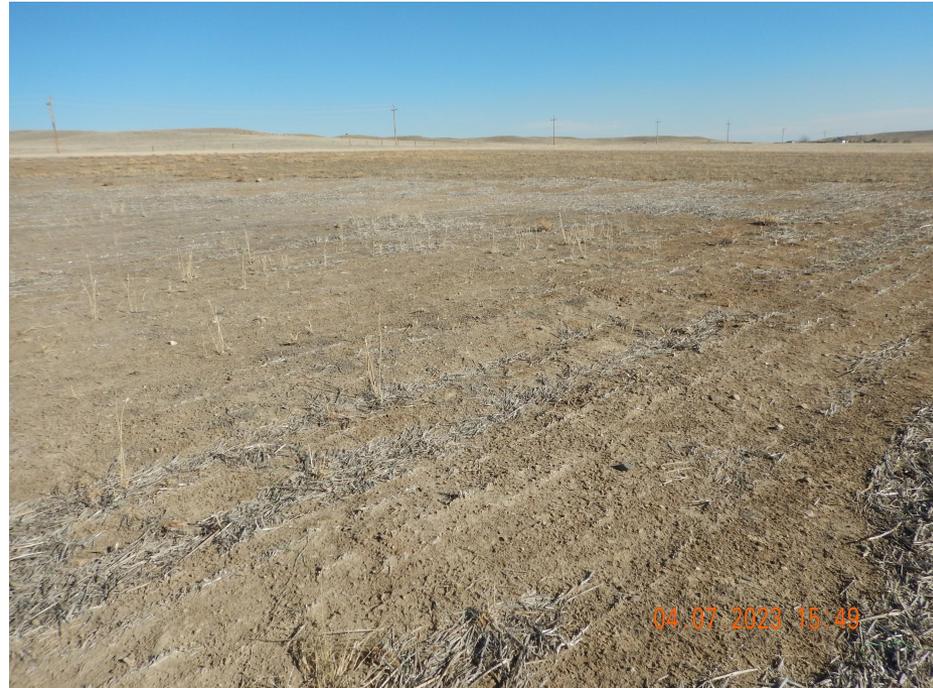
Photo 2. Photo taken from the central interim reclamation area, facing Southeast. See comments under Photo 1.

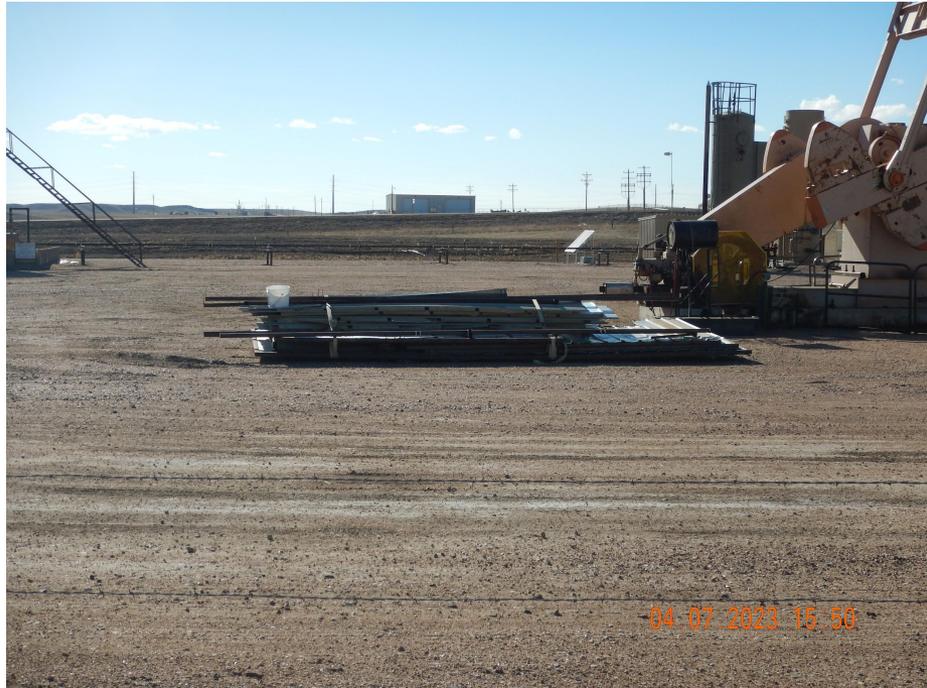
Photo 3. Photo taken from the well location, facing West. During an inspection with the Operator on 4/12/23, it was stated that this would be equipment used to build a shed.

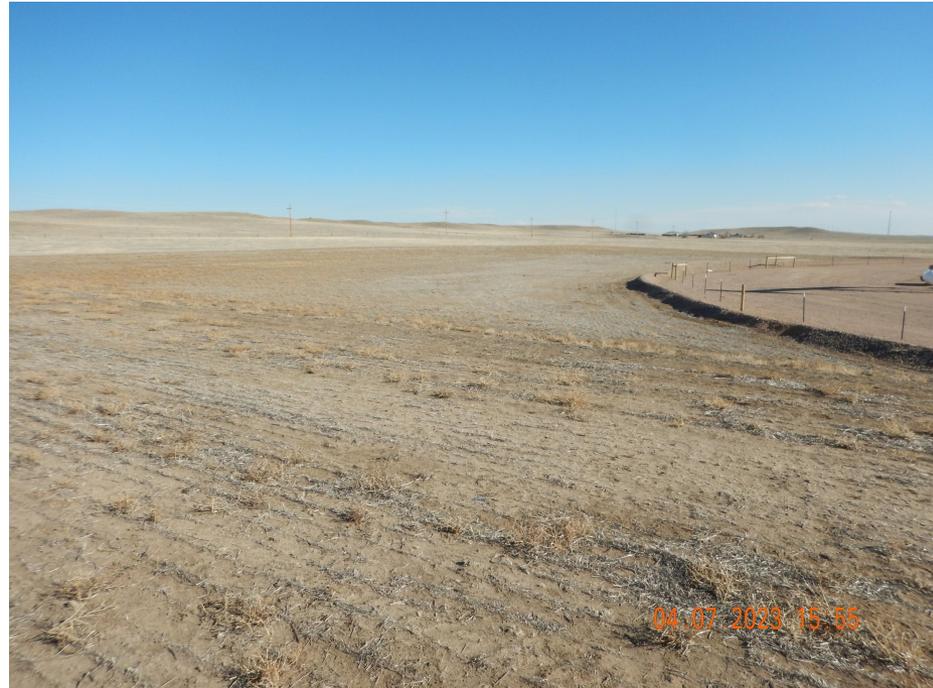
Photo 4. Photo taken from the northern interim reclamation area, facing Southeast. There did not appear to be any establishment of Cereal rye along the northern perimeter.

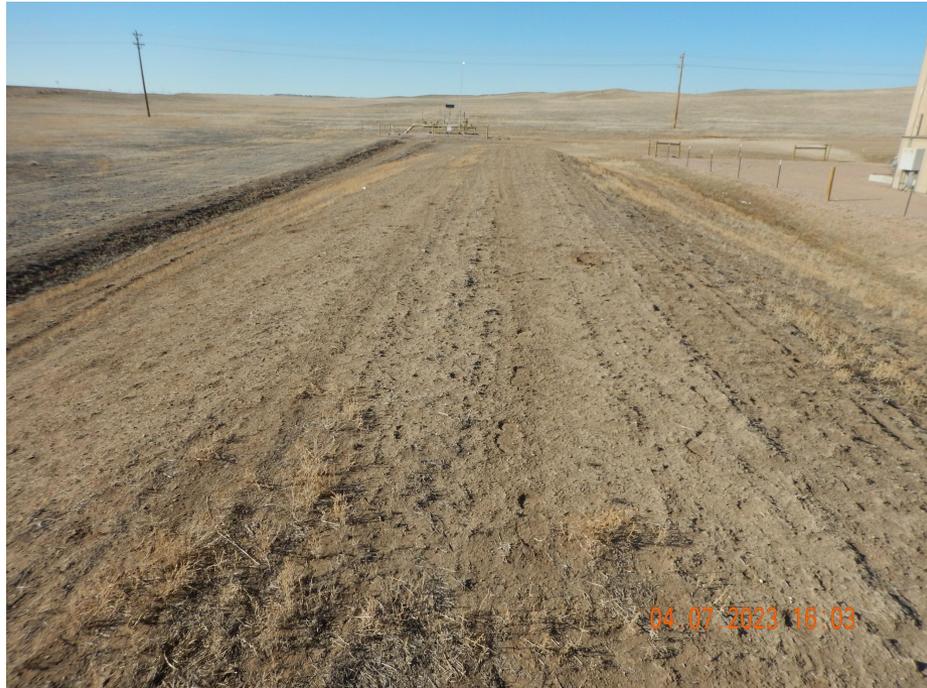
Photo 5. Photo taken from the western topsoil stockpile, facing North. Photo illustrates the lack of stabilization and prevention of weed establishment. See comments under Photo 1.

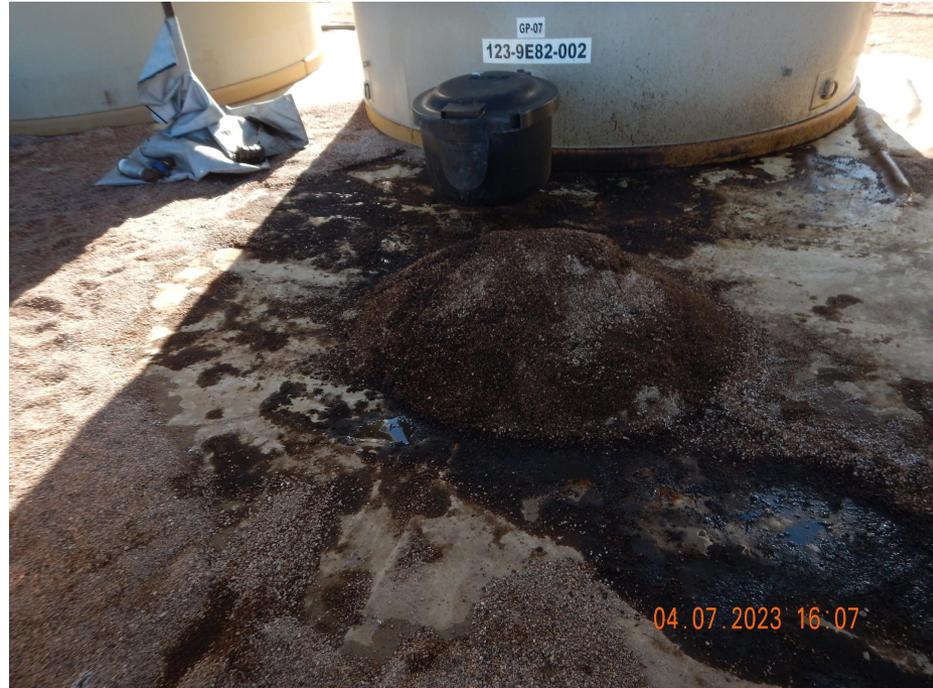
Photo 6. Photo taken from within the secondary containment of oily waste that needs to be removed and properly disposed of.
