Inspection Photos

Operator: GORDON ENGINEERING INC -
34720

Location #334074
Mesa County, CO

Aaron Trujillo
NW Reclamation Specialist
COGCC

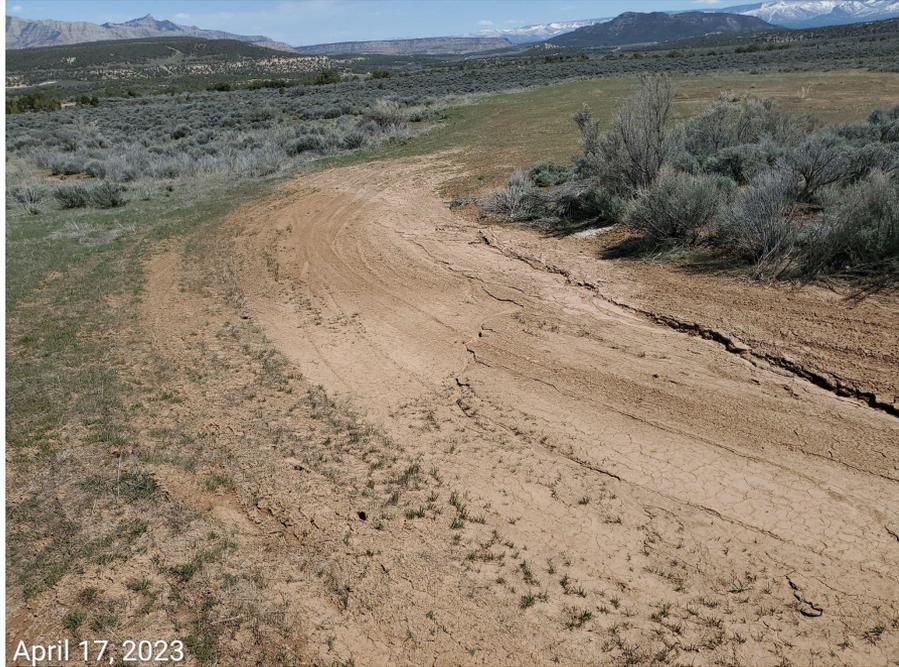
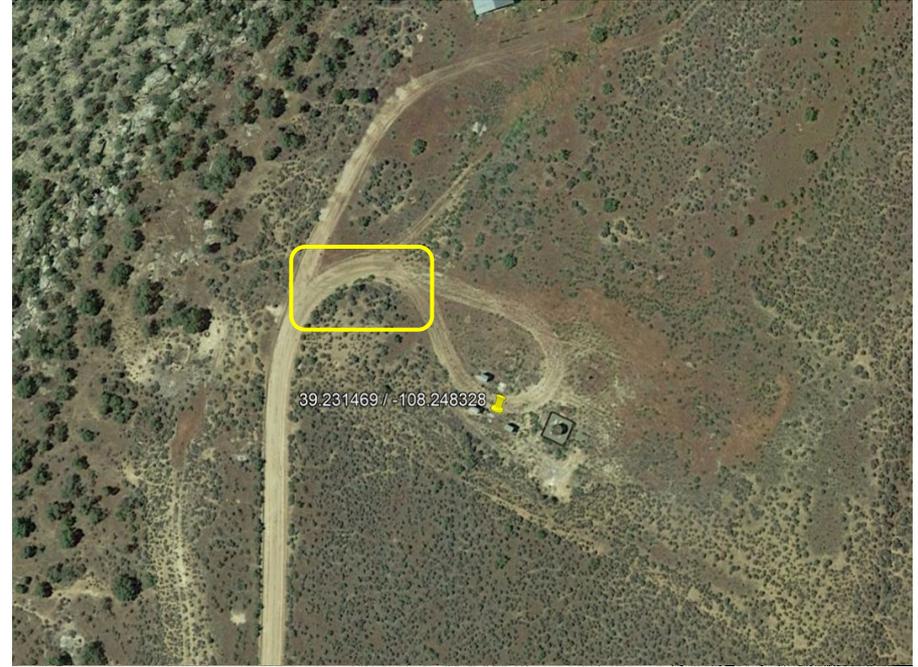
Photo 1: Photo taken from the access road. Photo shows section of access road identified in previous inspections as requiring reclamation. Photos show reclamation work including, but not limited to, compaction alleviation, recontouring/regrading and seeding have not been performed.

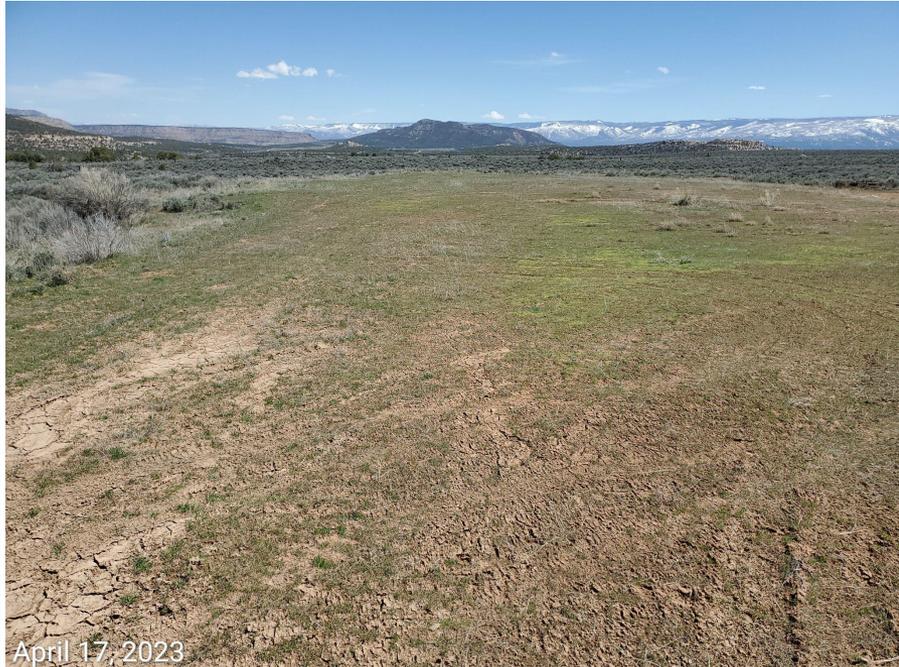
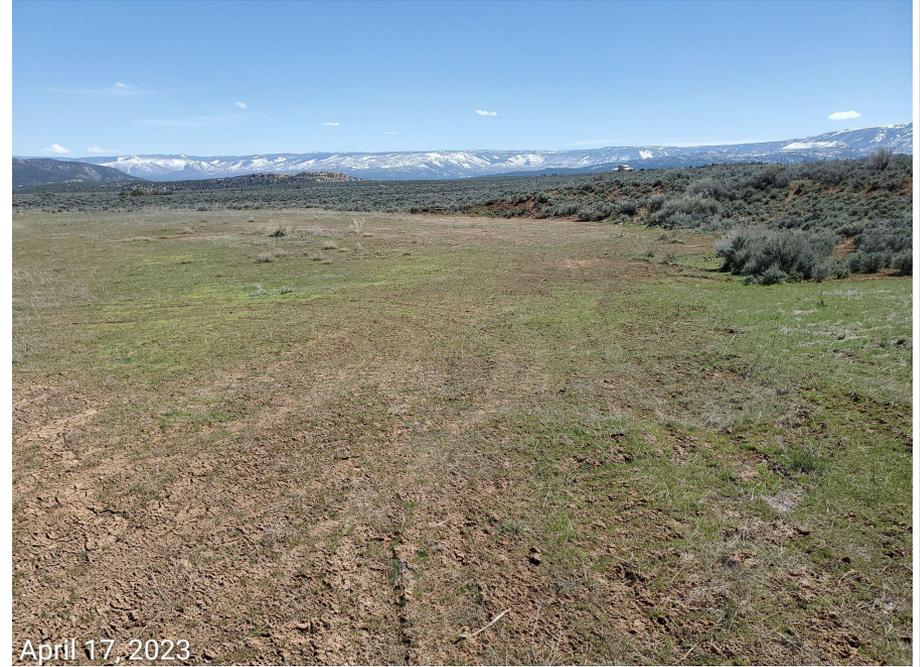
Photo 2: Photos taken from the west end of the Location facing east, southeast. Photos provide an overview of the Location. Reclamation work including, but not limited to, compaction alleviation, regrading and seeding has not been conducted in accordance with 1004 requirements- compaction issues remain, portions of cut slope remains apparent; It should be noted that the green vegetation observed on the unreclaimed working pad is predominantly Undesirable Plant Species, such as Cheatgrass.

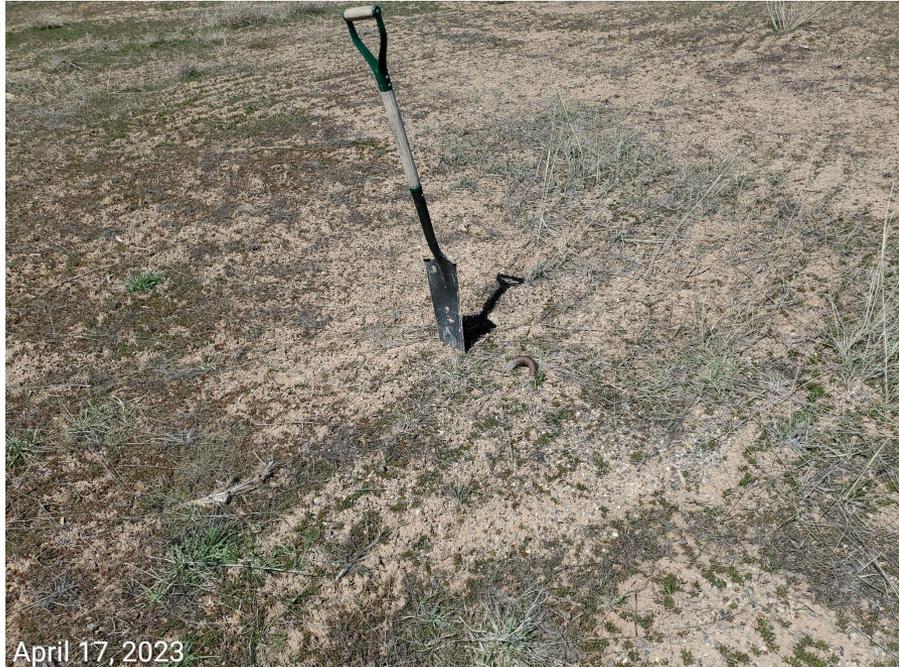
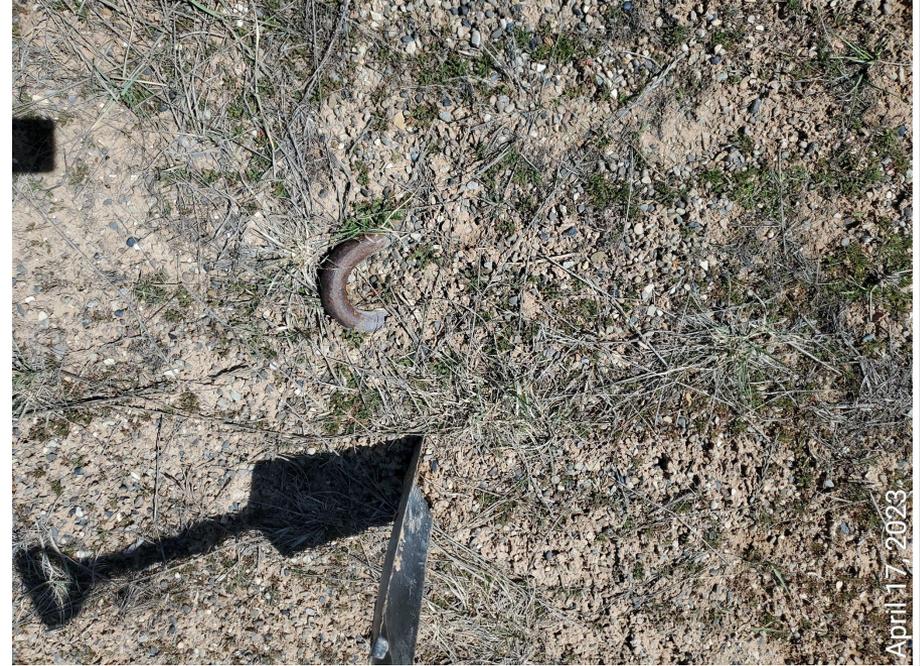
Photo 3: Photo shows anchor equipment remaining on the Location. Pursuant to 1004.a, all surface equipment is required to be removed within within three (3) months of plugging a well; anchors should have been removed by May 2017.

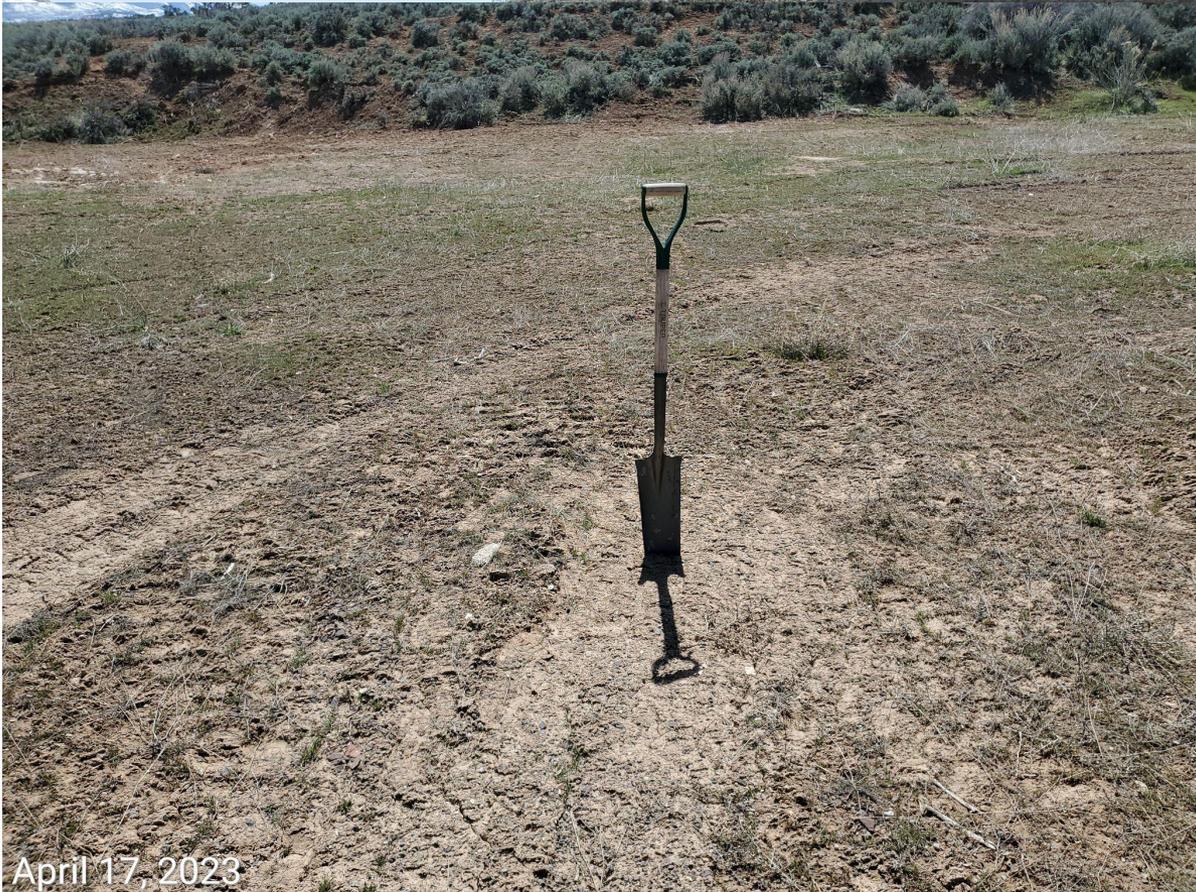
Photo 4: Photo shows Reclamation Specialist was only able to easily penetrate approximately the top 3 inches of soils before encountering a zone of compaction-compaction alleviation not performed.

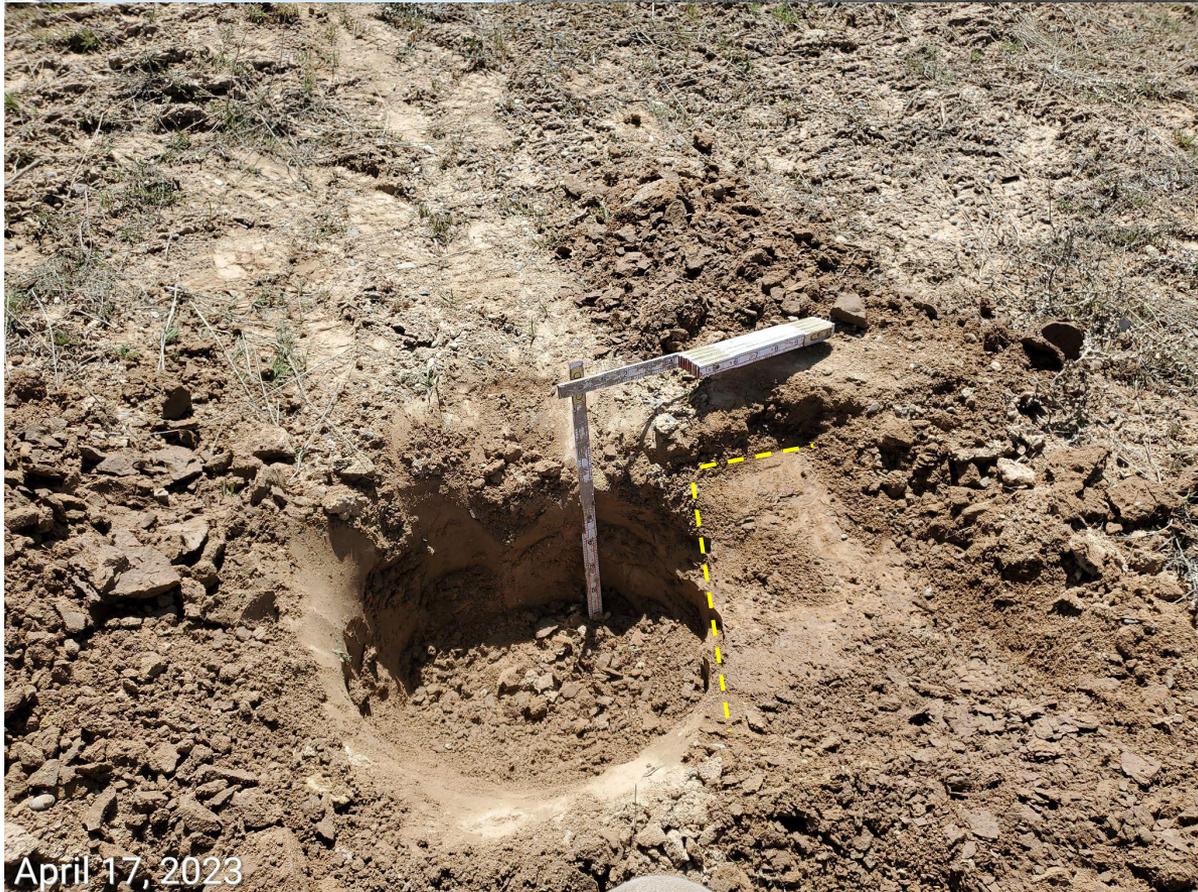
Photo 5: Continued from photo 4. Photo shows Location has not been decompacted; zone of compaction (right of the dotted yellow lines) observed ~ 3 inches below ground surface.

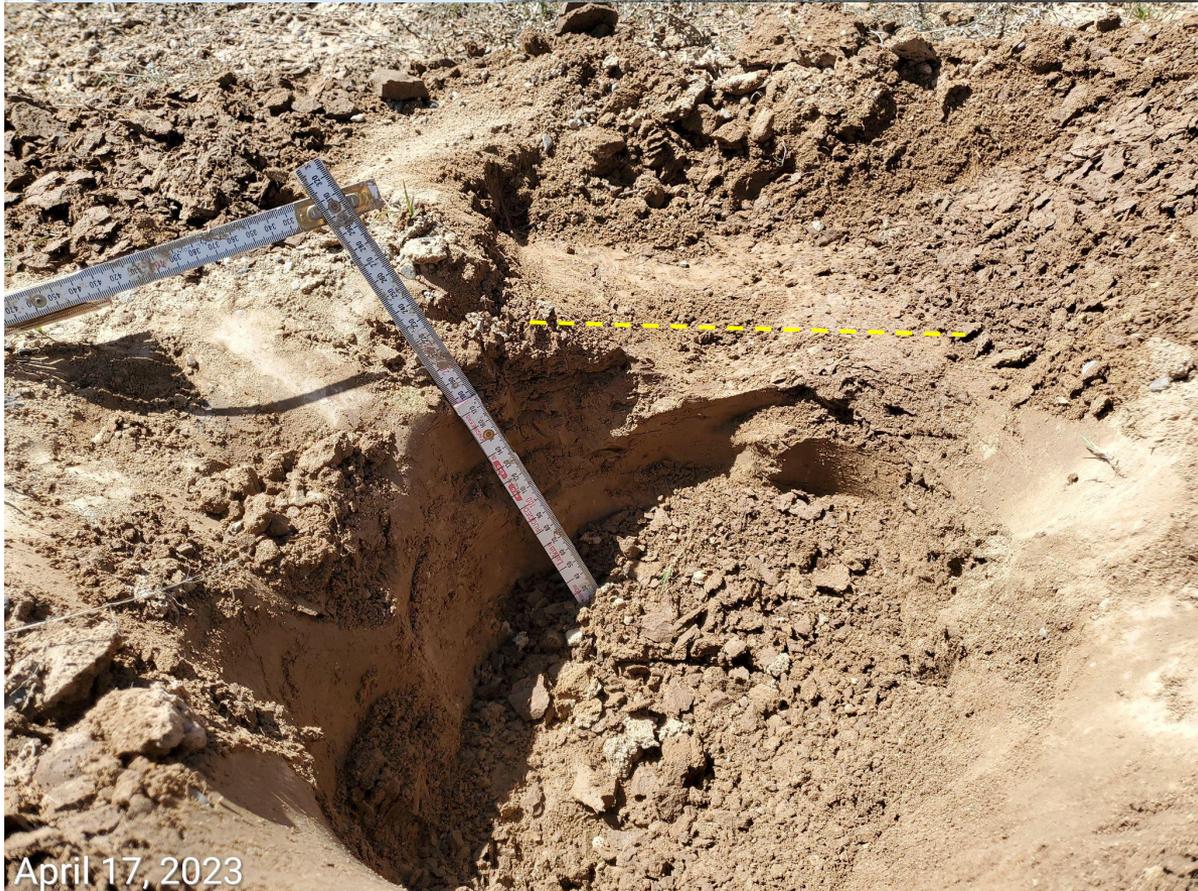
Photo 6: Continued from photo 4. Photo shows Location has not been decompacted; zone of compaction, represented by the dotted yellow line, observed ~ 3 inches below ground surface.
