Inspection Photos

4/17/2023

Operator: LARAMIE ENERGY LLC -10433 /
BLACK HILLS PLATEAU PRODUCTION LLC -
10150

Location #312420
Mesa County, CO

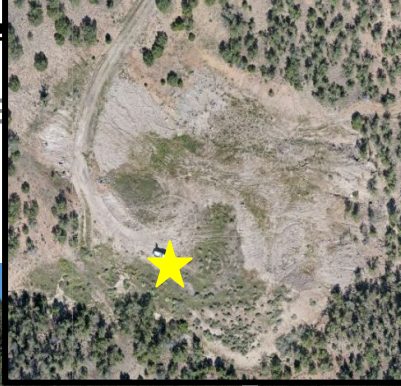
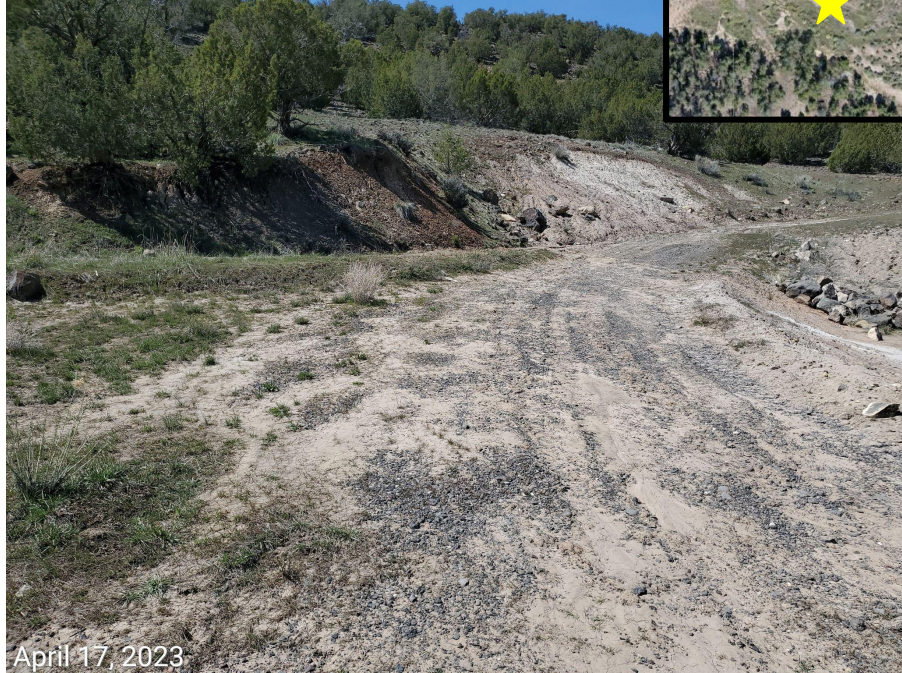
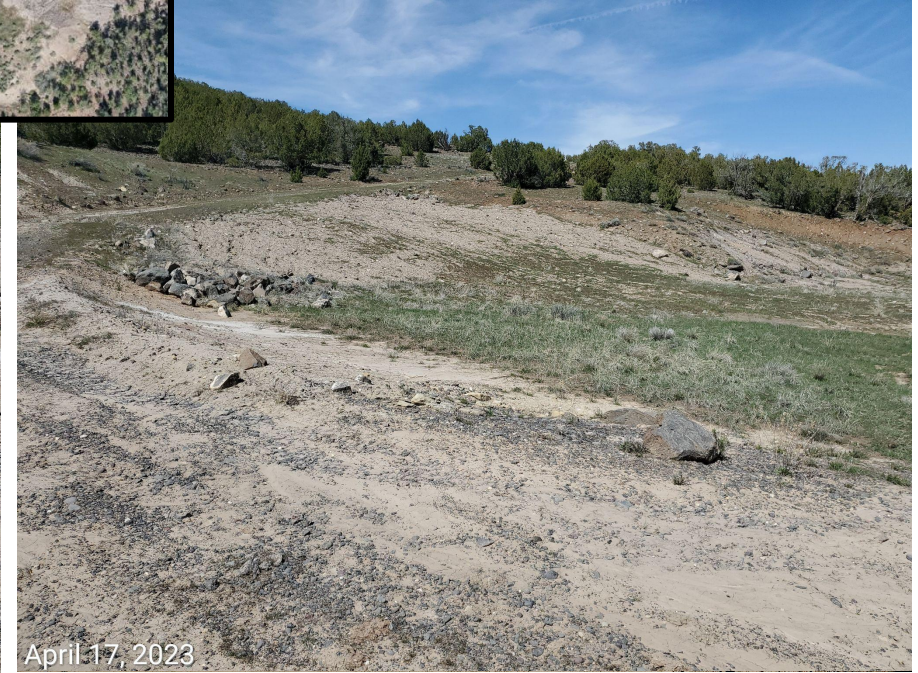
Photo 1: Photos 1-2 taken from southwest end of the Location. Photos provide an overview of the Location from northwest, north, northeast to southeast. Photos also show that reclamation work, including by not limited to, removal of gravel/road base, compaction alleviation, recontouring/regrading and revegetation activities have not been performed on the Location. Picture insert at top shows aerial view of the Location- star represents approximate location of where photos were taken.

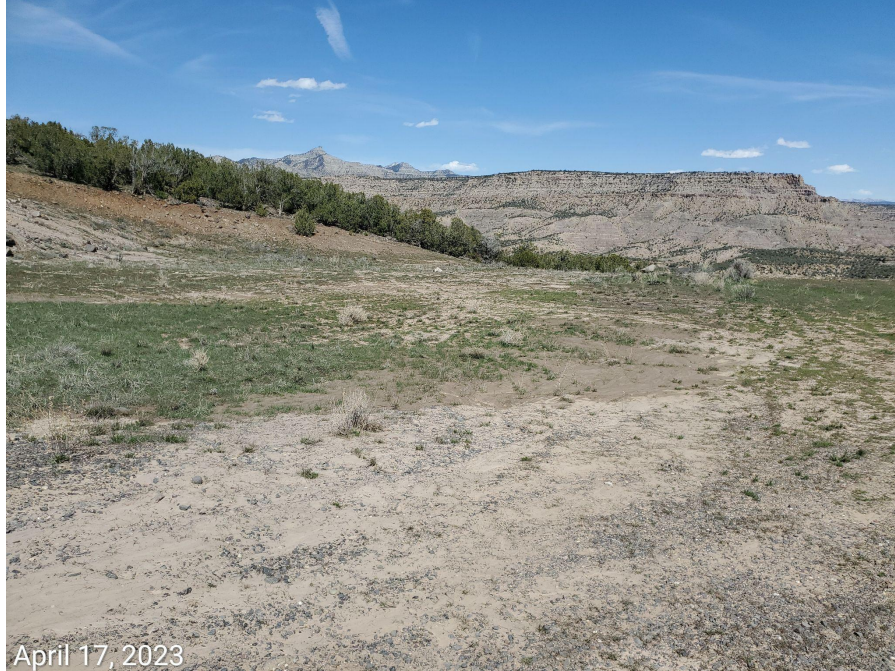
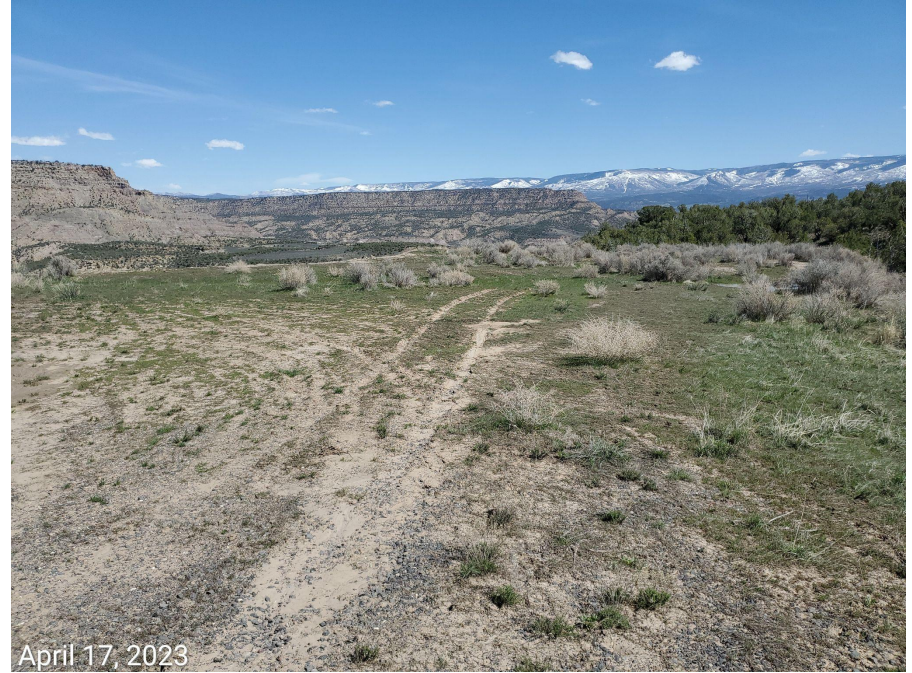
Photo 2: See comments under photo 1.

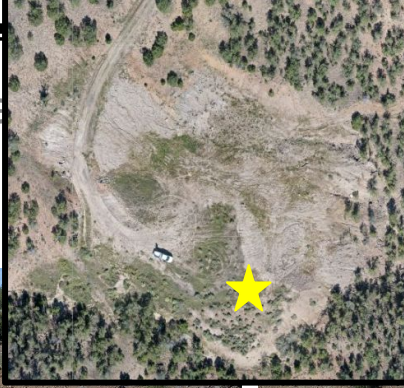
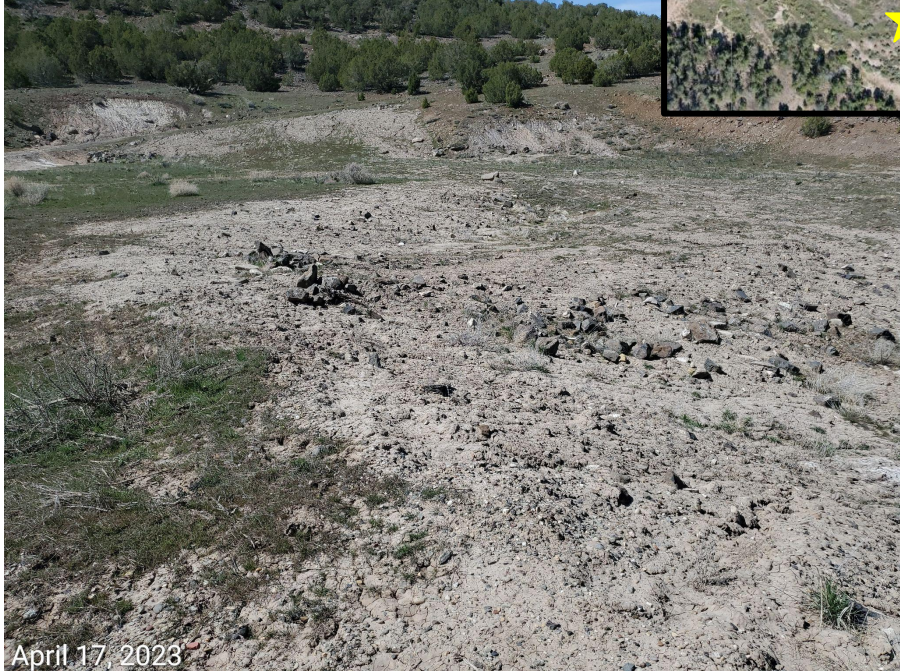
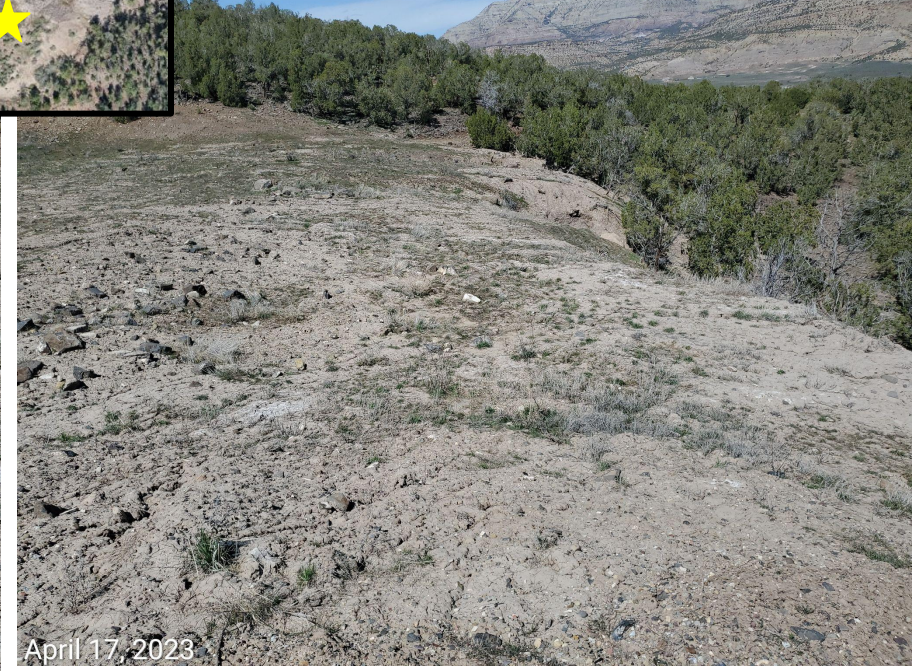
Photo 3: Photos taken from the southern (fill slope) corner of the Location, facing northwest and northeast. Photos provide an overview of the Location and show reclamation work, including recontouring and regrading has not been performed on the Location. Picture insert at top shows aerial view of the Location- star represents approximate location of where photos were taken.

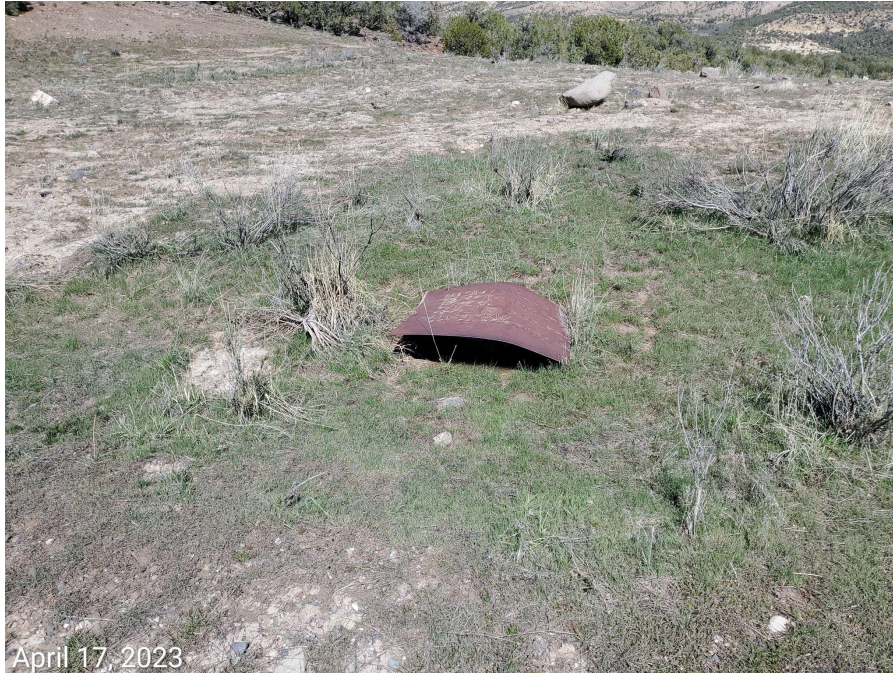
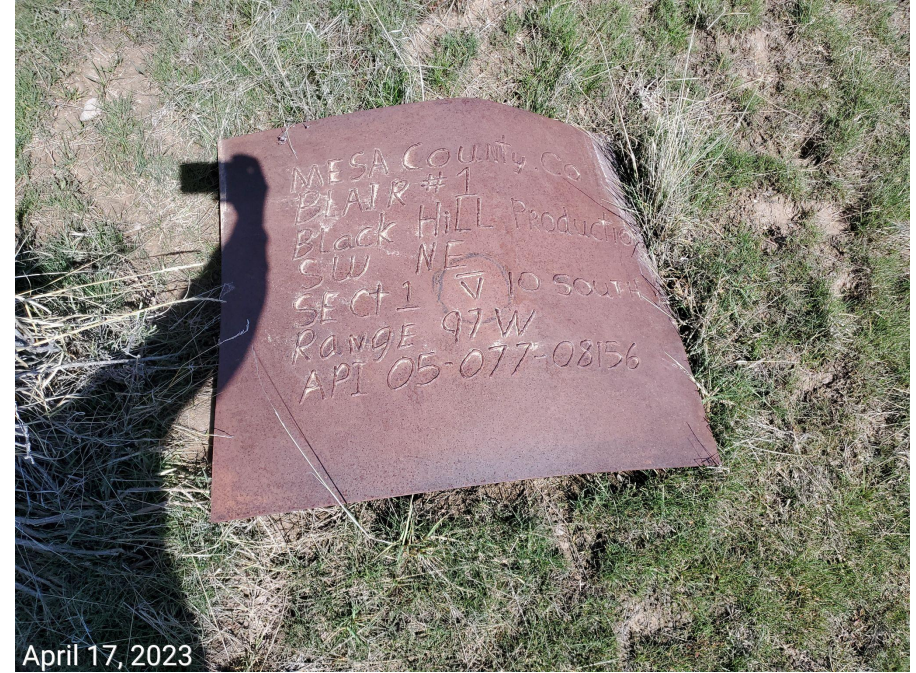
Photo 4: Photo shows welded plate representing the well marker left at the surface. Rules at time of plugging required permanent monuments marking well at surface was required to be a piece of pipe not less than 4 inches in diameter and not less than 10 feet in length, of which 4 feet shall be above the general ground level; monument left at surface does not comport with abandoned well marker requirements.

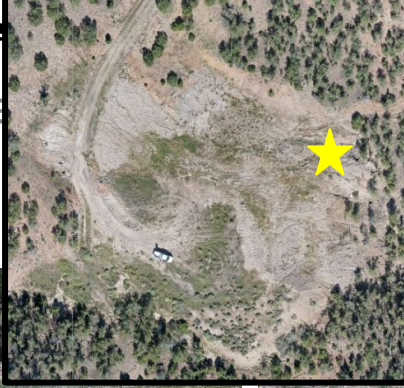
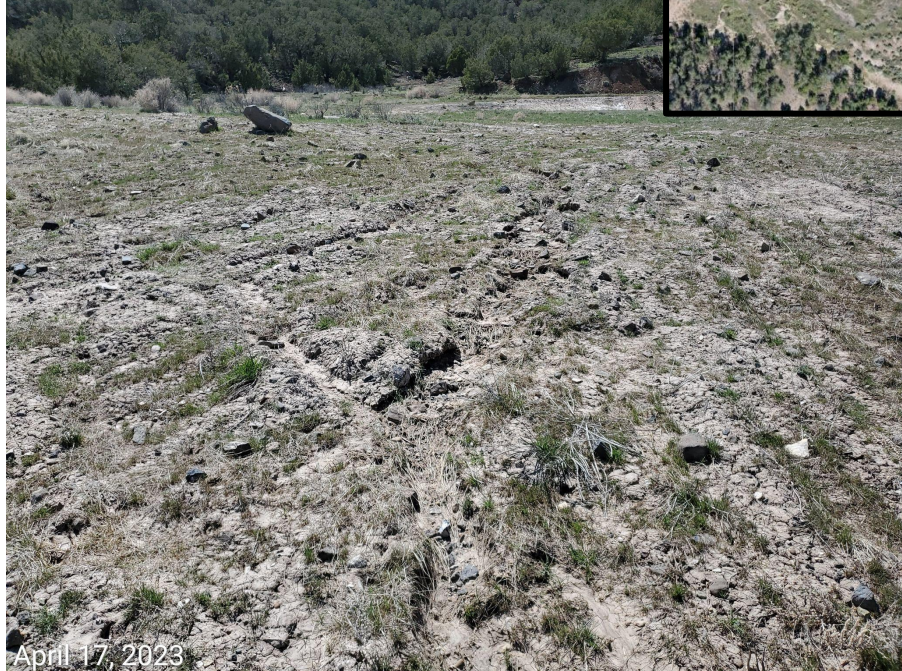
Photo 5: Photos 5-14 have been taken throughout the entire Location. Photos show stormwater management, including BMPs to minimize erosion, degradation and sediment transport remain missing or insufficient- erosion/degradation has persisted throughout the Location and access road. 6 foot measuring stick identified by yellow arrows used for reference. Picture insert at top shows aerial view of the Location- star represents approximate location of where photos were taken.

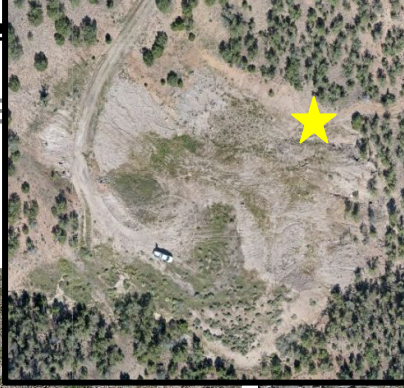
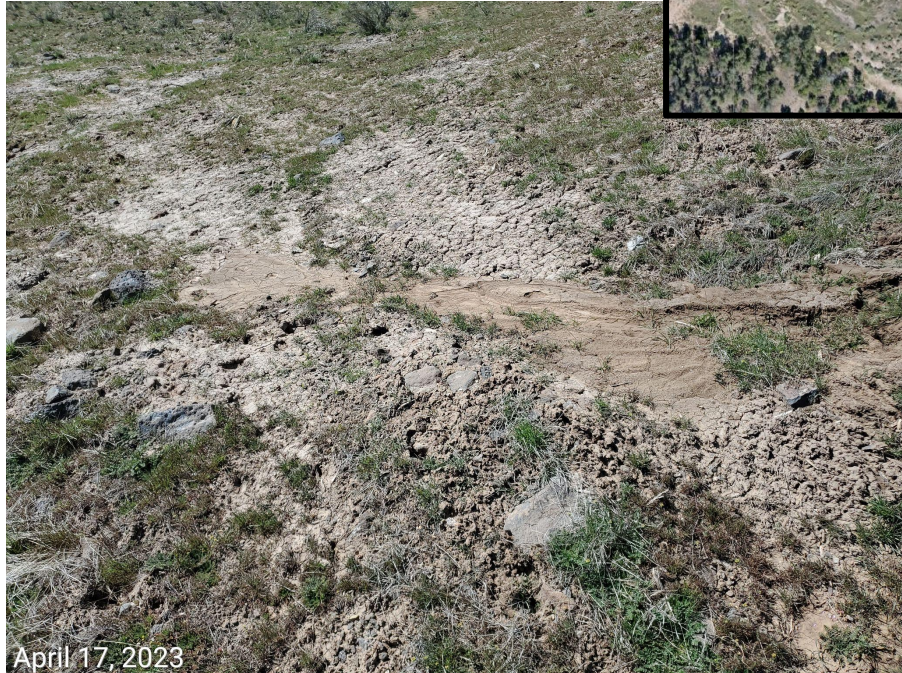
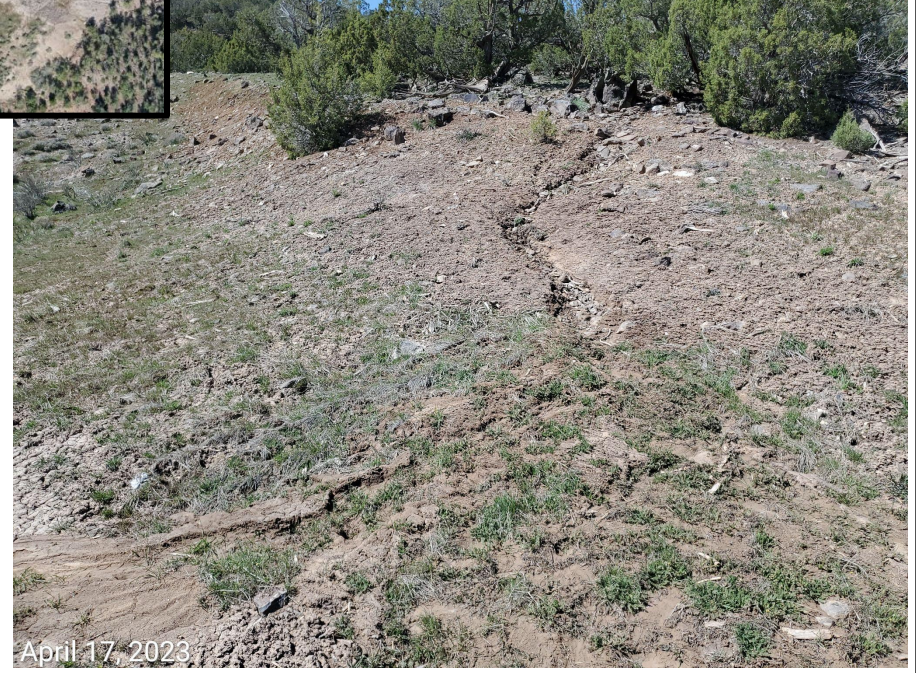
Photo 6: Photos taken from the northeast end of the Location. See comments under photo 5. Picture insert at top shows aerial view of the Location- star represents approximate location of where photos were taken.

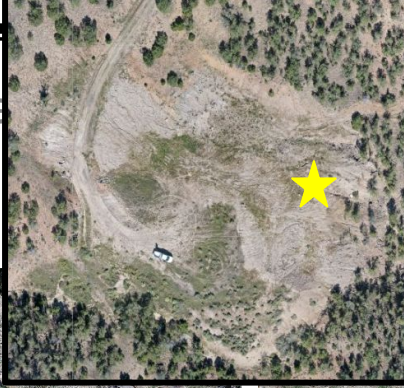
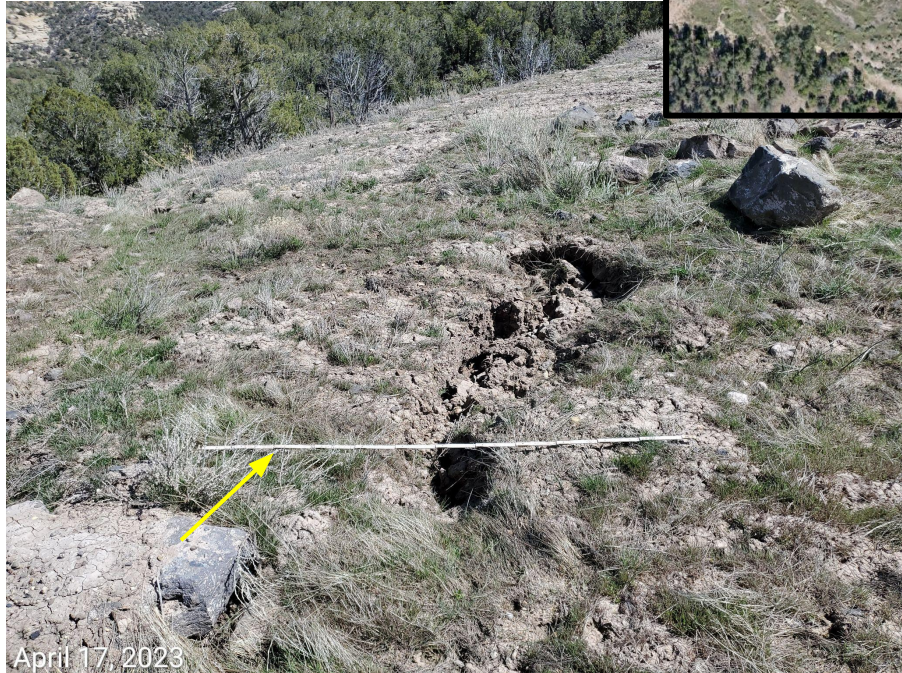
Photo 7: Photos taken from the east end (fill slope areas) of the Location. See comments under photo 5. Picture insert at top shows aerial view of the Location- star represents approximate location of where photos were taken.

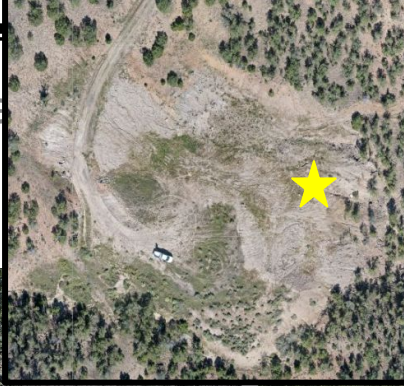
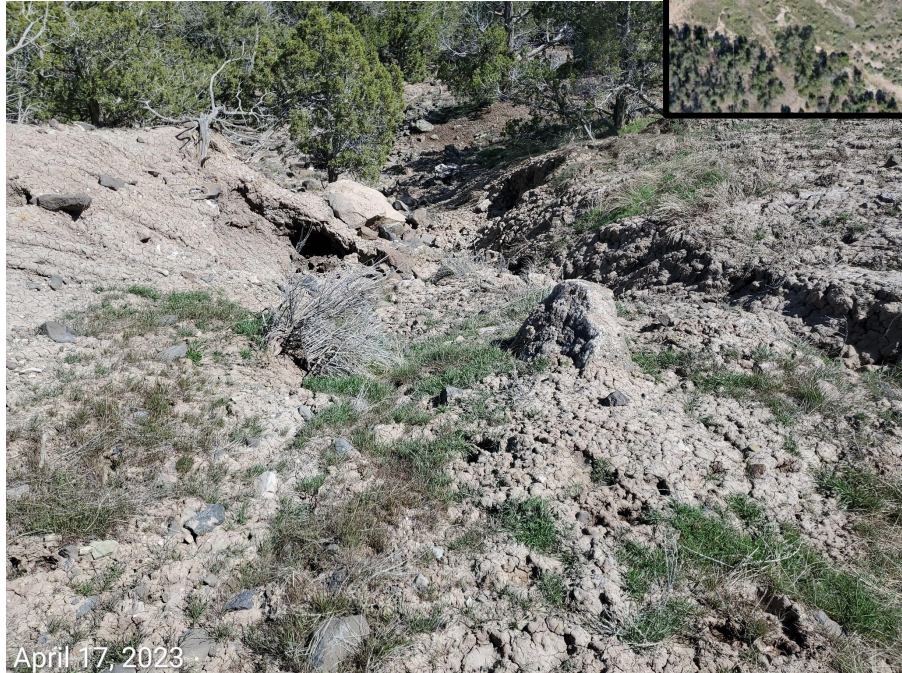
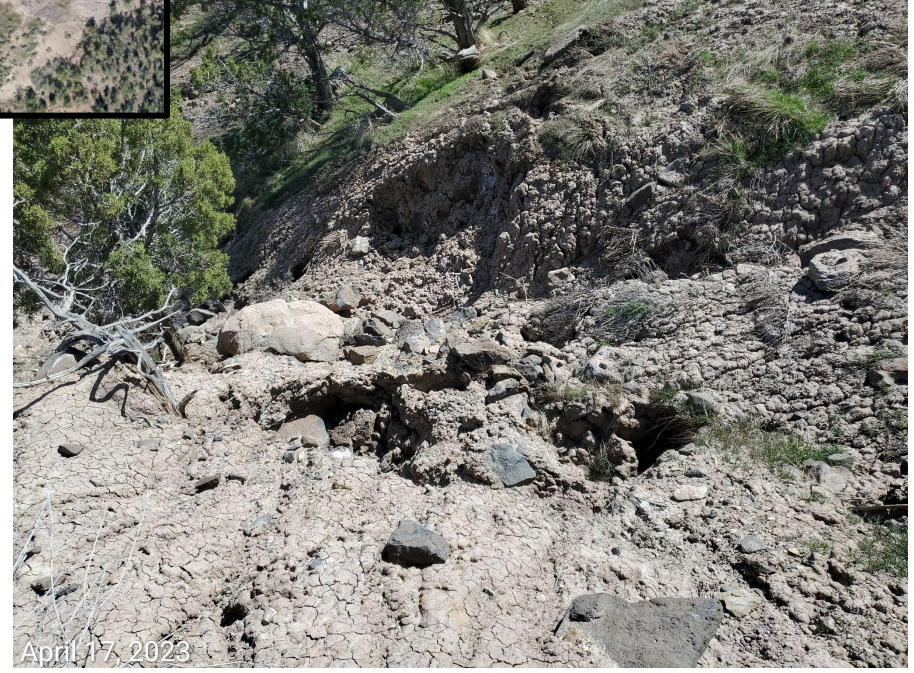
Photo 8: Photos taken from the east end (fill slope areas) of the Location. See comments under photo 5. Picture insert at top shows aerial view of the Location- star represents approximate location of where photos were taken.

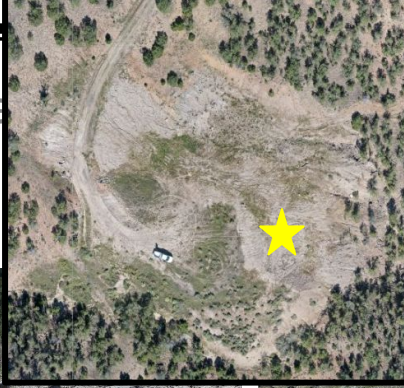
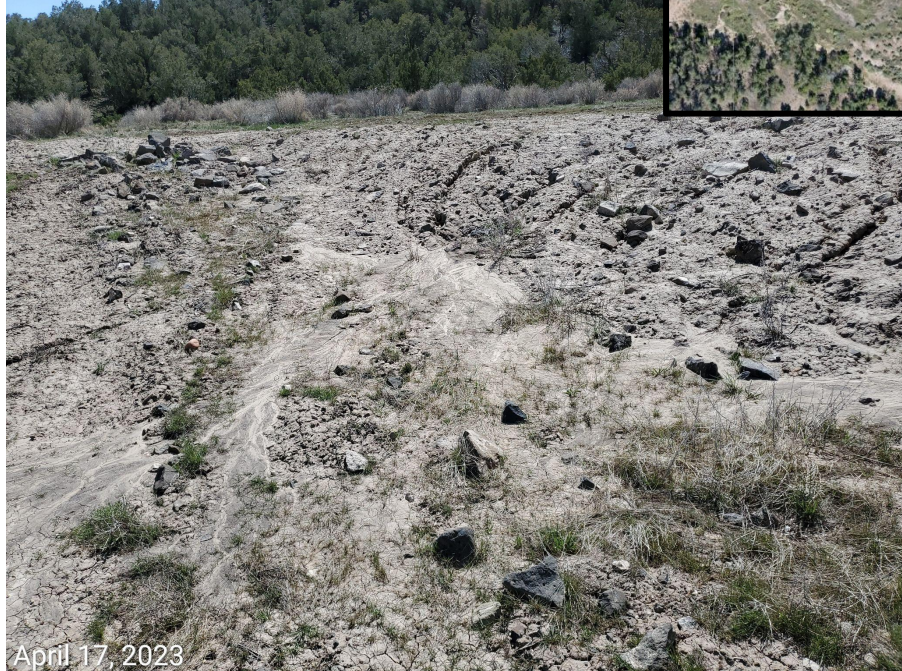
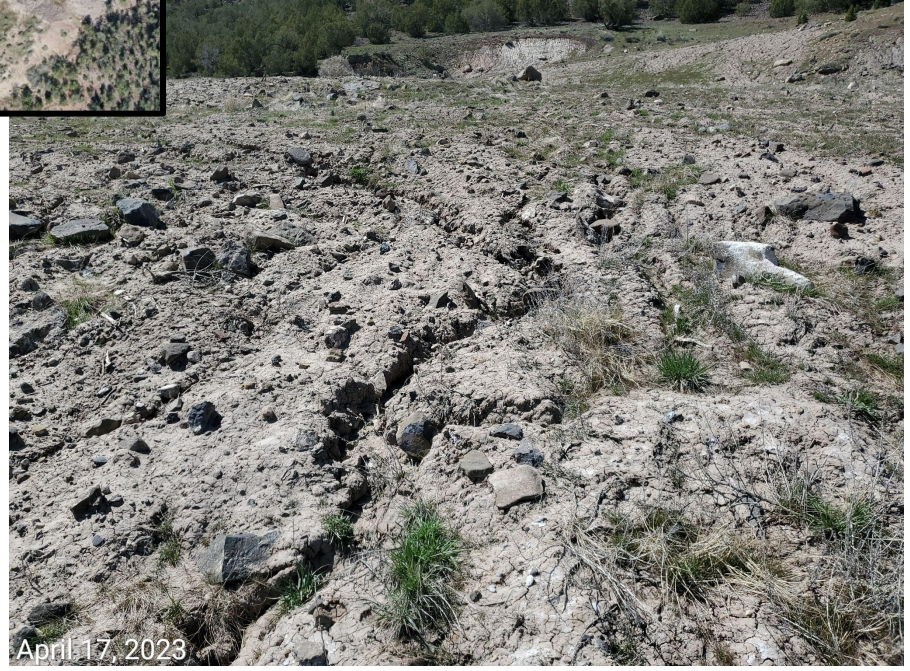
Photo 9: Photos taken from the east end (fill slope areas) of the Location. See comments under photo 5. Picture insert at top shows aerial view of the Location- star represents approximate location of where photos were taken.

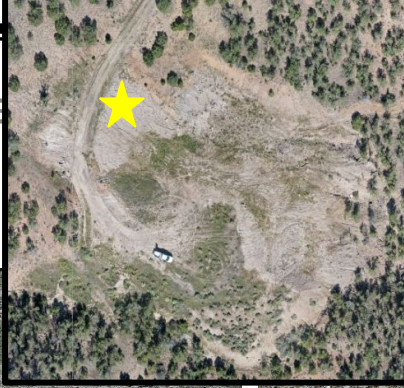
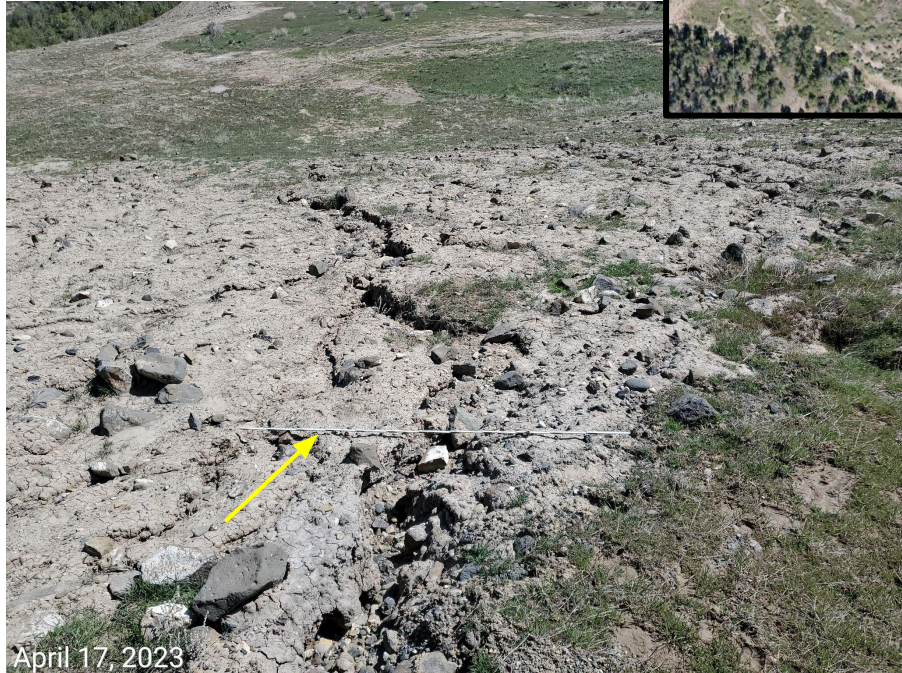
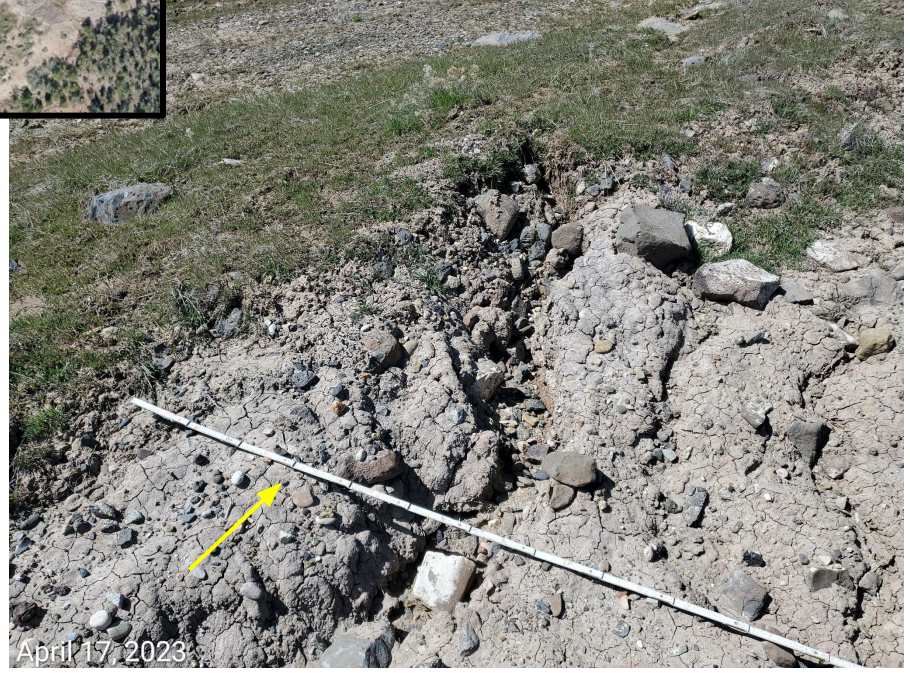
Photo 10: Photos taken from the cut areas adjacent to the access road, on the west end of the Location. See comments under photo 5. Picture insert at top shows aerial view of the Location- star represents approximate location of where photos were taken.

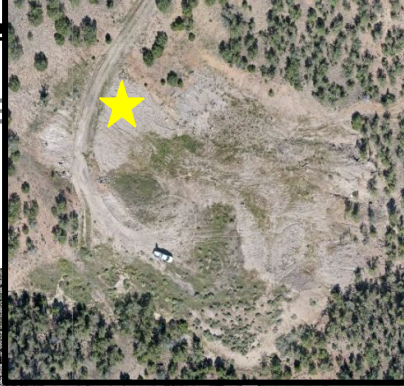
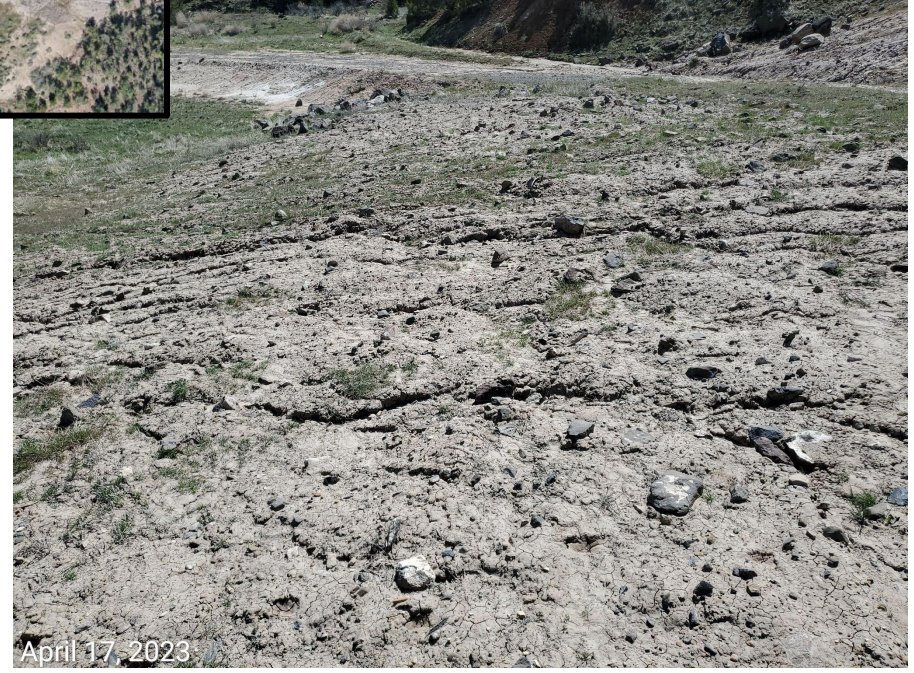
Photo 11: Photos taken from the cut areas adjacent to the access road, on the west end of the Location. See comments under photo 5. Picture insert at top shows aerial view of the Location- star represents approximate location of where photos were taken.

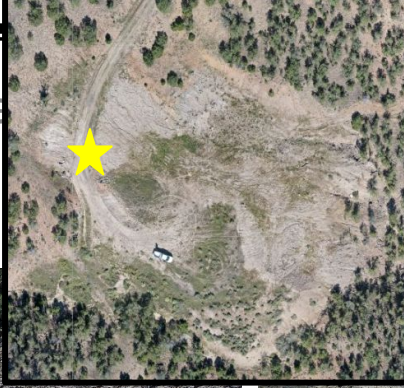
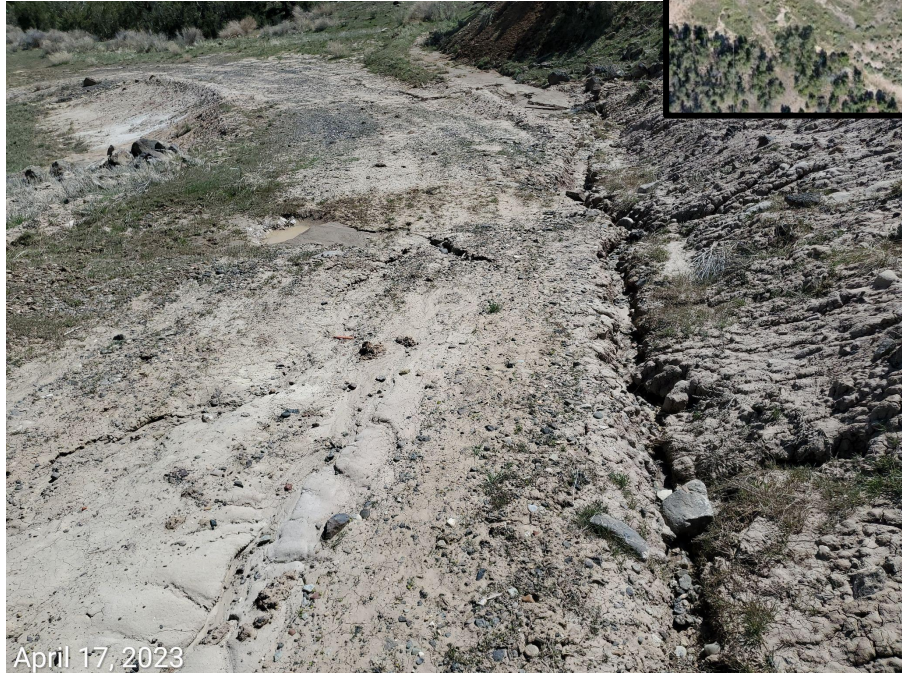
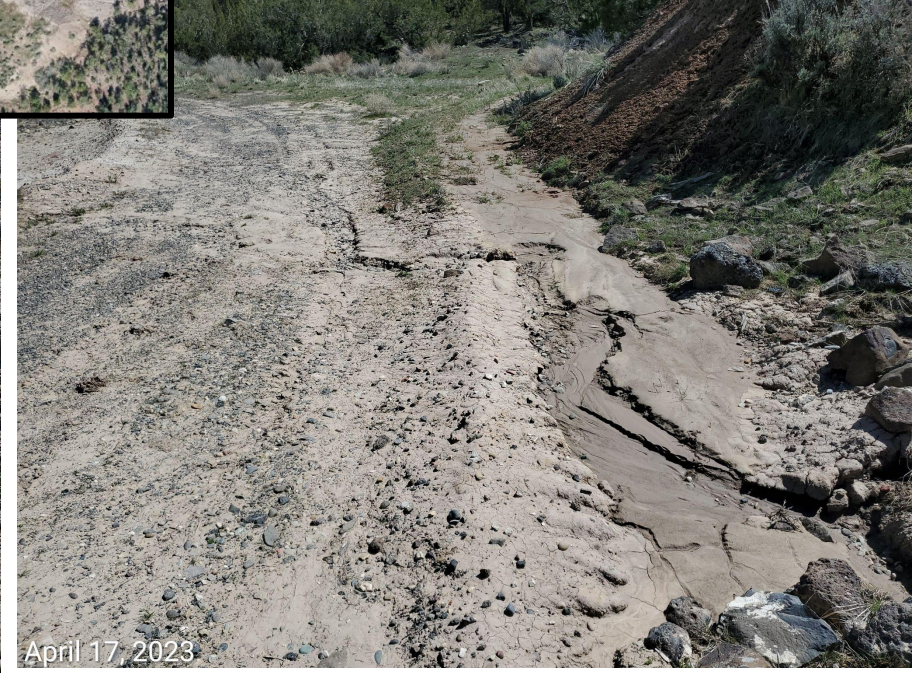
Photo 12: Photo taken from the access road, and cut slope areas on the west end of the Location. See comments under photo 5. Picture insert at top shows aerial view of the Location- star represents approximate location of where photos were taken.

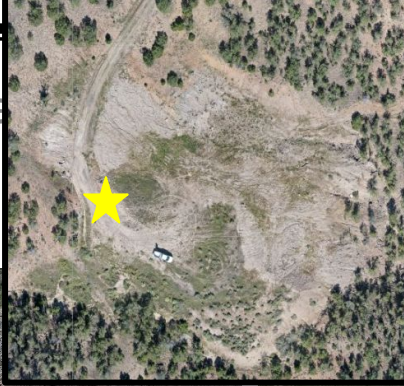
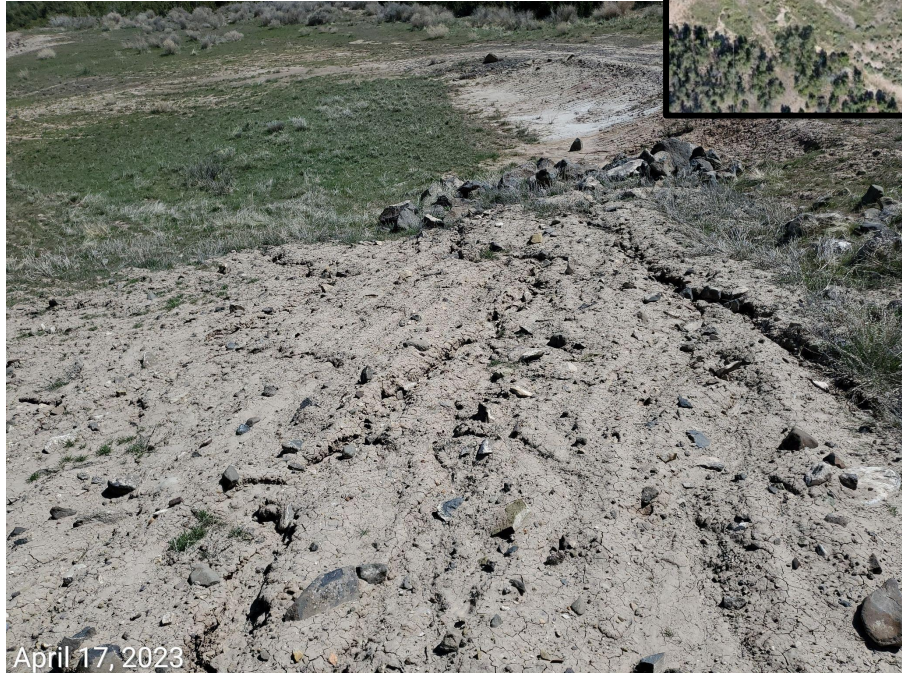
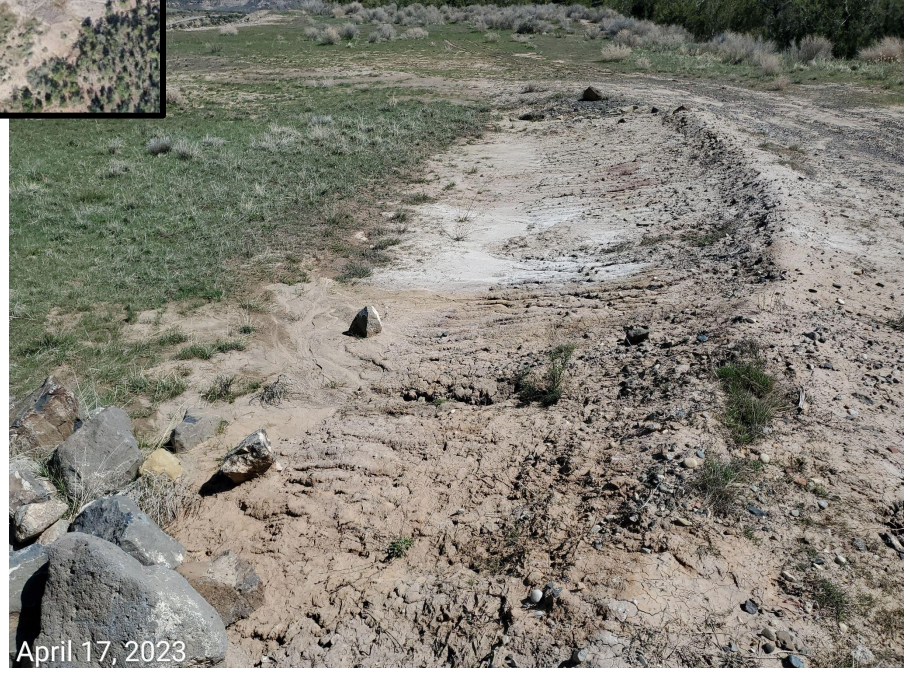
Photo 13: Photos taken from the cut areas adjacent to the access road, on the west end of the Location. See comments under photo 5. Picture insert at top shows aerial view of the Location- star represents approximate location of where photos were taken.

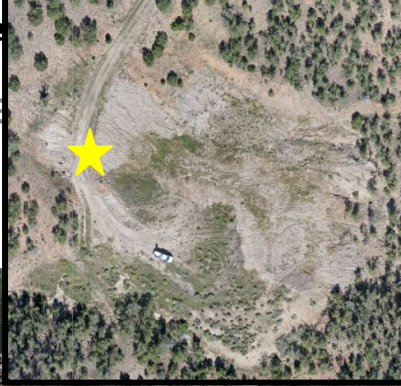
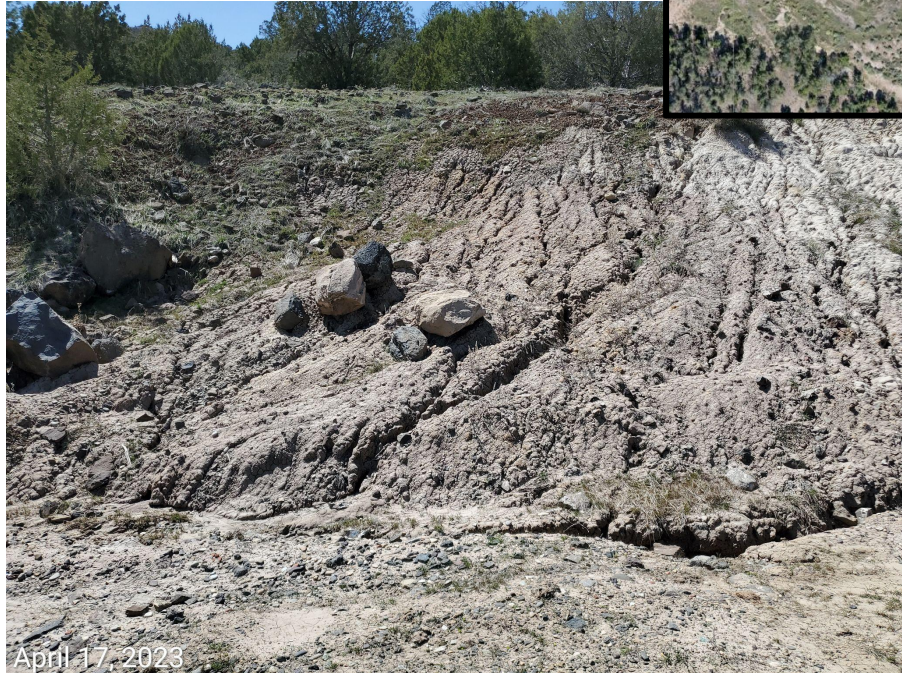
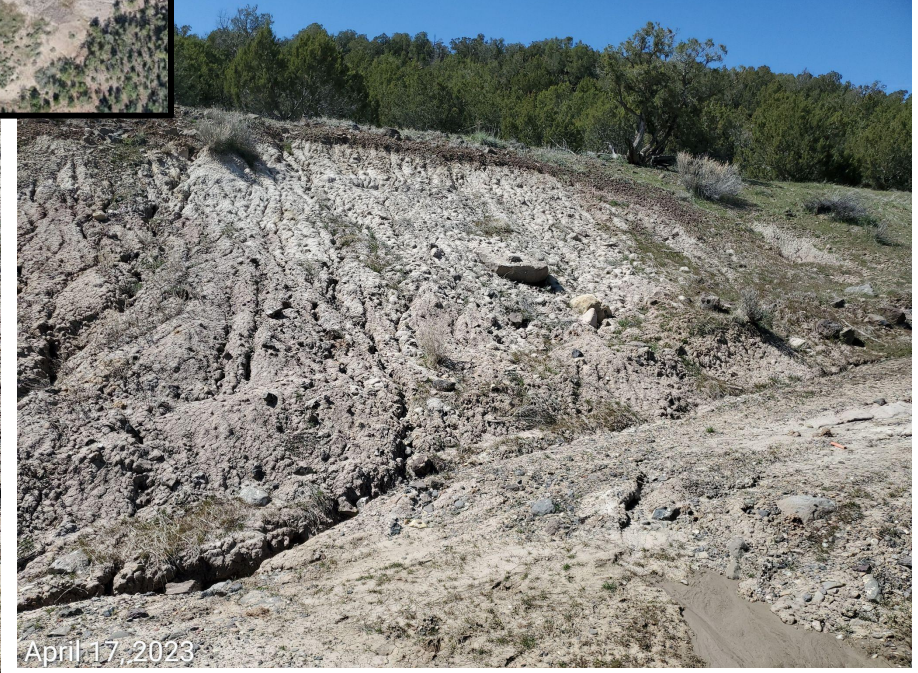
Photo 14: Photo shows cut slopes on the west end of the Location. See comments under photos 1 and 5. Picture insert at top shows aerial view of the Location- star represents approximate location of where photos were taken.

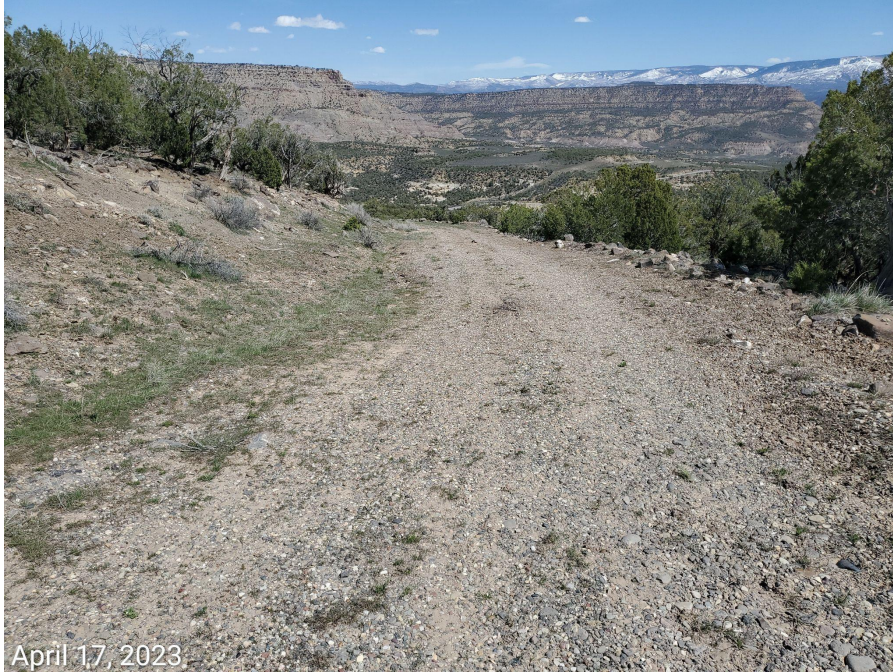
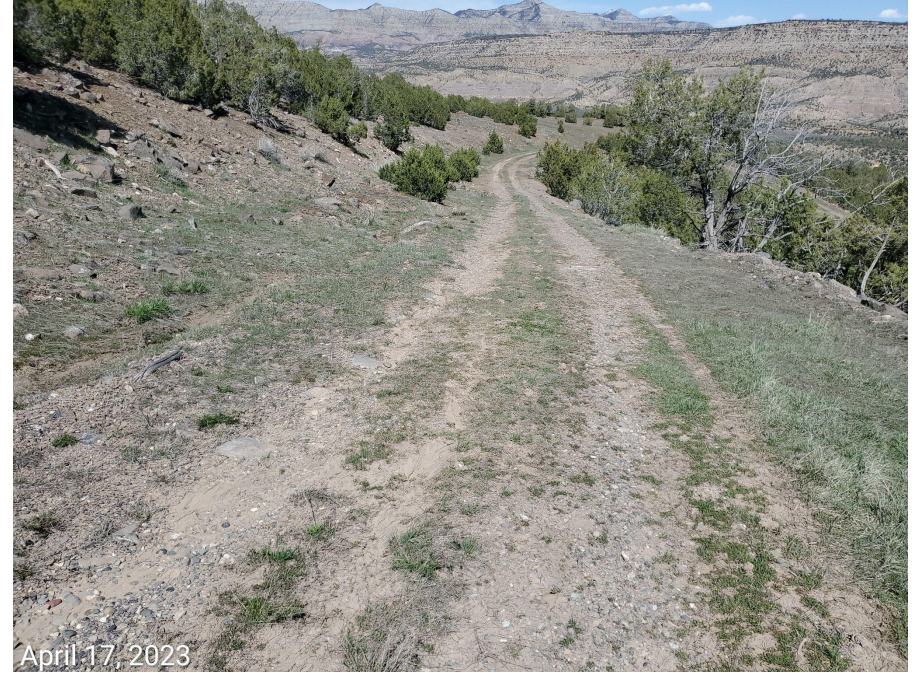
Photo 15: Photo taken from the access road leading to the Location. Photos also show that reclamation work, including by not limited to, removal of gravel/road base, compaction alleviation, recontouring/regrading and revegetation activities have not been performed on the Access Road.

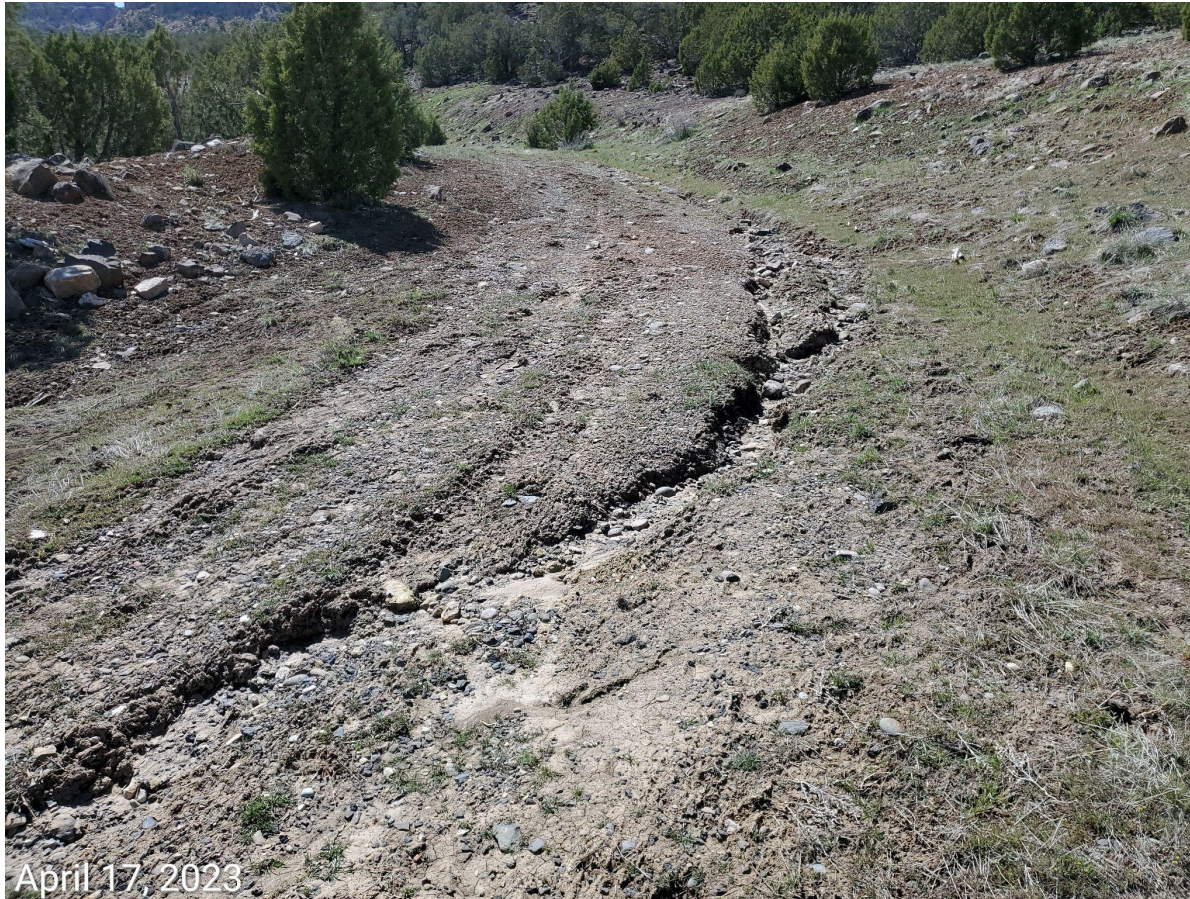
Photo 16: Erosion degradation at the access road.

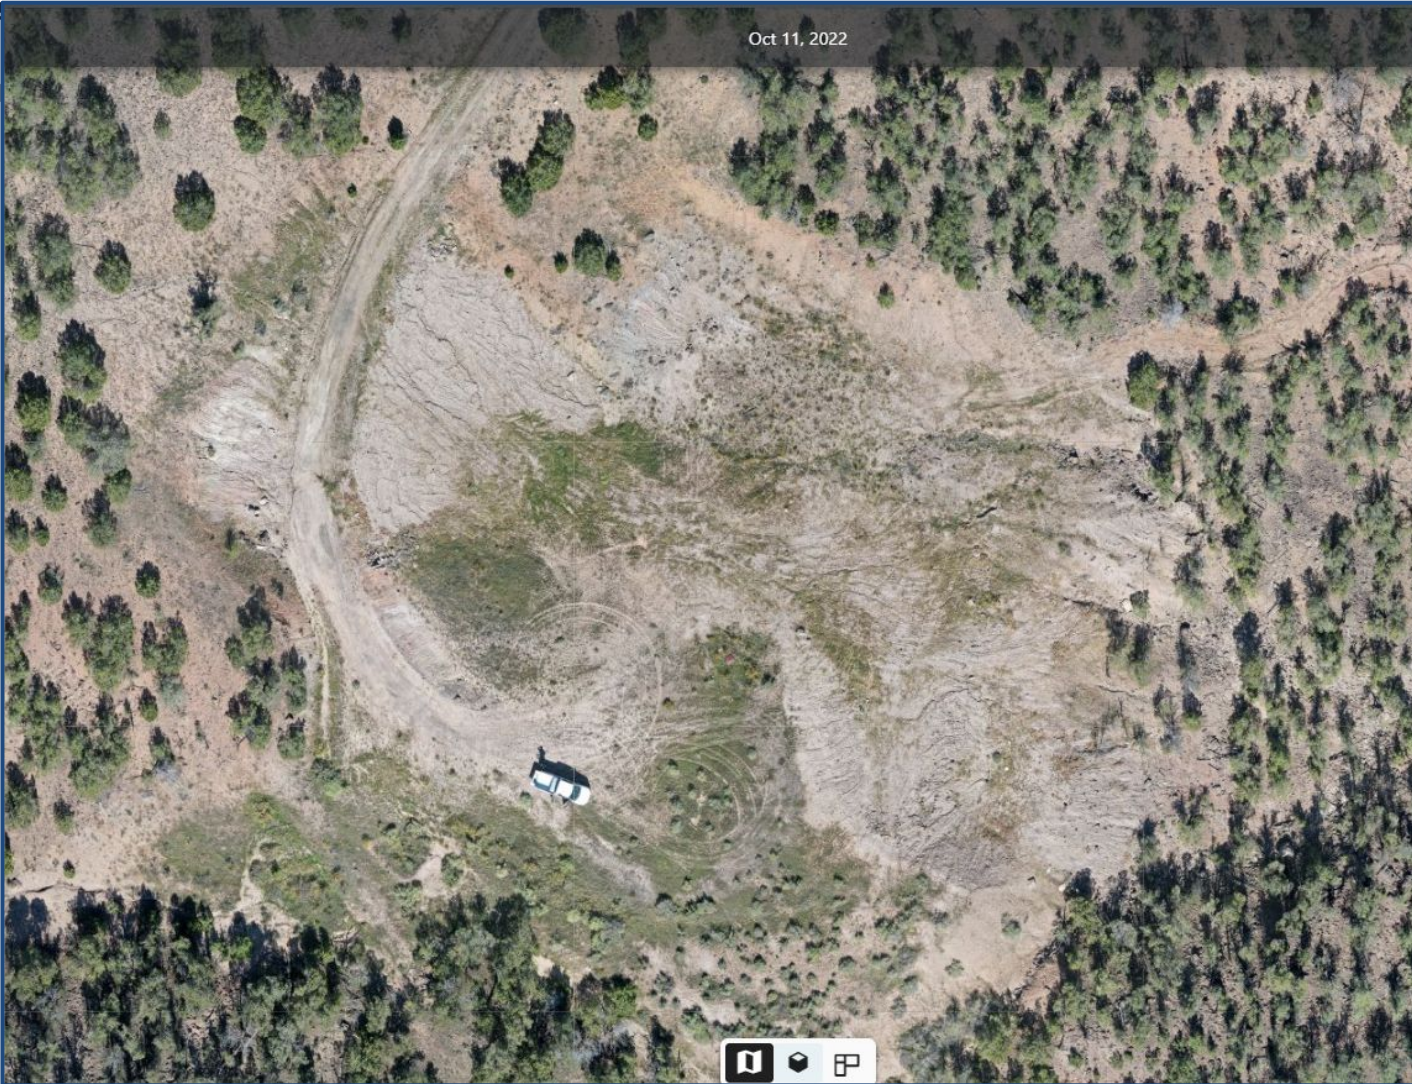
Photo 17: Drone aerial imagery of the Location dated 10/11/2022.
