Inspection Photos

4/17/2023

Operator: LARAMIE ENERGY LLC -10433 /
BLACK HILLS PLATEAU PRODUCTION LLC -
10150

Location #312420
Mesa County, CO

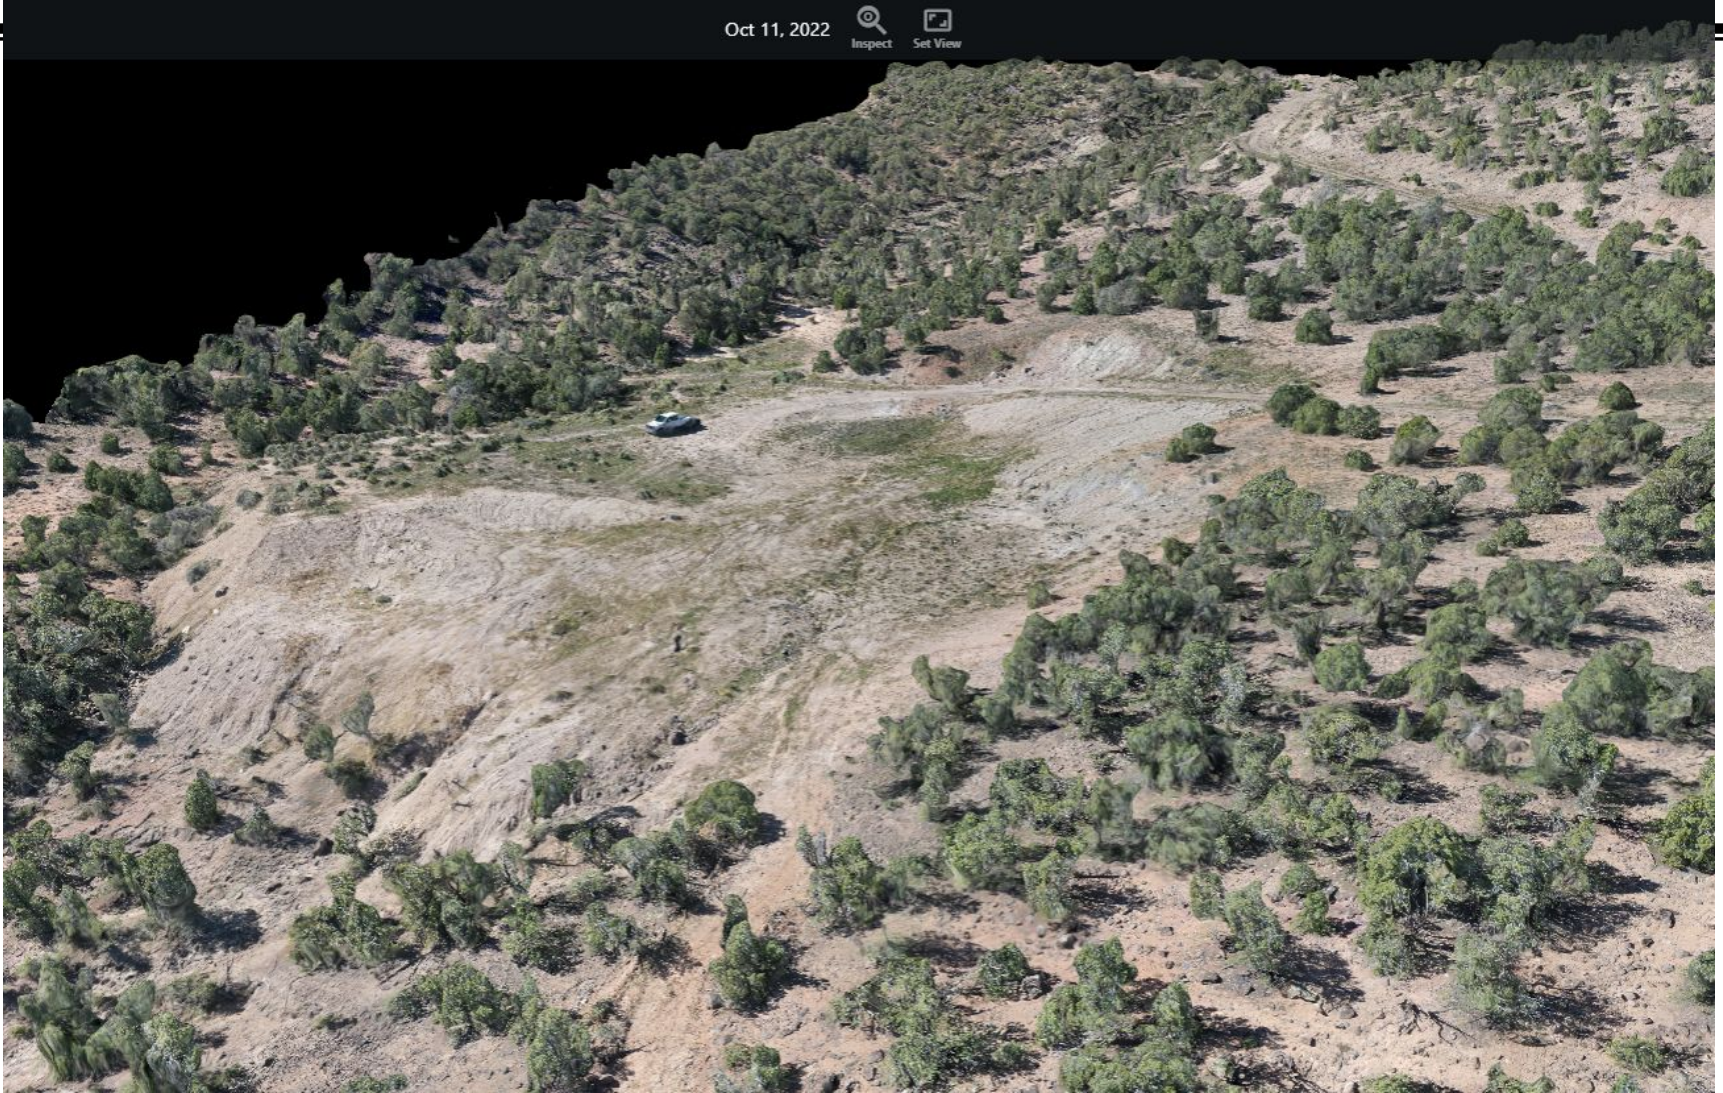
Photo 17: 3-D model of the Location- imagery dated 10/11/2022.
