Final Reclamation Inspection

Operator: BONANZA CREEK ENERGY OPERATING COMPANY LLC - #8960

Location ID: 331380

Inspection Photos
Location Name: DOW #23-28
Location ID: 331380

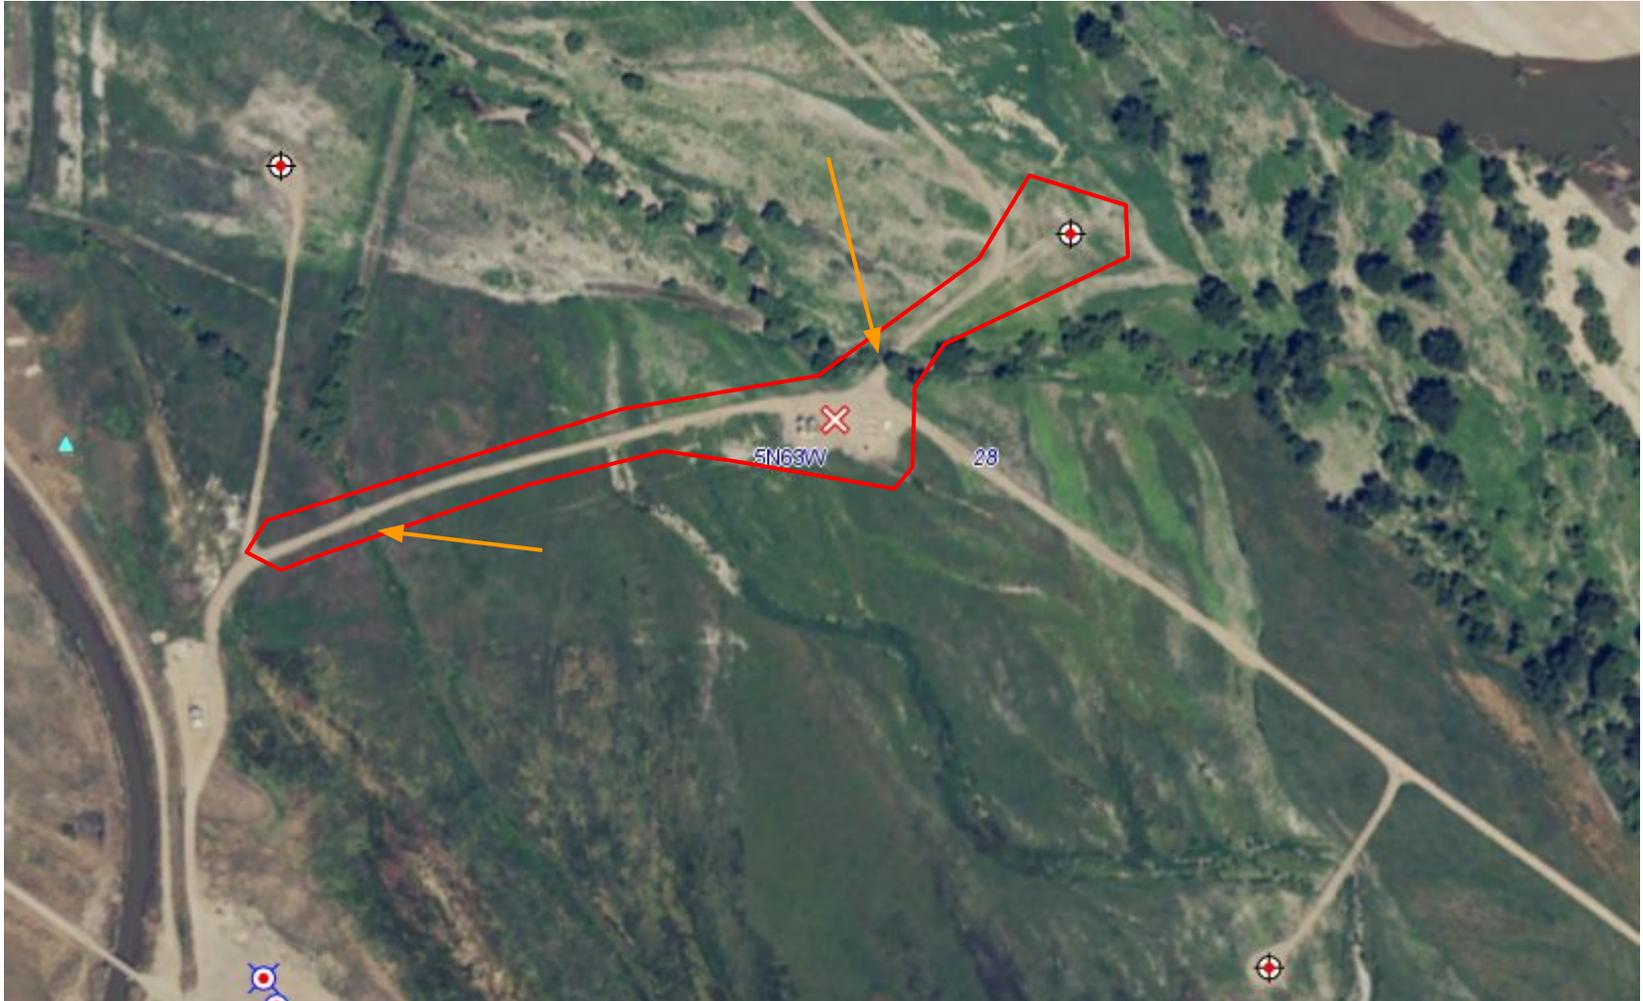
Photo 1. COGCC GISOnline aerial imagery from 2015. This inspection covers the well location, offsite tank battery and access road. The access road crossed two (2) drainages that will be addressed (orange arrows).

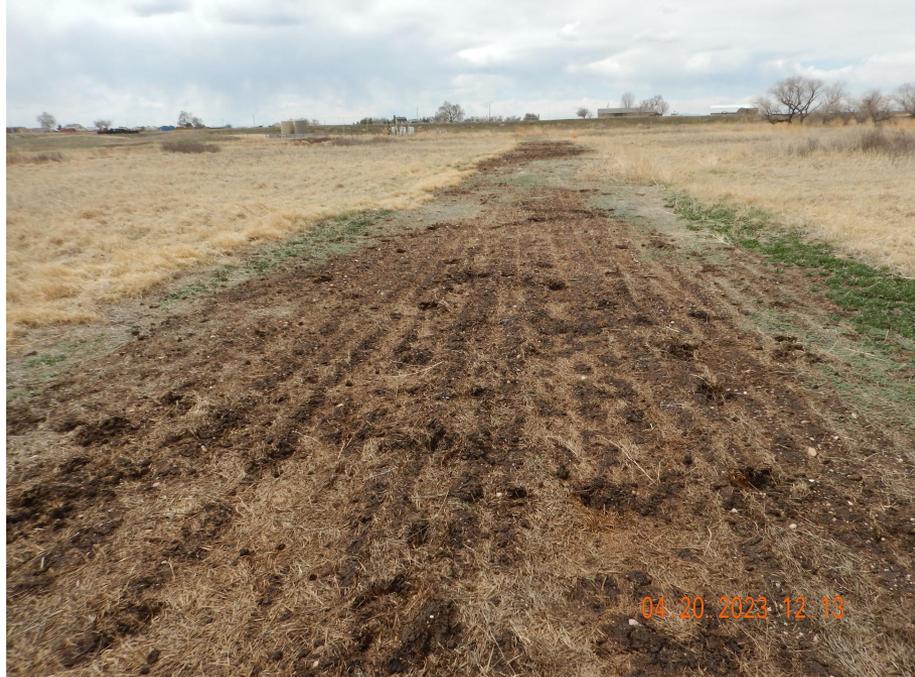
Photo 2. Photo taken from a portion of the access road, facing Southwest. Photo illustrates the access road is mostly bare that is not reflective of reference areas.

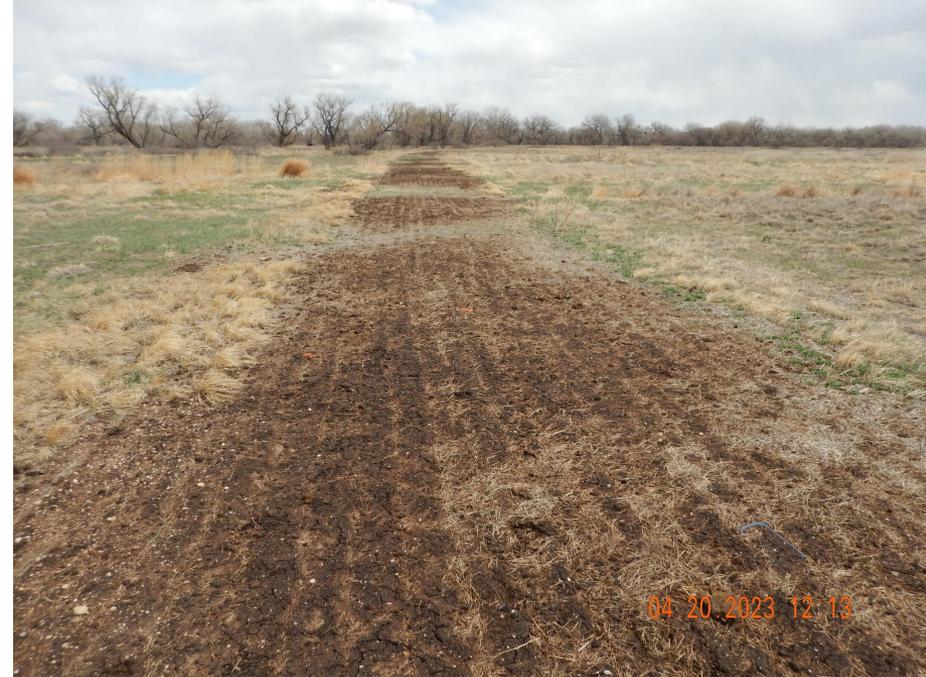
Photo 3. Photo taken from a portion of the access road, facing Northeast. See comments under Photo 2.

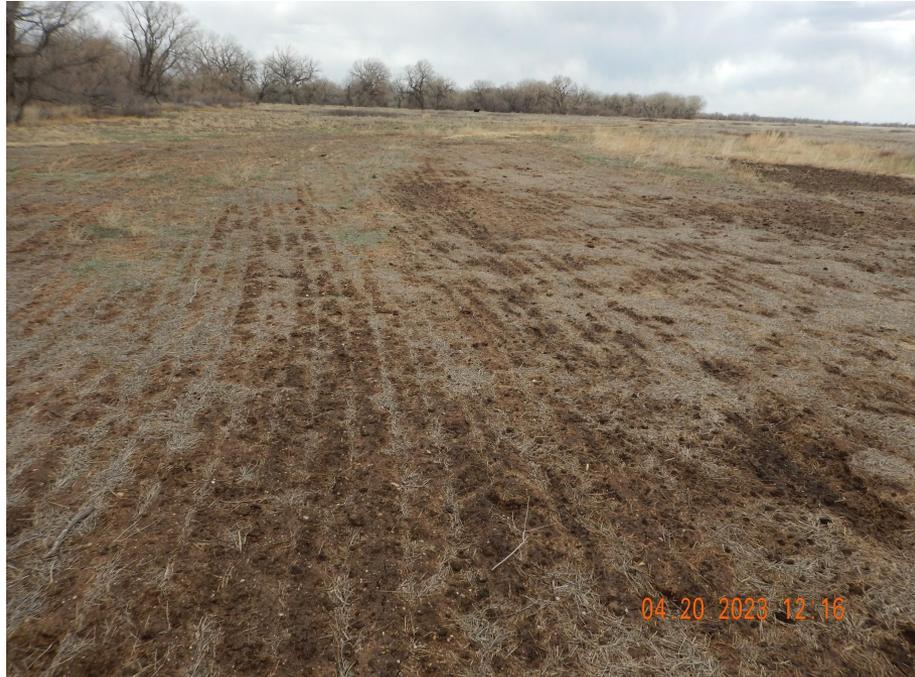
Photo 4. Photo taken from the offsite tank battery, facing East. Photo illustrates the tank battery is mostly bare that is not reflective of reference areas.

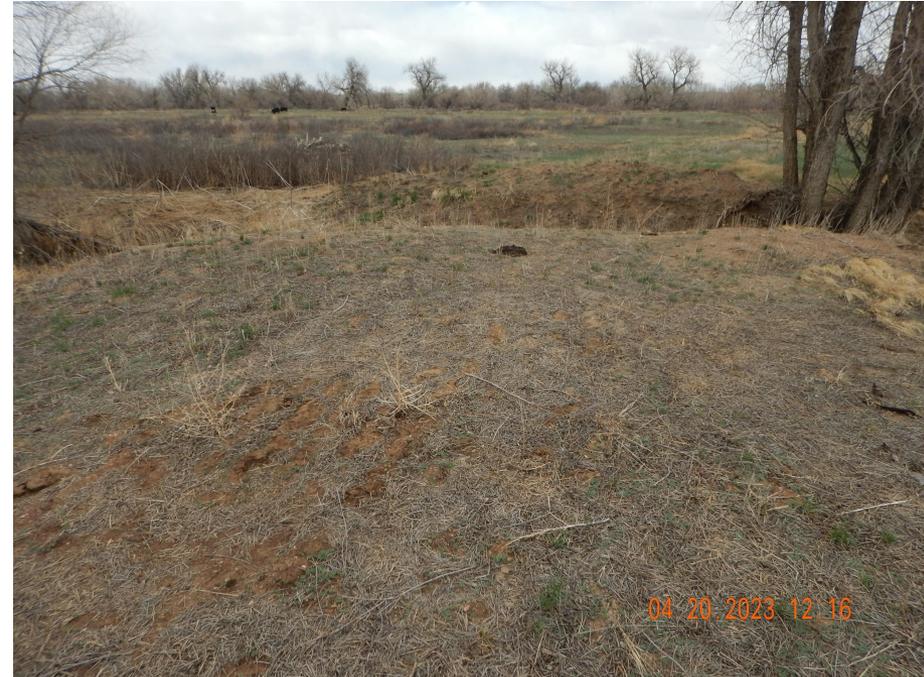
Photo 5. Photo taken from the northern drainage crossing, facing North. This area needs to be recontoured as the bottom is higher than the drainage which could impede flow.

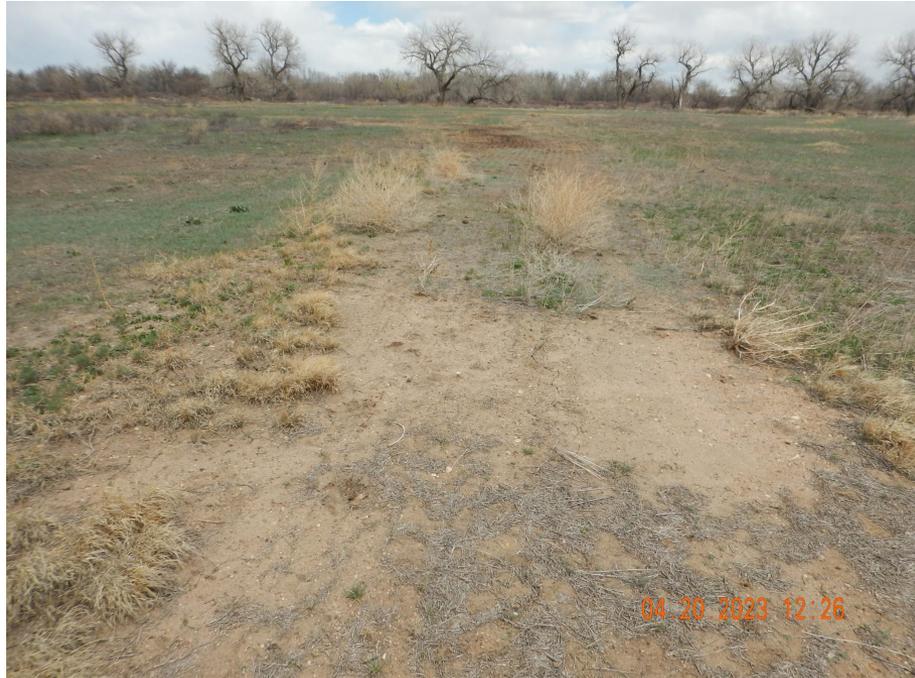
Photo 6. Photo taken from the well location, facing North. Photo illustrates the well location is mostly bare with weeds that is not reflective of reference areas.

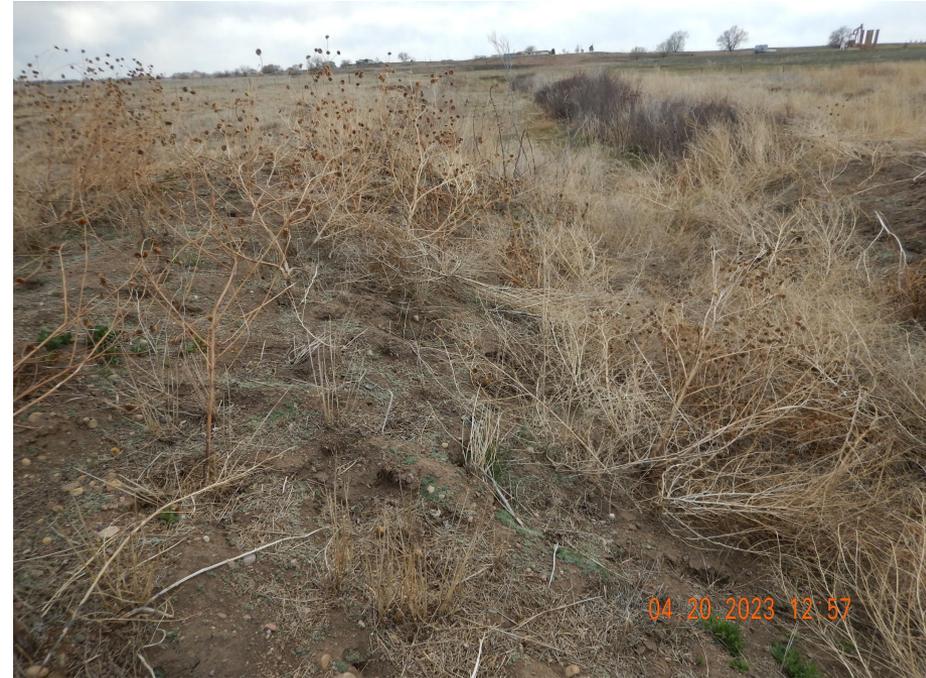
Photo 7. Photo taken from the southern drainage crossing, facing South. This area needs to be recontoured as the bottom is higher than the drainage which could impede flow.
