Inspection Photos

Operator: GENESIS GAS & OIL COLORADO LLC
- 10384

Location Number: 413497
Rio Blanco County, CO

Aaron Trujillo
NW Reclamation Specialist
COGCC

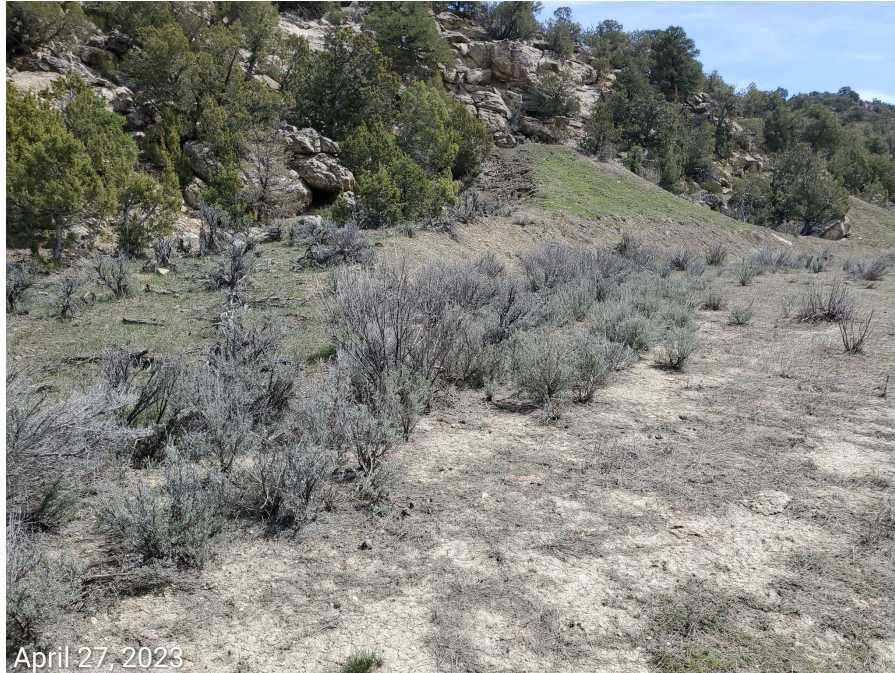
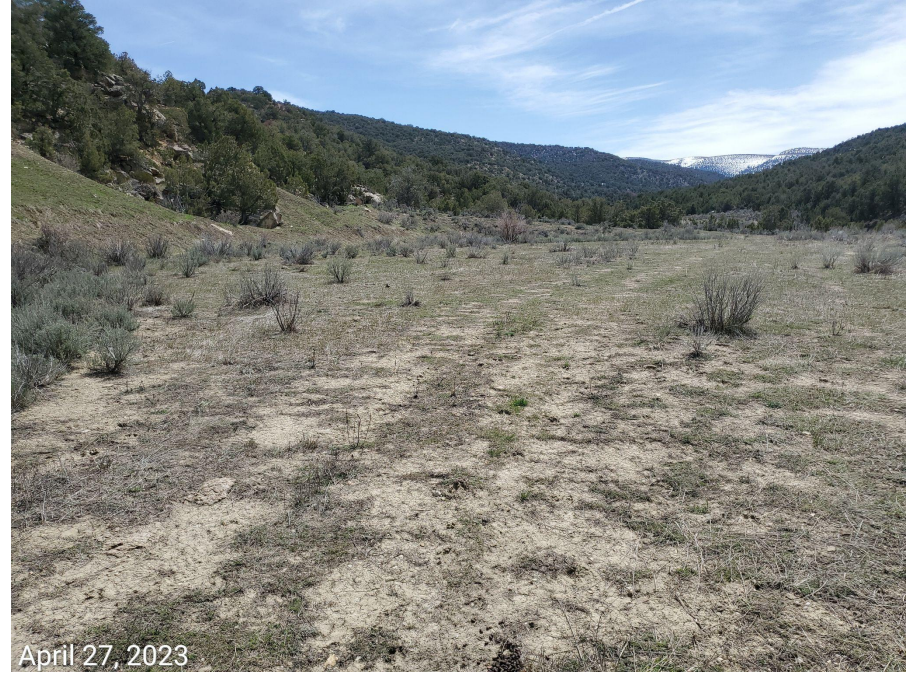
Photo 1: Photos 1-2 taken from the northwest end of the Location. Photos provide an overview of the Location from northeast, southeast, south to southwest. Photos show final reclamation including, but not limited to, compaction alleviation, recontouring/regrading and reclaiming has not been conducted on the Location.

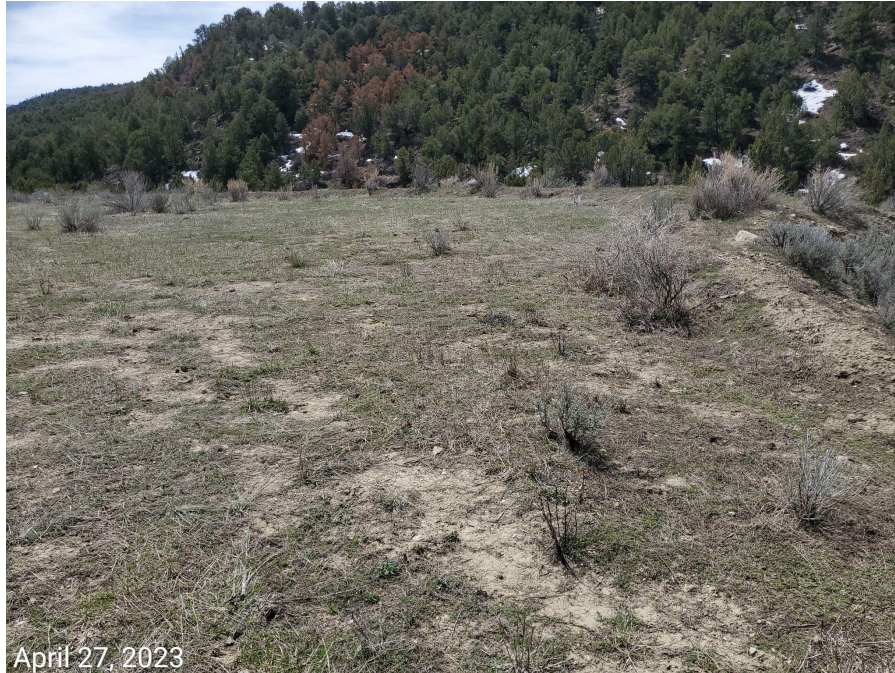
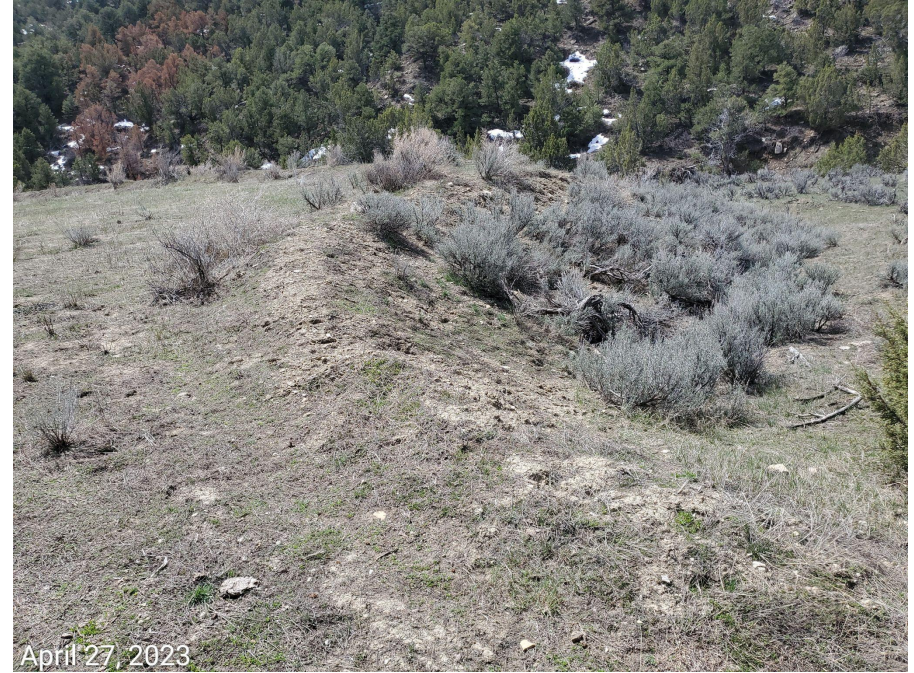
Photo 2: See comments under photo 1.

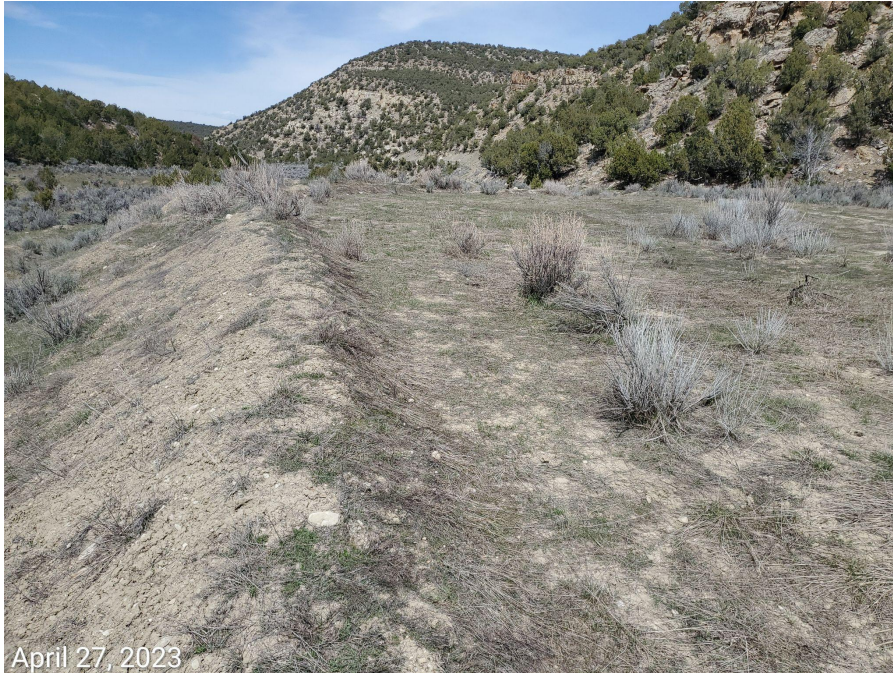
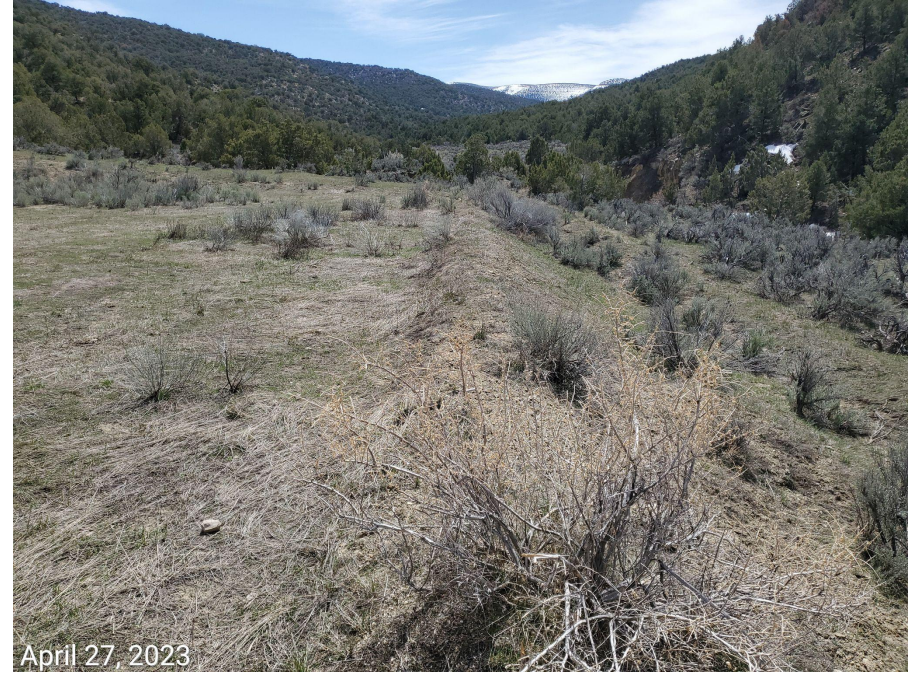
Photo 3: Photos taken from the southwest end of the Location. Photos show fill slopes remaining. Reclamation including, but not limited to, compaction alleviation, recontouring/regrading and reclaiming has not been conducted on the Location.

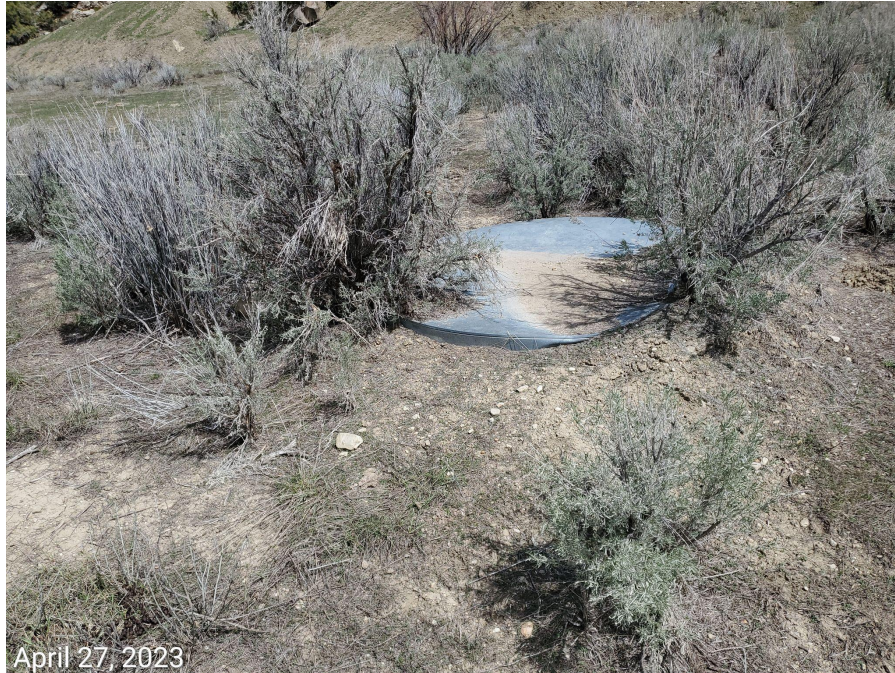
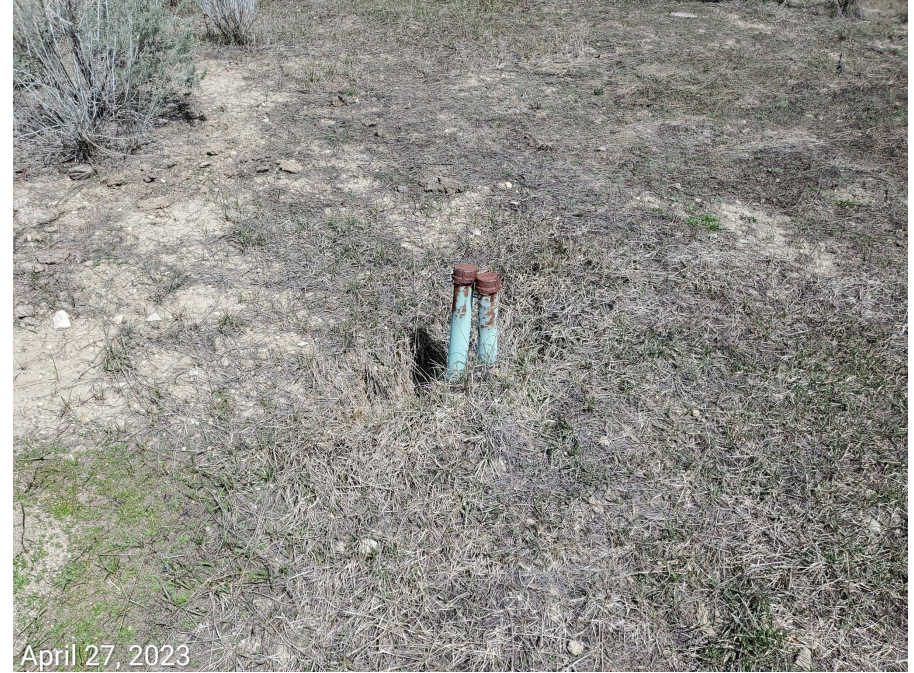
Photo 4: Equipment remaining on Location

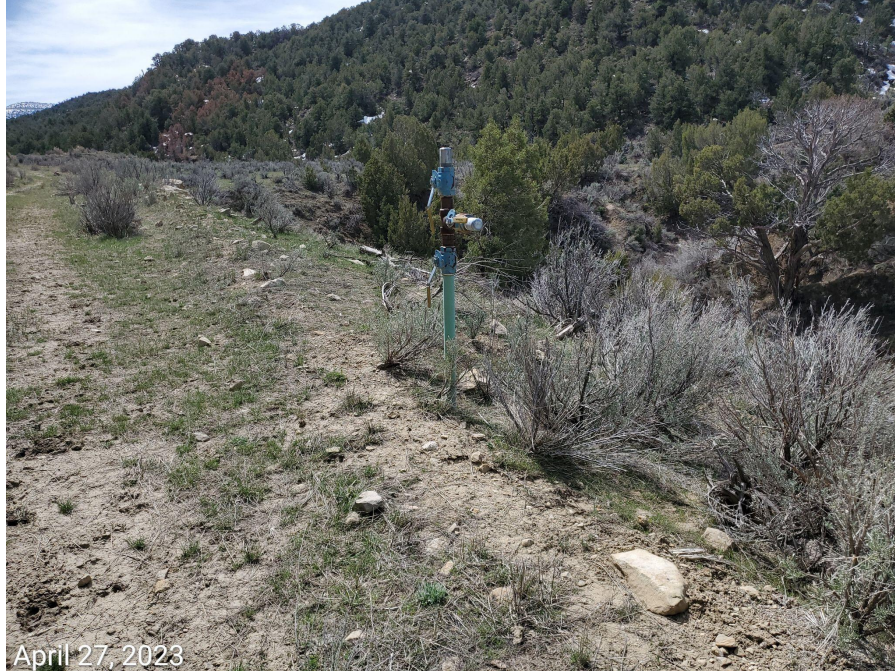
Photo 5: Surface equipment remaining along access road.

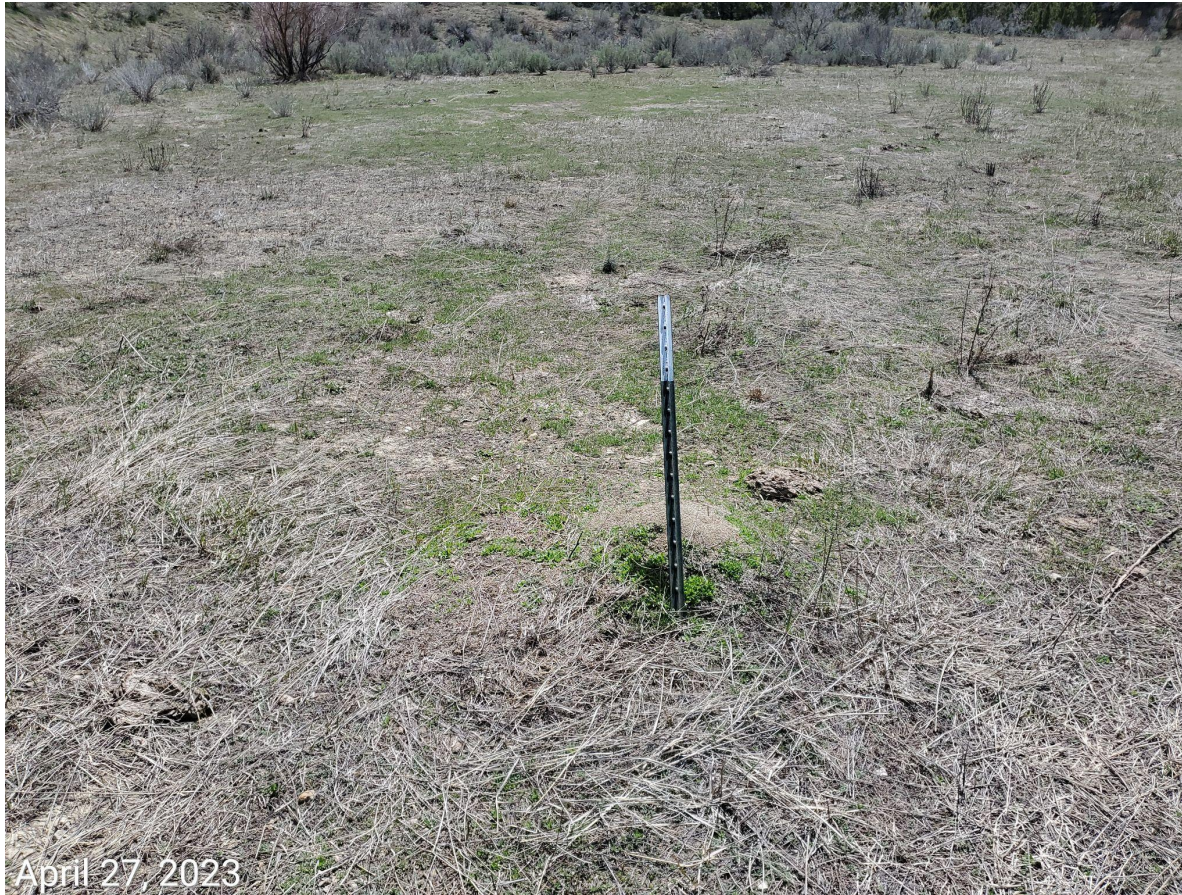
Photo 6: Well marker. Well has not been drilled. All Form 2 and Federal “permits to drill” on file for the Location have expired.

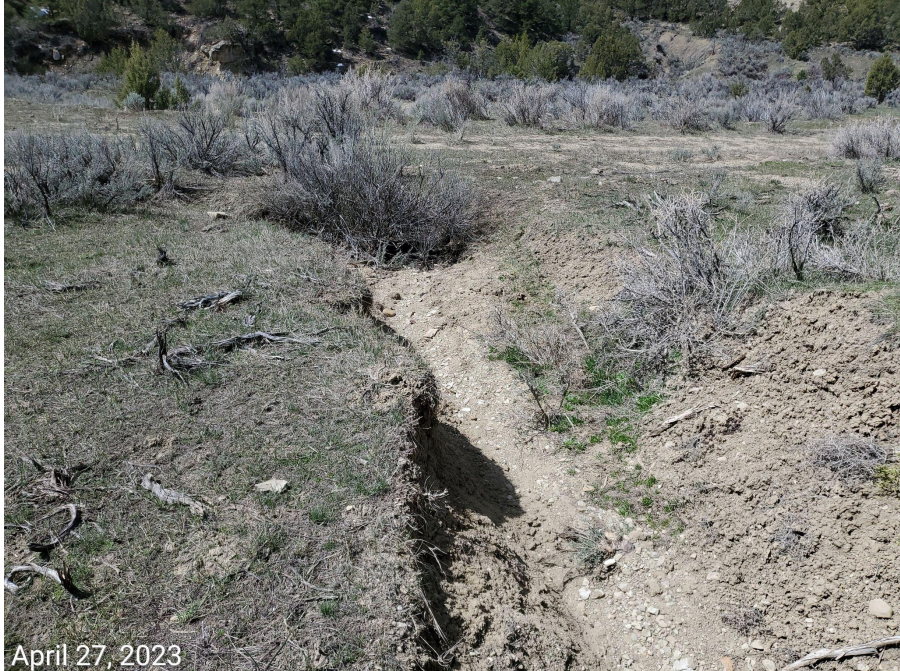
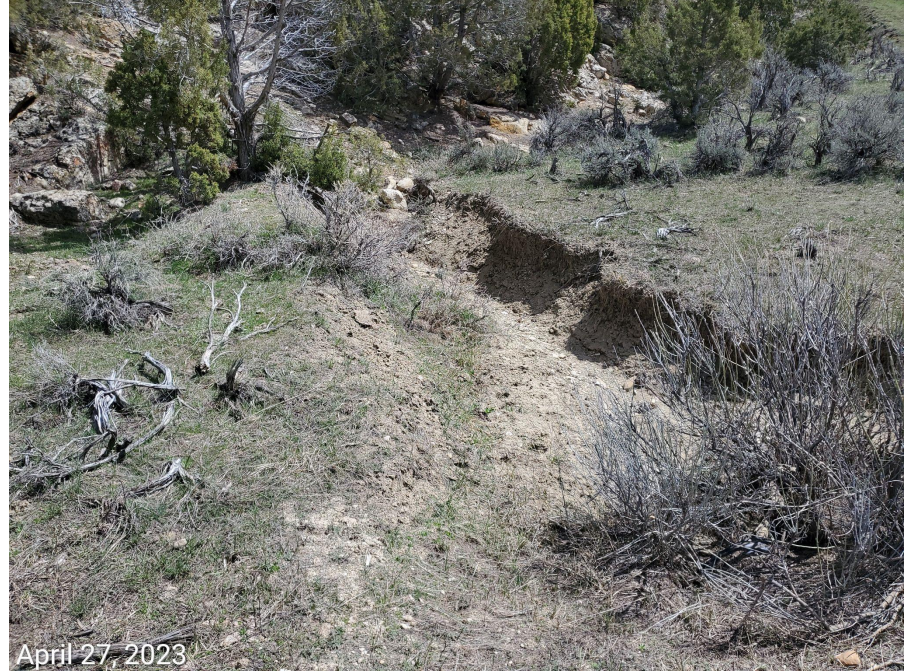
Photo 7: Photo taken from the north end of the Location. Photo shows what appears to be the stormwater run-on ditch along the northern perimeter of the Location. BMP has not been installed per good engineering practices, or maintained in proper functioning condition, and has facilitated gully erosion on the Location. Culvert within ditch appears to have filled with sediment; unable to find outlet.

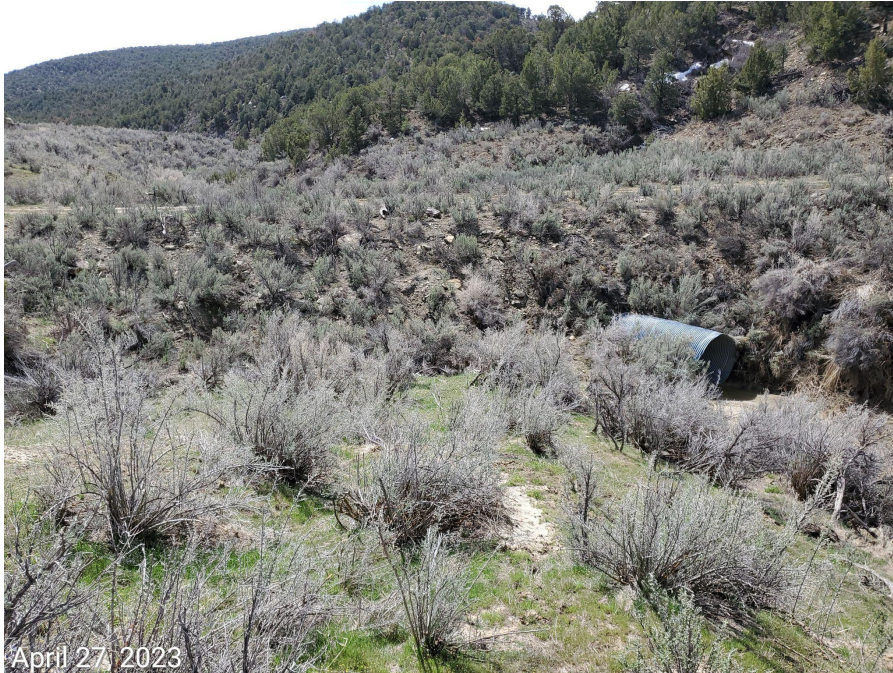
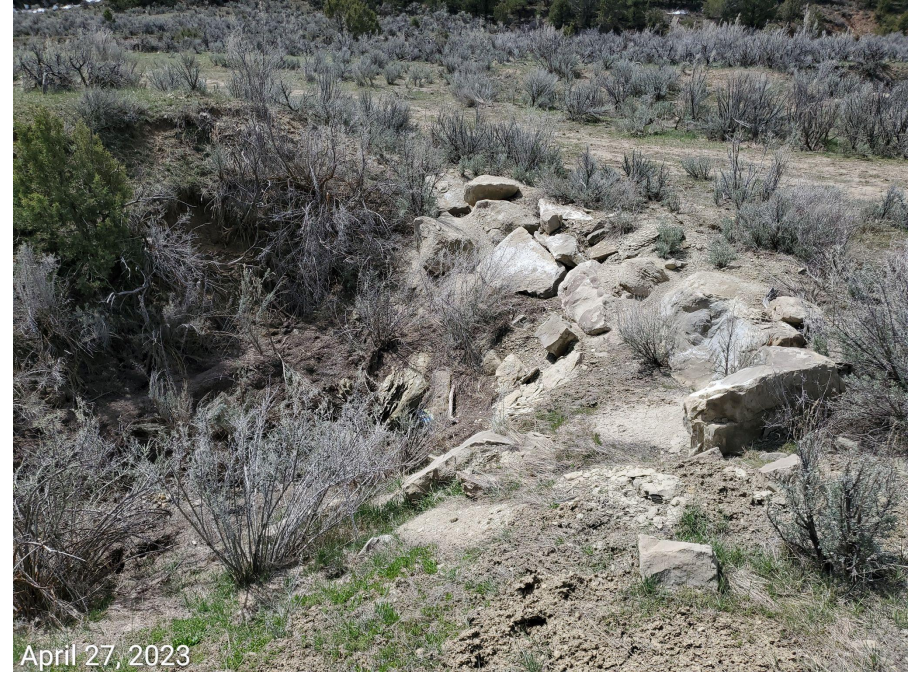
Photo 8: Photos taken from the access road. Photos examples showing final reclamation including, but not limited to, compaction alleviation, recontouring/regrading and reclaiming has not been conducted on the access road. Photos also examples of culverts observed remaining along the access road.

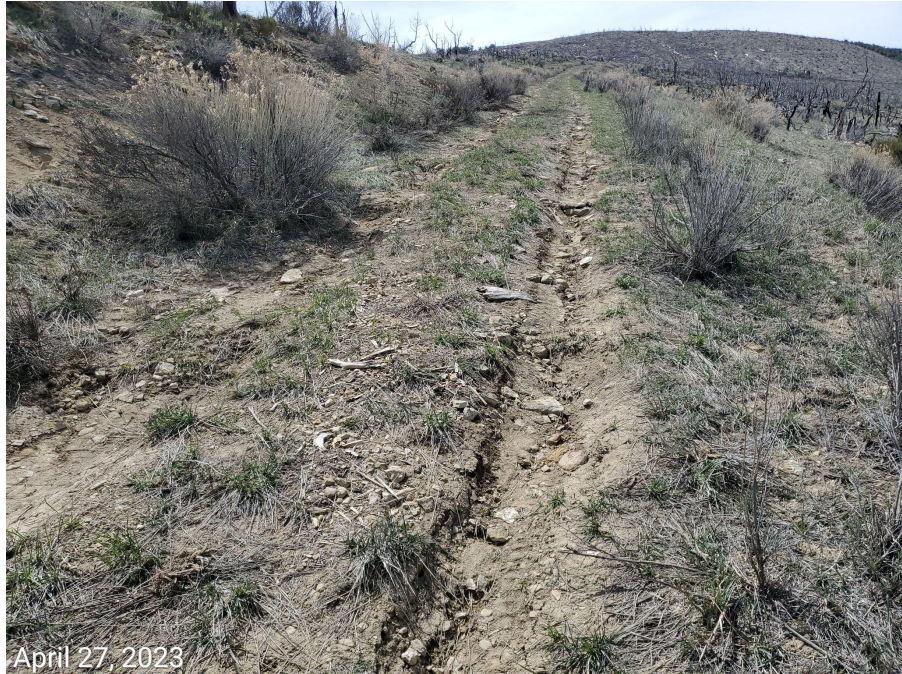
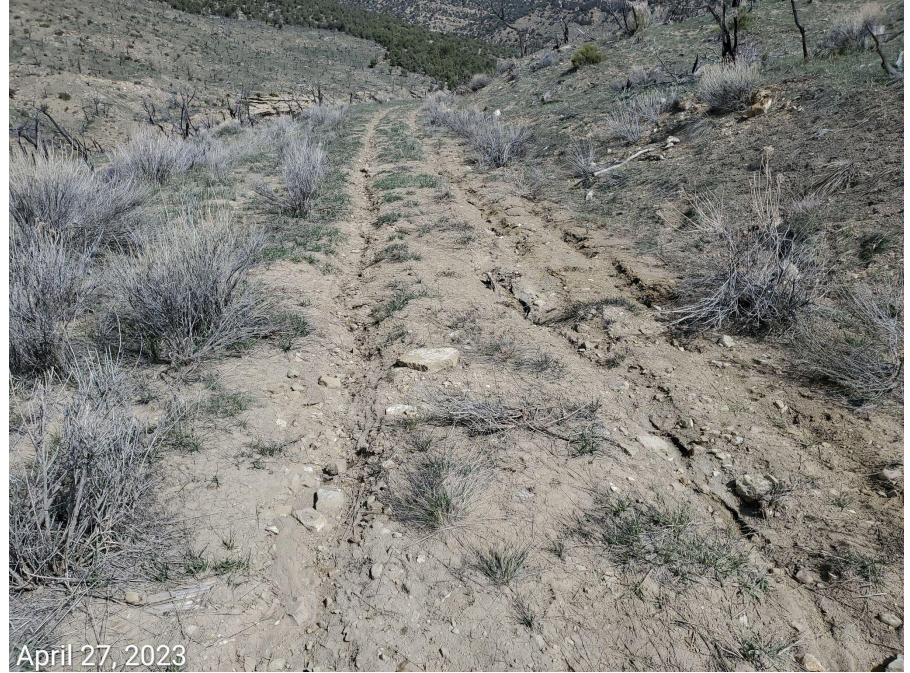
Photo 9: Photos 9-15 taken from the access road. Photos examples showing final reclamation including, but not limited to, compaction alleviation, recontouring/regrading and reclaiming has not been conducted on the entire access road. Photos also show erosion degradation at access road due to inadequate stormwater management and slope stabilization. Access road intersects with Co Rd 122 at 40.076157°/-108.637129°.

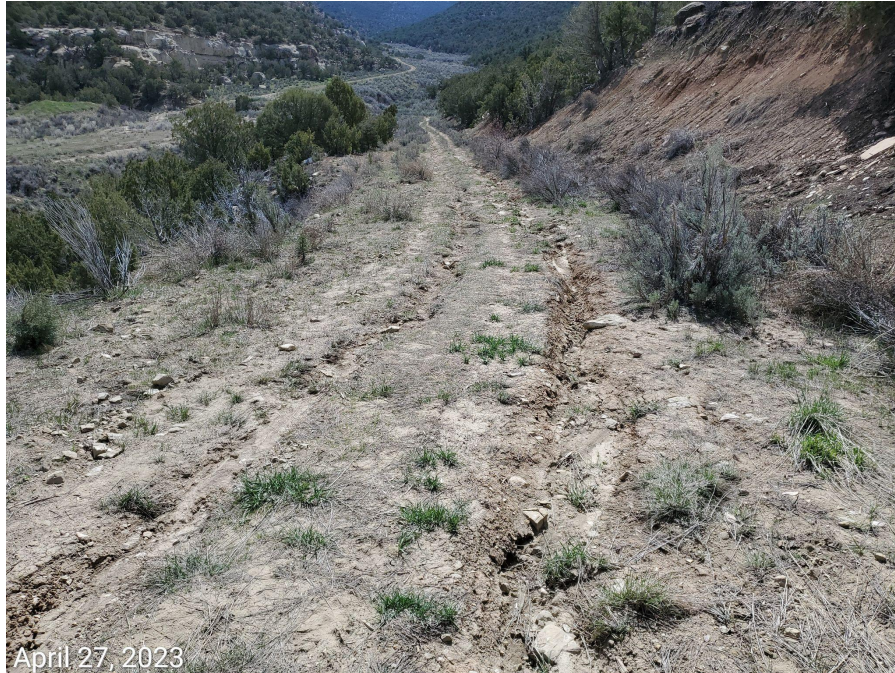
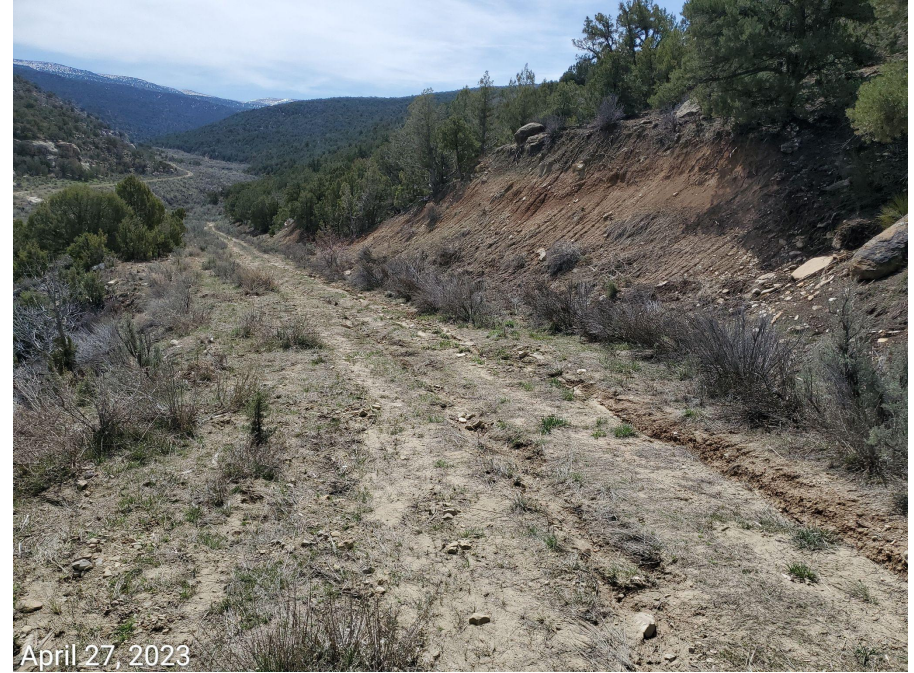
Photo 10: See comments under photo 9. Photo shows erosion degradation observed along cutslopes of the access road; slopes lack stabilization.

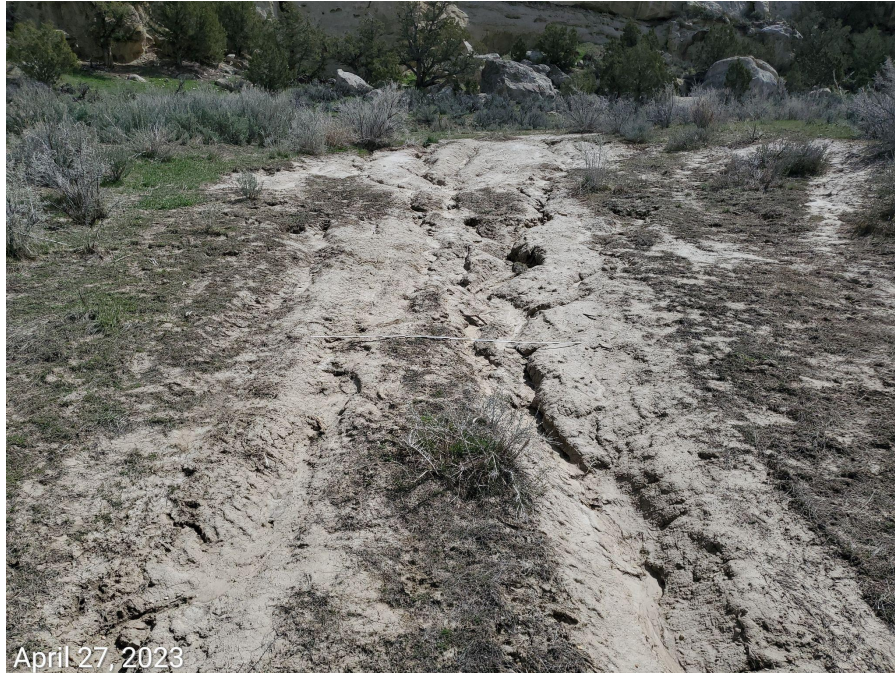
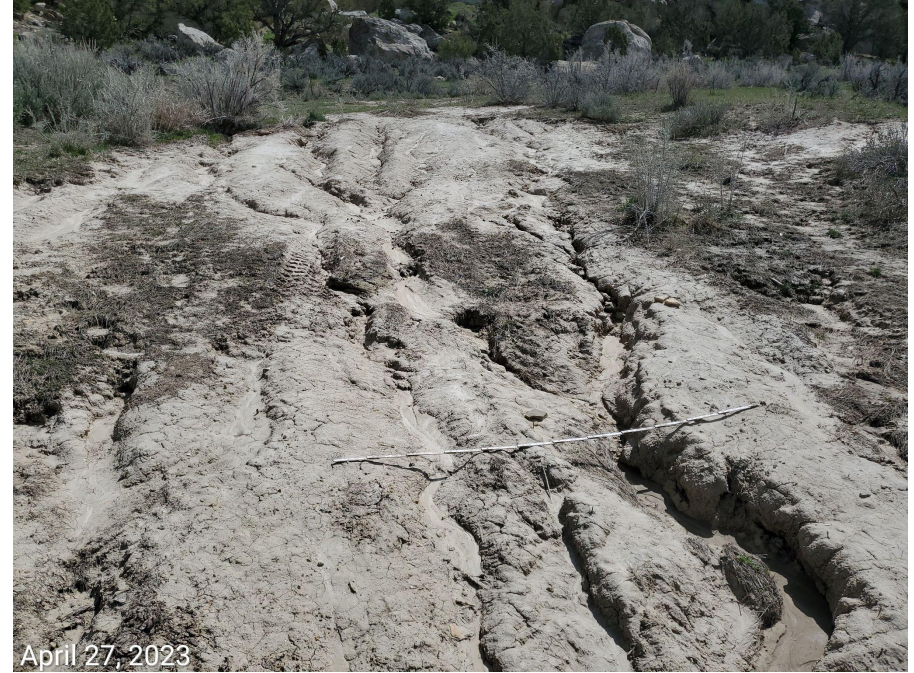
Photo 11: See comments under photo 9. 6 foot measuring stick for reference.

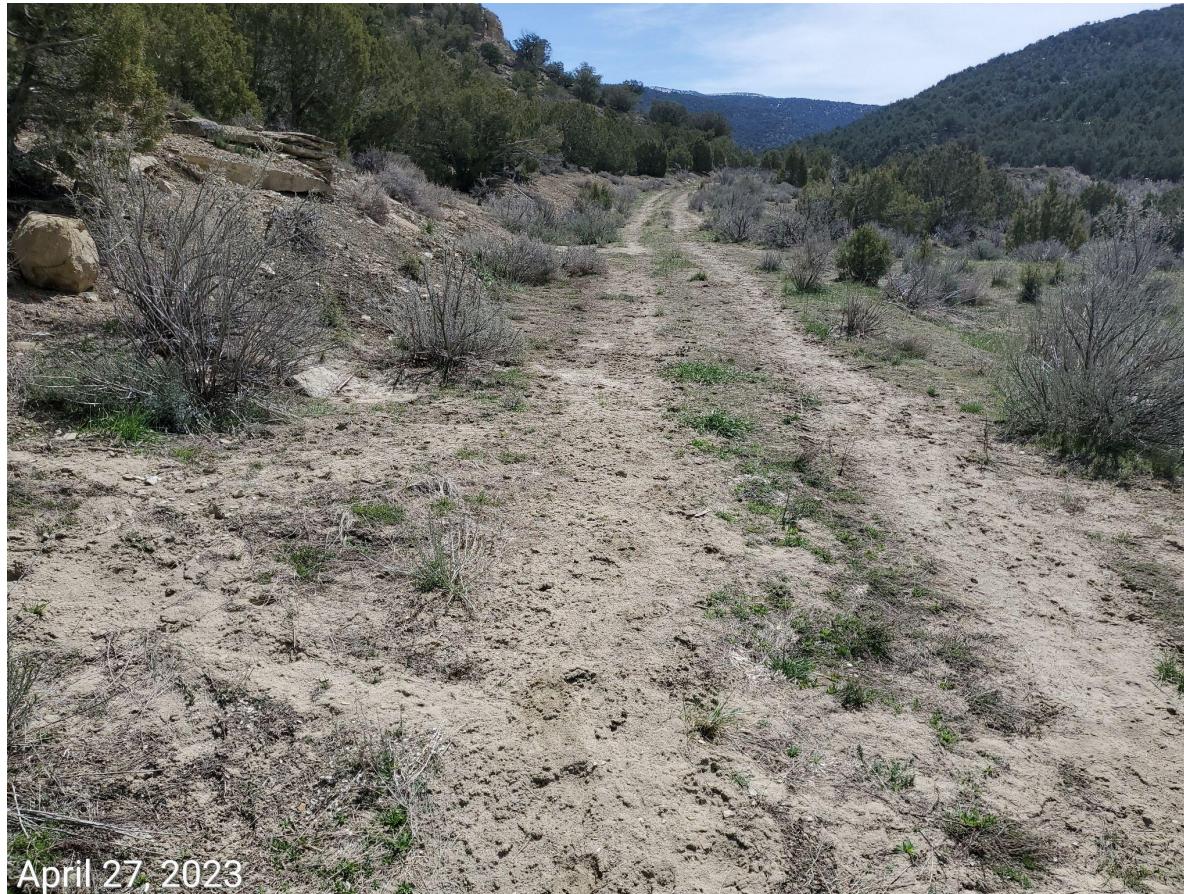
Photo 12: See comments under photo 9

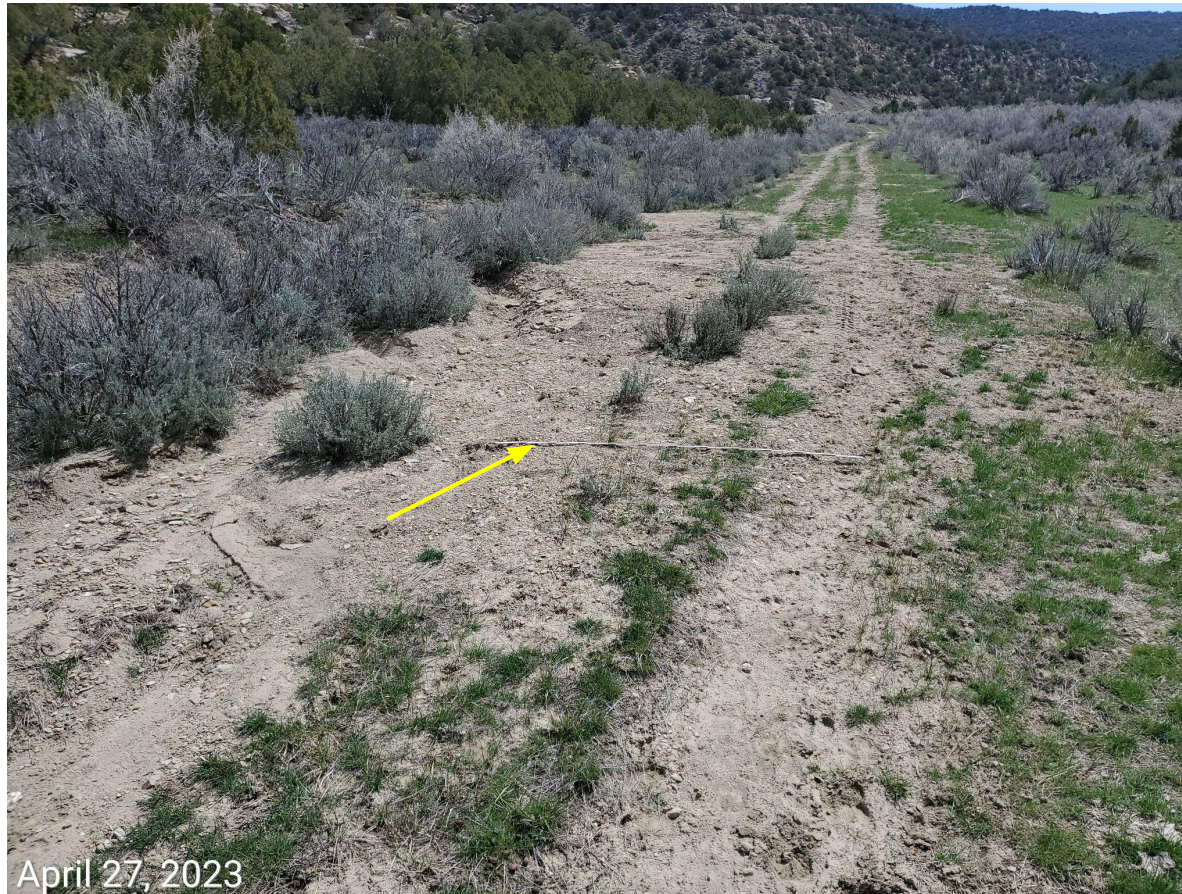
Photo 13: See comments under photo 9. Photo shows sediment deposition onto the access road due to inadequate stormwater run-on BMPs. 6 foot measuring stick for reference.

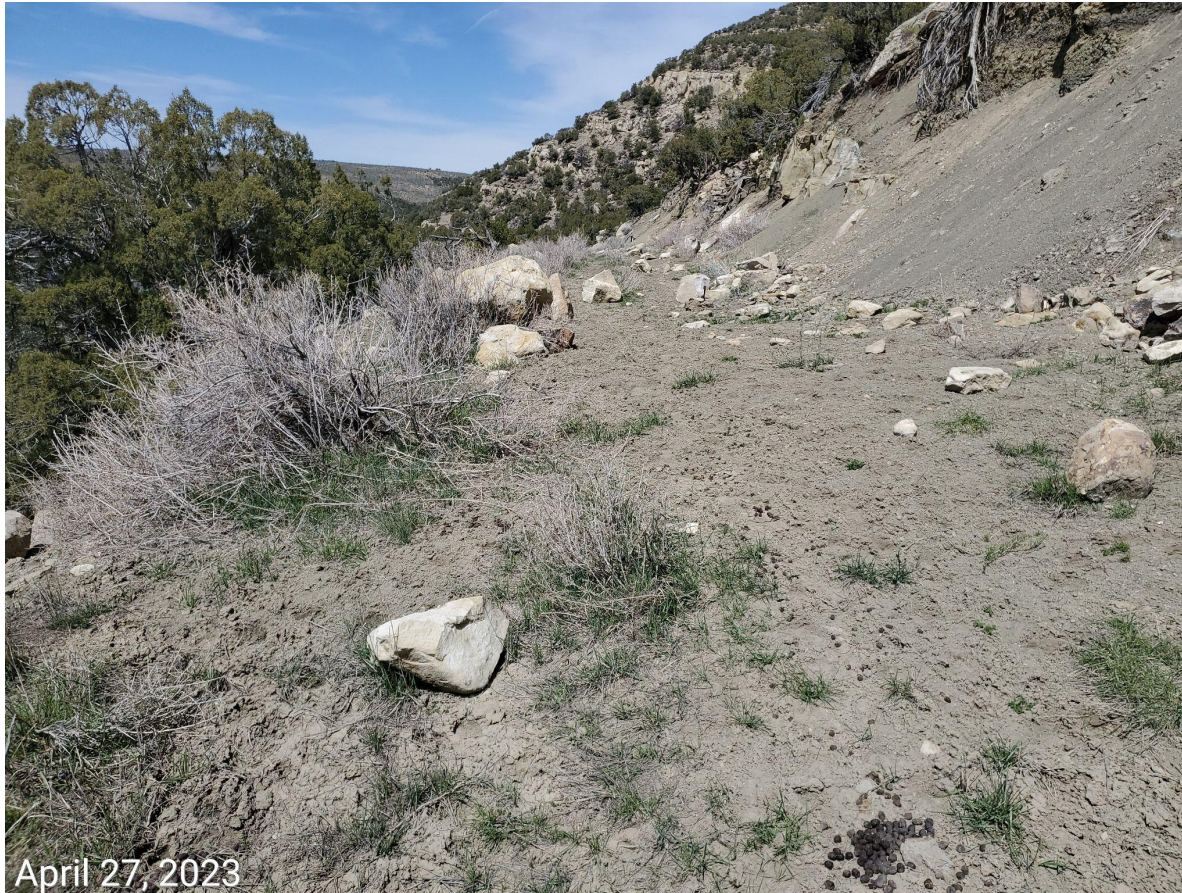
Photo 14: See comments under photo 9. Photo shows rock-falls from the unstabilized slopes has rendered the Location inaccessible by vehicle.

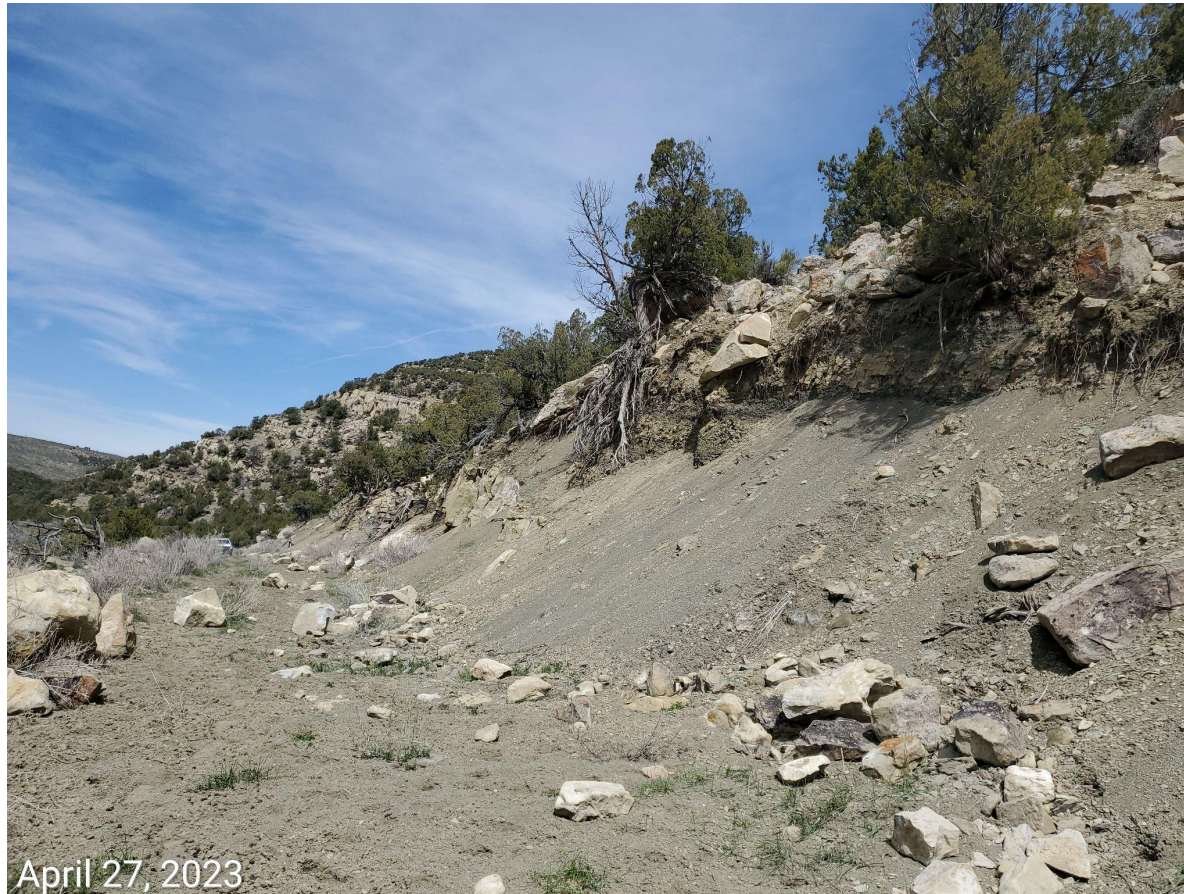
Photo 15: See comments under photo 9. Photo shows rock-falls from the unstabilized slopes has rendered the Location inaccessible by vehicle.

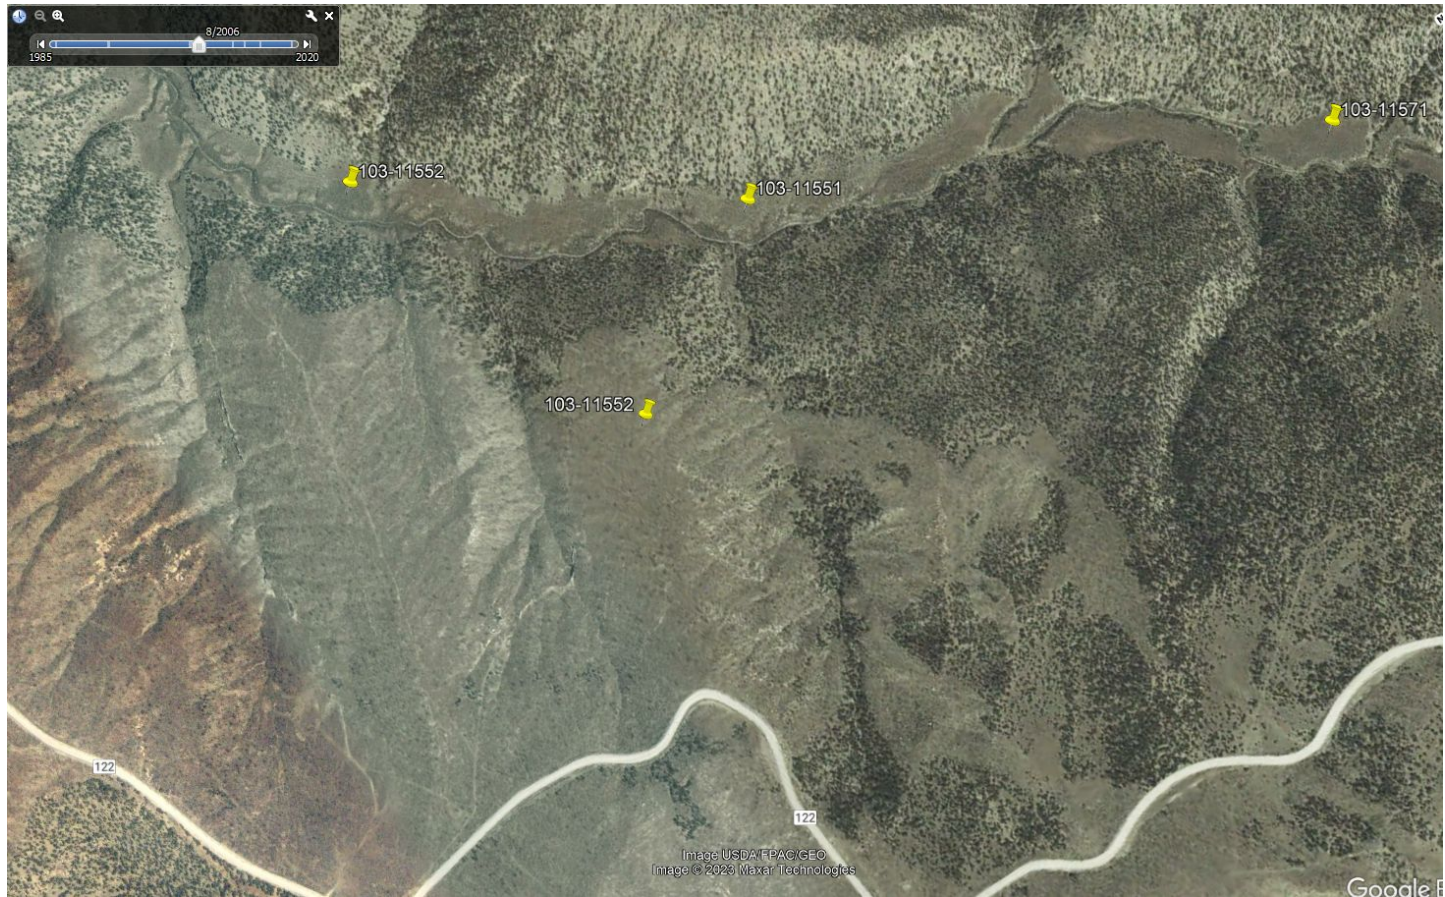
Photo 16: 2006 Google Earth aerial imagery showing the 4 expired Genesis Locations within the Fletcher Gulch Drainage, prior to construction of the Locations and access road—access roads did not exist prior to O&G disturbance.

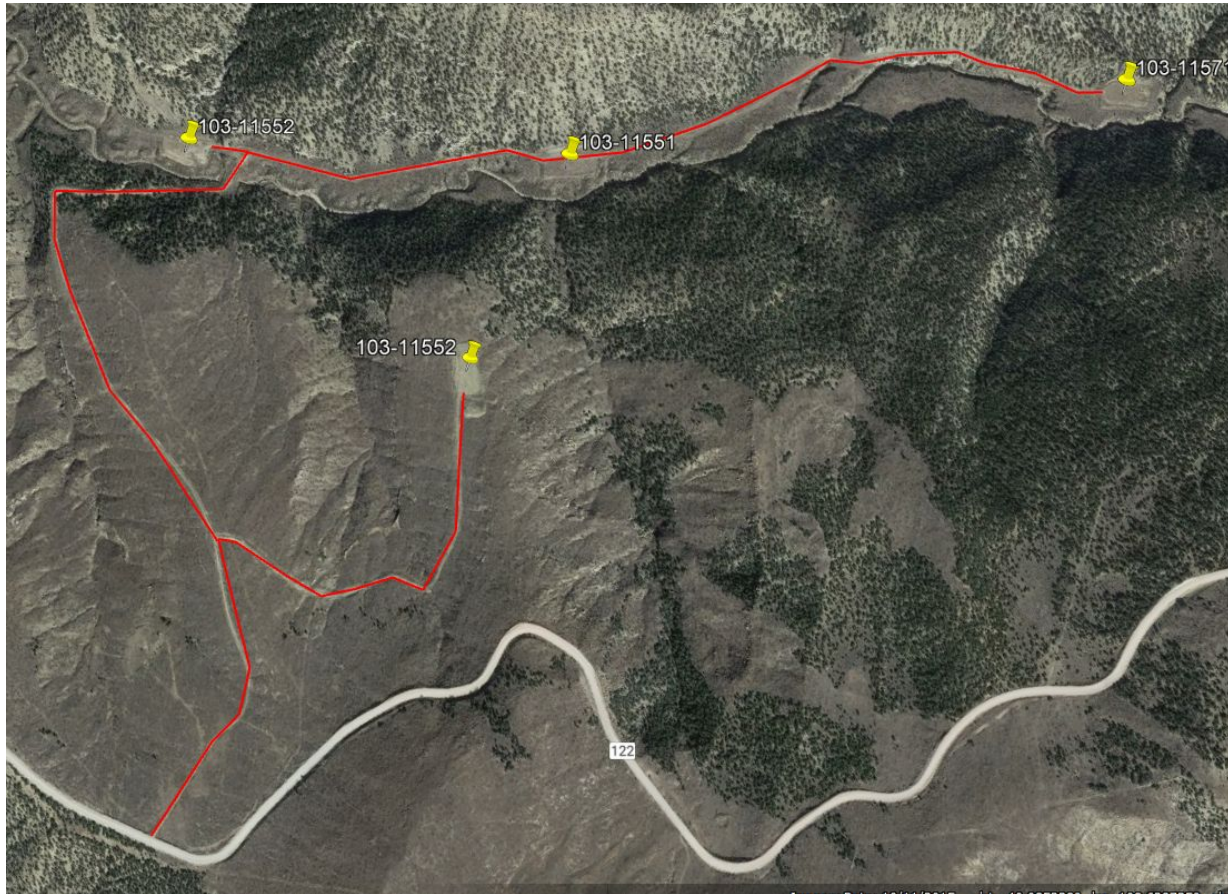
Photo 17: Google Earth aerial imagery showing the 4 expired Genesis Locations constructed within the Fletcher Gulch Drainage, and the access road(s) leading to the Locations (accessed via Co. Rd 122). Locations/Access roads subject to 1004 Reclamation.
