Inspection Photos

4/27/2023

Operator: GENESIS GAS & OIL COLORADO LLC
- 10384

Location Number: 413496
Rio Blanco County, CO

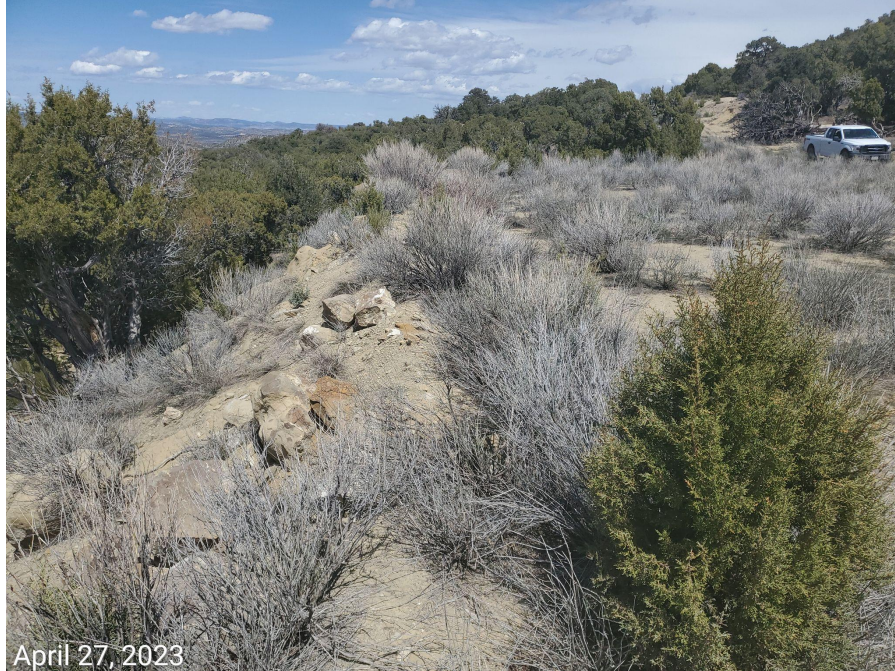
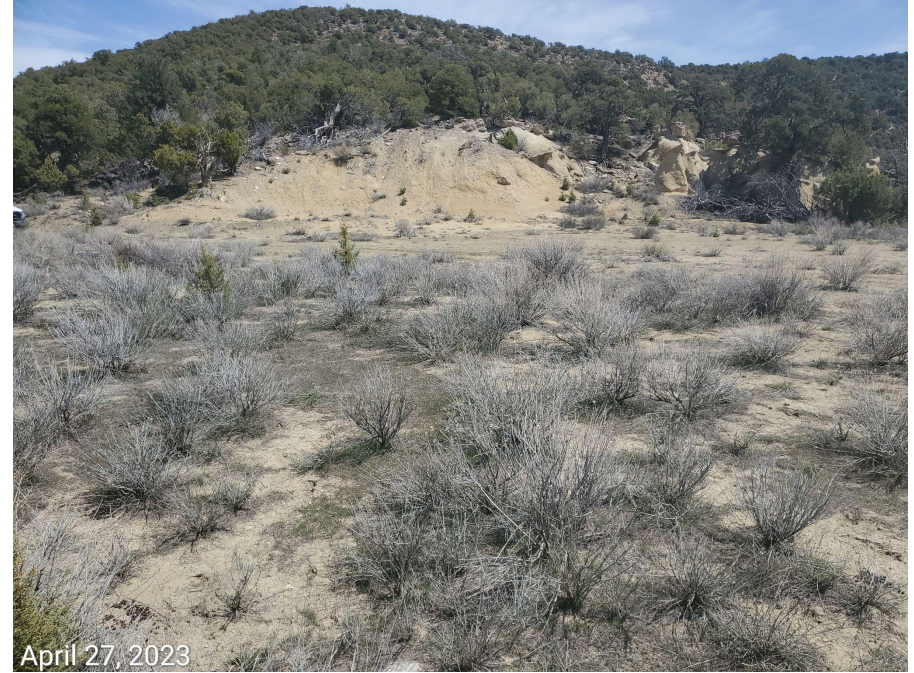
Photo 1: Photos 1-2 taken from the northwest end of the Location. Photos provide an overview of the Location from northeast, southeast, south to southwest. Photos show final reclamation including, but not limited to, compaction alleviation, recontouring/regrading and reclaiming has not been conducted on the Location.

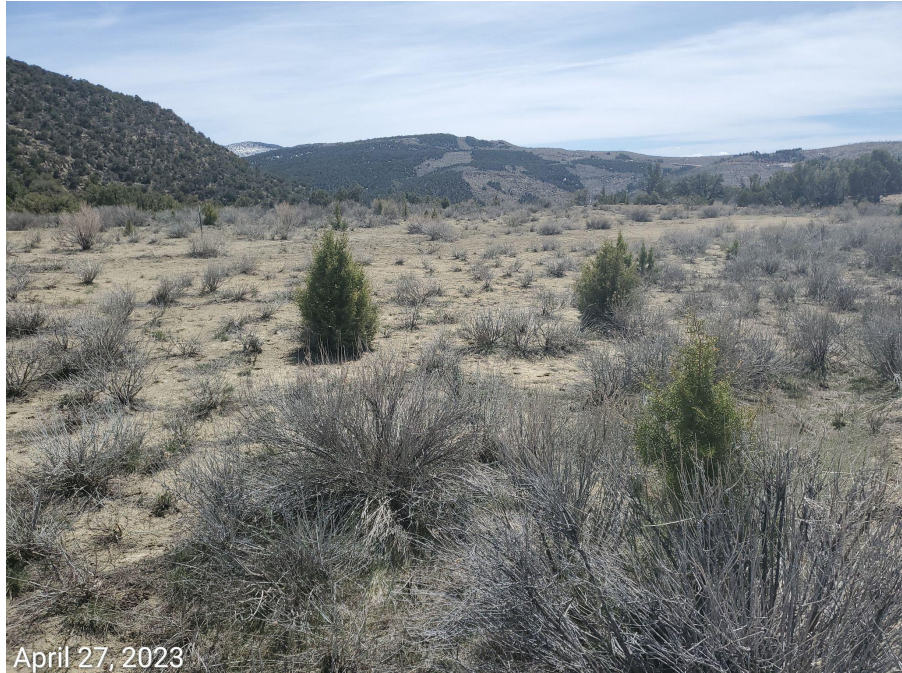
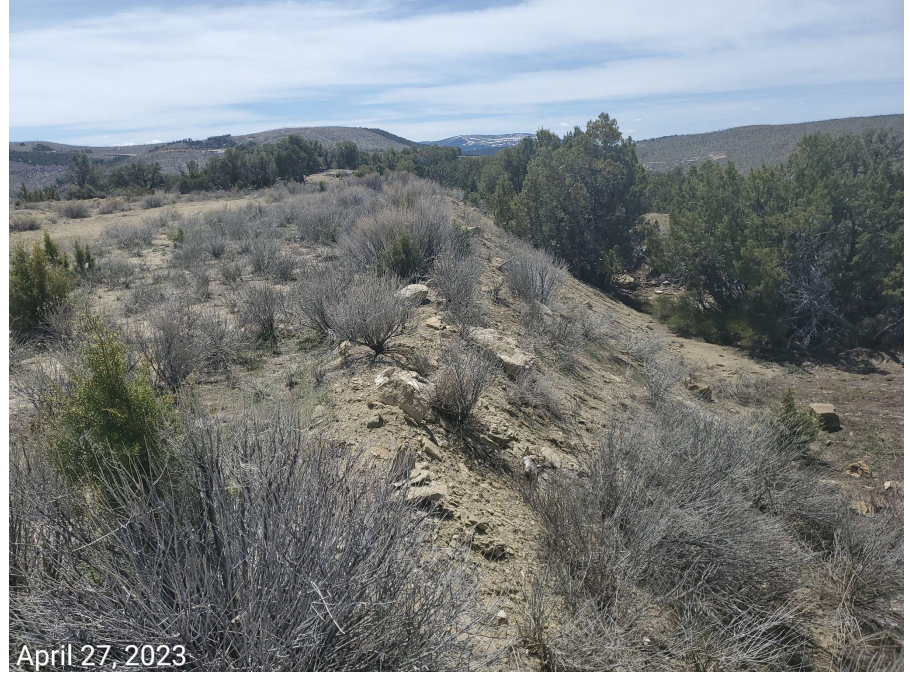
Photo 2: See comments under photo 1.

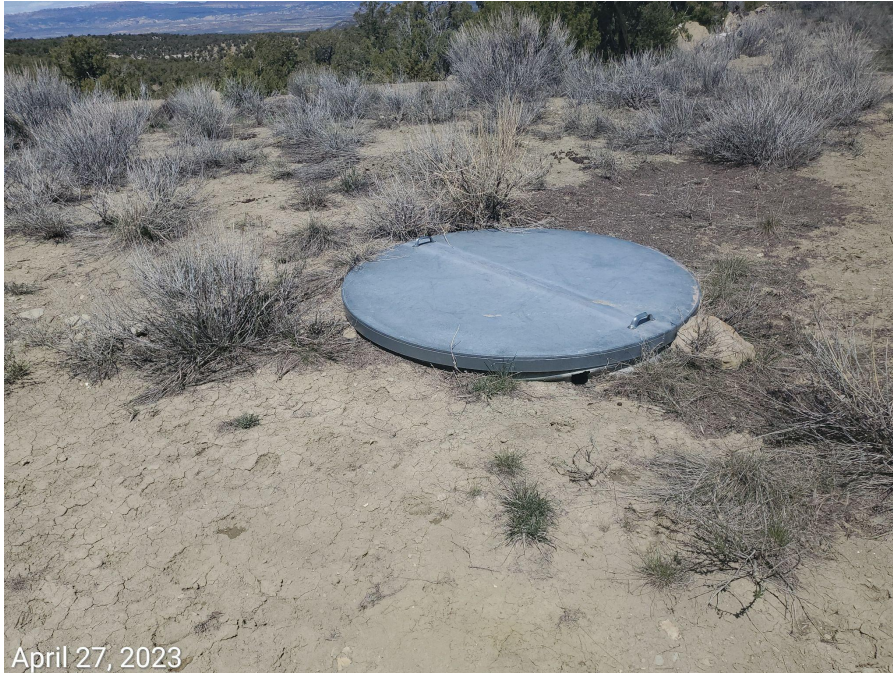
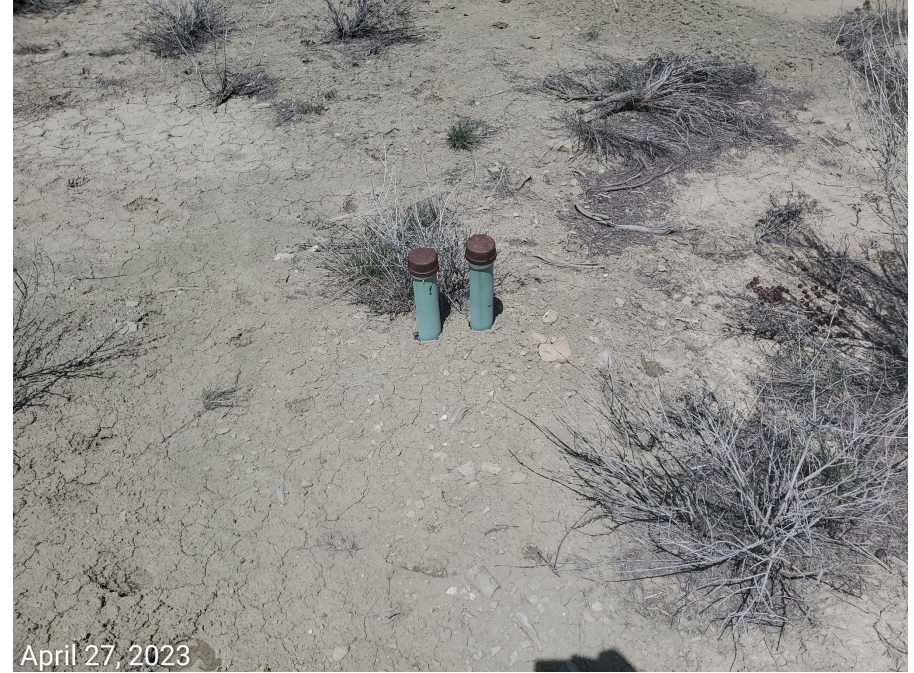
Photo 3: Photo of equipment remaining on the Location.

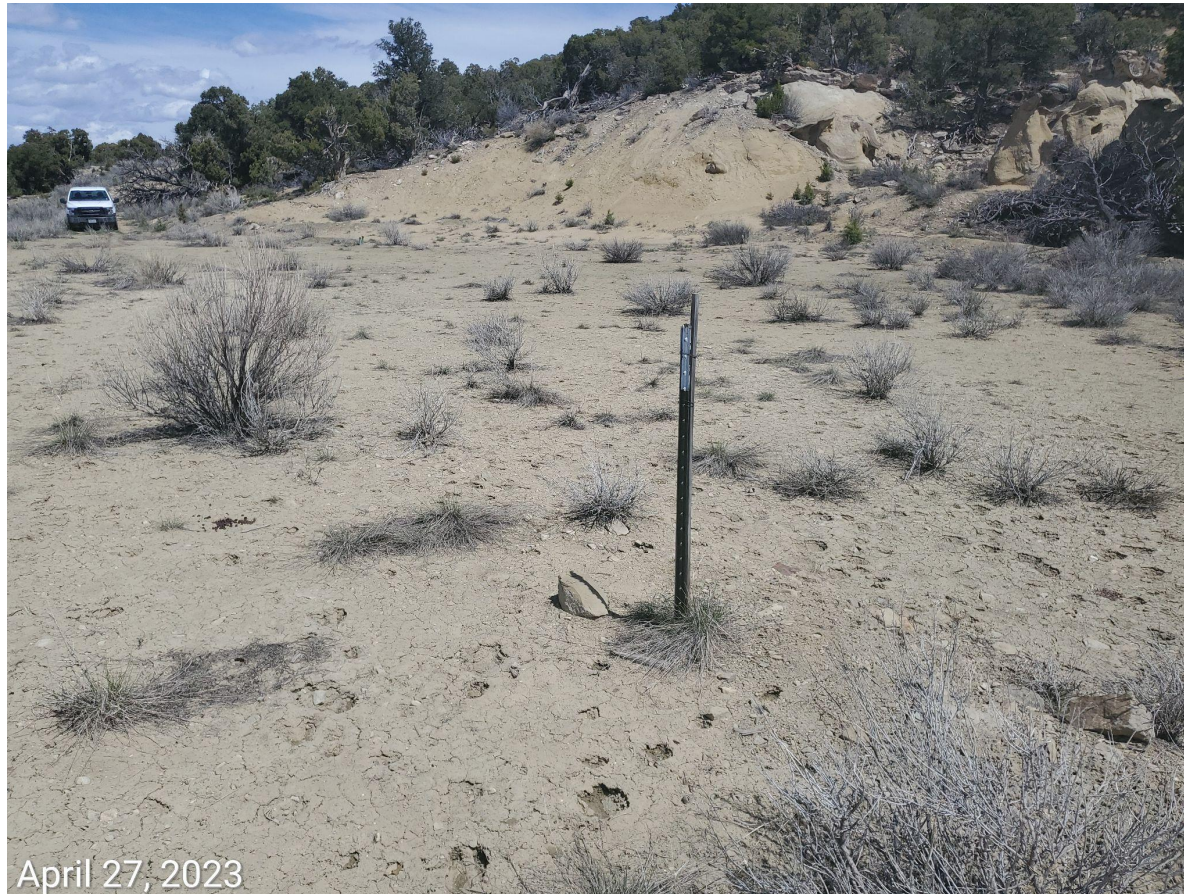
Photo 4: Photo shows well marker. Well has not been drilled. All Form 2 and Federal permits to drill have expired.

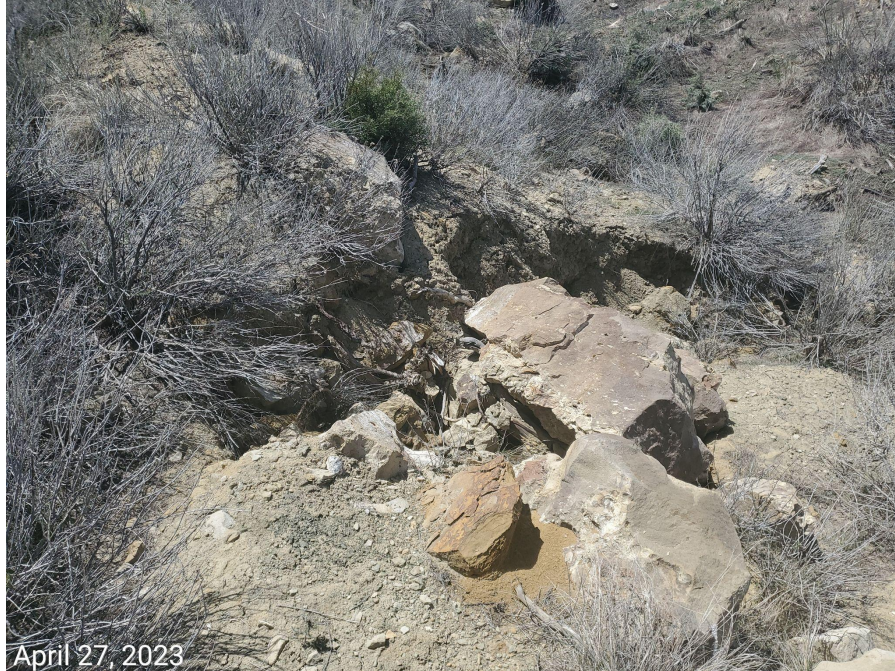
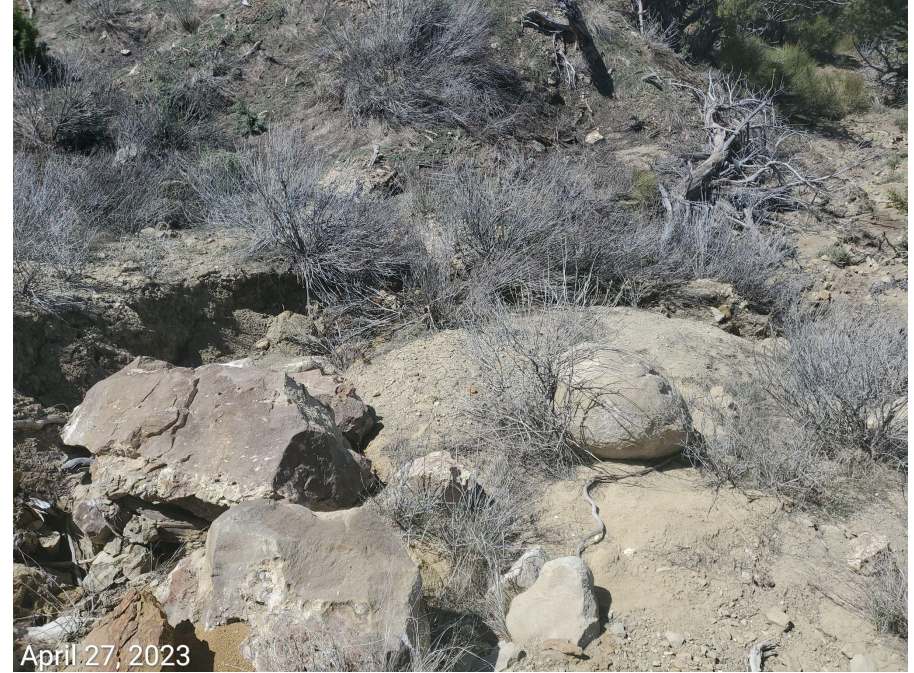
Photo 5: Photos taken from the north end of the Location. Photo shows stormwater runoff from the location has resulted in gully erosion at the slopes of the Location; BMPs to allow for proper stormwater discharge in such a manner as to minimize erosion, degradation and off-site sediment transport inadequate.

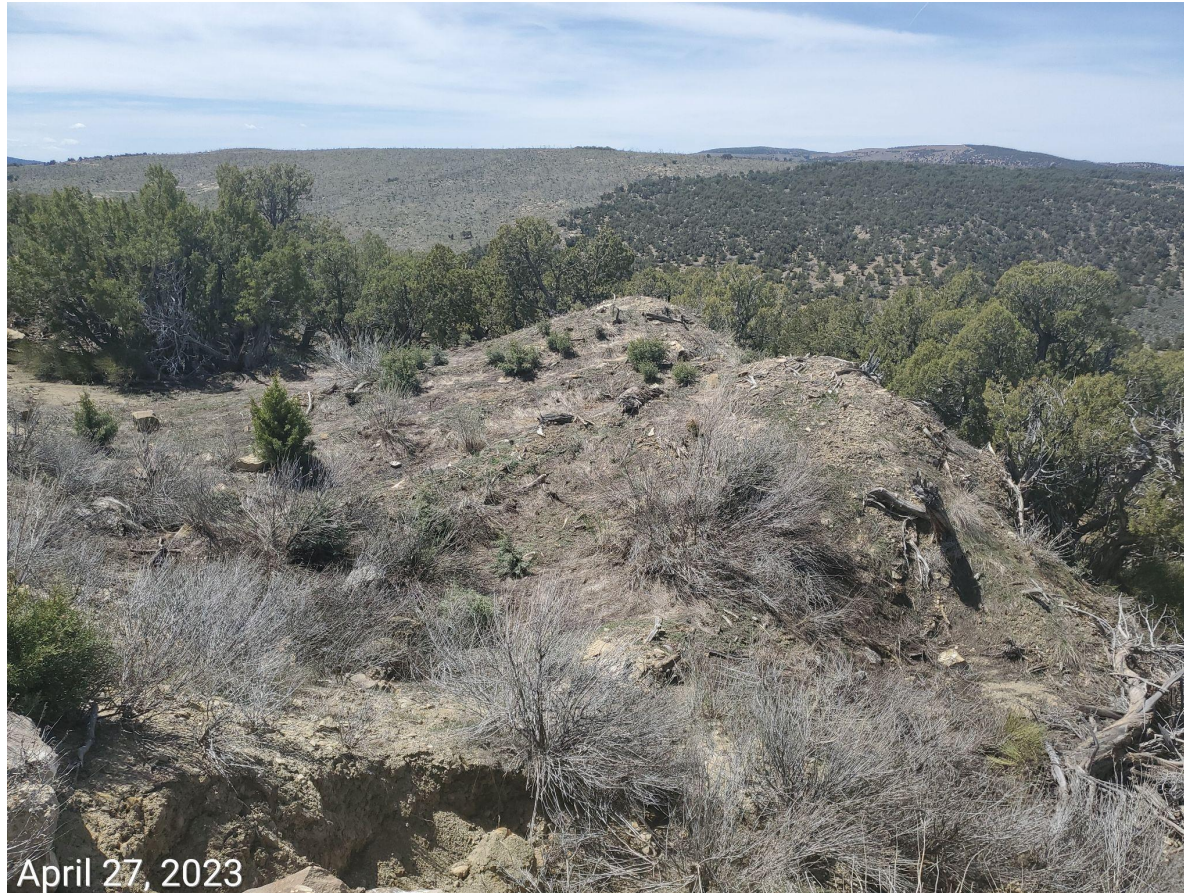
Photo 6: Soil stockpiles on the north end of the Location.

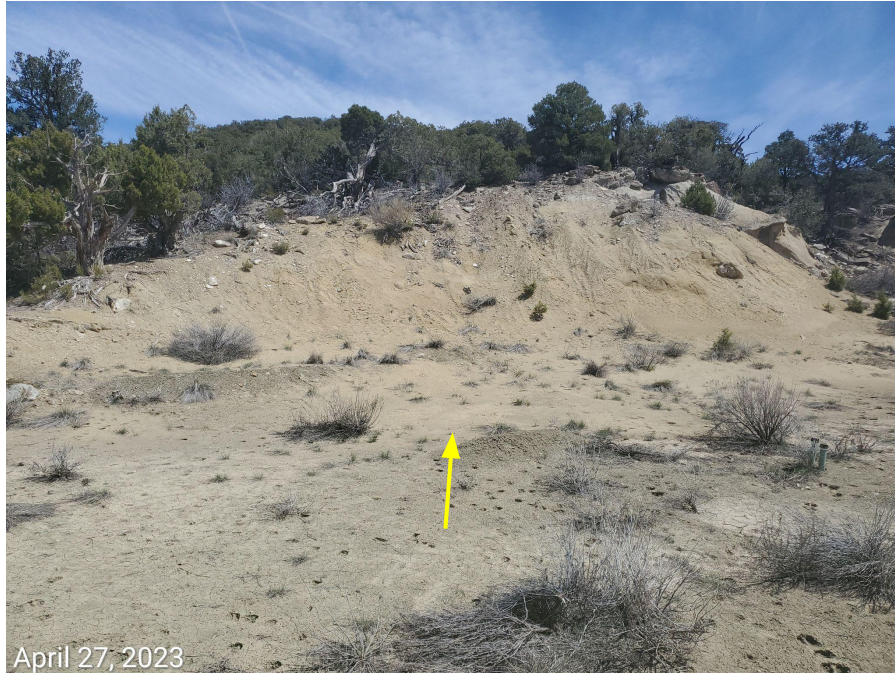
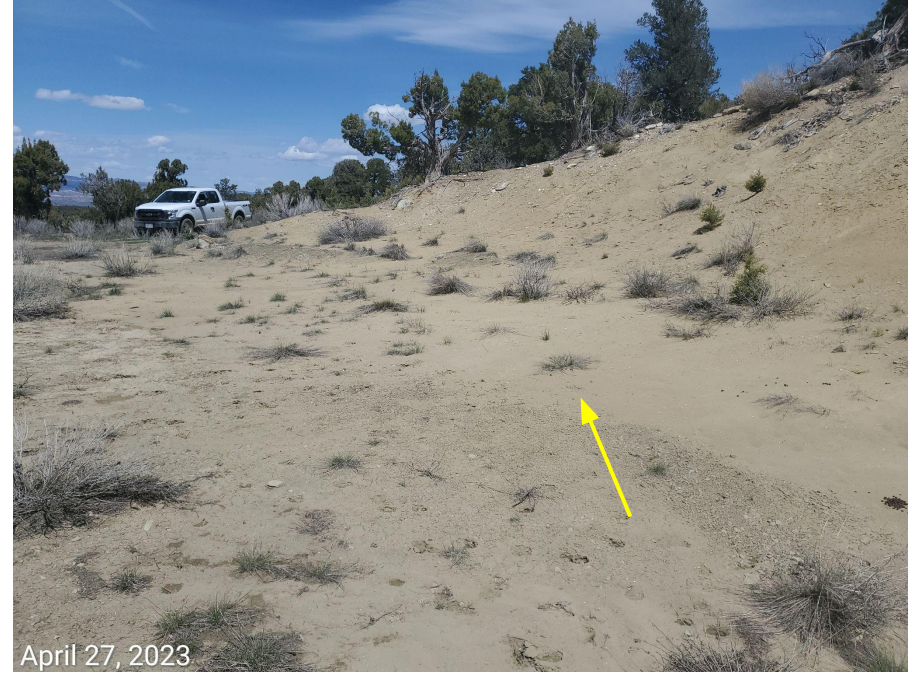
Photo 7: Photos taken from the cut slopes on the northeast end on the Location. Photos examples showing cut slopes lack stabilization. BMPs to minimize erosion, degradation and sediment transport missing or insufficient. Lighter soils observed at base of slopes is sediment deposition due to unstabilized cut slopes.

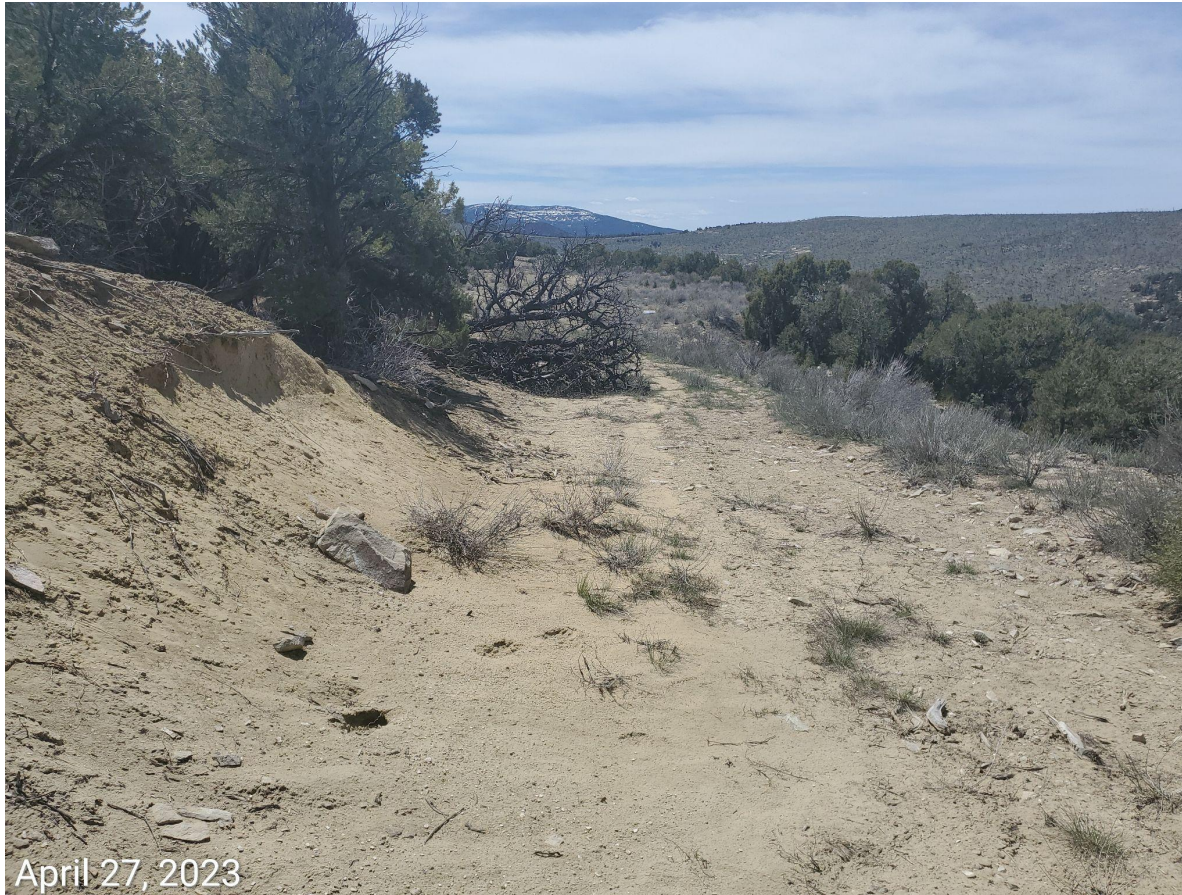
Photo 8: Photo taken from the access road. Fallen tree partially blocking access road. Photo also example showing cut slopes of the access road lack stabilization, resulting in erosion degradation and sediment deposition onto the road.

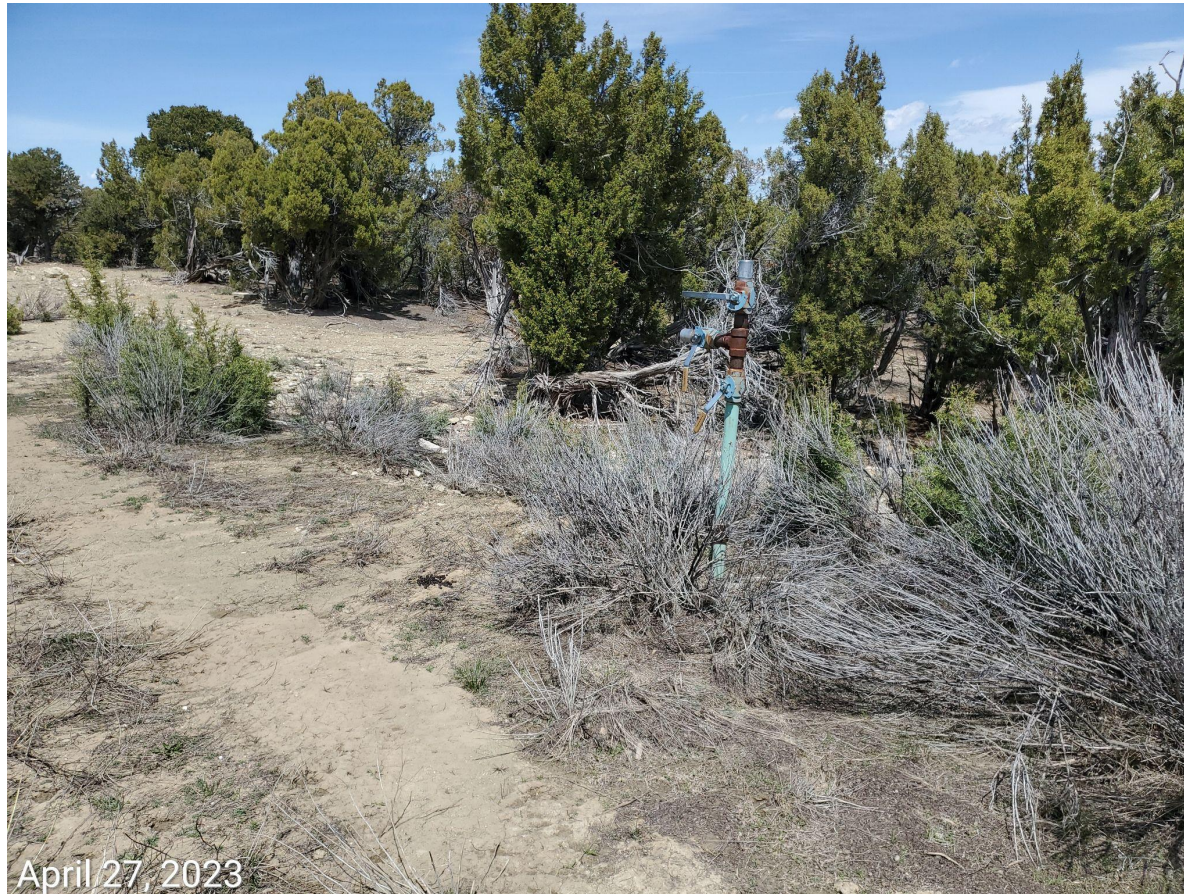
Photo 9: Example of surface equipment remaining along access road.

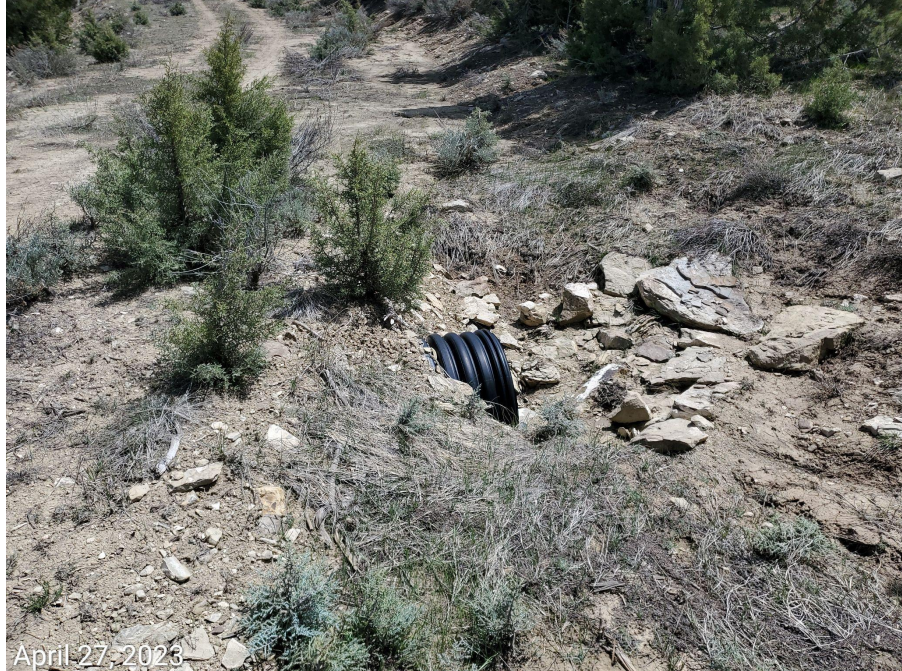
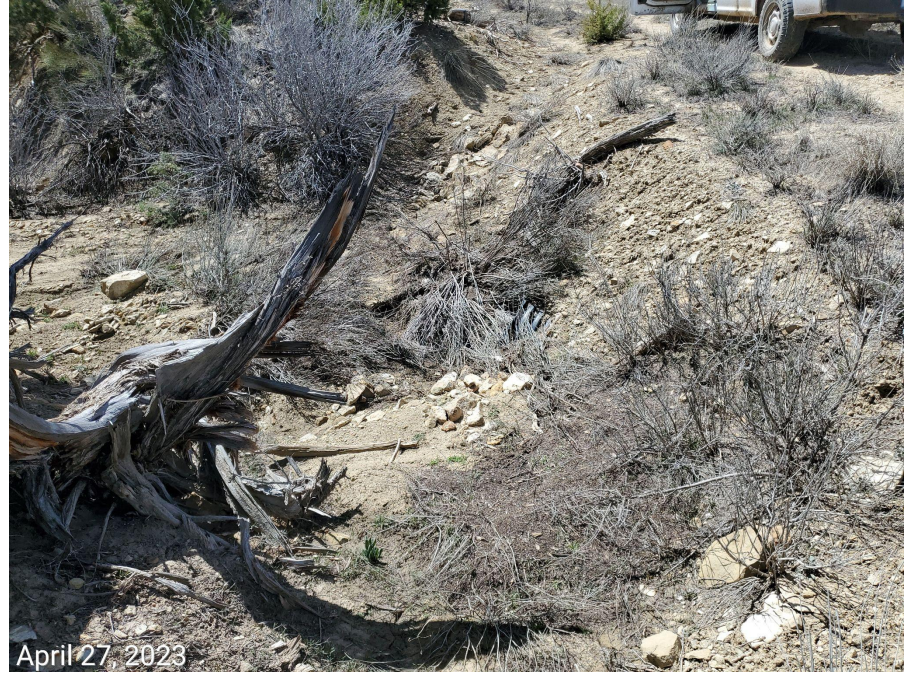
Photo 10: Photos taken from the access road. Photos examples showing final reclamation including, but not limited to, compaction alleviation, recontouring/regrading and reclaiming has not been conducted on the access road. Photos also examples of culverts observed remaining along the access road.

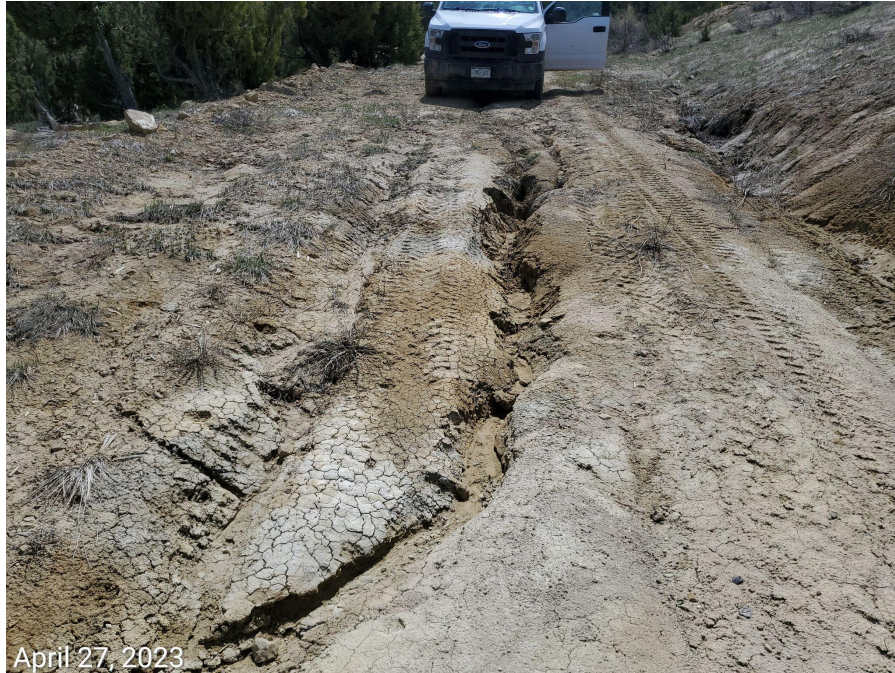
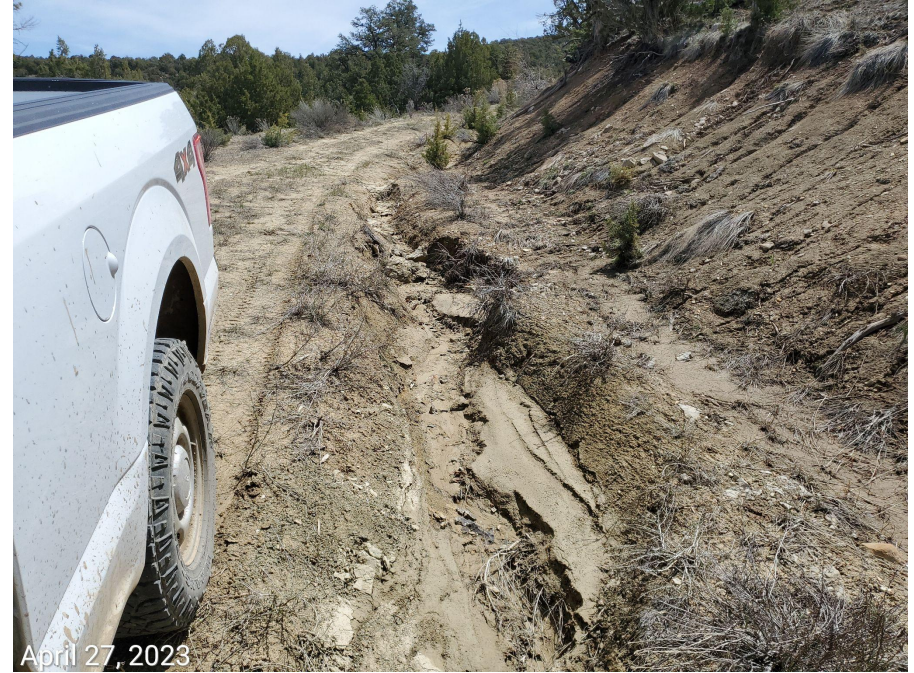
Photo 11: Photos 11-13 taken from the access road. Photos examples showing final reclamation including, but not limited to, compaction alleviation, recontouring/regrading and reclaiming has not been conducted on the entire access road. Photos also show erosion degradation at access road due to inadequate stormwater management and slope stabilization.

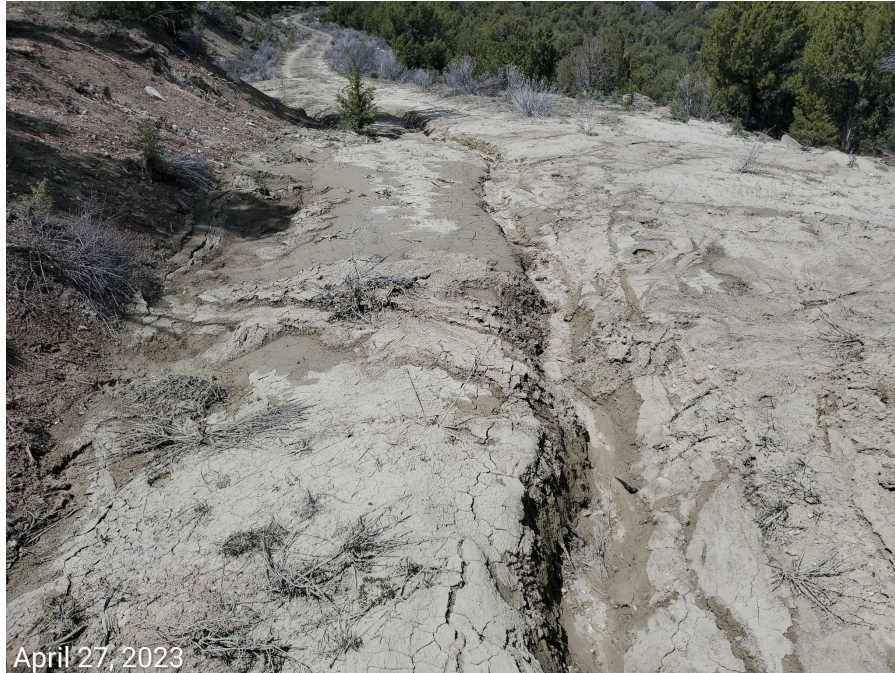
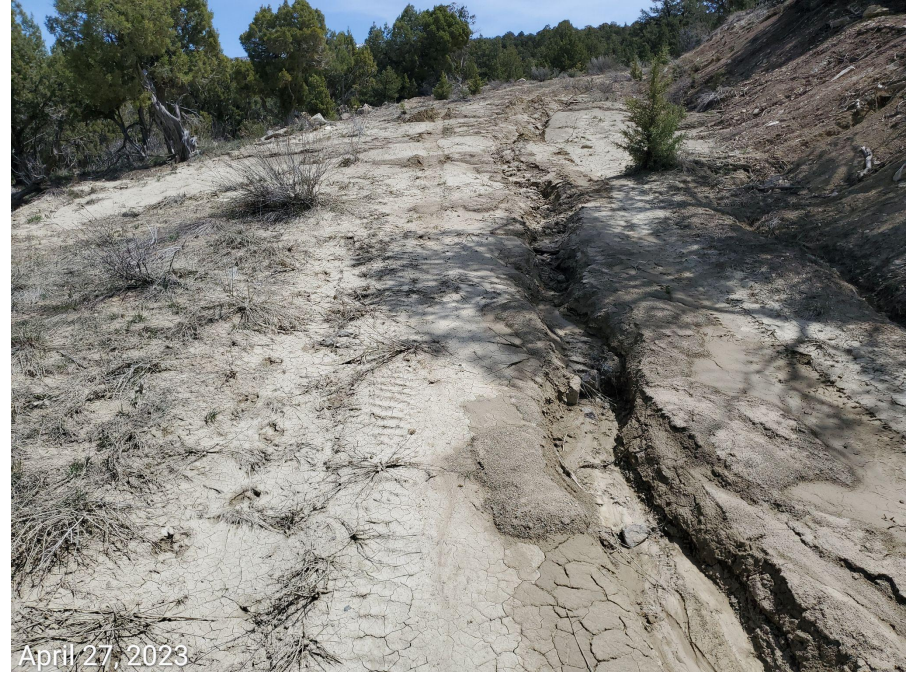
Photo 12: See comments under photo 11.

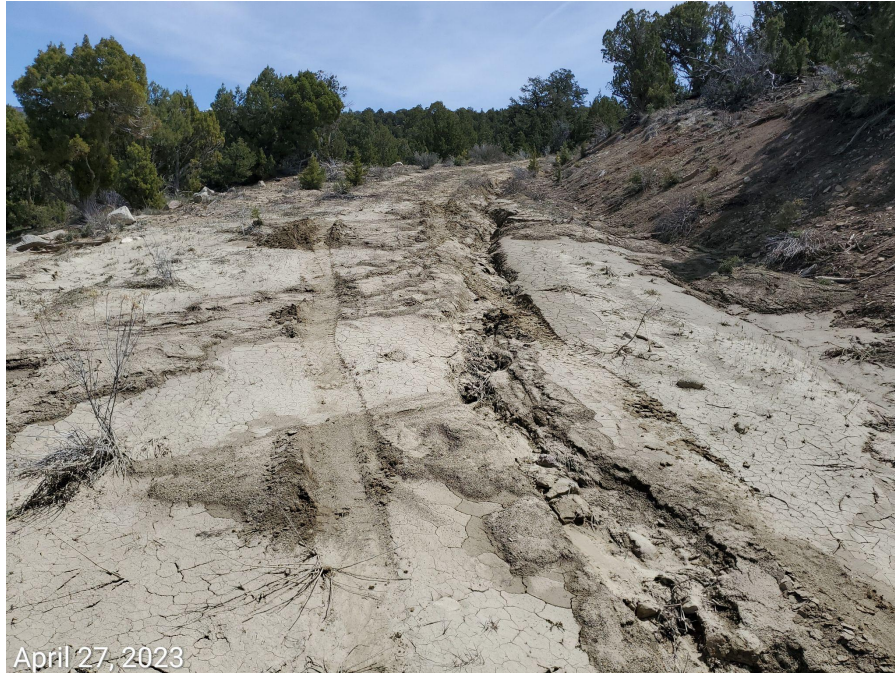
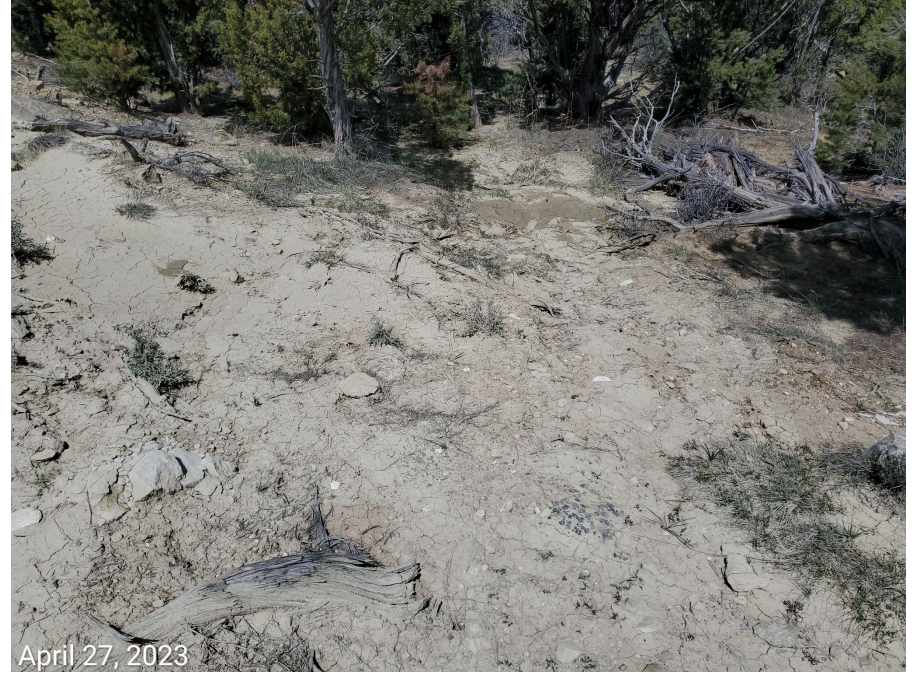
Photo 13: See comments under photo 11. Photo right shows sediment discharge/deposition from the access road.

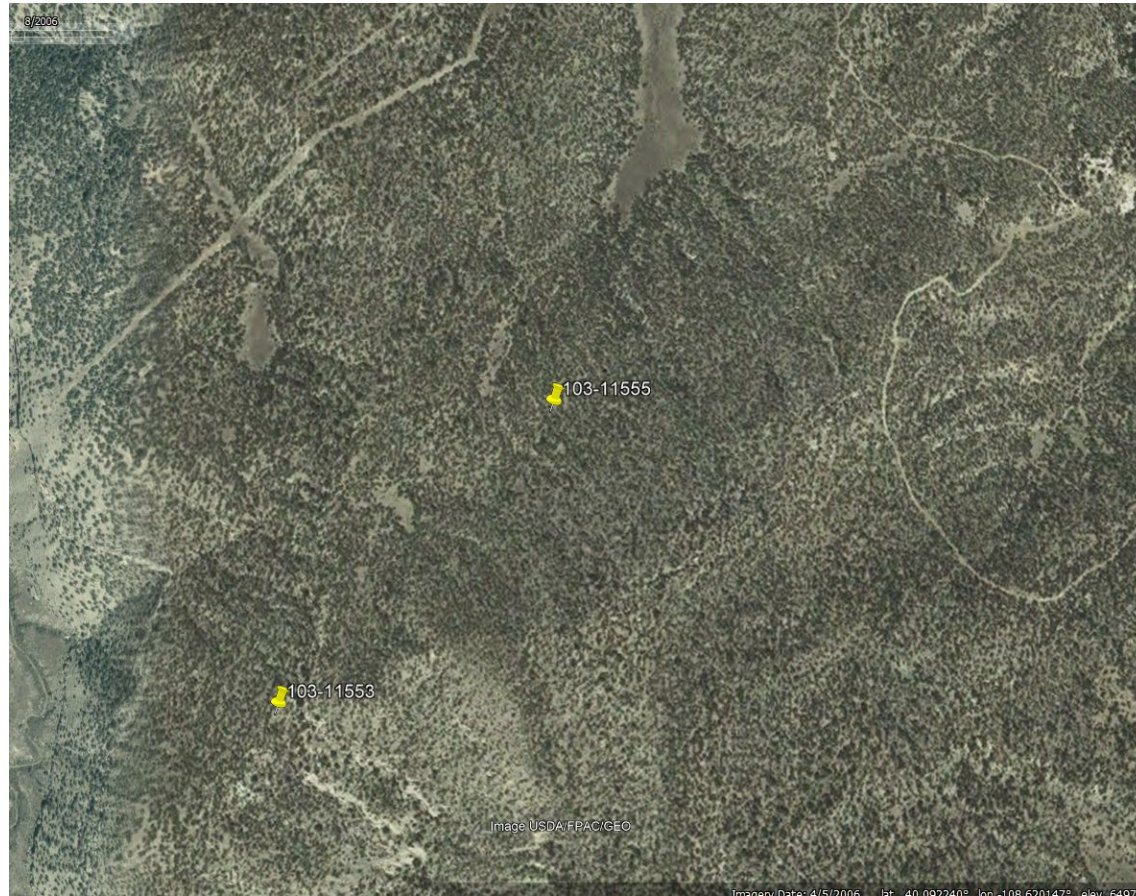
Photo 14: 2006 Google Earth aerial imagery showing the expired Genesis FGSU #4-12 and FGSU #33-42 Locations, prior to construction of the Locations and access road.

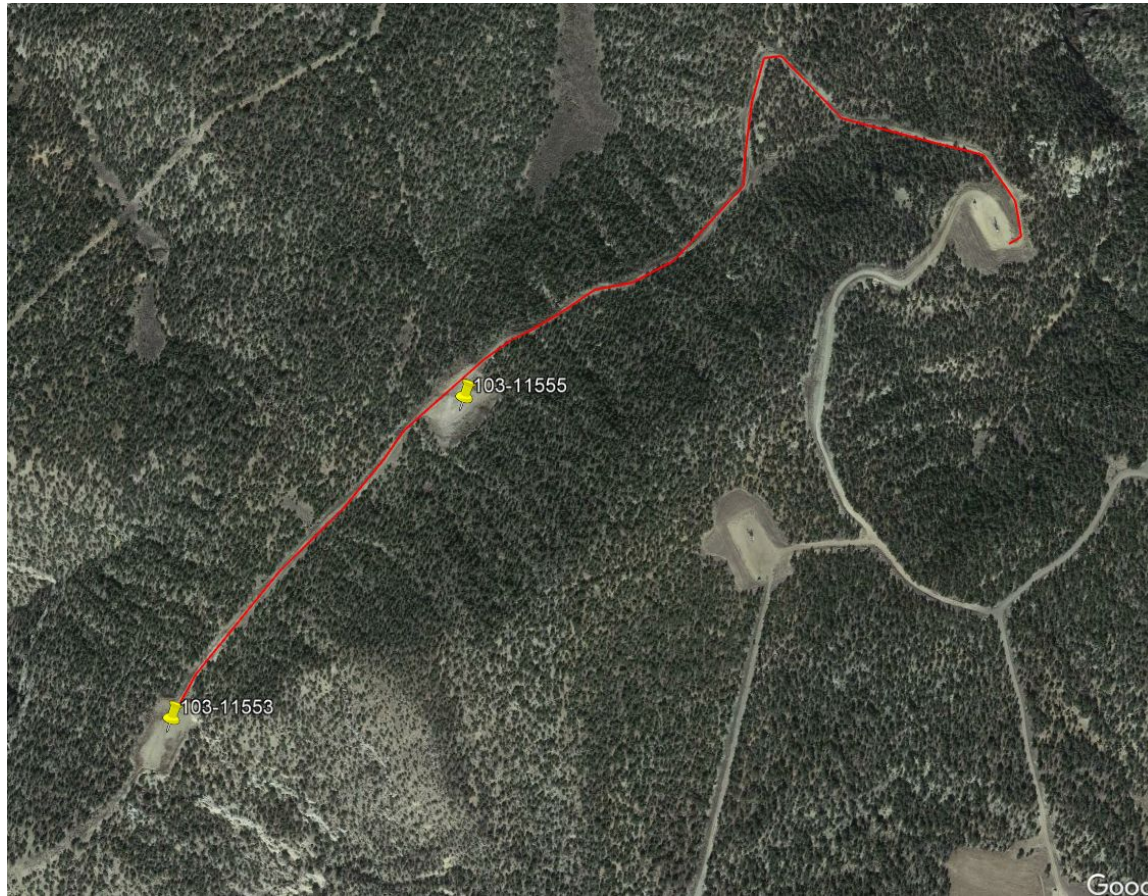
Photo 15: Google Earth aerial imagery showing the expired Genesis FGSU #4-12 and FGSU #33-42 Locations and the access road leading to the Locations. Locations/Access roads subject to 1004 Reclamation.
