Interim Reclamation and Stormwater Inspection

Operator: PDC ENERGY INC - 69175

Location ID: 429310

Inspection Photos
Location Name: Holton 31-12
Location ID: 429310

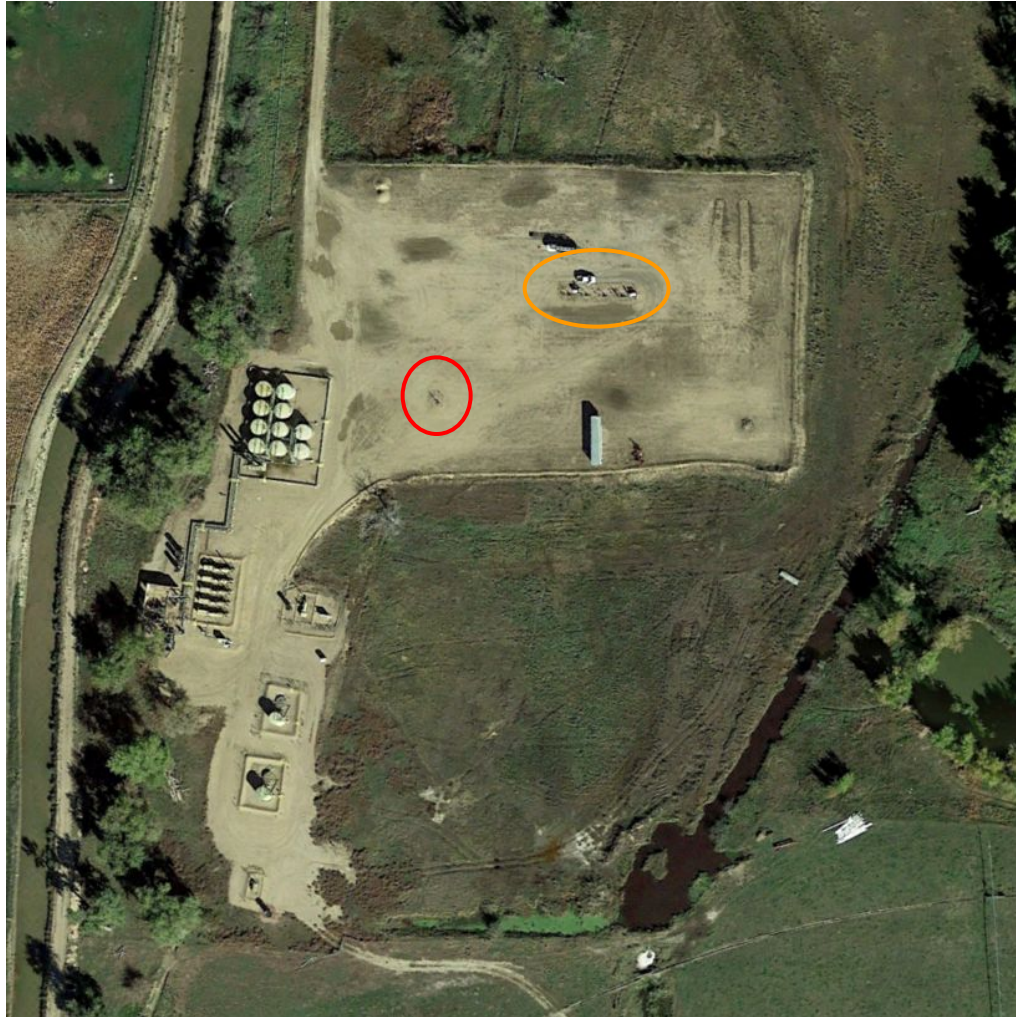
Photo 1. Google Earth aerial imagery from 10/14/2017 illustrates when the Operator drilled additional wells (orange circle) at the location. The first well was spud in 2012 (red circle;123-35776).

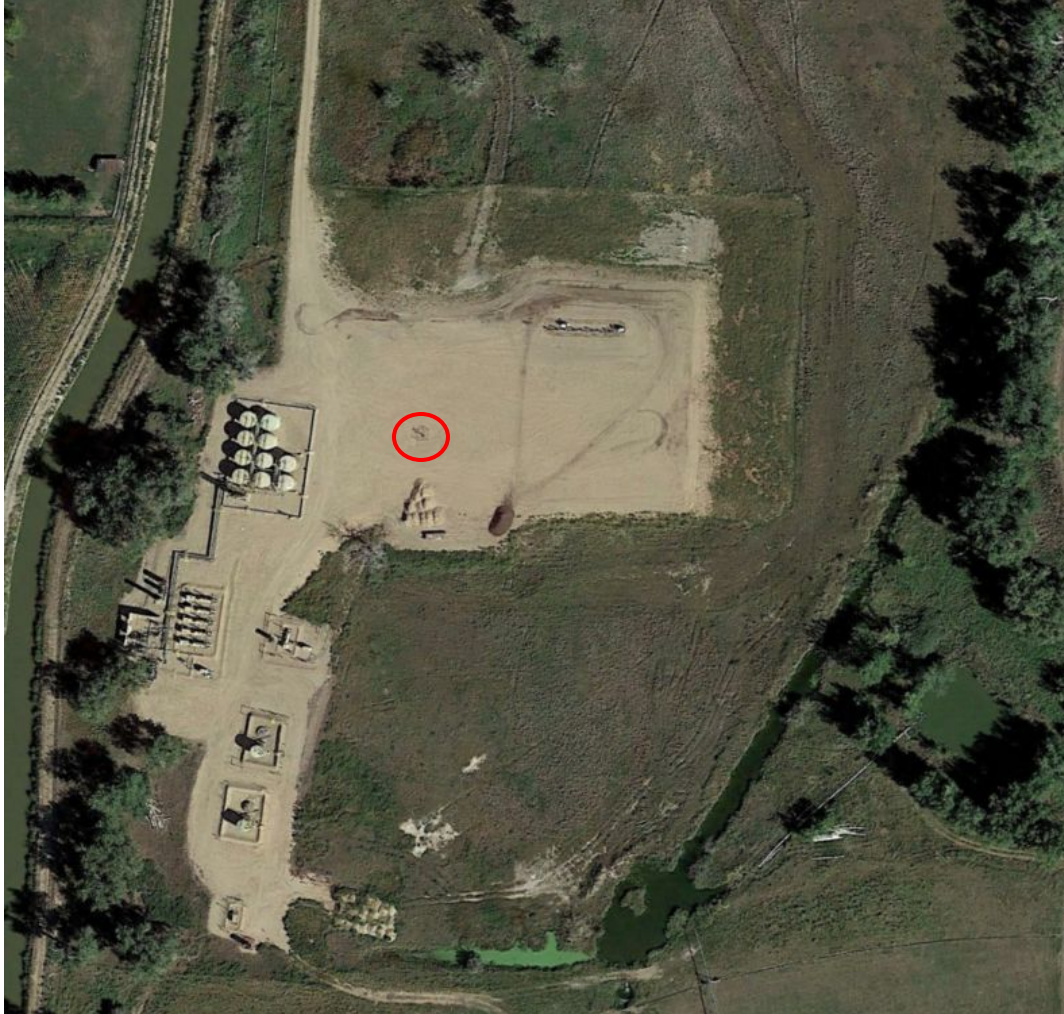
Photo 2. Google Earth aerial imagery from 9/12/2018 illustrates the Operator performed interim reclamation activities to reduce all area not needed for production operations.

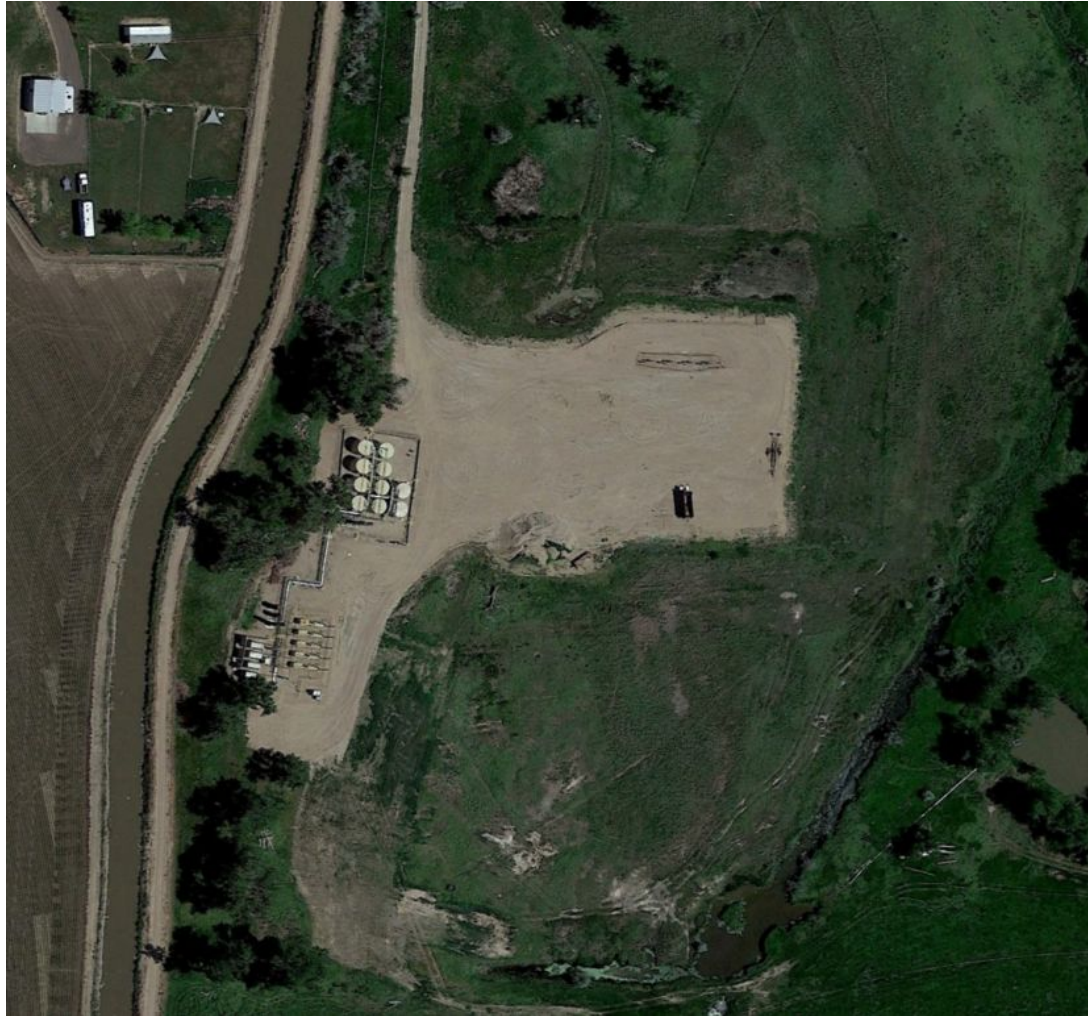
Photo 3. Google Earth aerial imagery from 6/11/2021 illustrates the Operator has plugged the original well (123-35776) but has failed to further reduce all areas not needed for production operations. Operator should have performed interim reclamation by no later than 10/10/2020. The southern/southeastern well pad can be further reclaimed per Rule 1003.

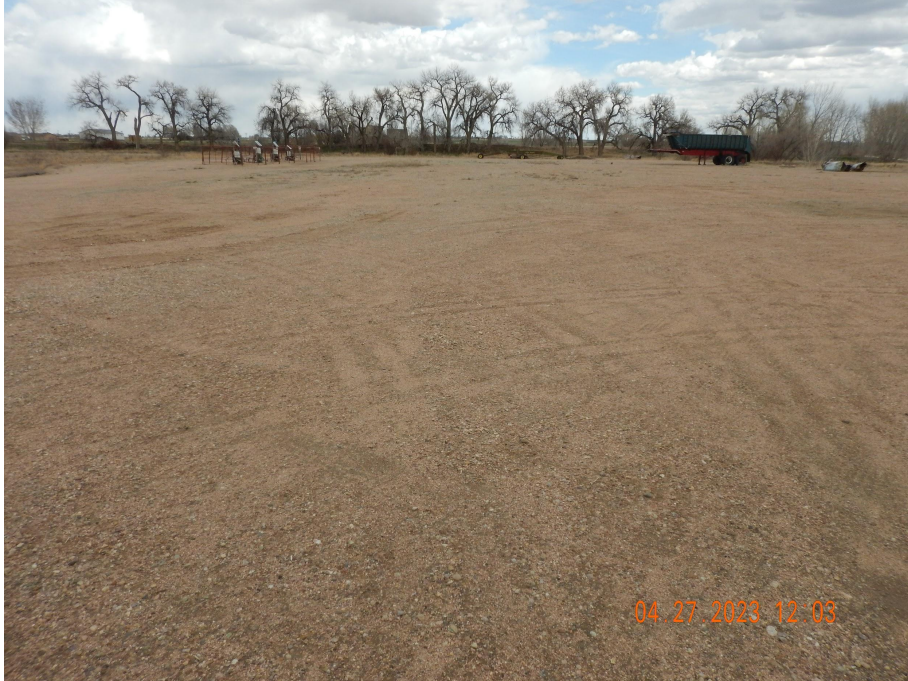
Photo 4. Photo taken from the western well pad, facing East. See comments under Photo 3.

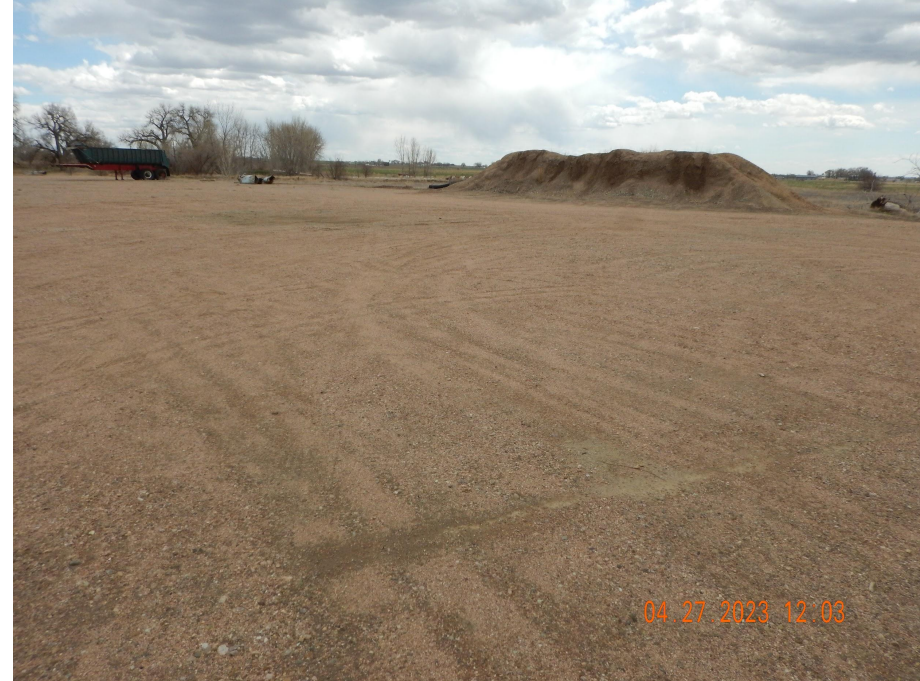
Photo 5. Photo taken from the western well pad, facing Southeast. See comments under Photo 3.
