Final Reclamation and Stormwater Inspection

Location ID: 317036

Inspection Document #: 708200246

Inspection Photos
Location Name: Fassler #3
Location ID: 317036

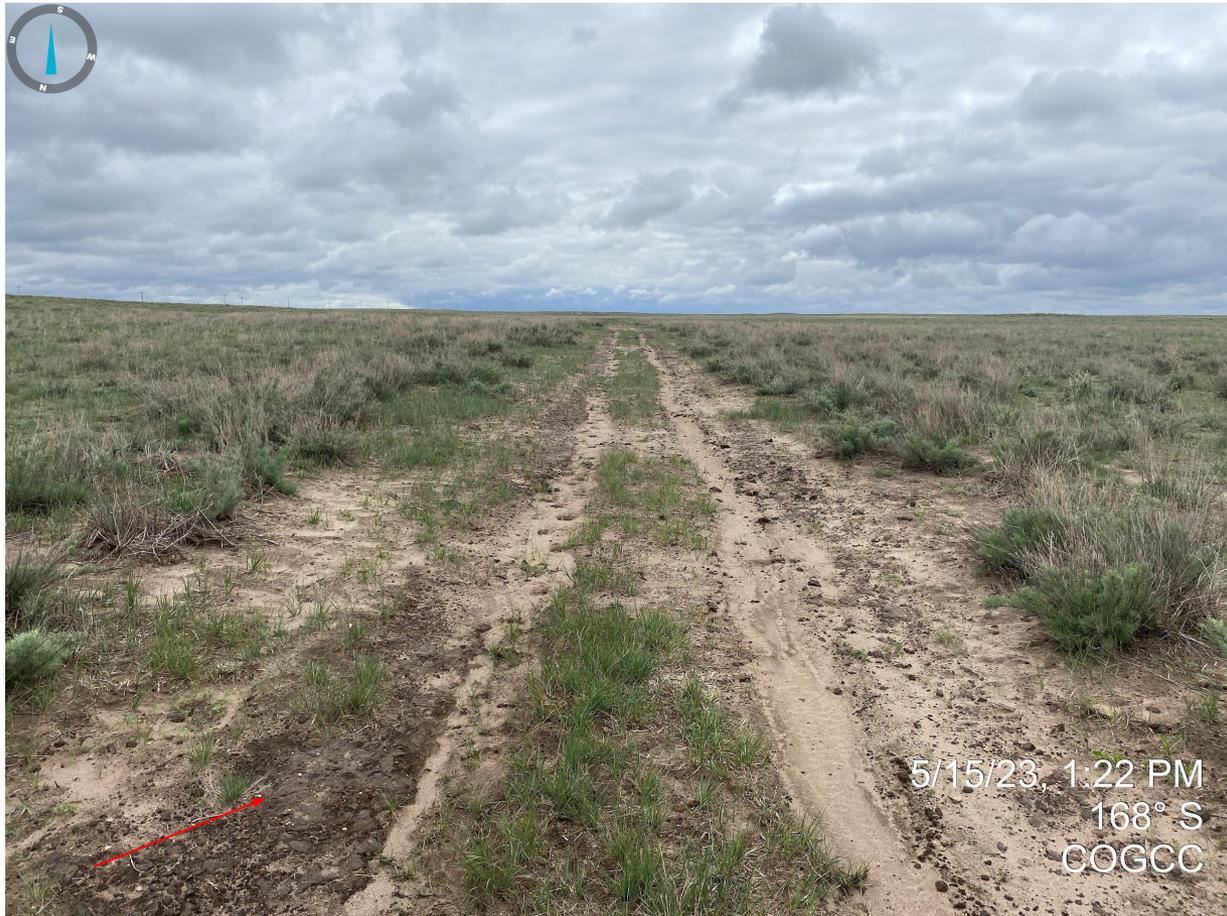
Photo 1. Facing south towards the former well. It does not appear the access road has been reclaimed with the presence of asphalt/road base material, contouring/grading that does not reflect adjacent reference areas, and non-uniform vegetation cover.

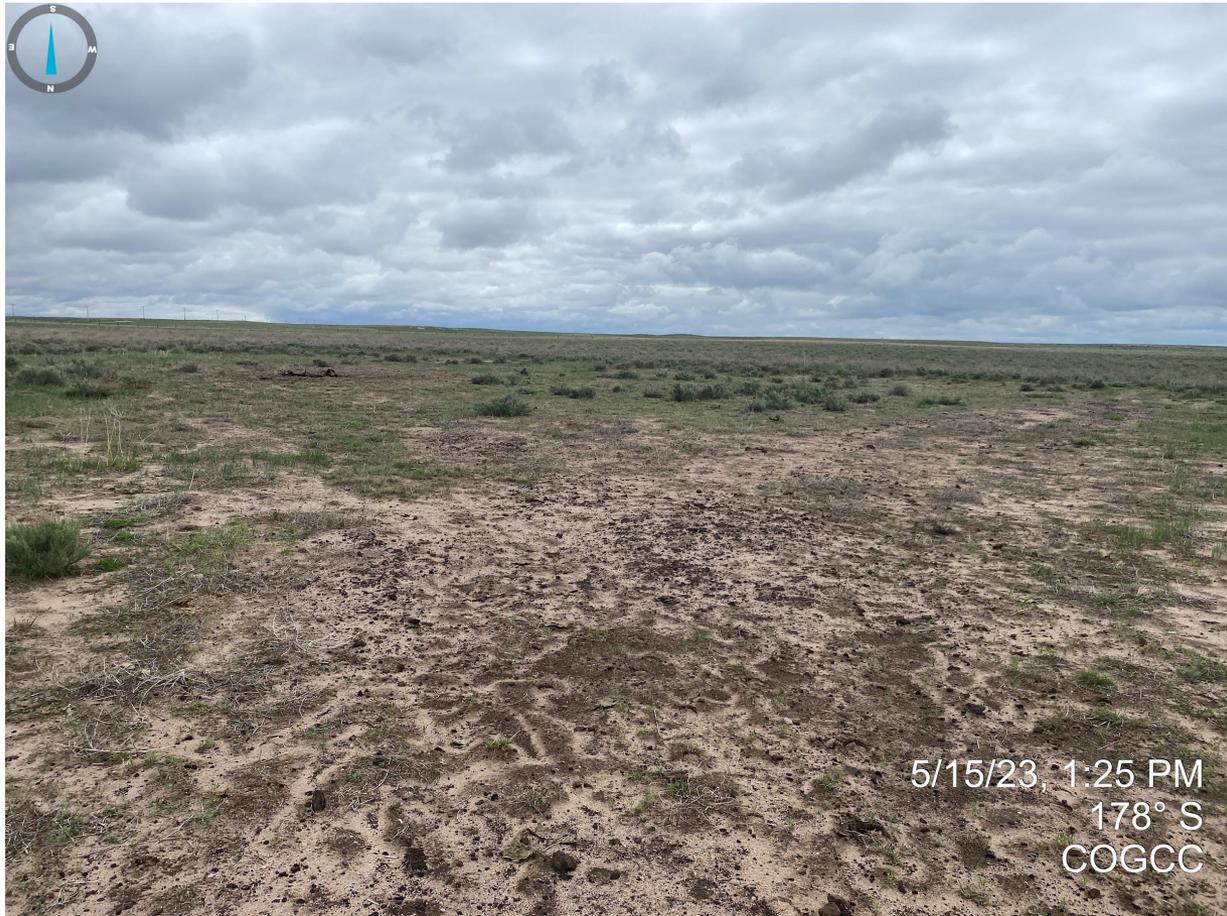
Photo 2. Facing south at location. It does not appear the location is progressing towards Rule 1004 reclamation standards with the presence of undesirable vegetation (e.g. russian thistle) and areas of non-uniform vegetation cover resulting in bare soil. The former well location is not reflective of reference areas.

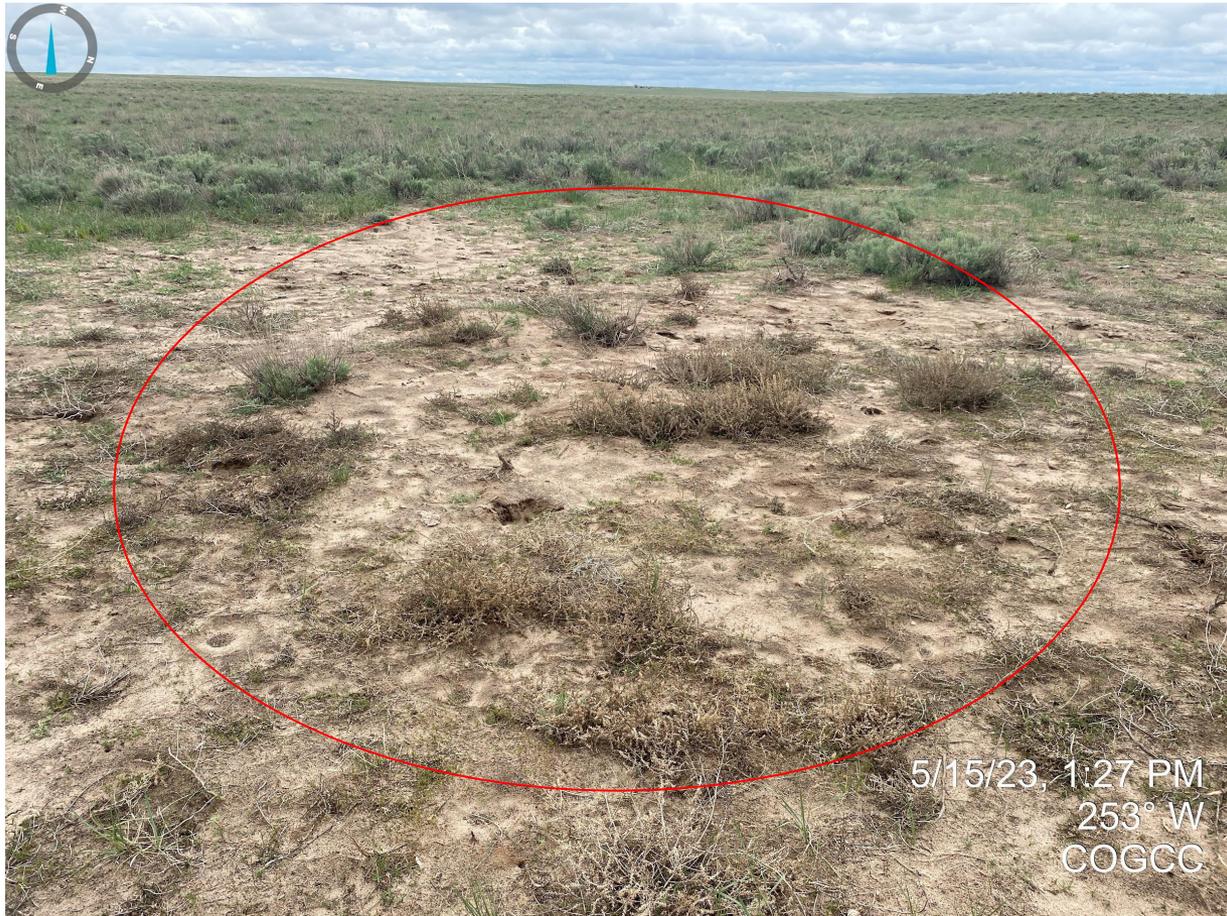
Photo 3. Close up of russian thistle observed on location. This undesirable weed species will need to be managed for in the future.

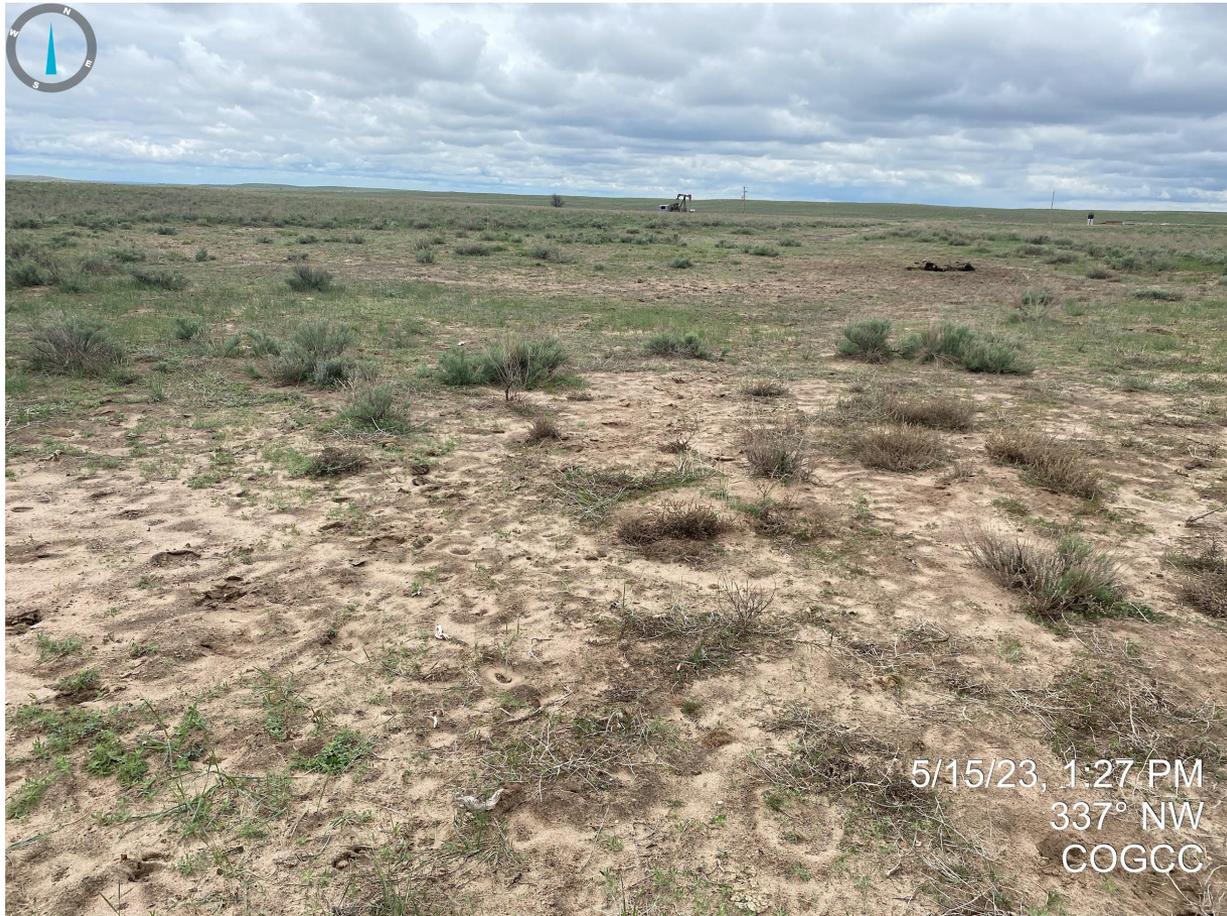
Photo 4. Facing northwest from the southern portion of the location; see comments in Photo 2.

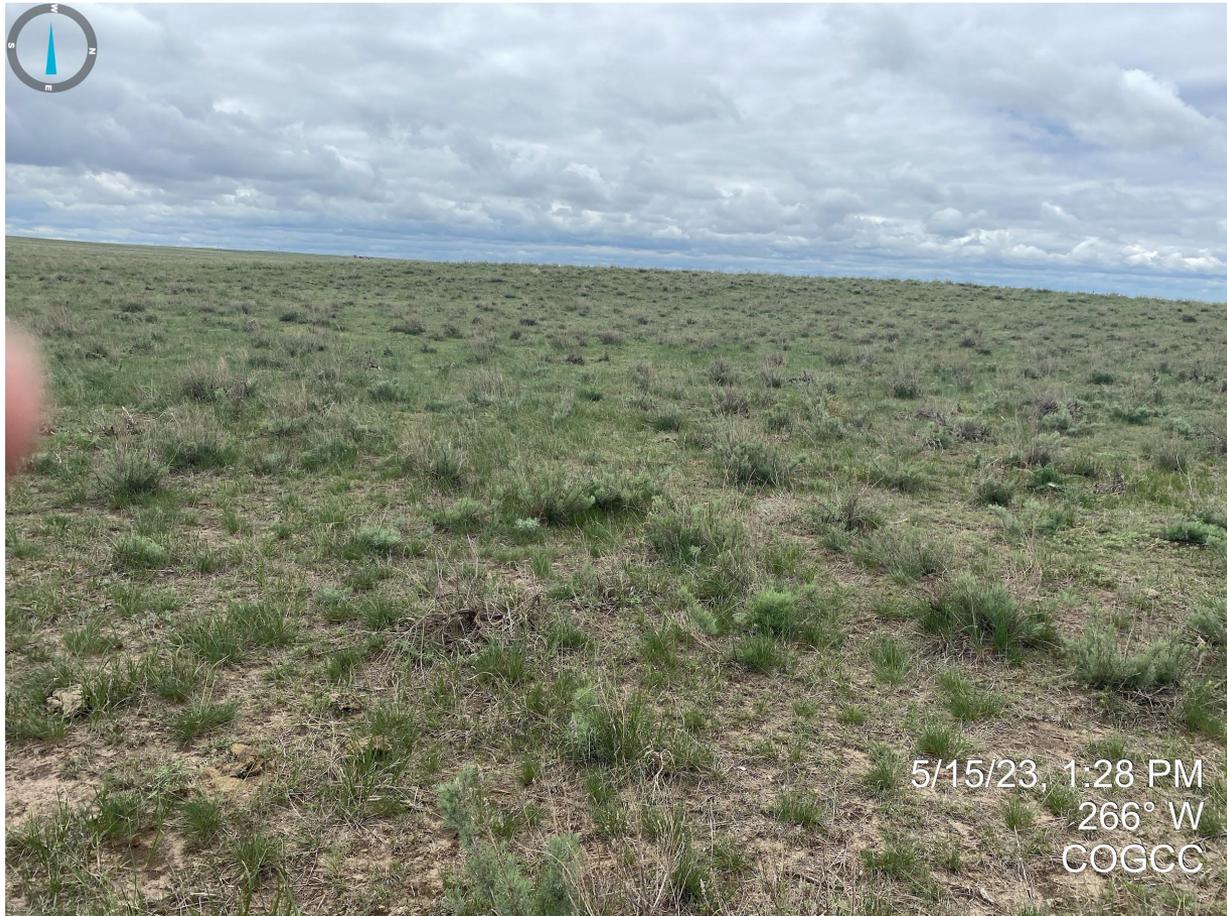
Photo 5. Reference are photo taken west of location, facing west.
