Inspection Photos

Loc: 470757

Operator: WESTERN OPERATING COMPANY

Inspection Date: 5/15/2023

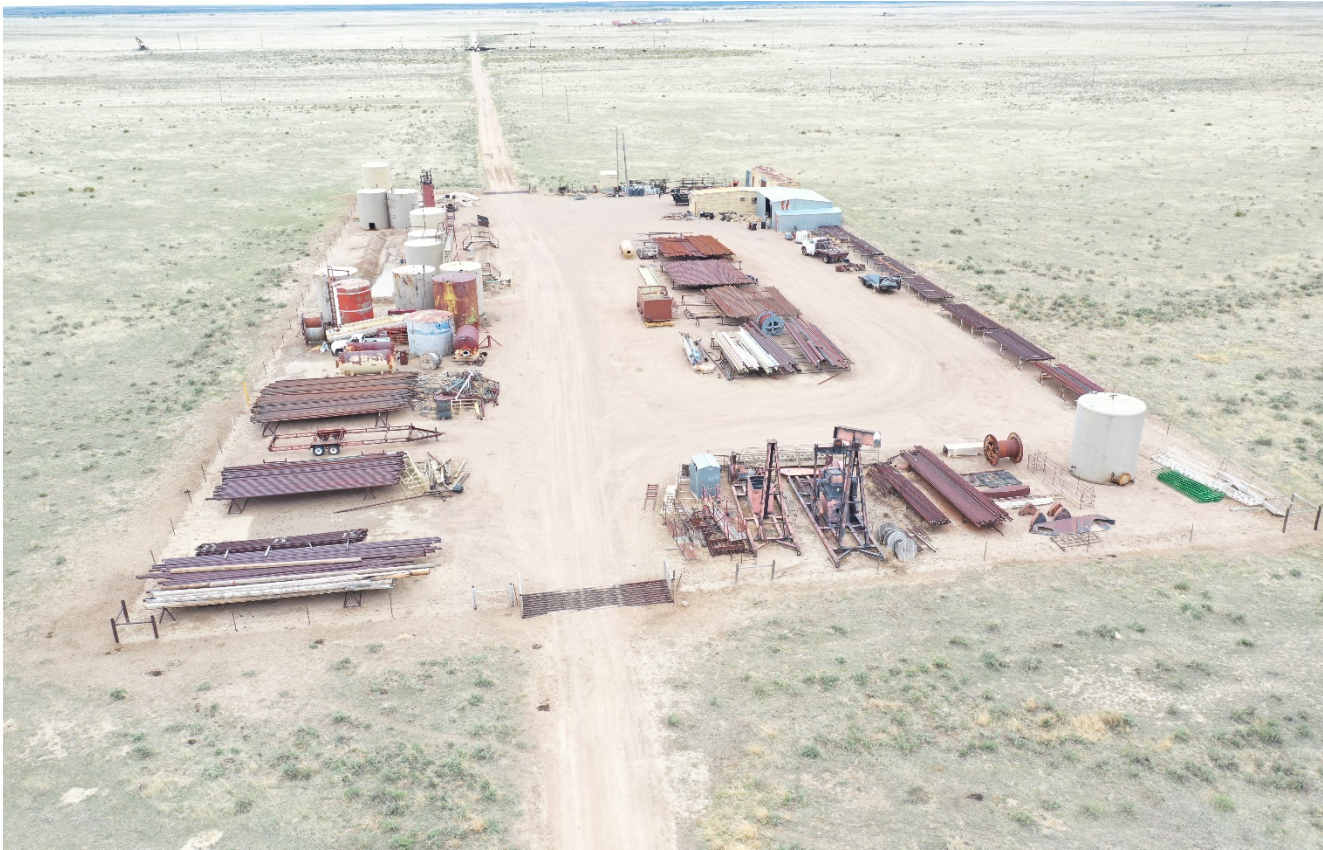
Photo 1. Drone aerial photo facing west toward the PYLES offsite tank battery and storage yard. The use of this location as a storage yard is prohibited per the rules. All unused equipment and supplies must be removed and interim reclamation must be performed.

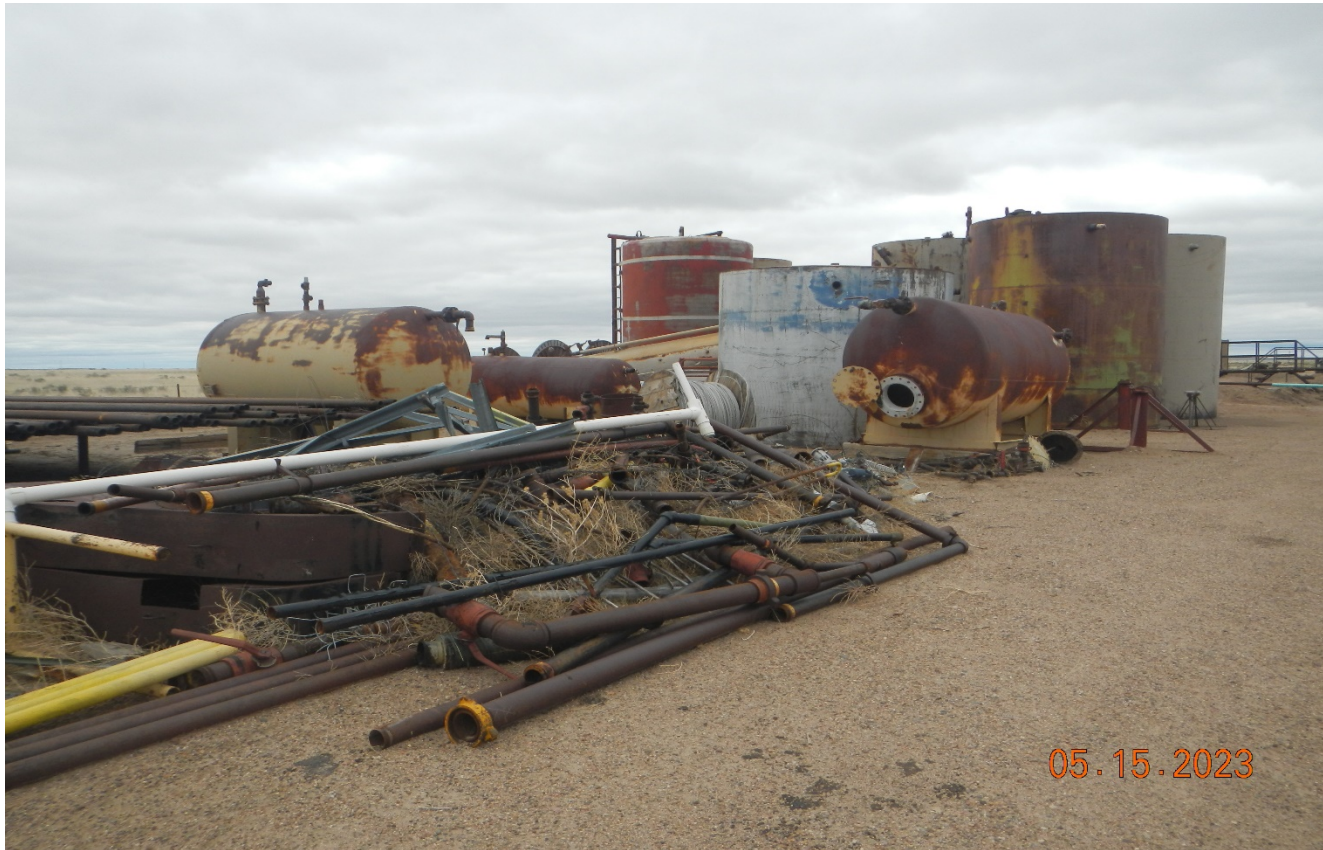
Photo 2. There is unused equipment being stored on location that needs to be removed. All equipment and supplies not necessary for use on this Oil and Gas Location is prohibited per Rule 606 and 1003.a.

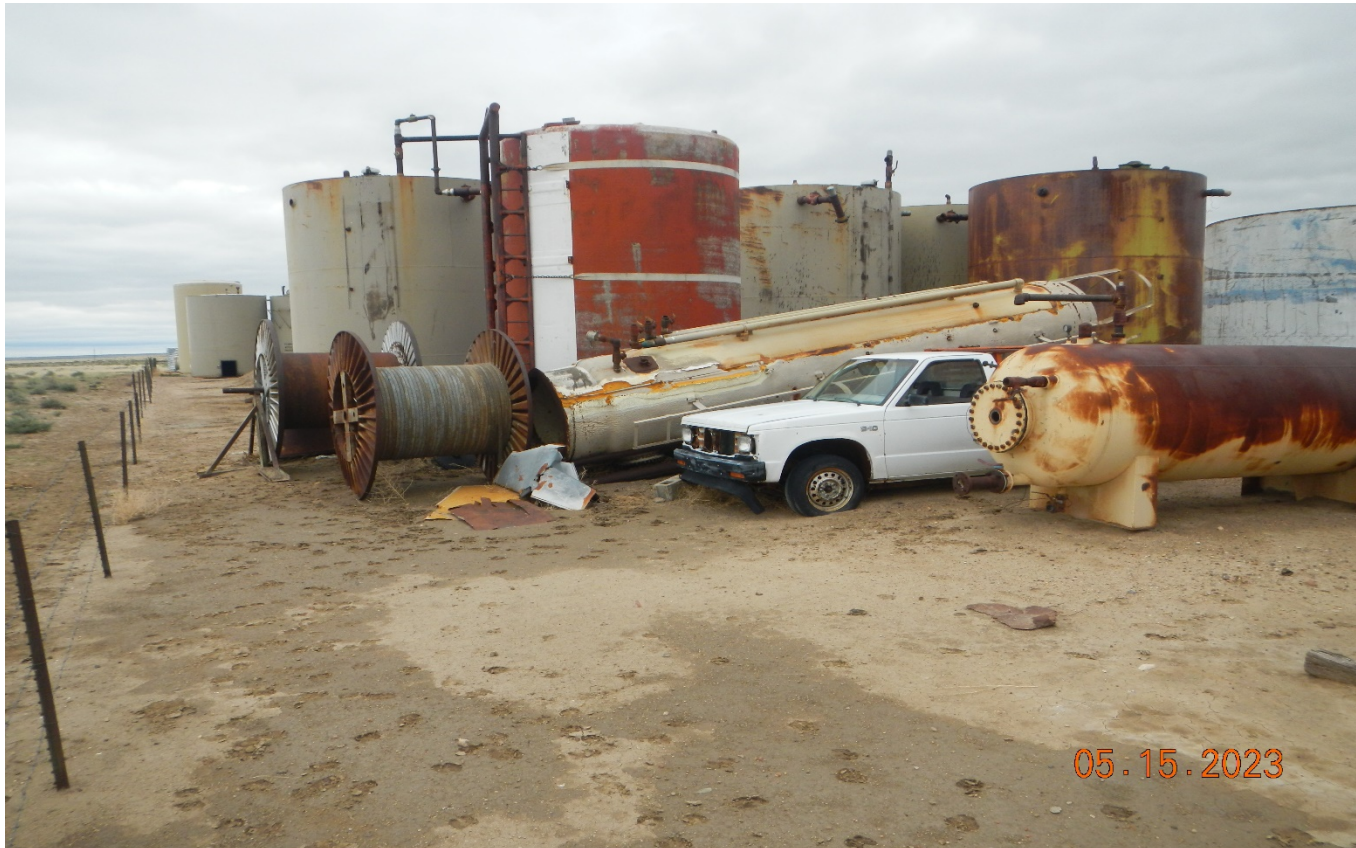
Photo 3. Facing west at the south side of the location. There is equipment and a vehicle that appears to have been sitting unused at this location for awhile.

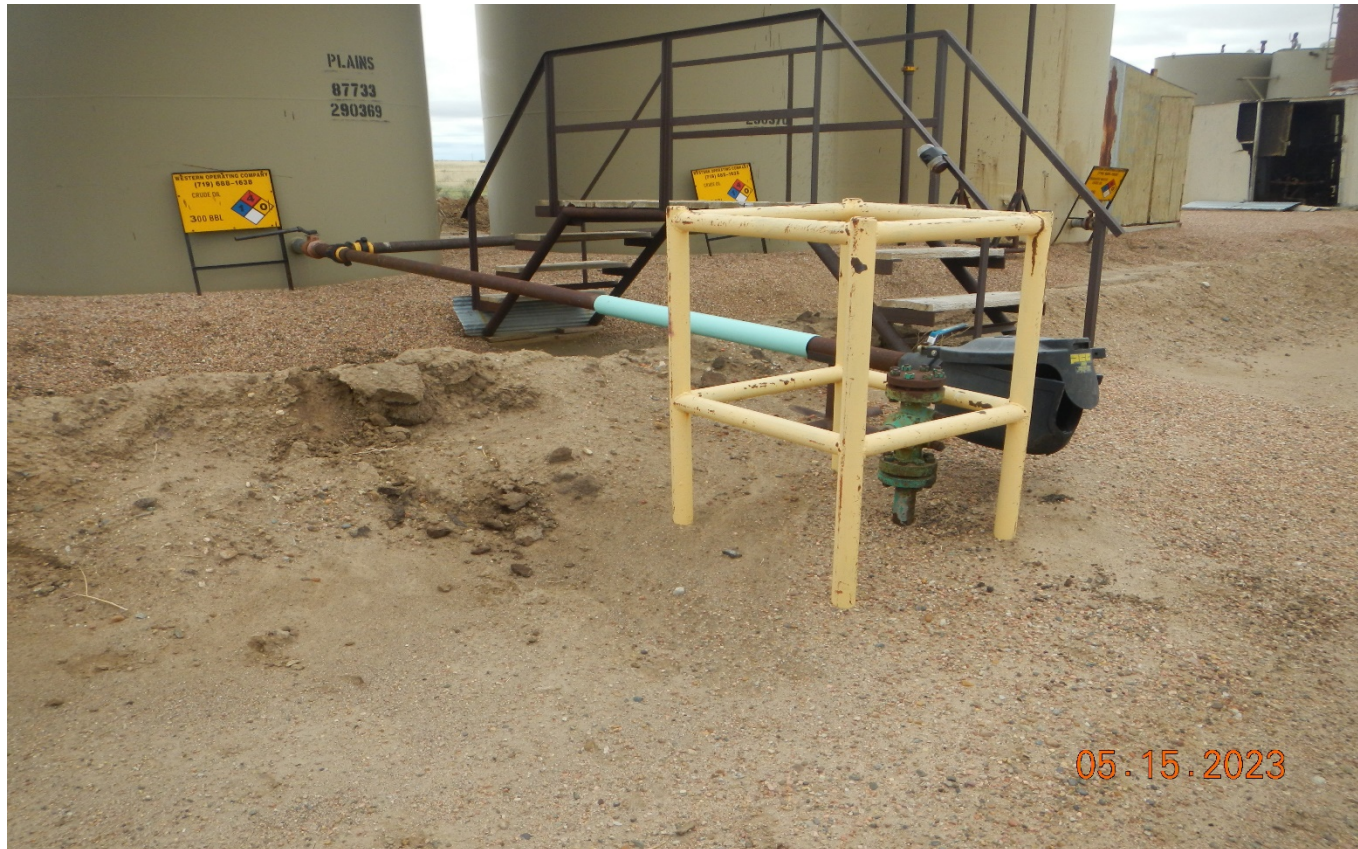
Photo 4. Facing toward the PYLES offsite tank battery at the location. There is still stained soil at the outlet and inside the plastic containment.

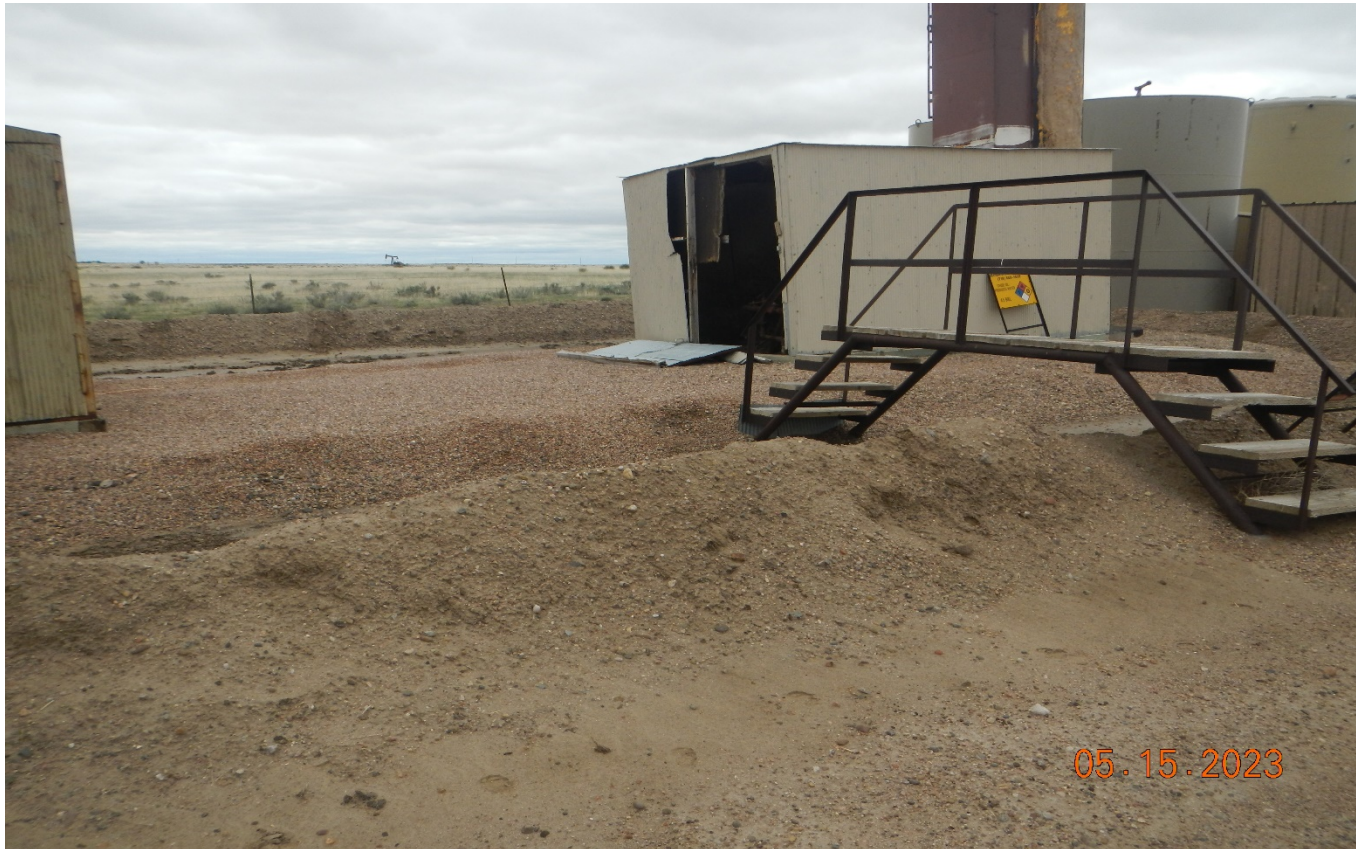
Photo 5. The shed inside the containment battery is not maintained with metal siding laying on the ground.

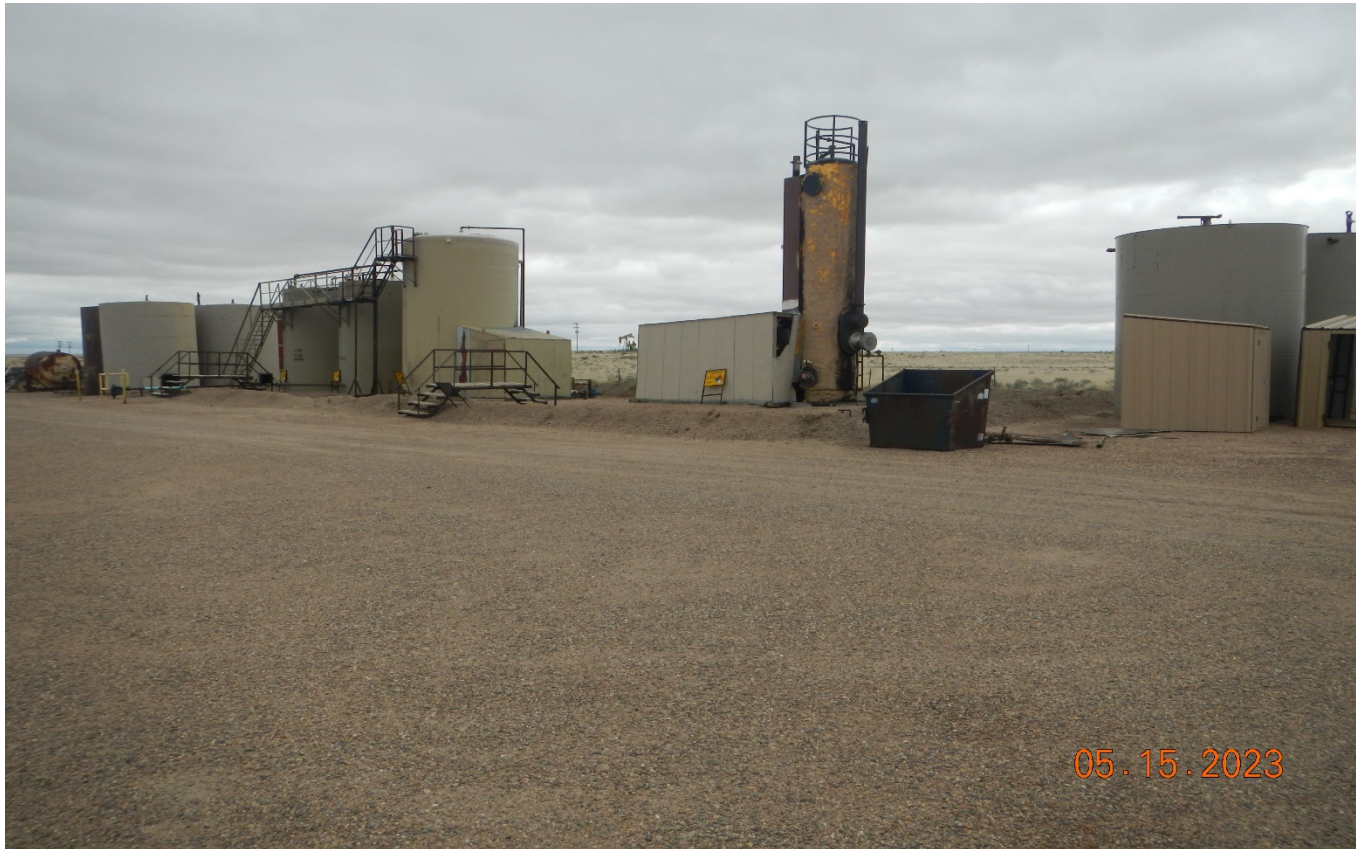
Photo 6. Facing back towards the PYLES tank battery. PYLES #5 wells sign is posted at the battery.

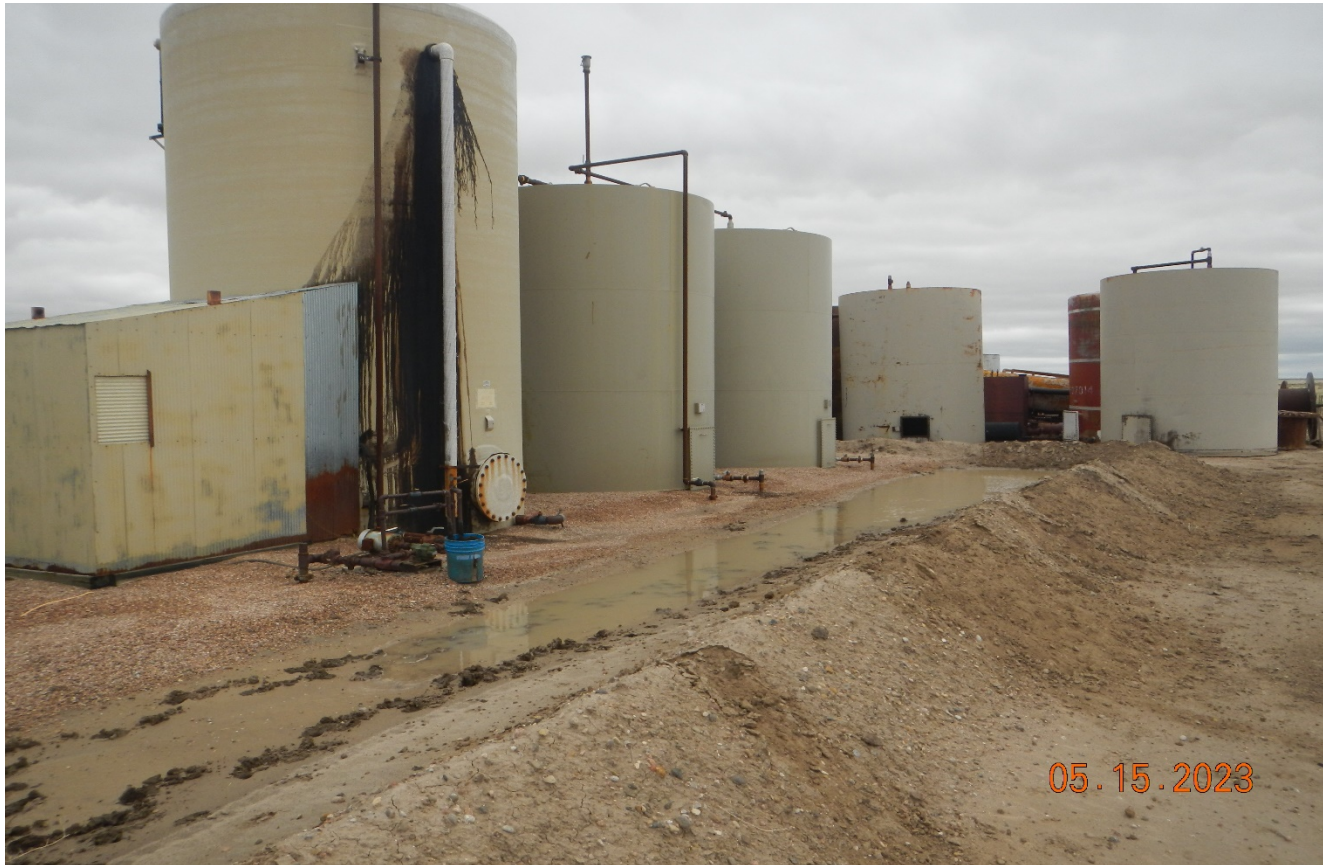
Photo 7. Facing at the back side of the tank battery. There was a spill from the tank which needs to be cleaned up. The blue bucket needs to be emptied and disposed of any oil.

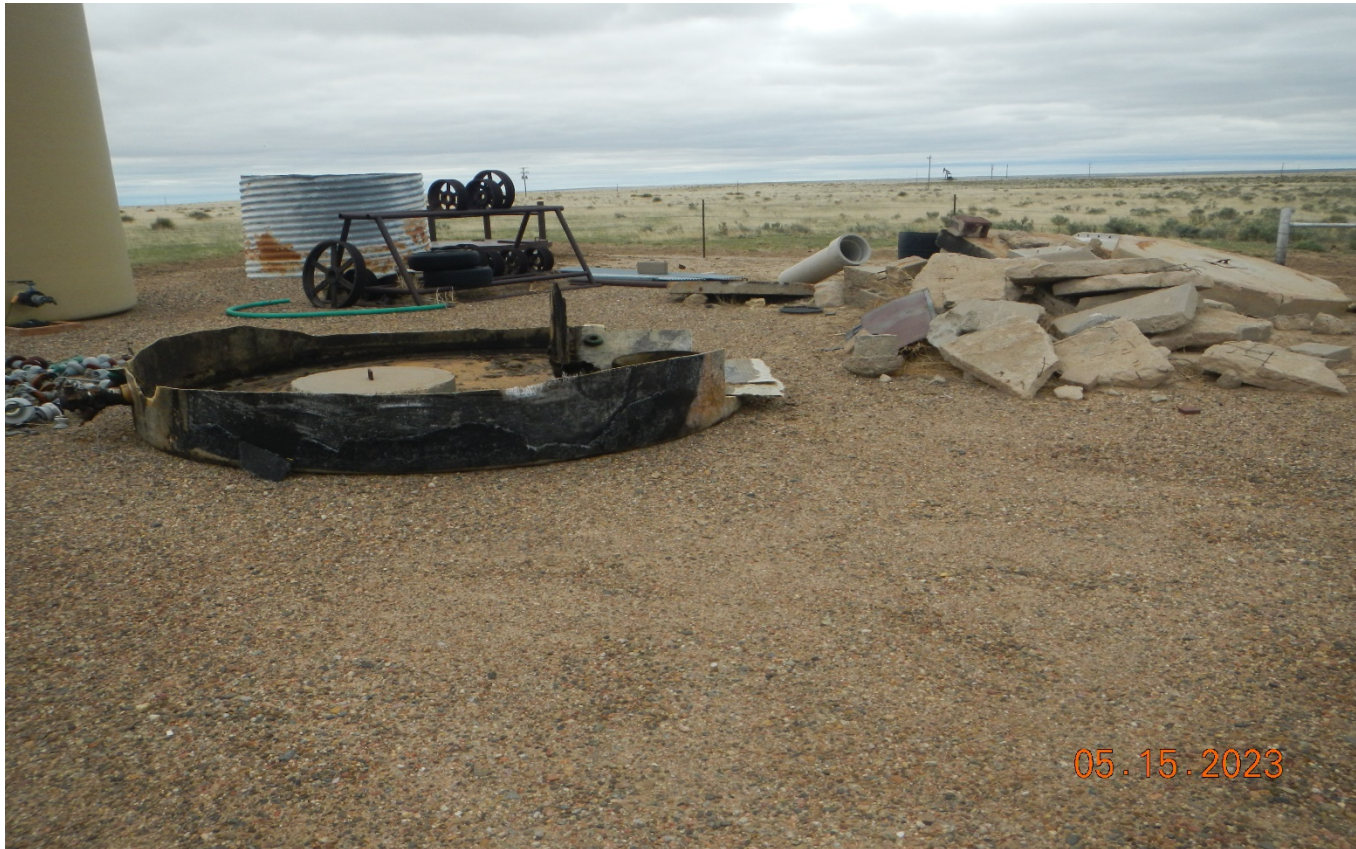
Photo 8. Facing toward the southwest side of the location. There is concrete debris and a broken bottom of a tank among other debris and equipment that must be removed per Rule 606 & 1003.a.

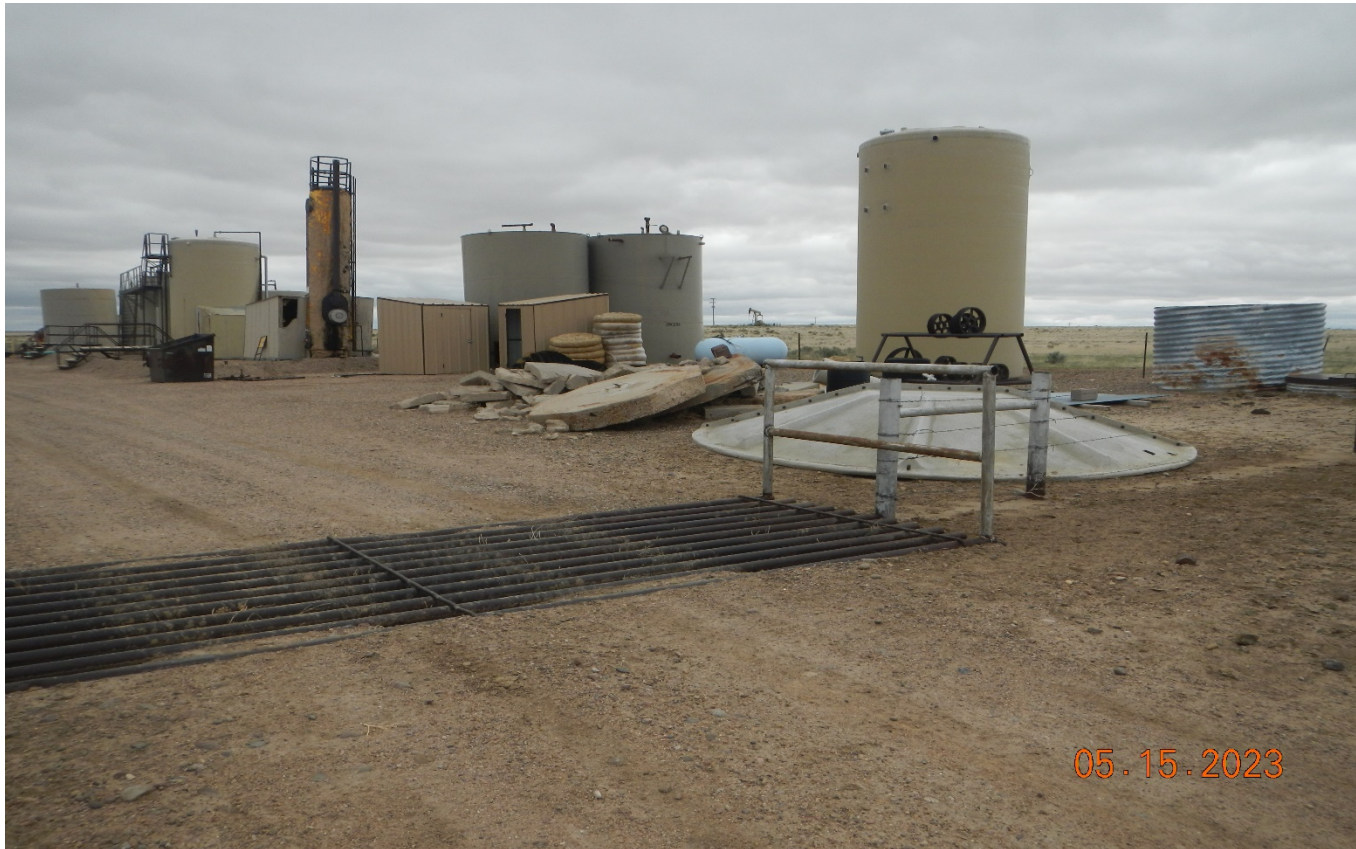
Photo 9. Facing southeast toward the PYLES offsite tank battery and storage yard. There is concrete debris and a broken bottom of a tank among other debris and equipment that must be removed per Rule 606 & 1003.a.

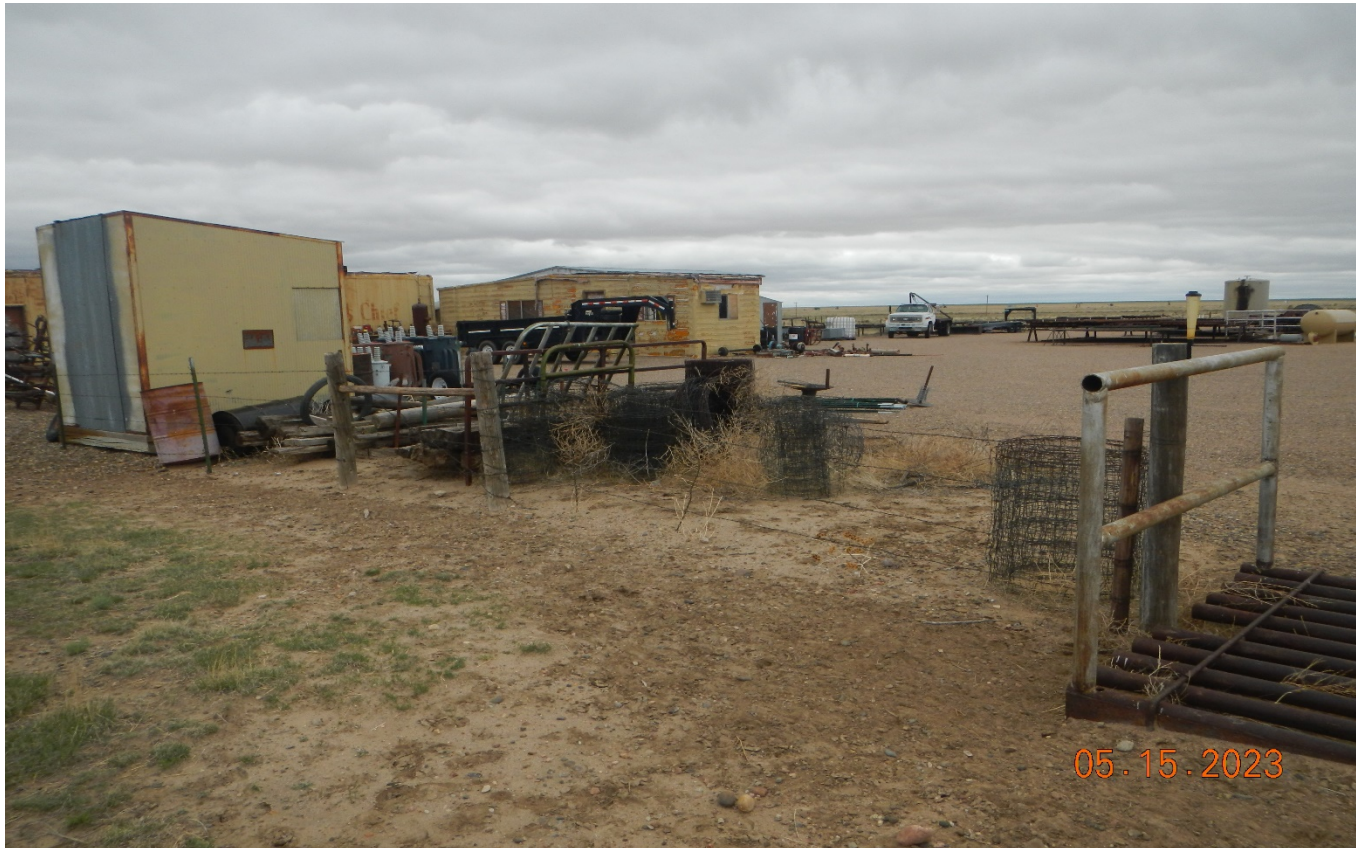
Photo 10. Facing northeast toward the PYLES offsite tank battery and storage yard.

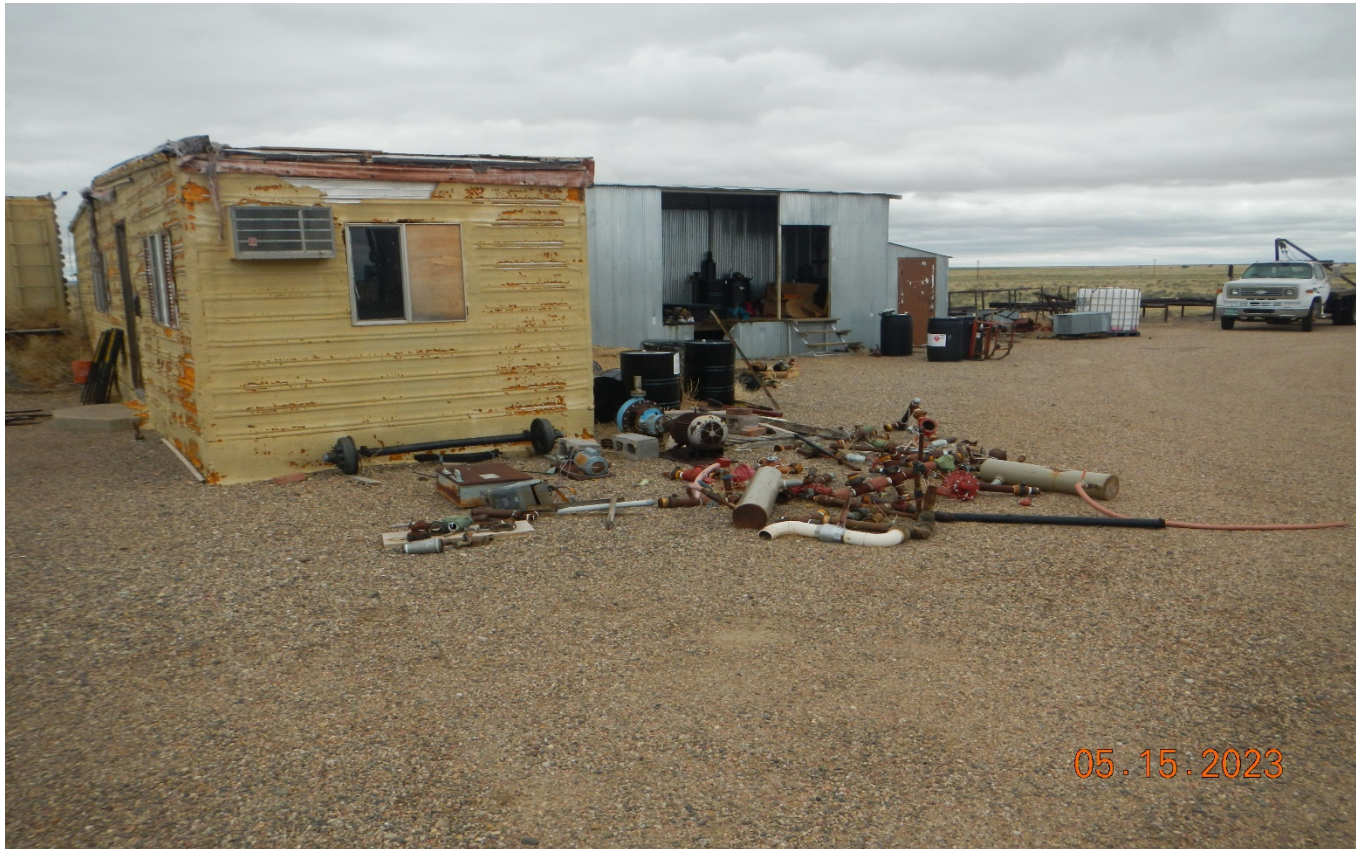
Photo 11. There is various parts and supplies being stored on location. All equipment and supplies not necessary for use on this Oil and Gas Location is prohibited per Rule 606 and 1003.a.

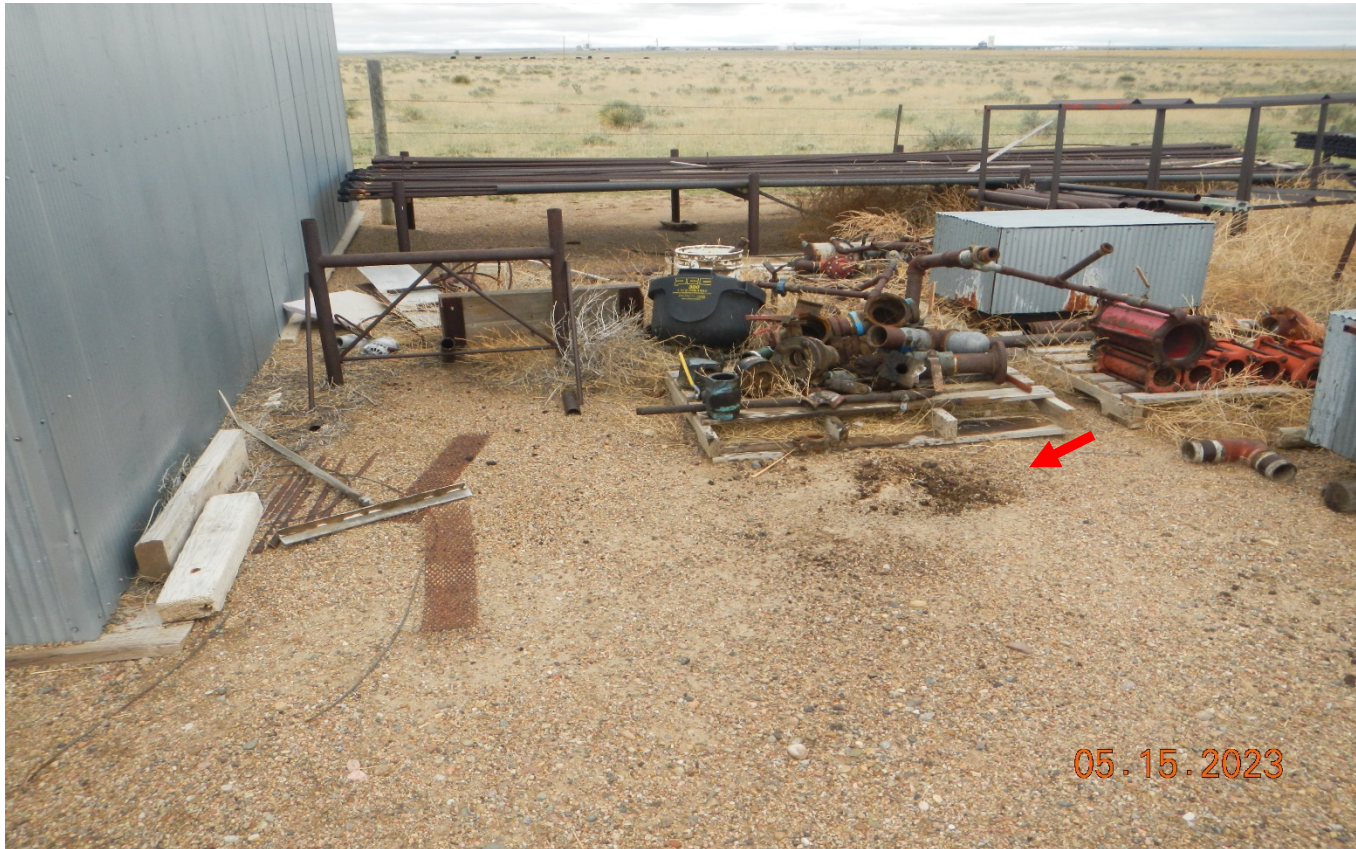
Photo 13. There are various parts and supplies in this area that need to be removed. The two buckets of oil have been removed however stain soils are still evident shown at red arrow.

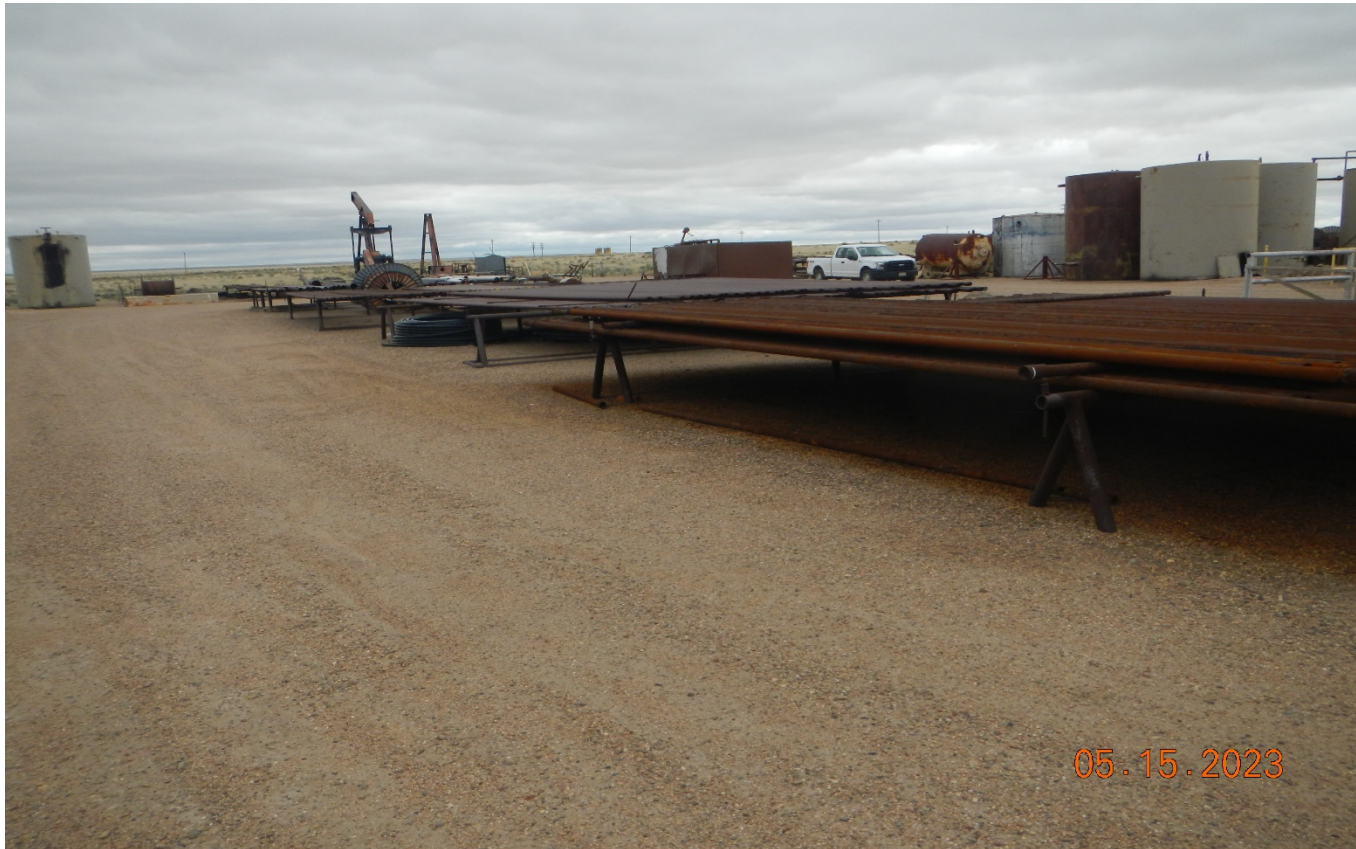
Photo 14. Facing southeast at the north side of the location. There is storage of unused drilling pipe at the location. All equipment and supplies not necessary for use on this Oil and Gas Location is prohibited per Rule 606 and 1003.a.

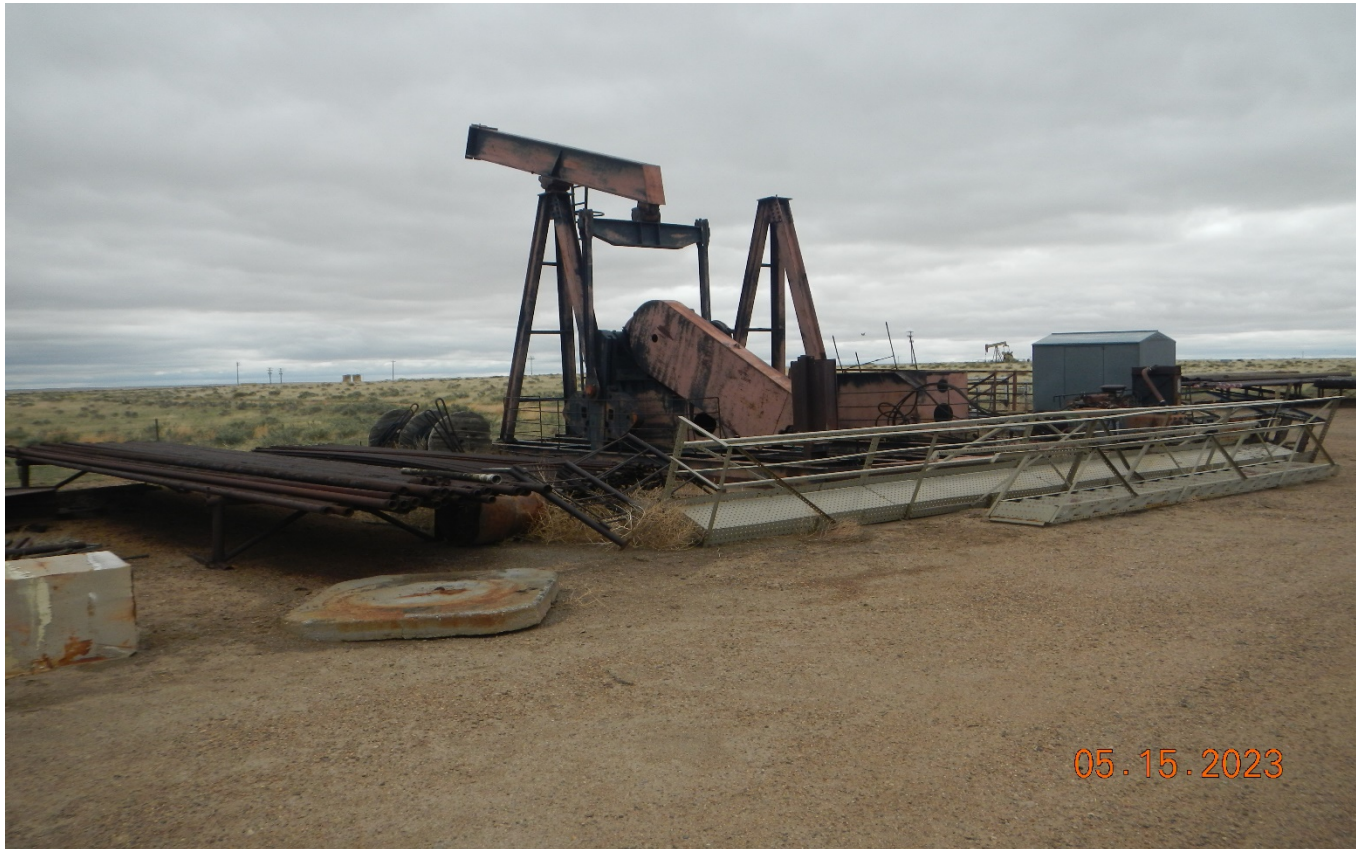
Photo 15. Facing toward the east side of the location. All equipment and supplies not necessary for use on this Oil and Gas Location is prohibited per Rule 606 and 1003.a.

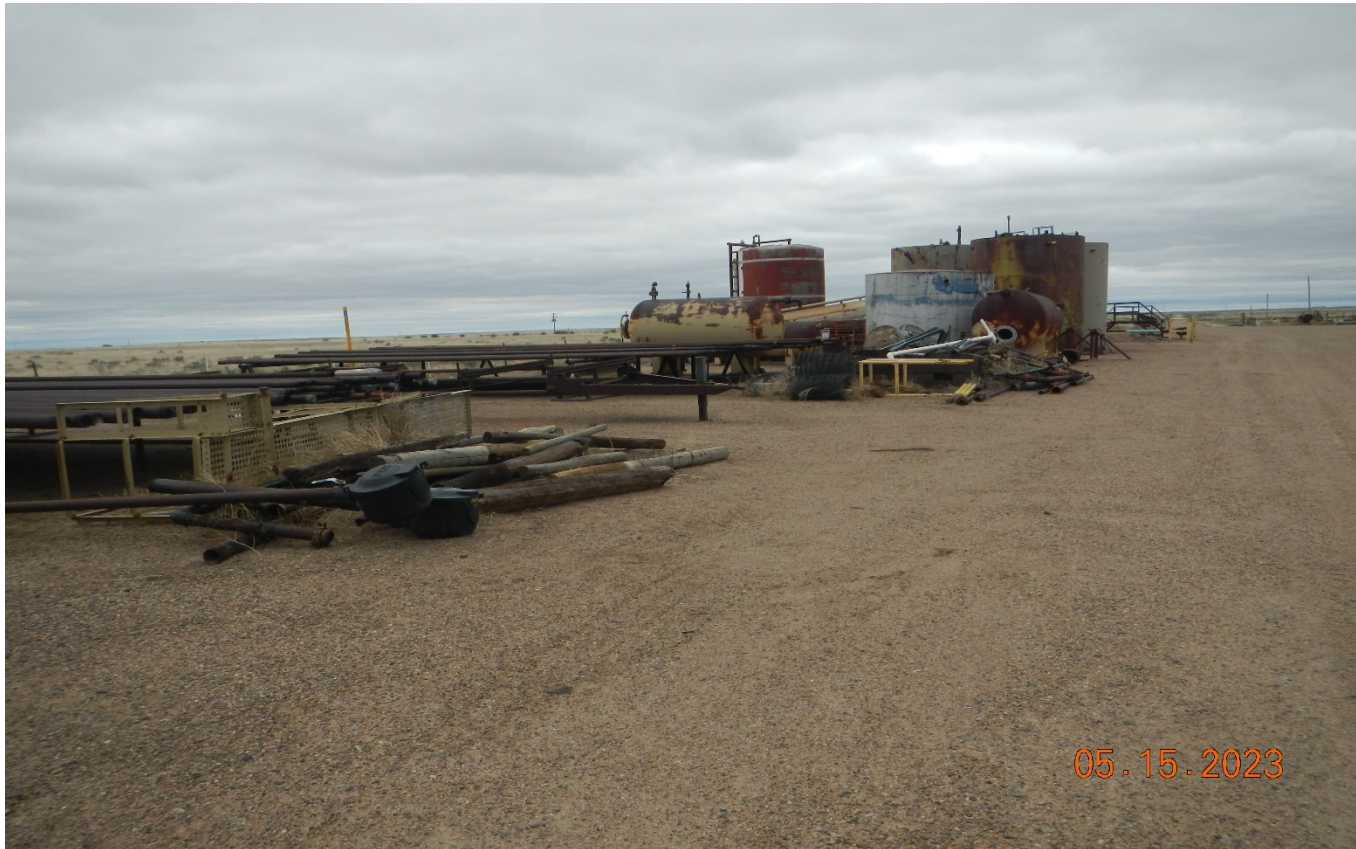
Photo 16. Facing southwest at the location PYLES offsite tank battery and storage yard. The use of this location as a storage yard is prohibited per the rules.
