Inspection Photos

Operator: LARAMIE ENERGY LLC #10433 /
BLACK HILLS PLATEAU PRODUCTION LLC
#10150

Location Number: 312407
Mesa County, CO

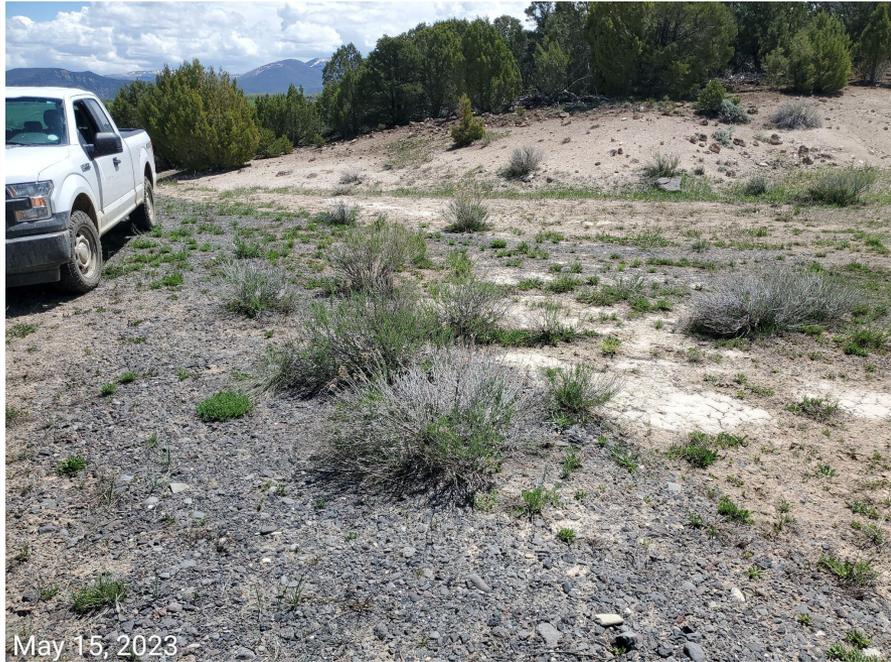
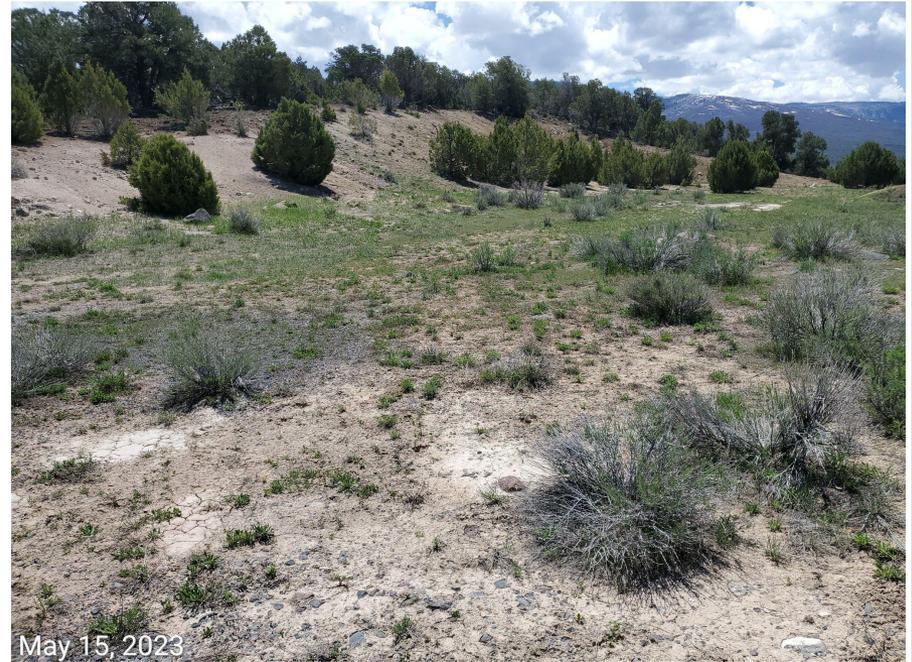
Photo 1: Photos 1-2 taken from the north end of the Location. Photos provide an overview of the Location from east, southeast, southwest to west.

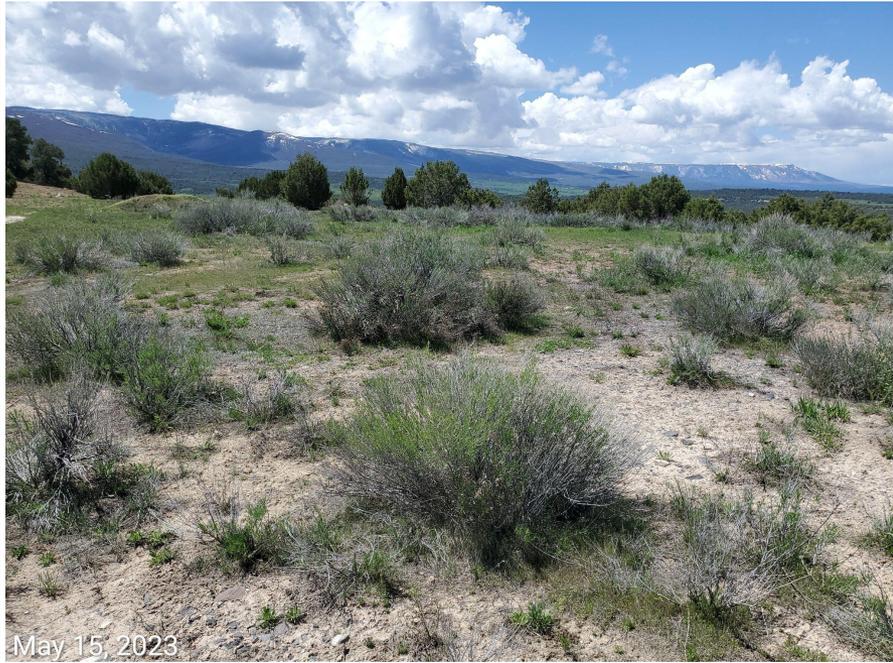
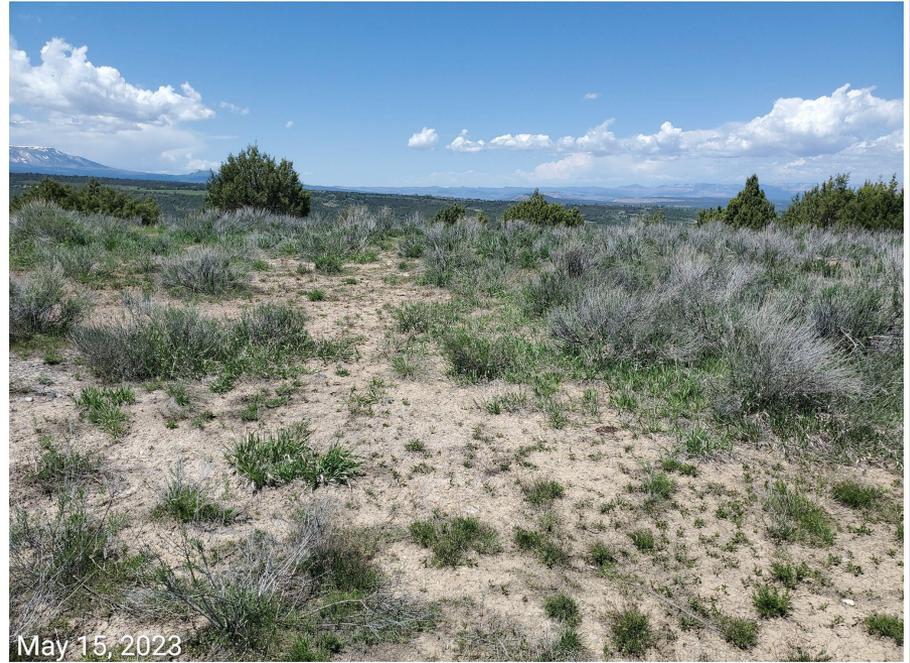
Photo 2: See comments under photo 1.

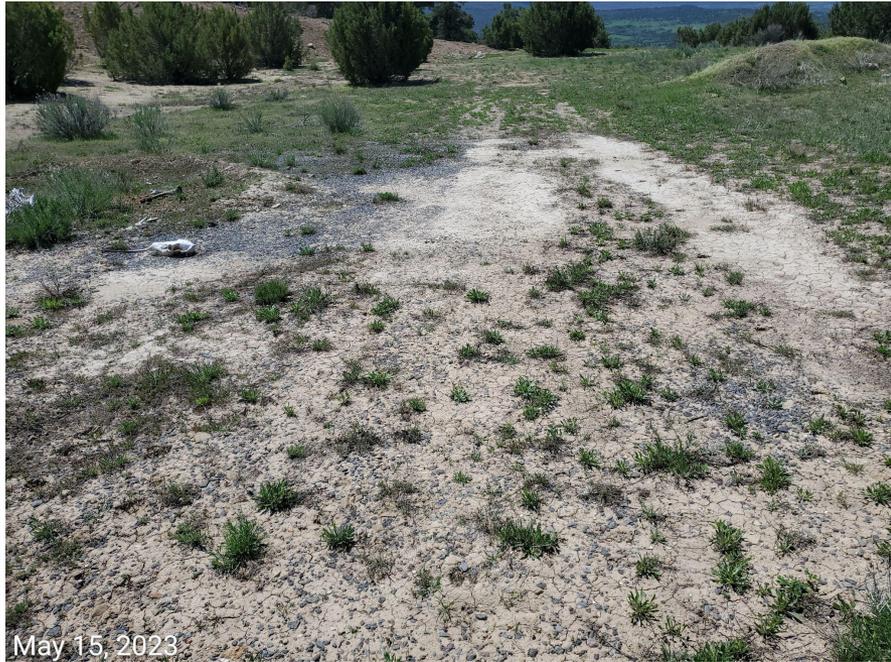
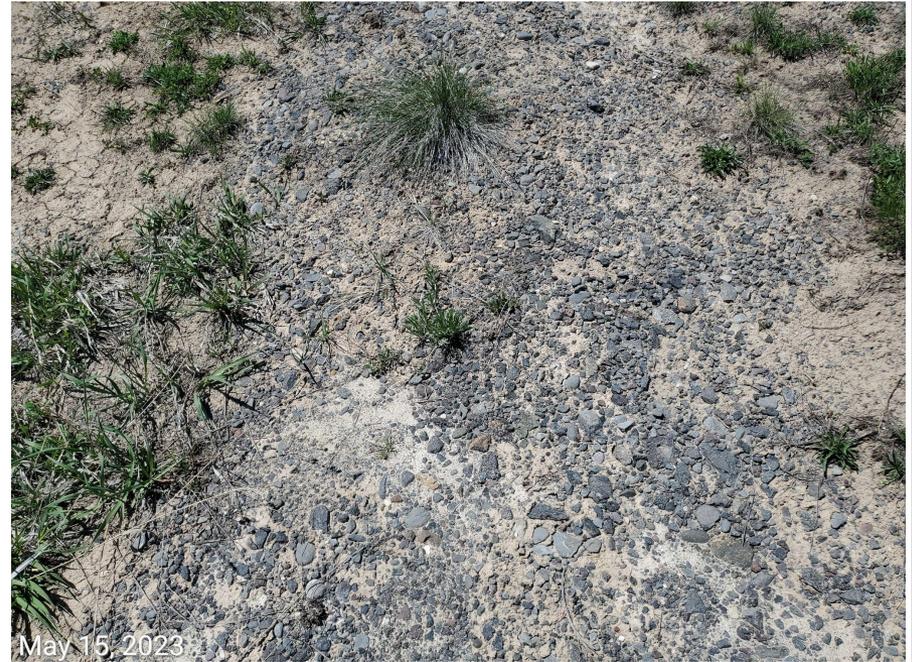
Photo 3: Gravel/Road base material observed remaining on Location.

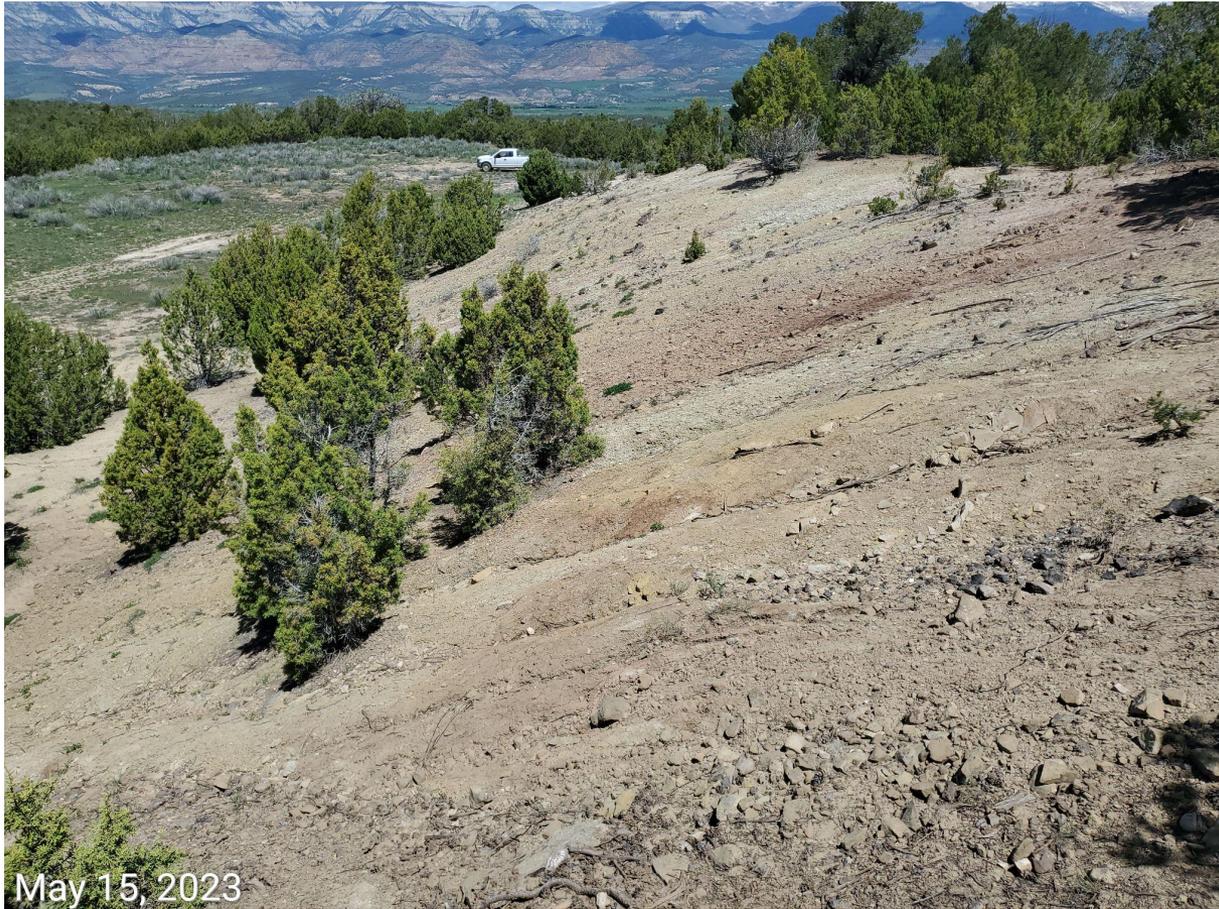
Photo 4: Photo taken from the southeast end of the Location, facing north. Photo shows cut and fill slopes remain; Location has not been recontoured/regraded/reclaimed.

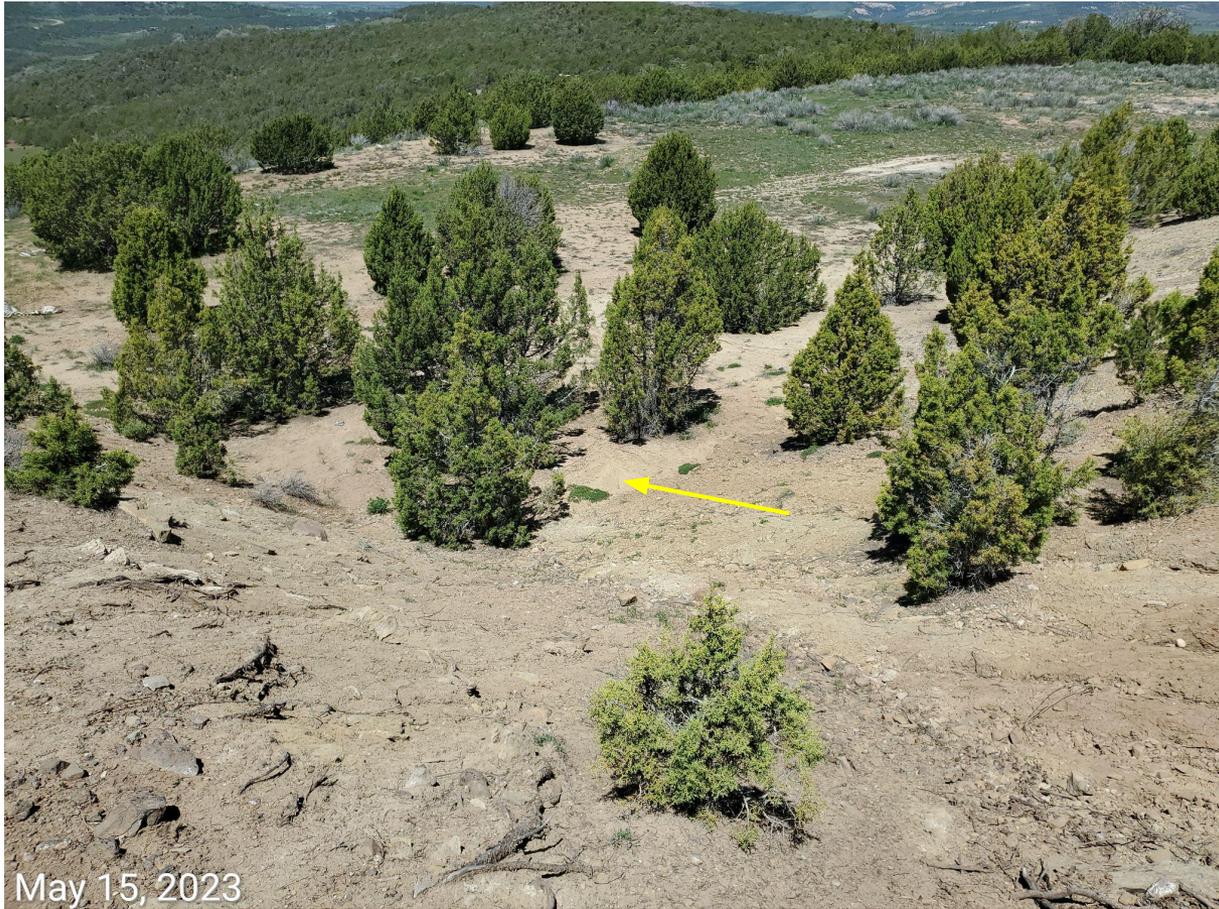
Photo 5: Photo taken from the cut slopes on the southeast end of the Location. Photo shows slopes lack stabilization. Arrow shows sediment deposition due to erosion degradation and sediment transport from the cut slopes.

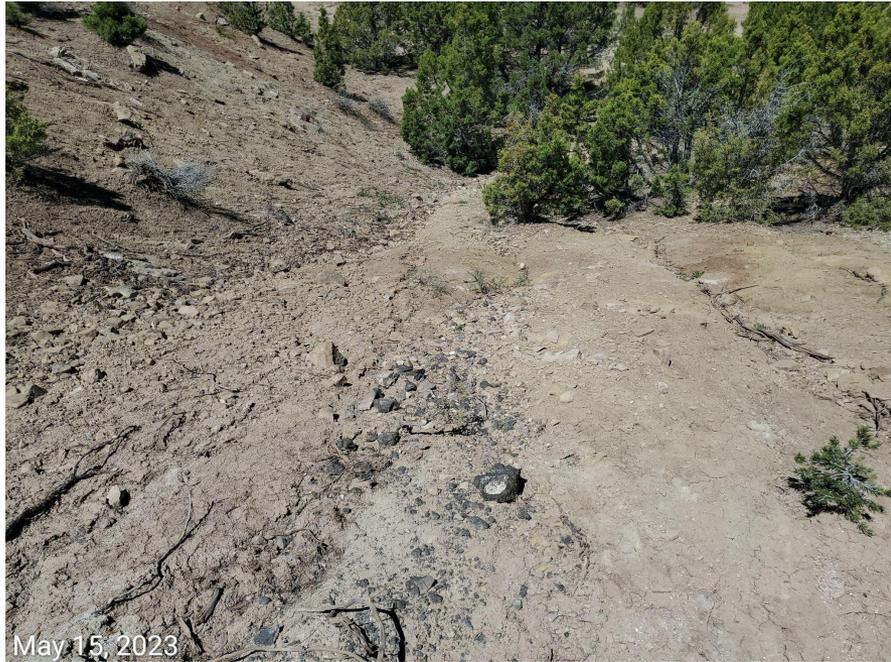
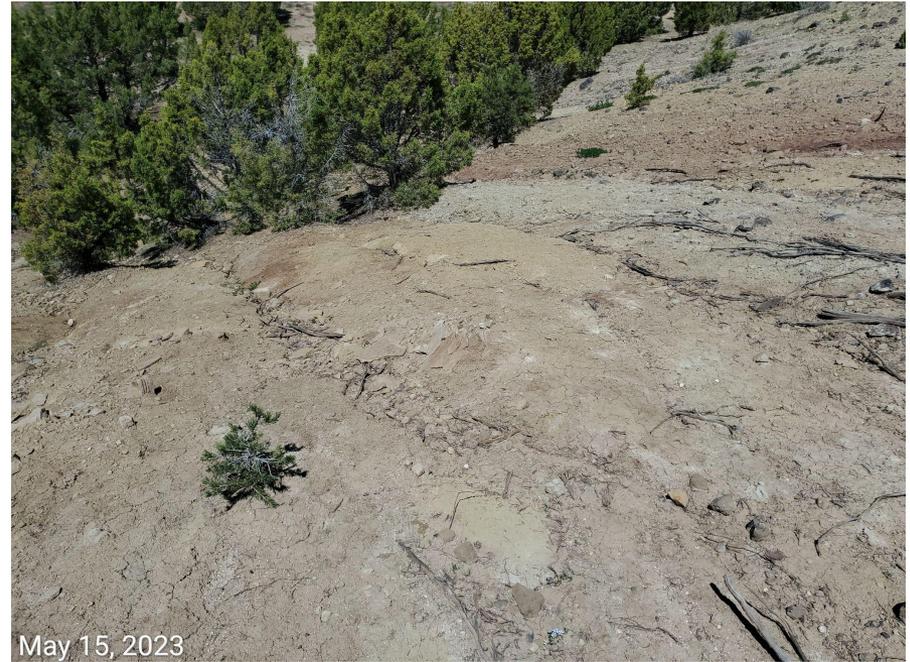
Photo 6: Photo taken from the cut slopes on the southeast end of the Location. Photo shows slopes lack stabilization; erosion degradation observed.

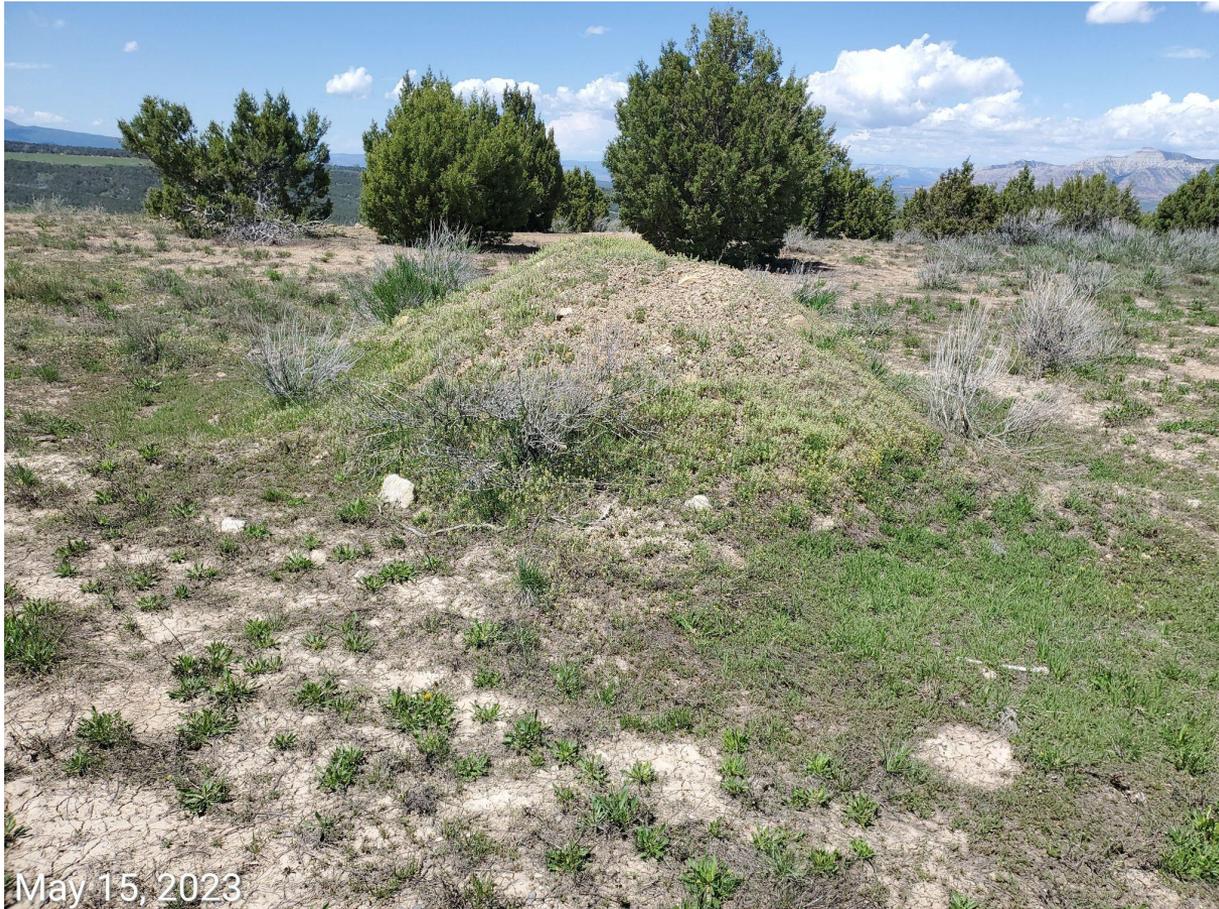
Photo 7: Photo show soil stockpile remaining on the Location. Segregated soils have not been replaced to their relative original position and grade.

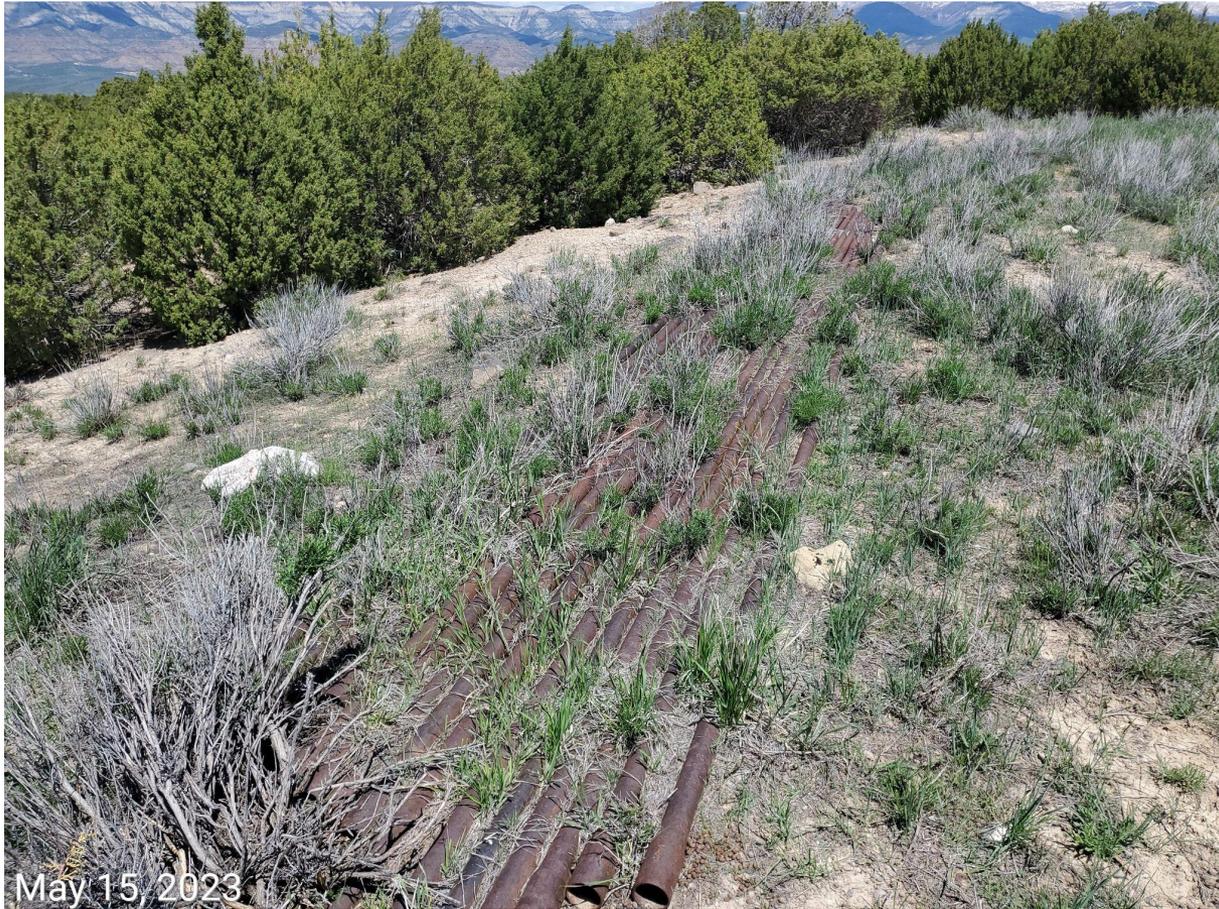
Photo 8: Photo shows unused pipe equipment remaining on the northwest end of the Location.

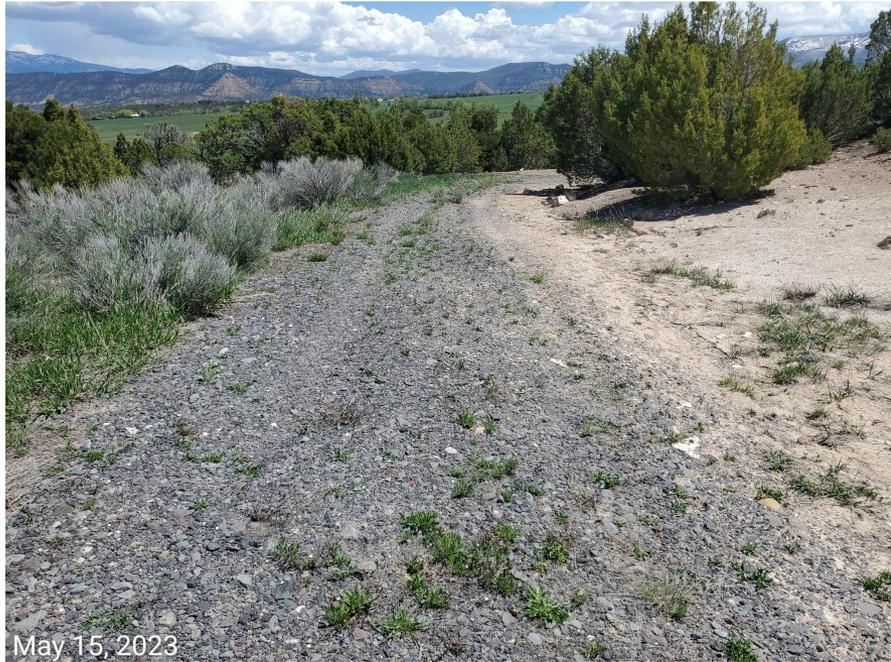
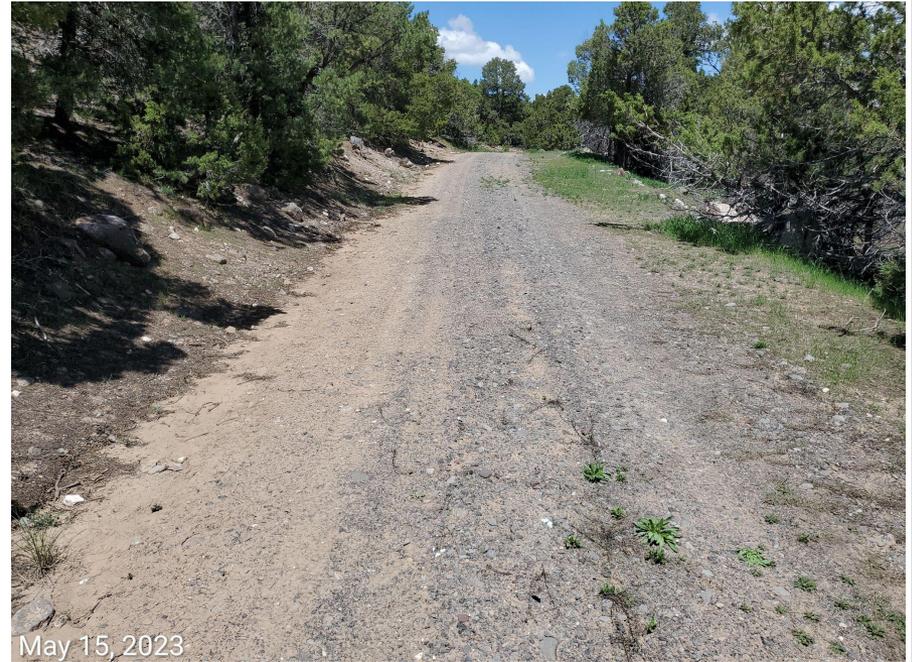
Photo 9: Photos examples showing the access road leading to the Location has not been reclaimed pursuant to Rule 1004; gravel/road base remains, access road has not been decompacted, recontoured/regraded and reclaimed.
