Inspection Photos

5/15/2023

Operator: LARAMIE ENERGY LLC #10433 /
BLACK HILLS PLATEAU PRODUCTION LLC
#10150

Location Number: 312404
Mesa County, CO

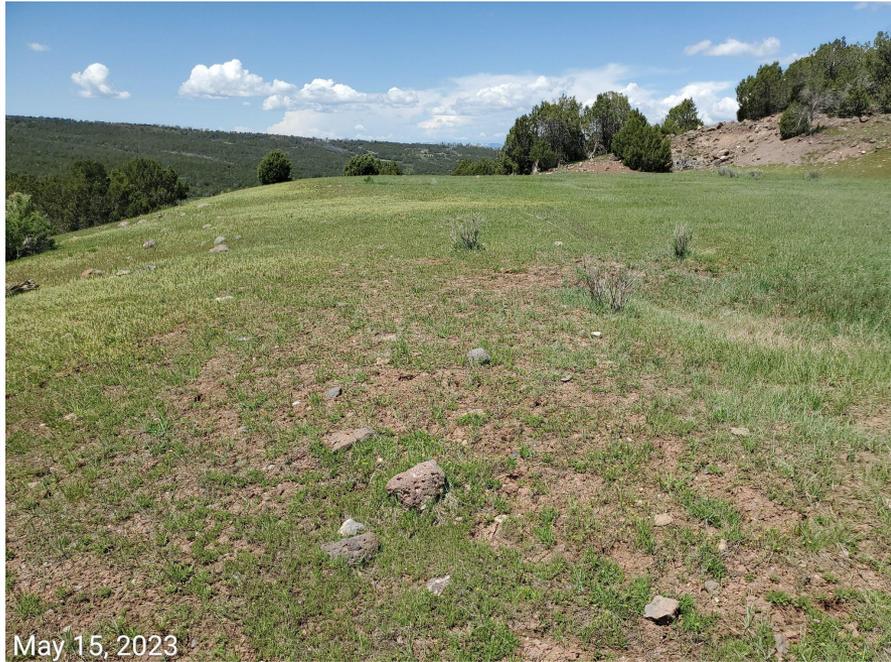
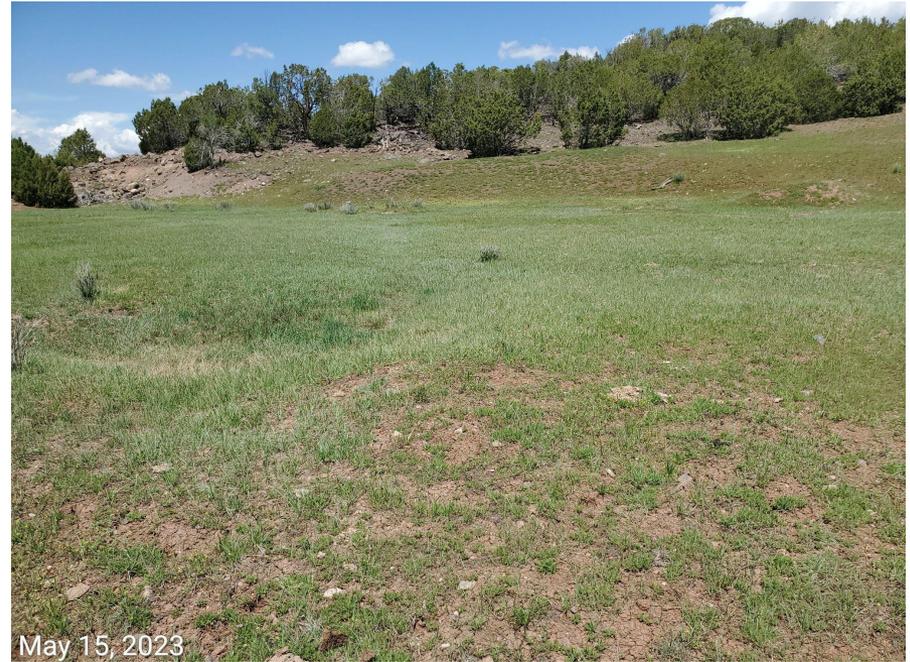
Photo 1: Photos 1-2 taken from the south end of the Location. Photos provide an overview of the Location from west, northwest, northeast to east.

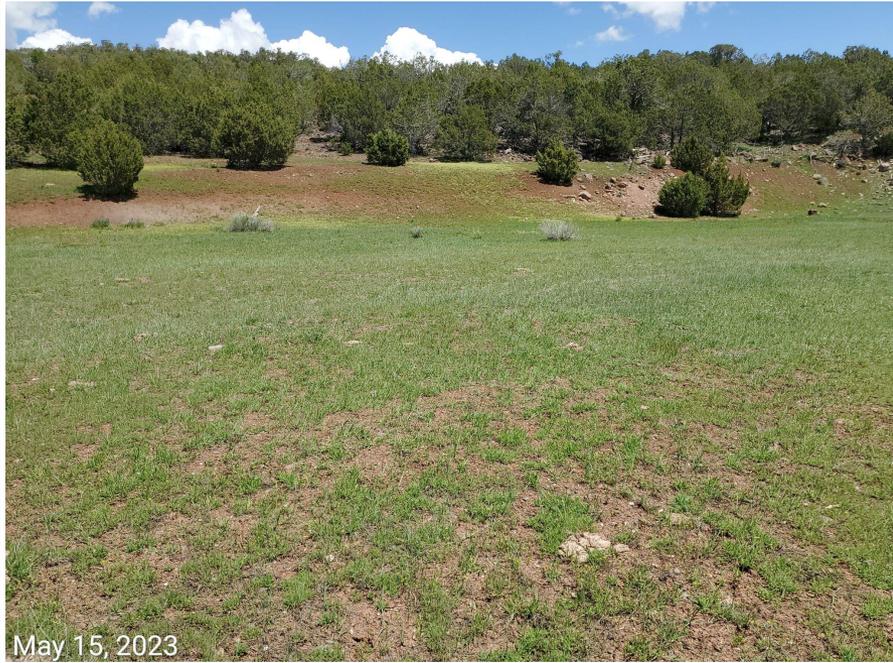
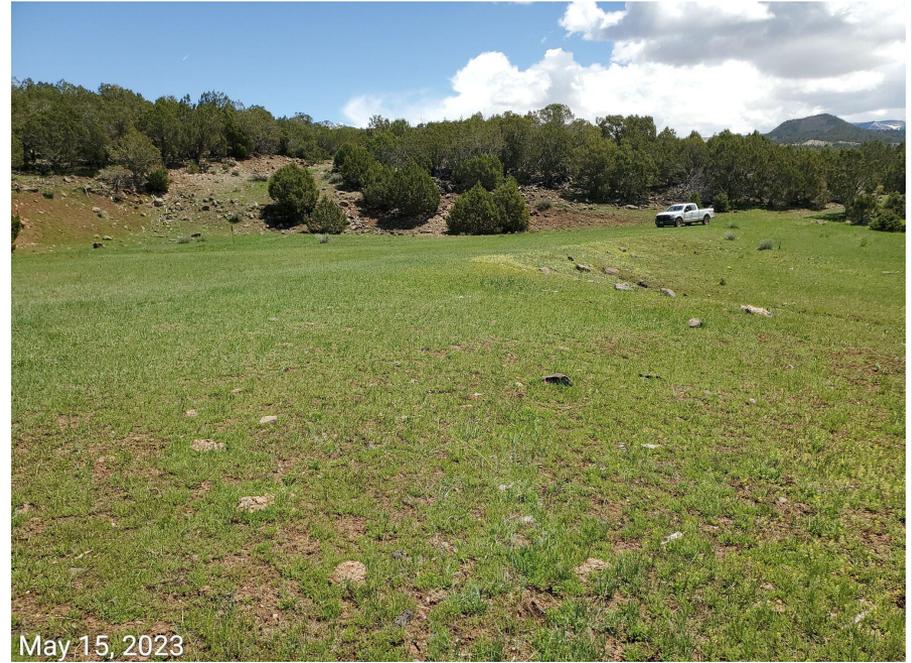
Photo 2: See comments under photo 1.

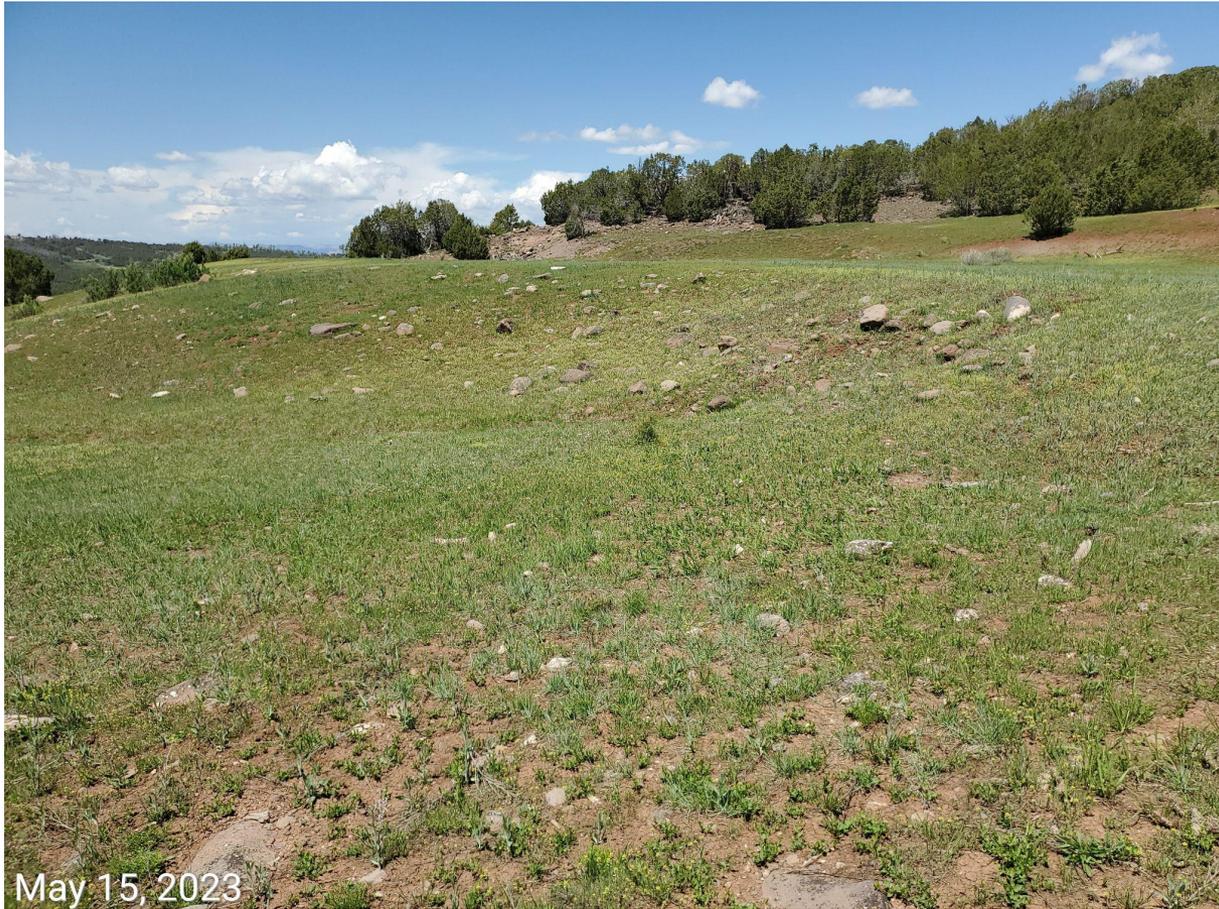
Photo 3: Photo taken from the southeast end of the Location, facing west. Photo shows cut and fill slopes remain; Location has not been recontoured/regraded/reclaimed.

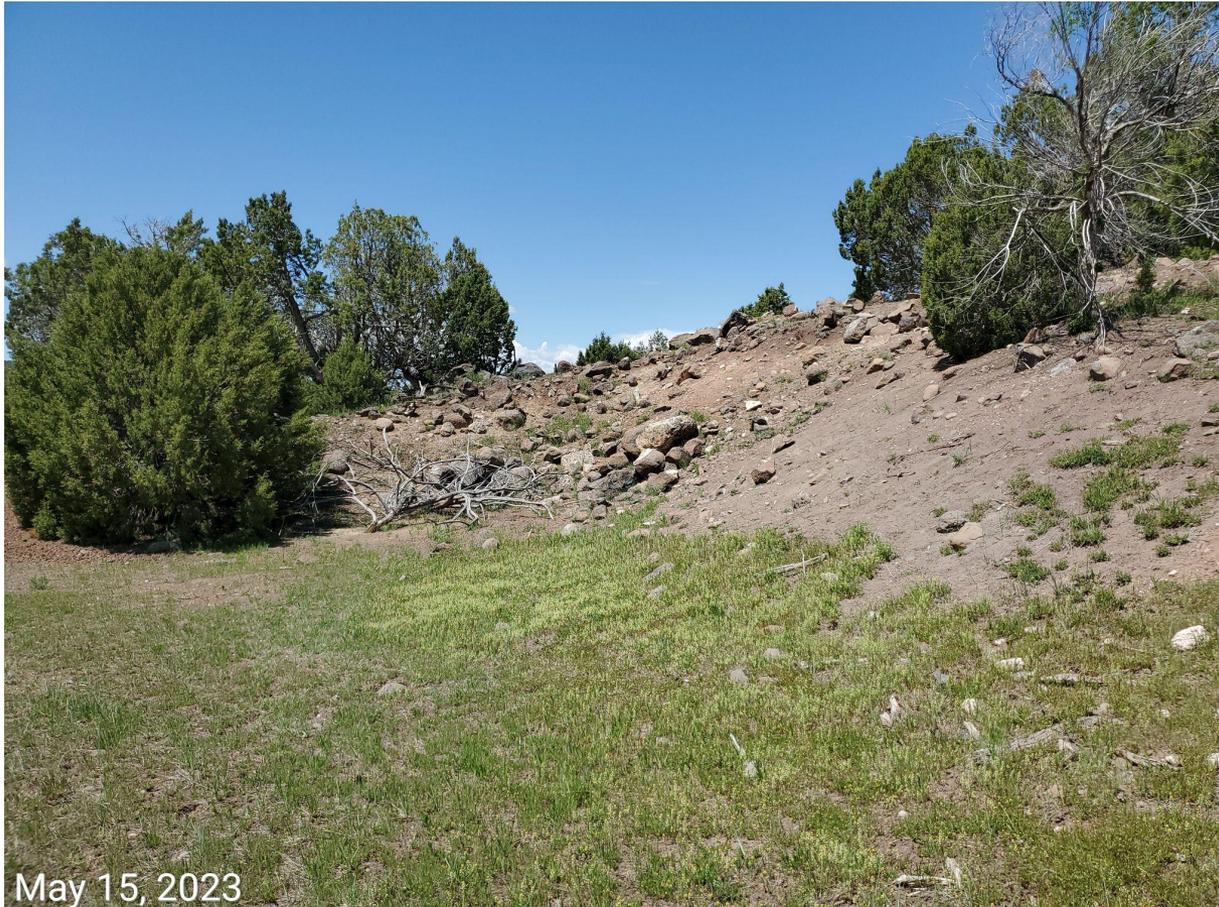
Photo 4: Photo taken from the northwest end of the Location, facing west. Photo shows cut and fill slopes remain; Location has not been recontoured/regraded/reclaimed.

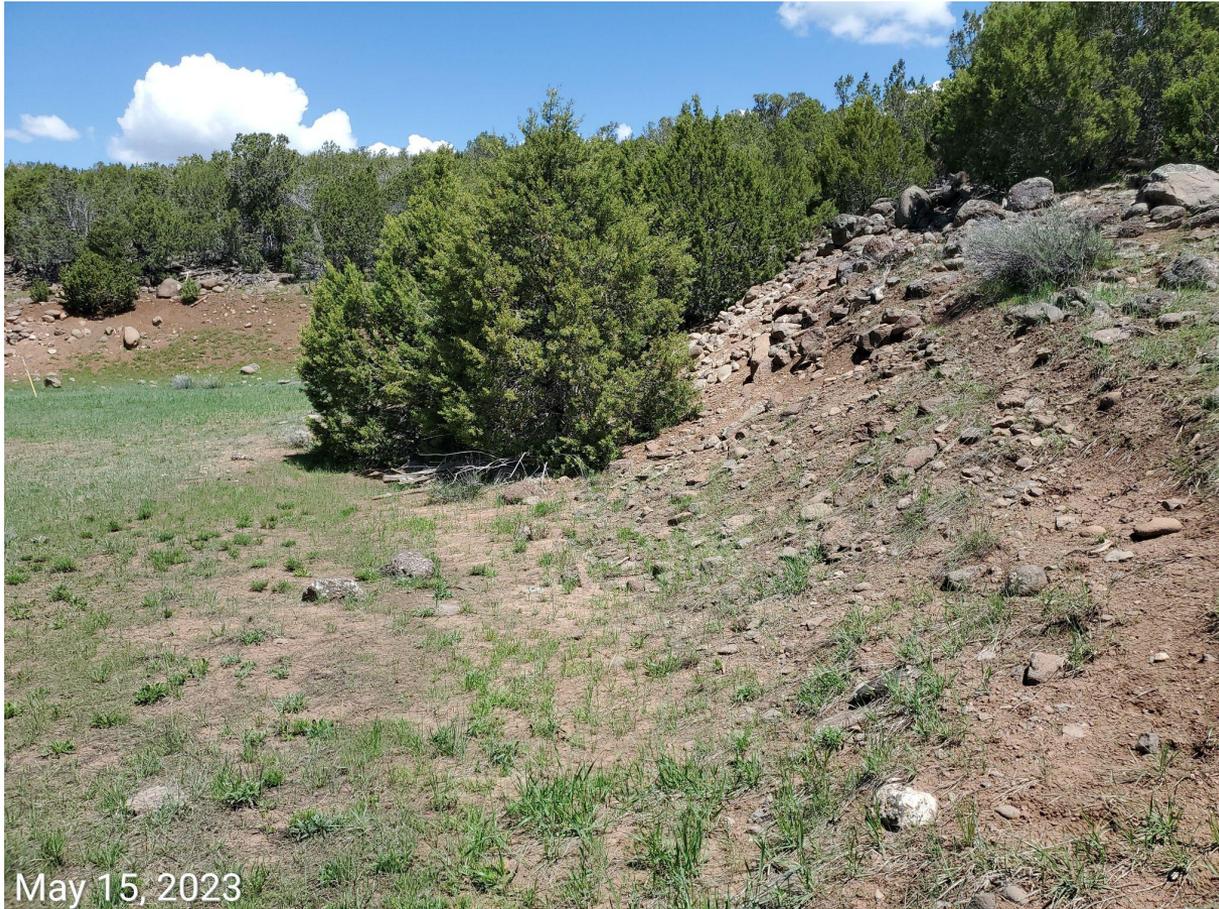
Photo 5: Photo taken from the east end of the Location, facing north. Photo shows cut and fill slopes remain; Location has not been recontoured/regraded/reclaimed.

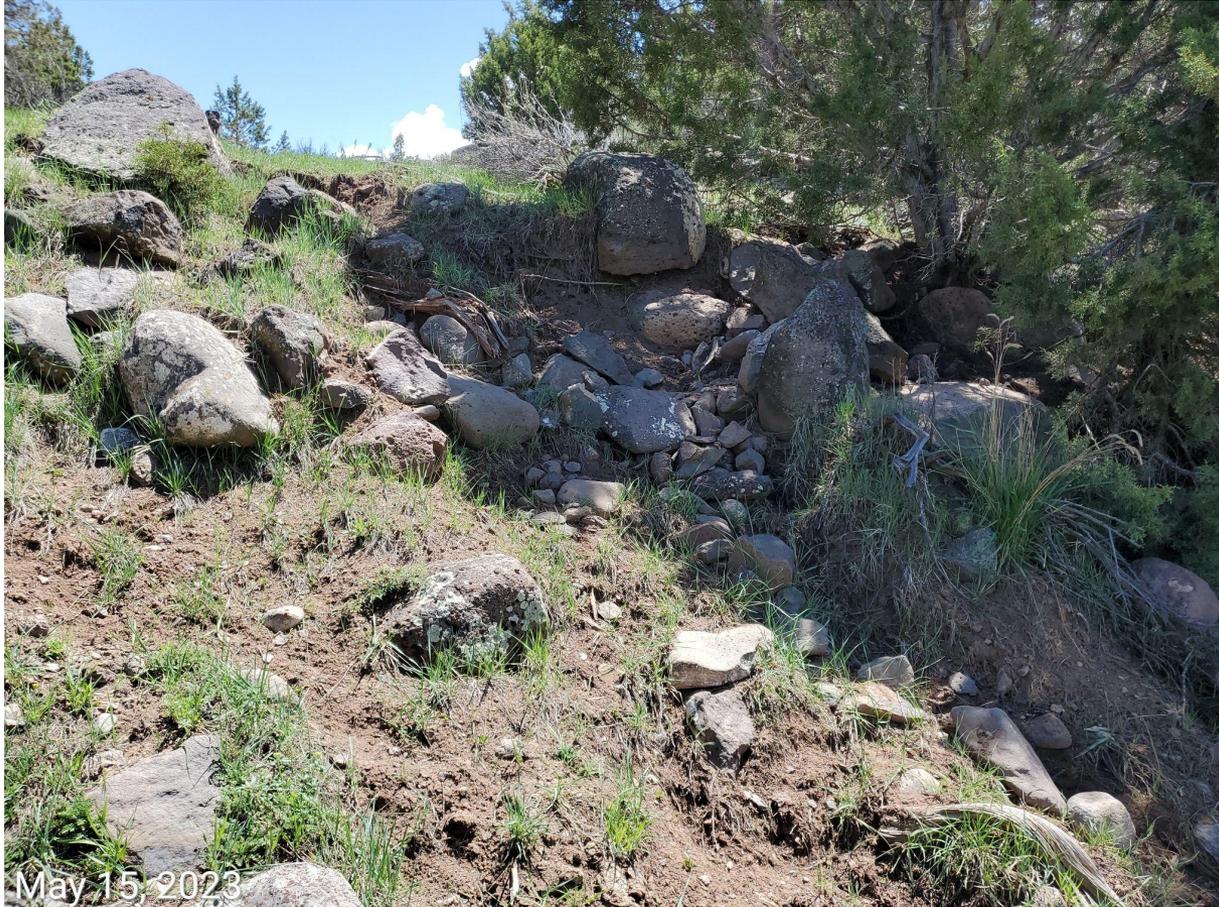
Photo 6: Photo taken from the cut slopes on the northeast end of the Location. Cut slopes lack stabilization; erosion degradation and sediment transport observed.

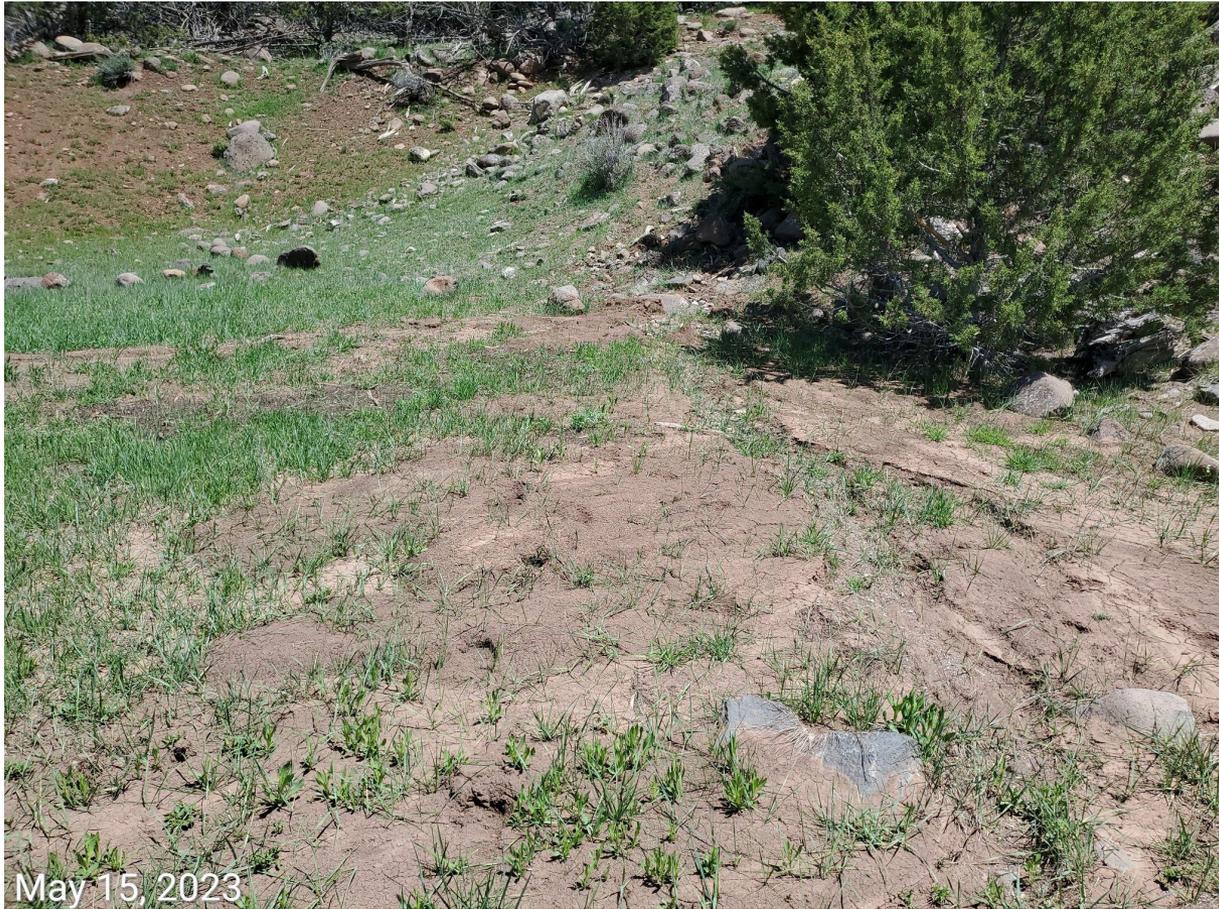
Photo 7: Photo taken from the cut slopes on the northeast end of the Location. Photo shows sediment deposition due to unstabilized cut slopes.

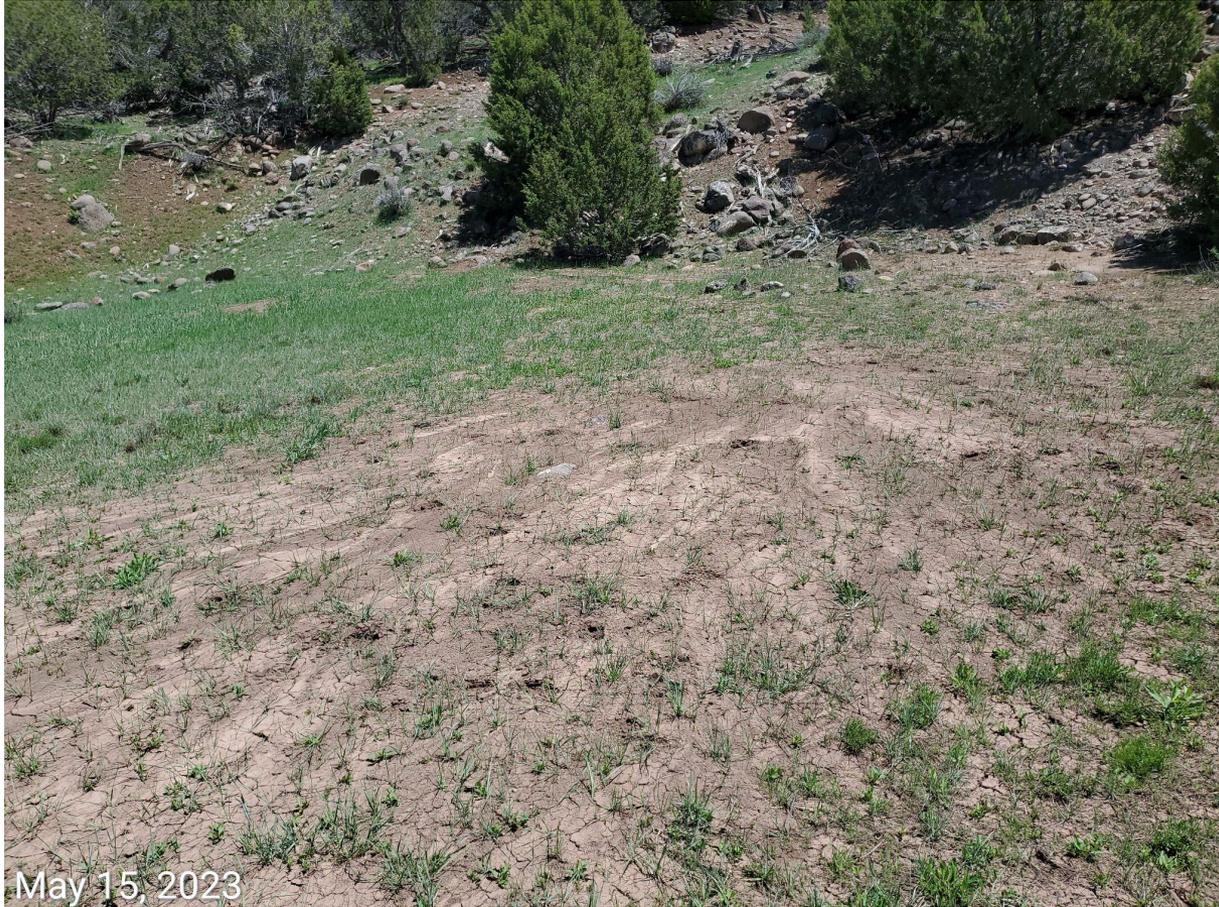
Photo 8: Photo taken from the cut slopes on the northeast end of the Location. Photo shows sediment deposition due to unstabilized cut slopes.

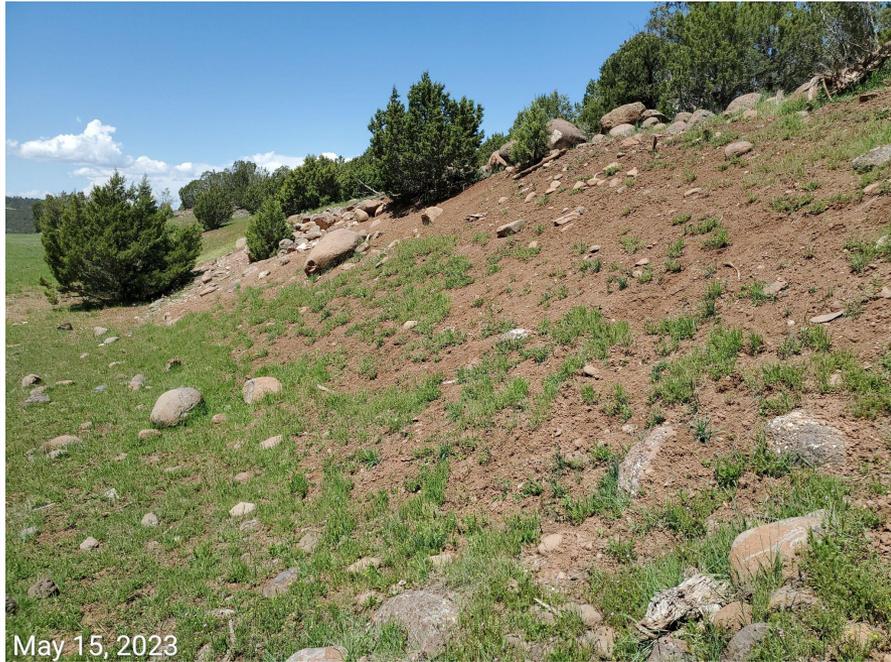
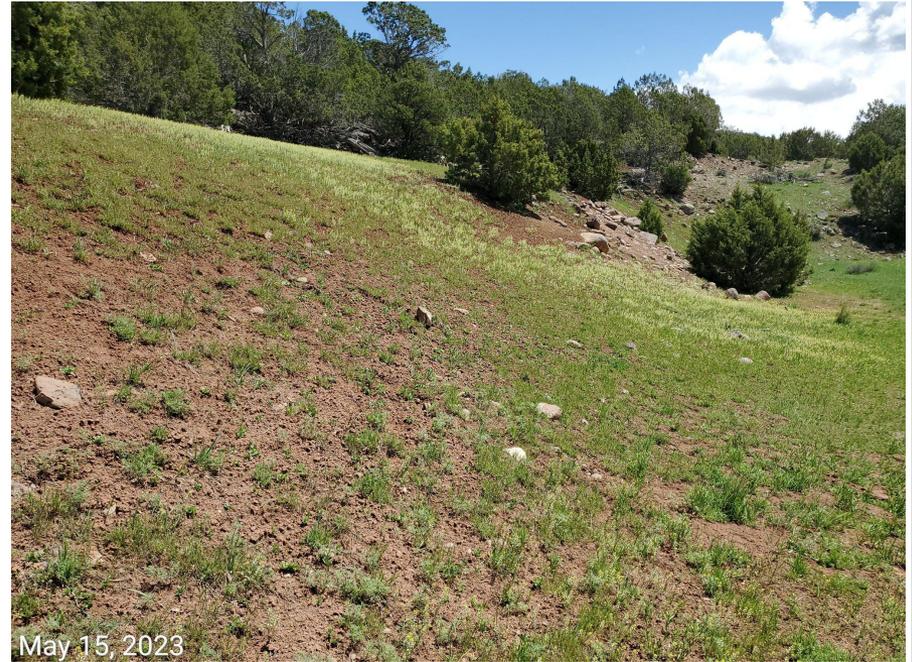
Photo 9: Photo shows cut and fill slopes remain; Location has not been recontoured/regraded/reclaimed. Vegetation observed on cut slopes predominantly Undesirable Plant Species, such as *Erodium cicutarium* and *Thlaspi arvense* (yellow flowered plant in photo right).

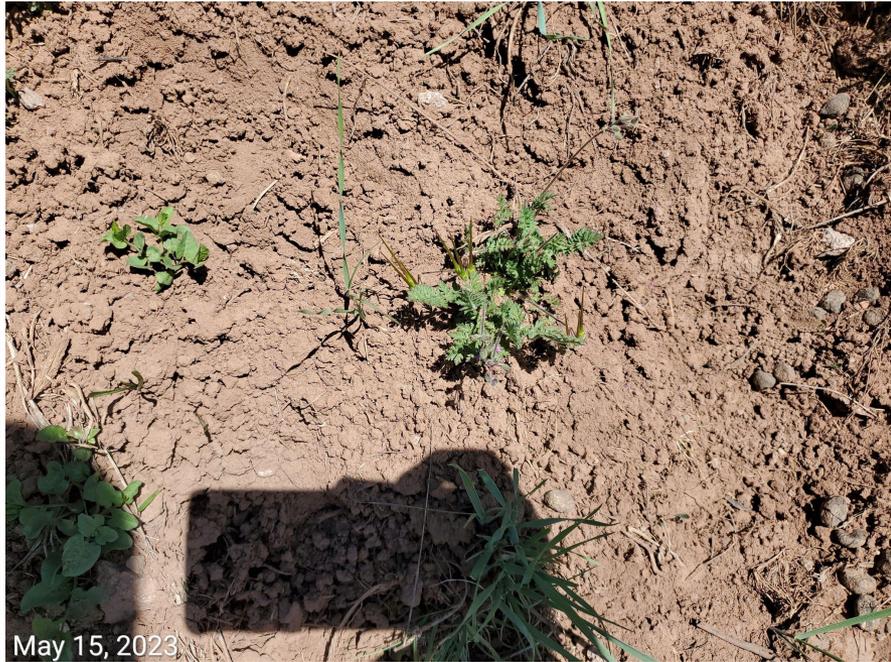
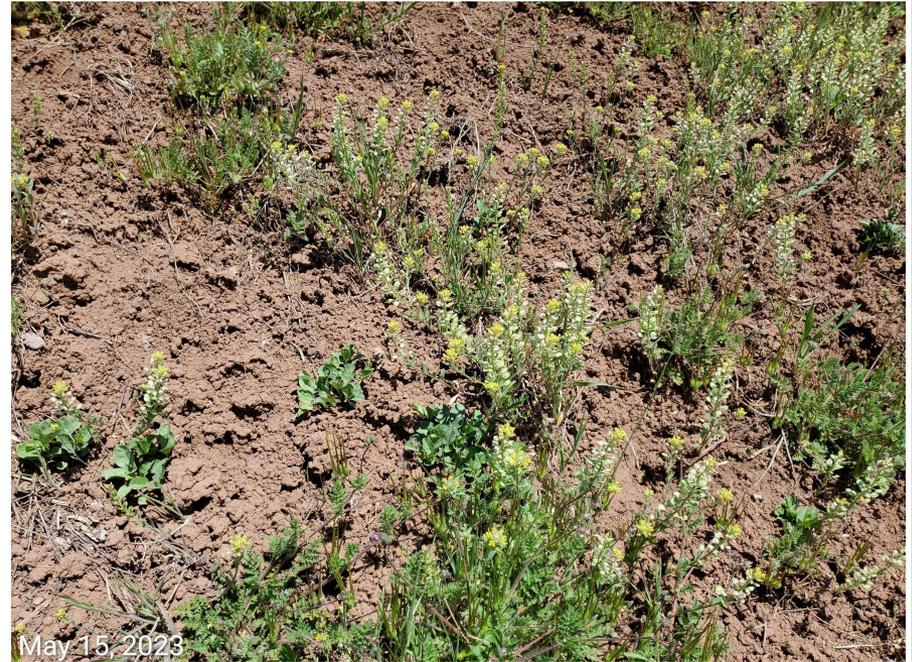
Photo 10: Photos examples showing Undesirable Plant Species observed on the cut slopes, such as such as *Erodium cicutarium* (photo left) and *Thlaspi arvense* (photo right).

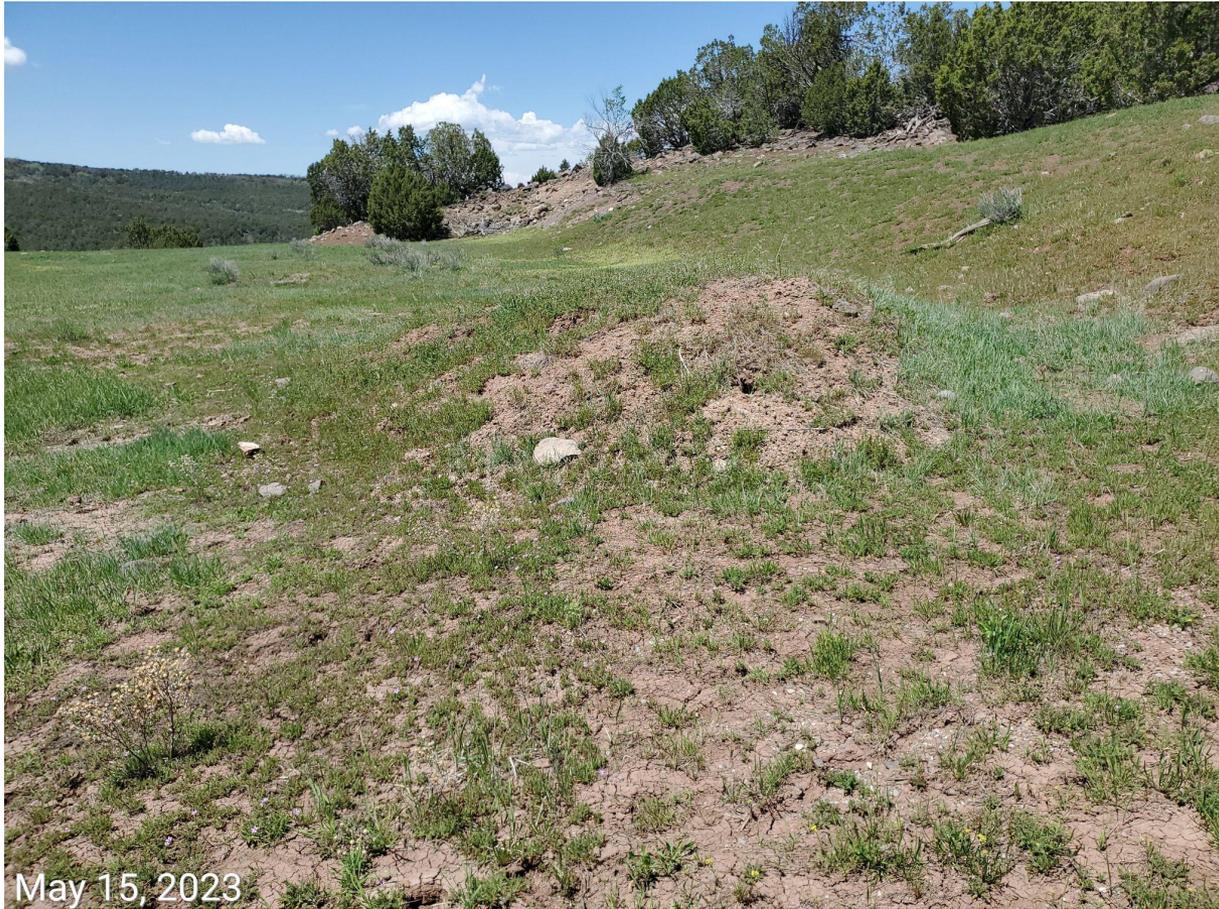
Photo 11: Photo show soil stockpile remaining on the Location. Segregated soils have not been replaced to their relative original position and grade.

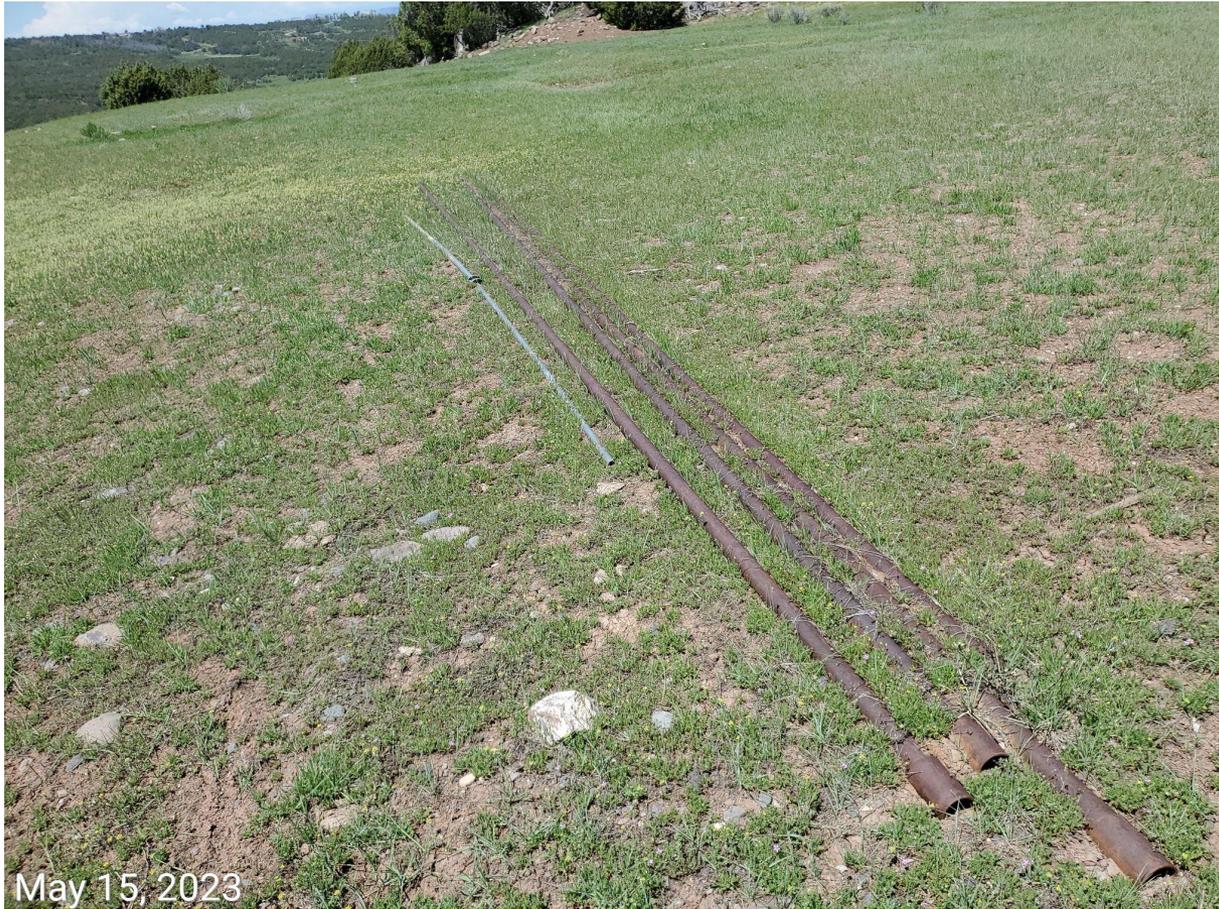
Photo 12: Photo shows unused pipe equipment remaining on the northwest end of the Location.

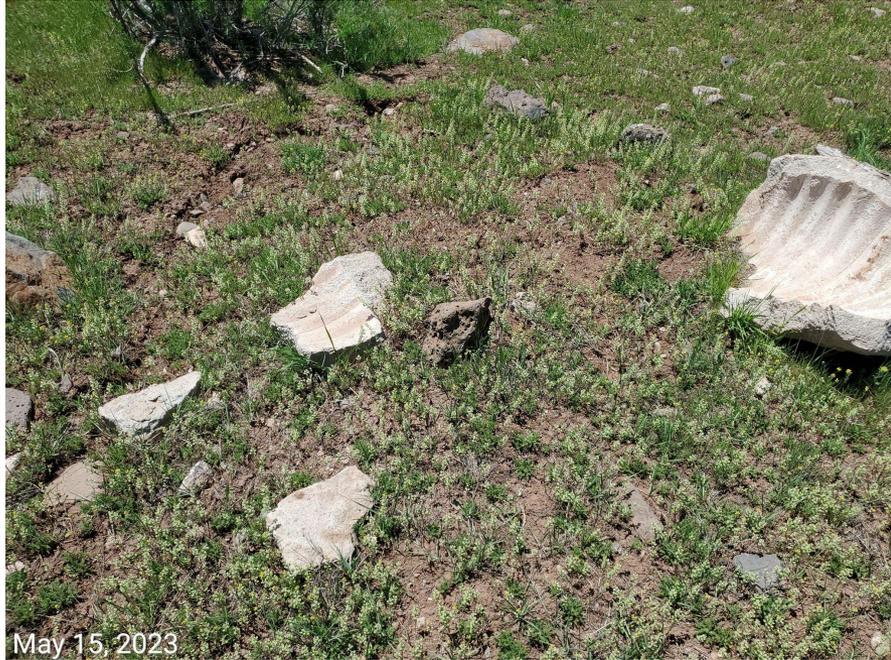
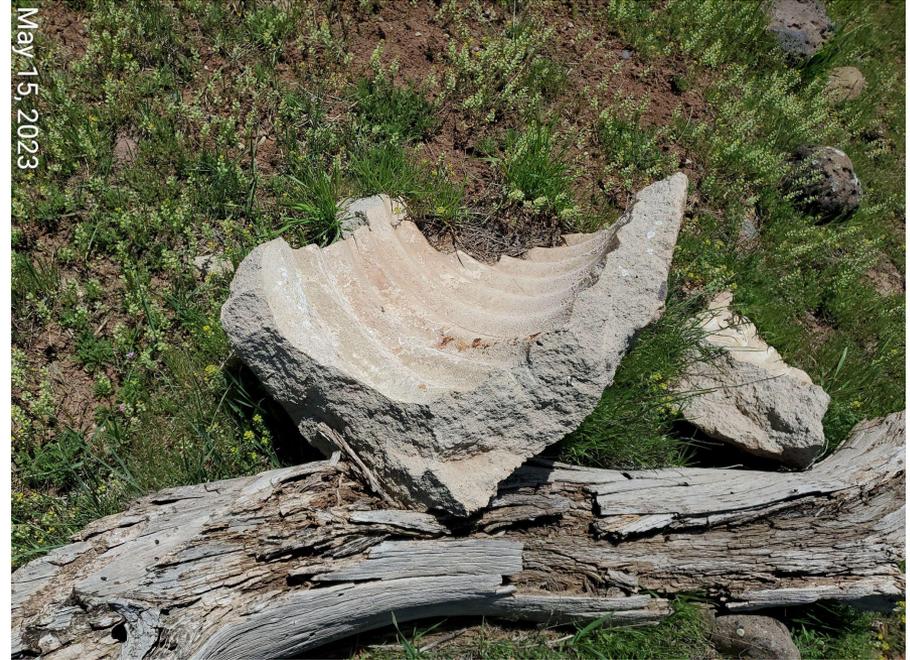
Photo 13: Photo shows what appears to be cement debris remaining on the south end of the Location.

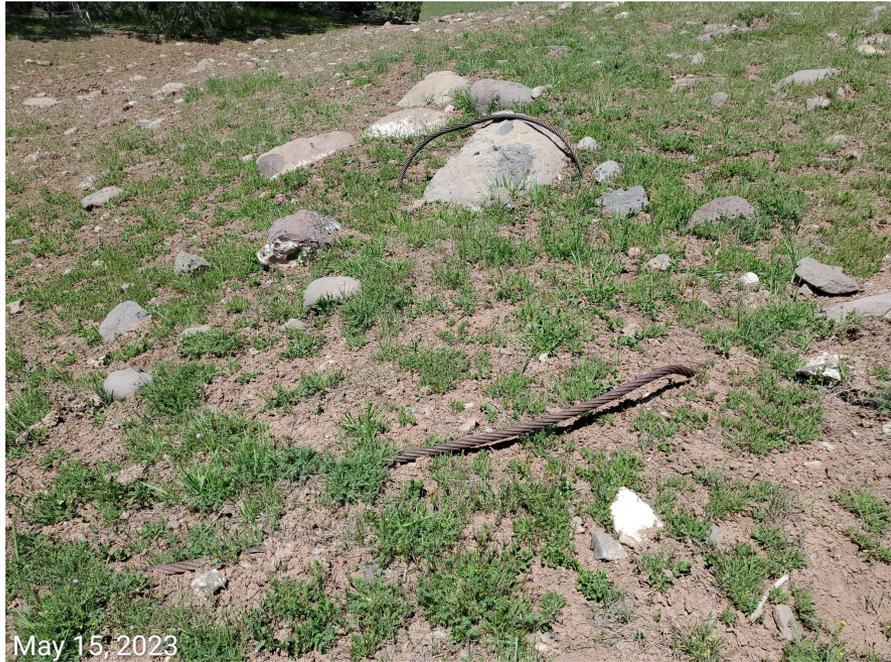
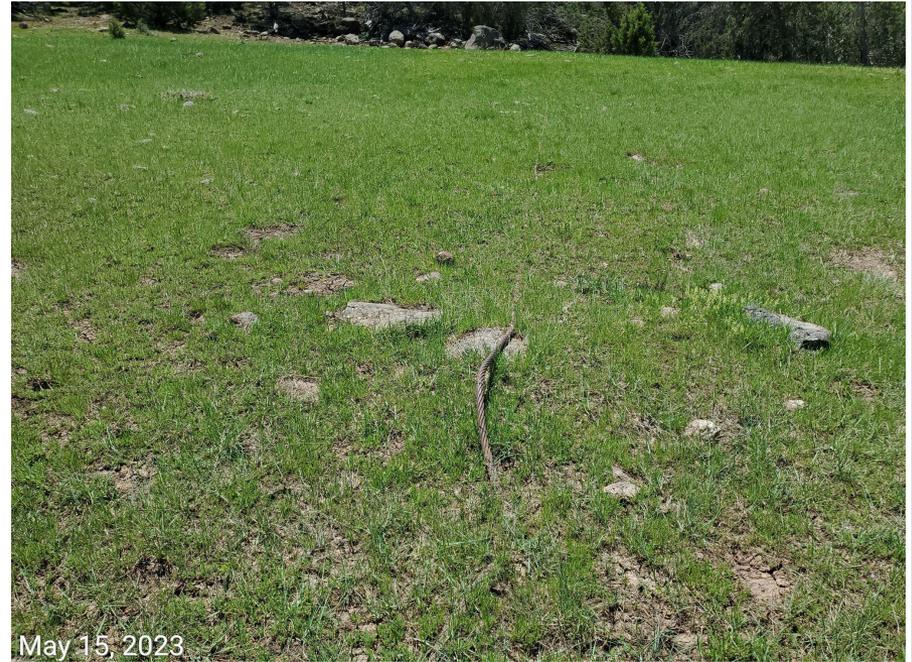
Photo 14: Photo shows unused cable equipment remaining on the southern end of the Location.

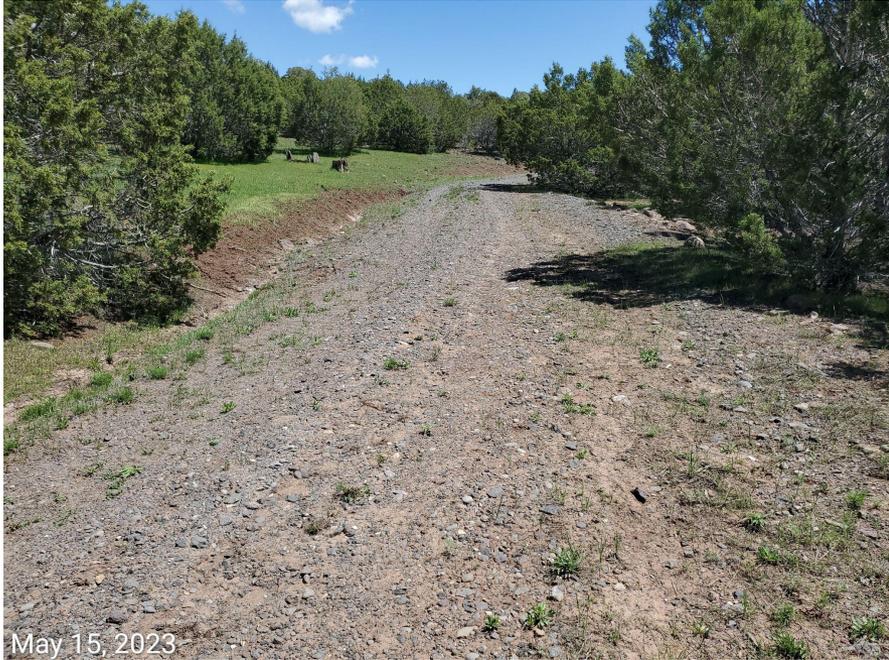
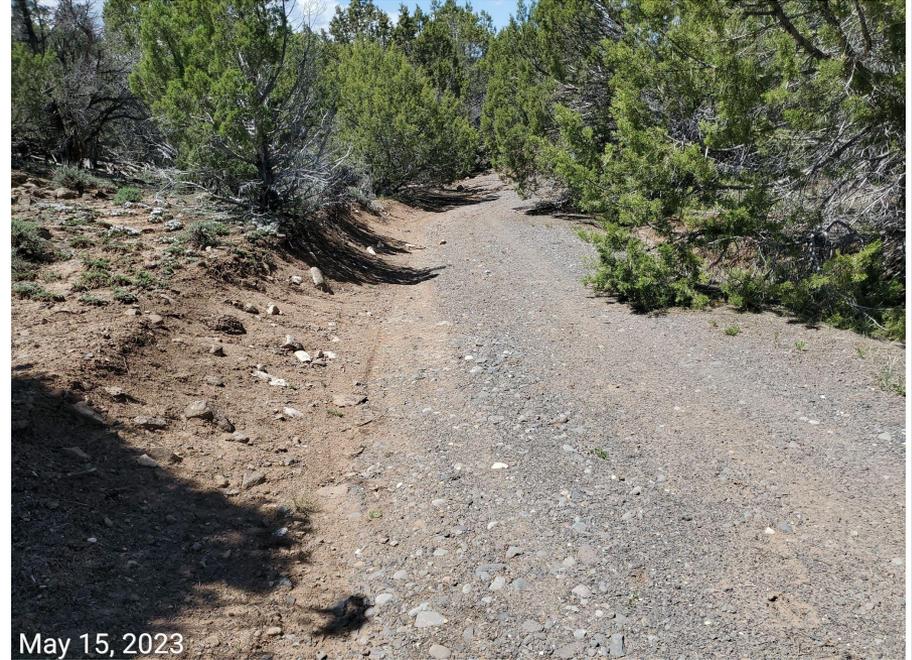
Photo 15: Photos examples showing the access road leading to the Location has not been reclaimed pursuant to Rule 1004; gravel/road base remains, access road has not been decompacted, recontoured/regraded and reclaimed.
