Inspection Photos

Operator: SCOUT ENERGY MANAGEMENT LLC
- 10779

Location Number: 315463
Rio Blanco County, CO

Aaron Trujillo
NW Reclamation Specialist
COGCC

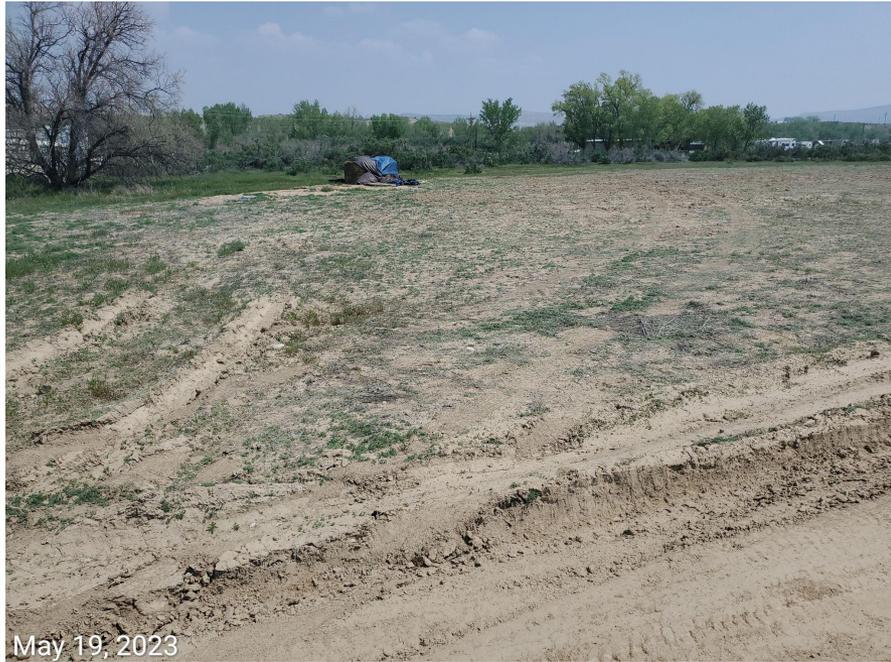
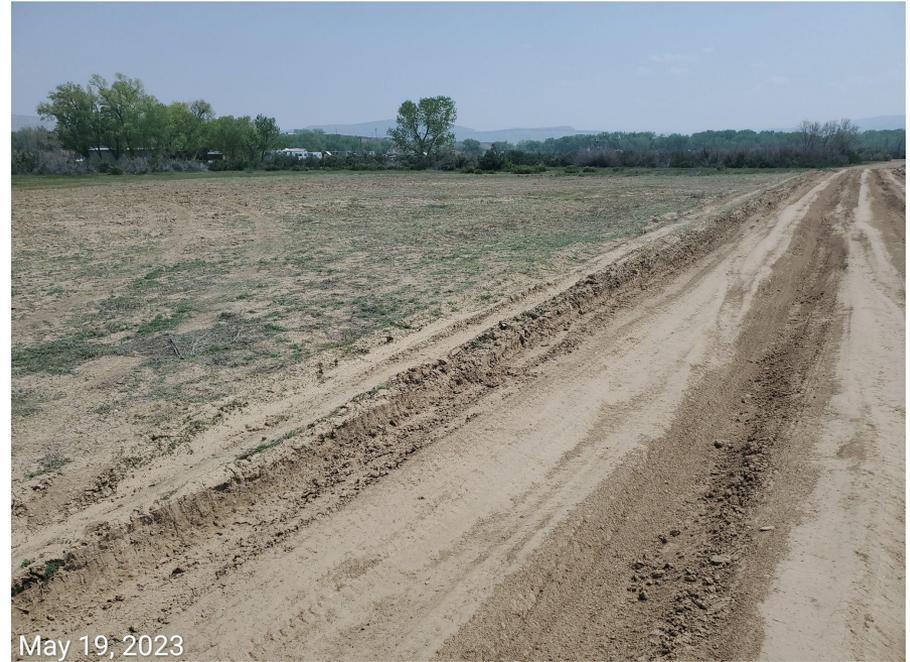
Photo 1: Photos 1-2 taken from the west end of the Location. Photos provide an overview of the Location from north, northeast, southeast to south. Vegetation observed on the Location is predominantly Undesirable Plant Species, such as Kochia, and Salsola sp.

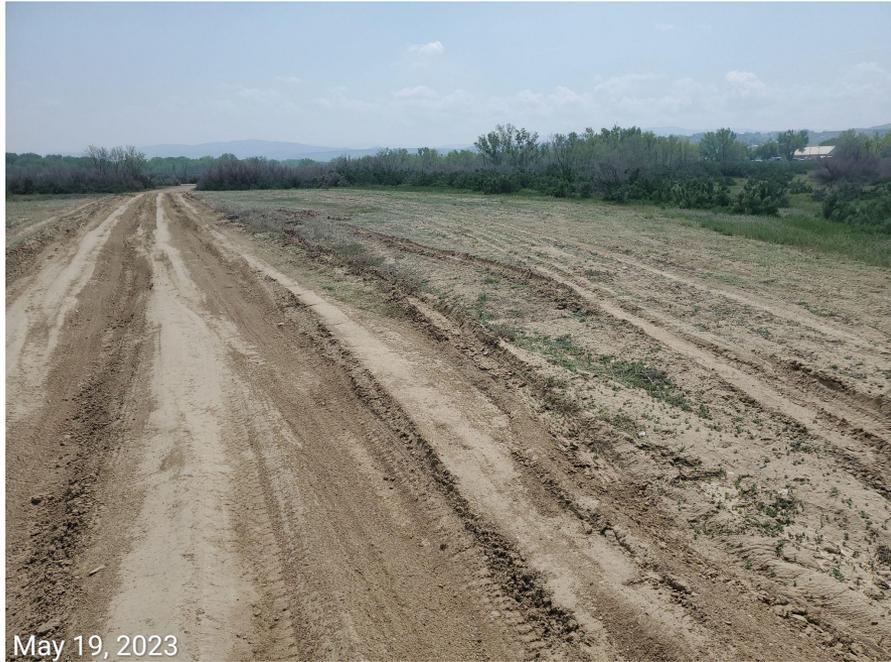
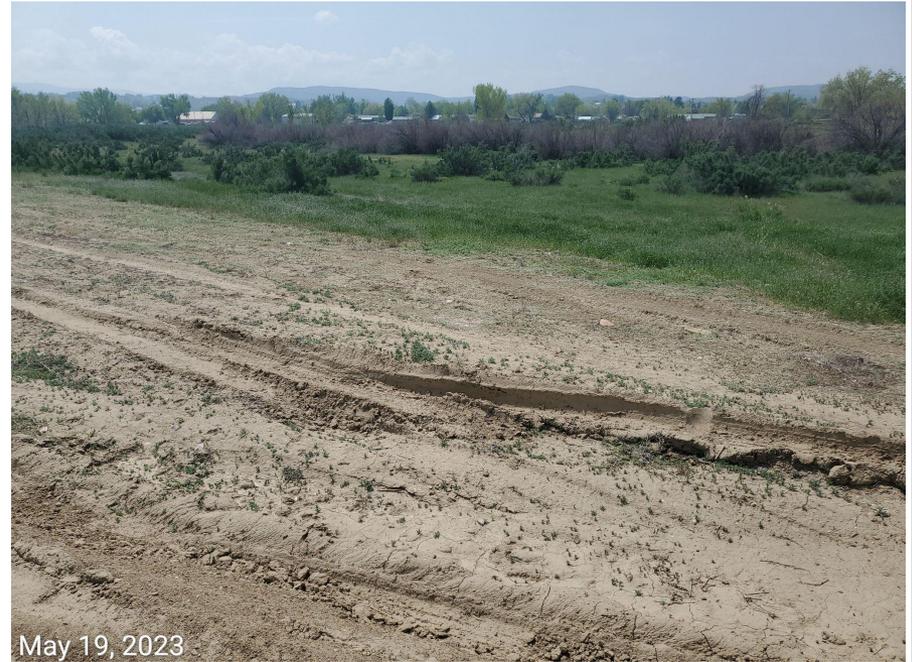
Photo 2: See comments under photo 1.

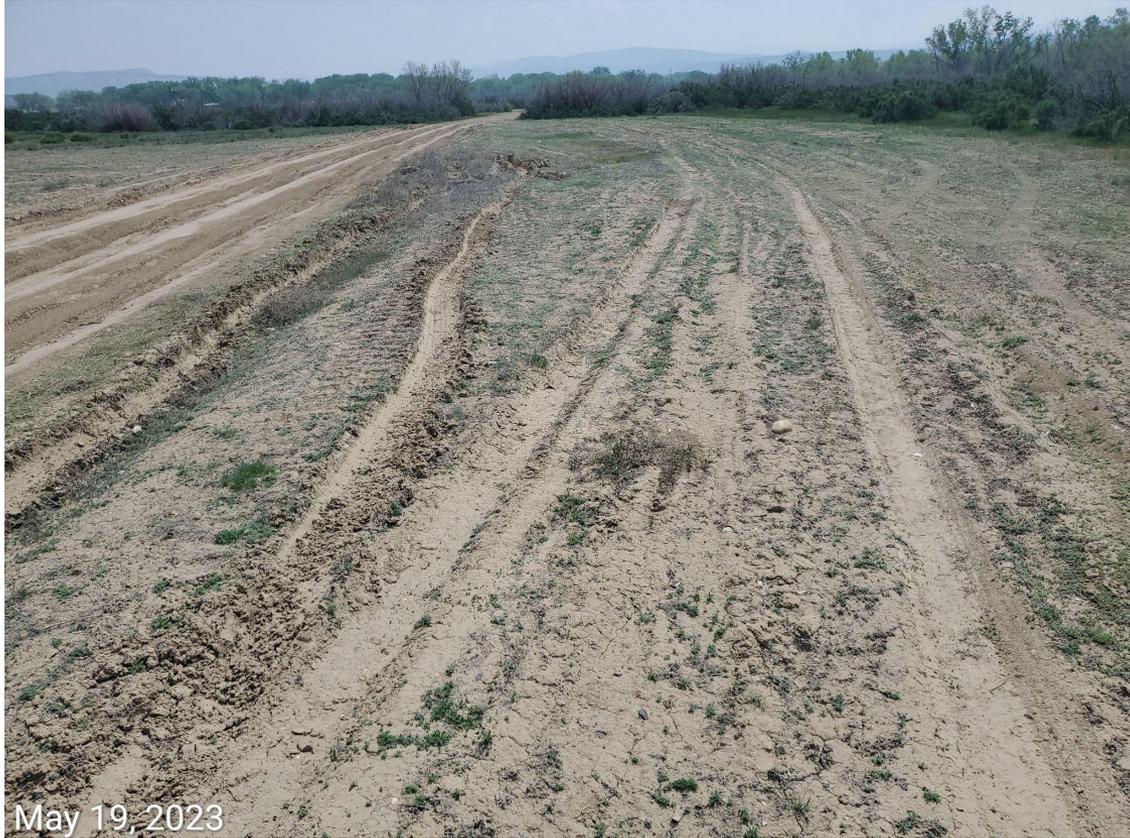
Photo 3: Photo taken from southern reclamation areas, facing east. Photo shows vehicles have traveled over and re-disturbed the reclamation areas.

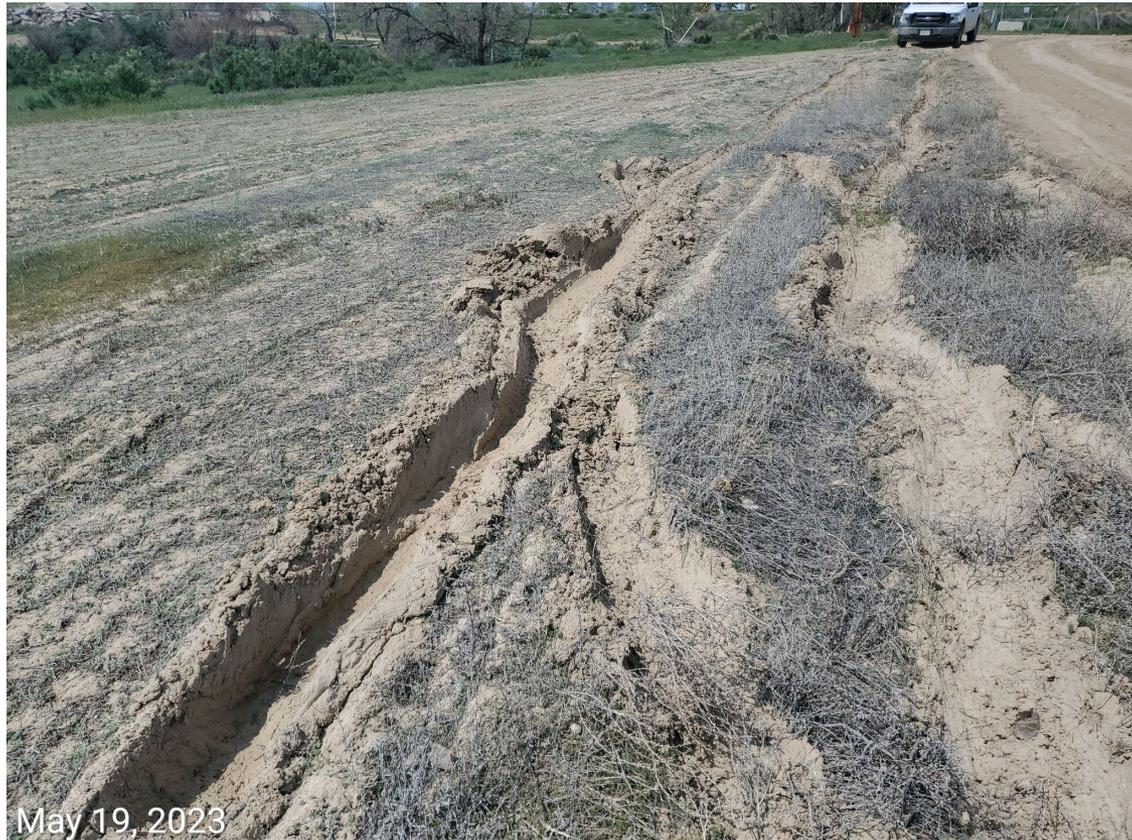
Photo 4: See comments under photo 3.

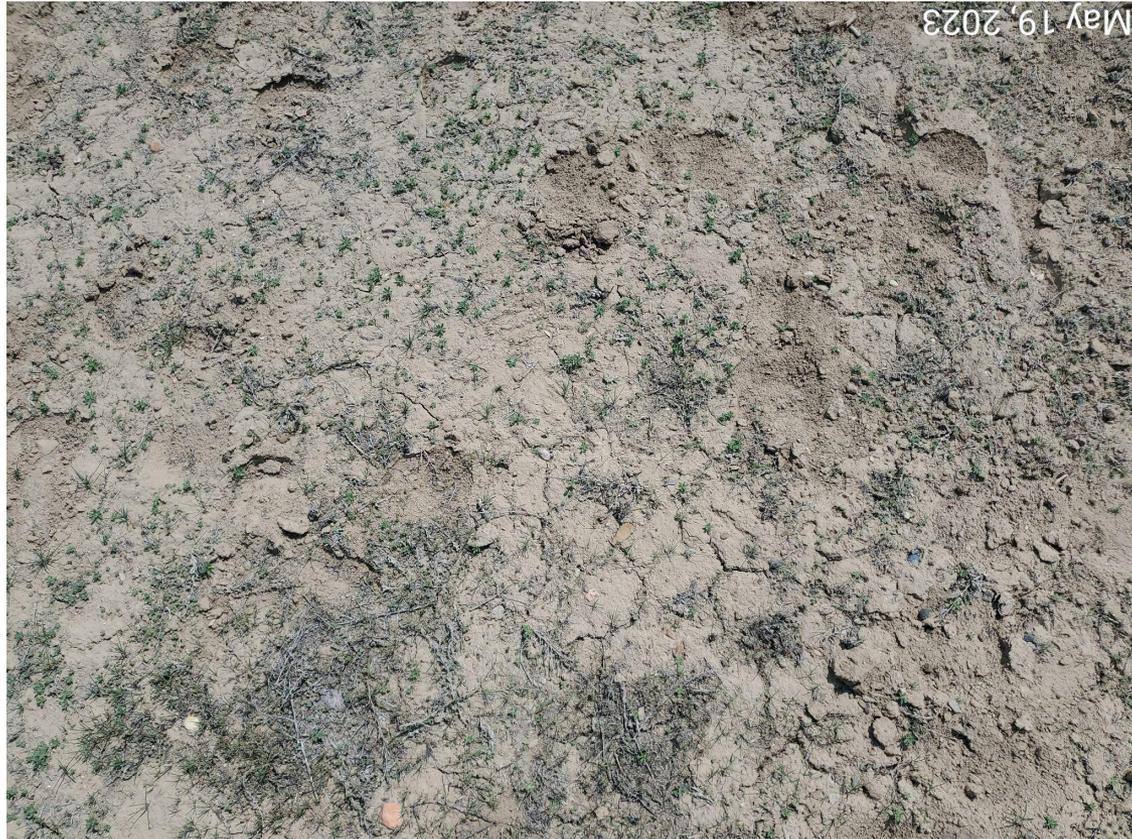
Photo 5: Photo example showing the surface of the reclamation areas. Desirable perennial plant germination/establishment on the Location was not observed; Location is bare or predominantly vegetated by Undesirable Plant Species such as Kochia, and Salsola sp.

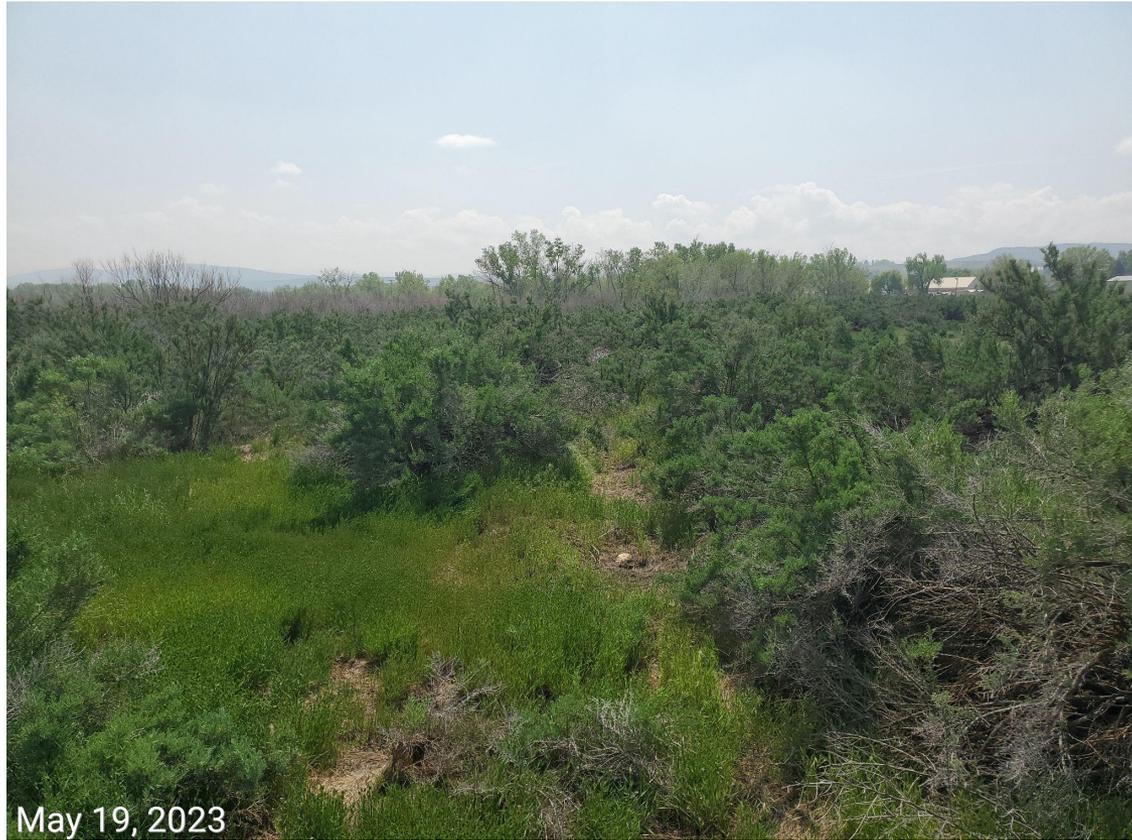
Photo 6: Photo example showing vegetation over the adjacent reference are.
