Location Name: ANGELINA #5, API #: 071-06771, Insp. #:695108248

PHOTO 1: WELL SIGN

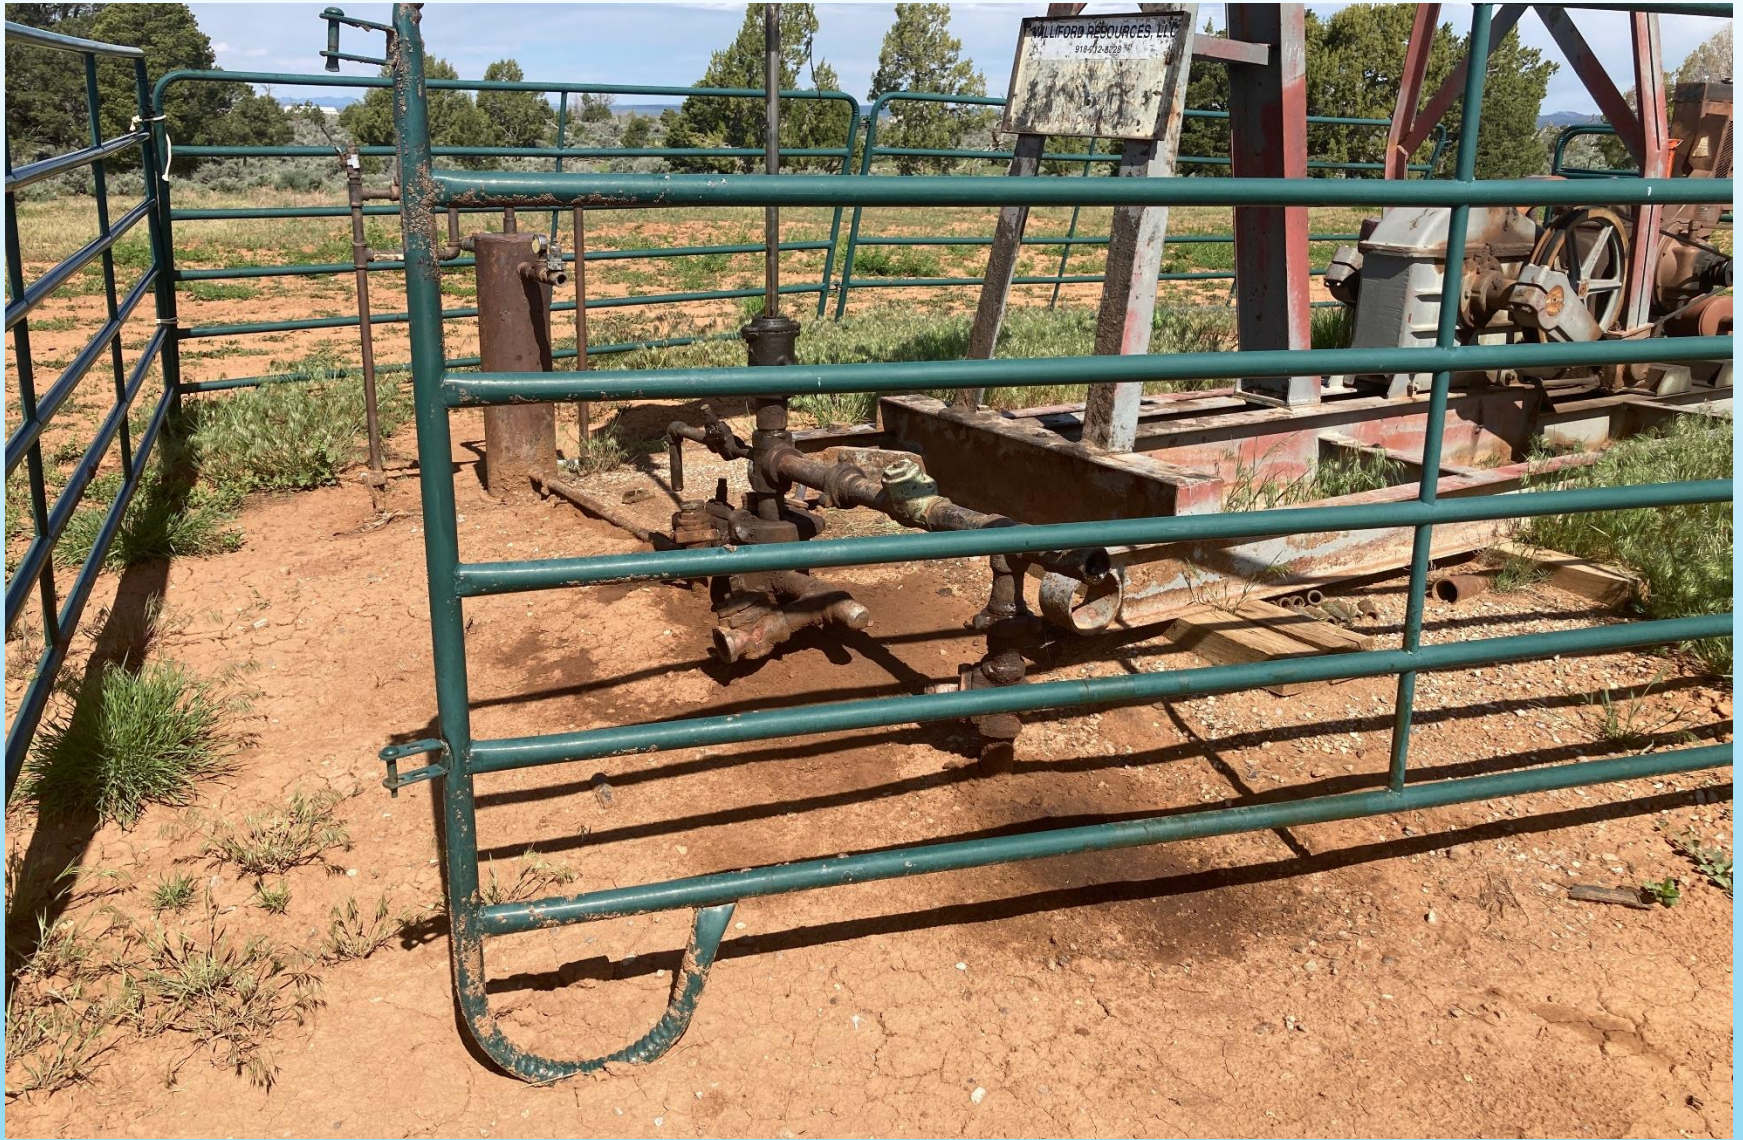
PHOTO 2: IMPACTED SOIL NEAR WELLHEAD. Conduct maintenance on equipment, cleanup stained material and review self inspection processes. COMPLY WITH RULE 1002,.(2).D. CA DATE 6-5-2023.

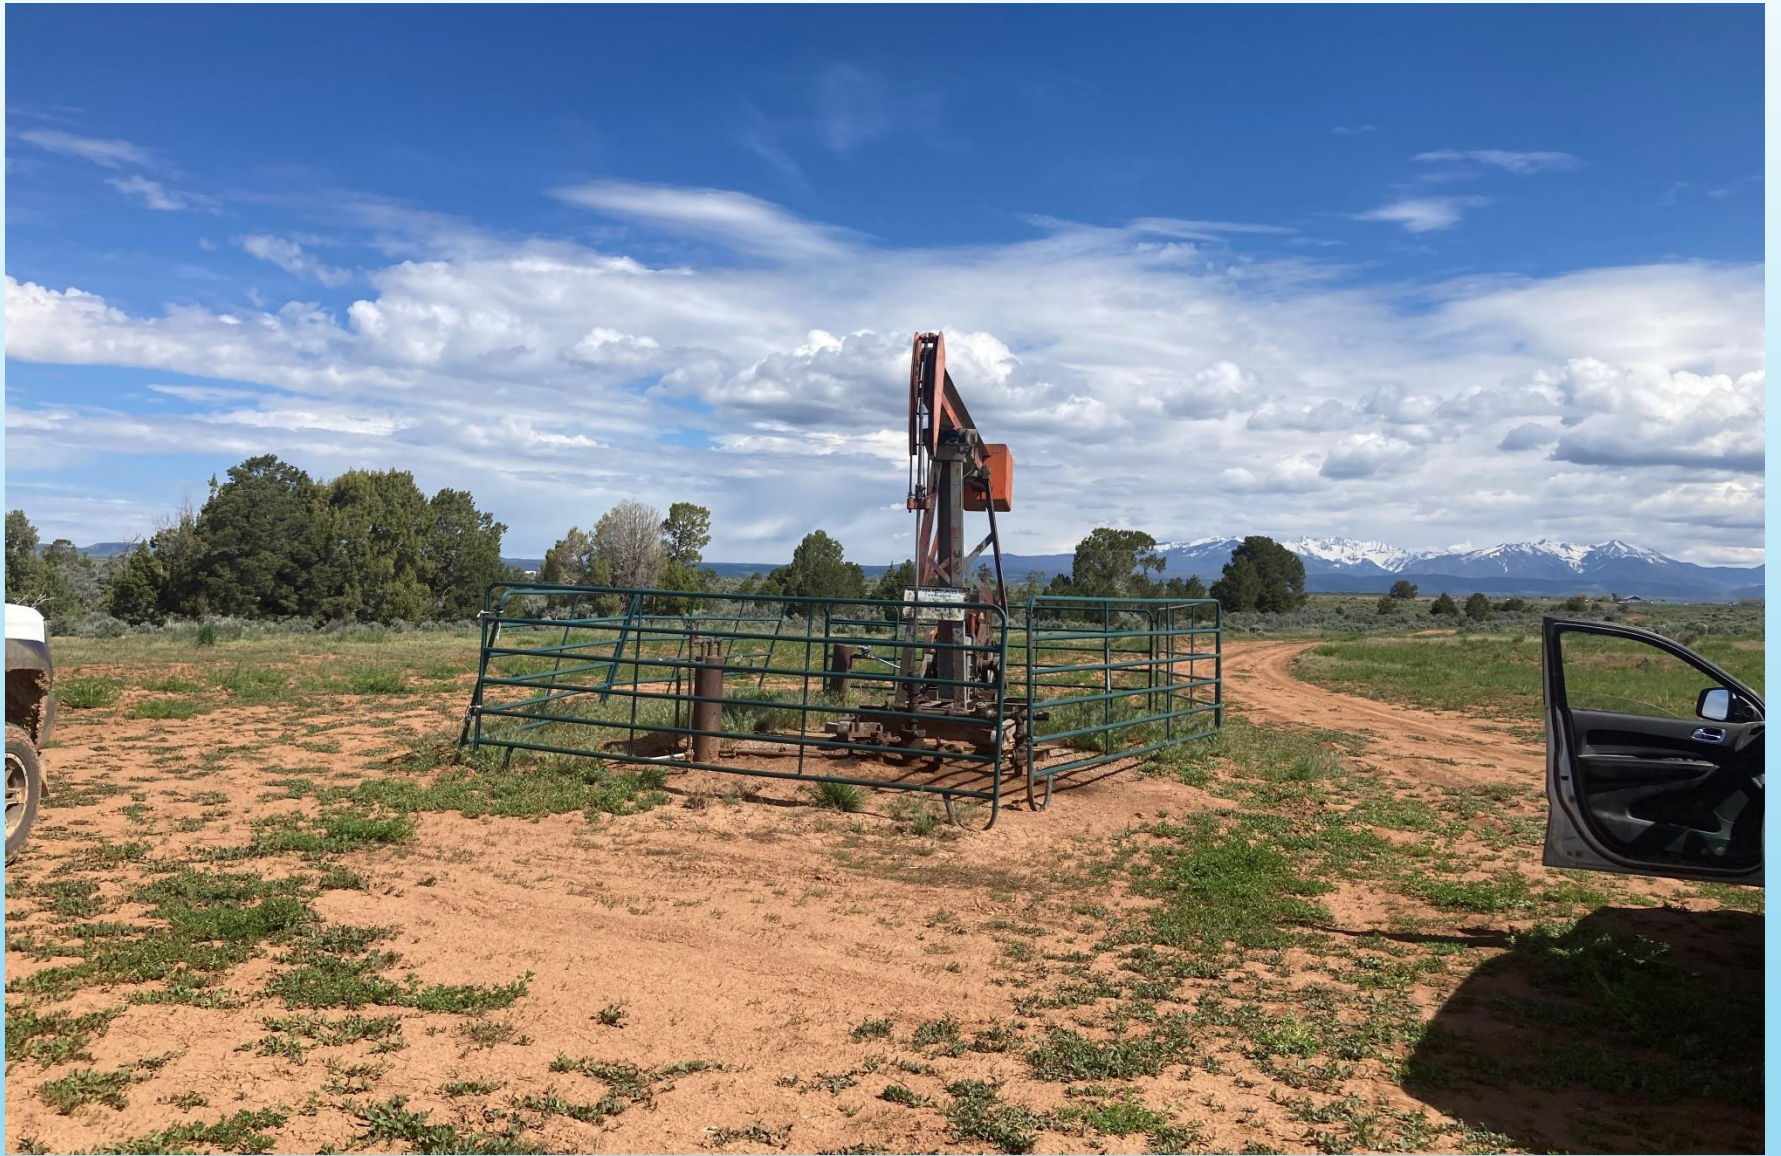
PHOTO 3: WELLHEAD AND EQUIPMENT
