Inspection Photos

Operator: CAERUS PICEANCE LLC - 10456

Location Number: 312380

Mesa County, CO

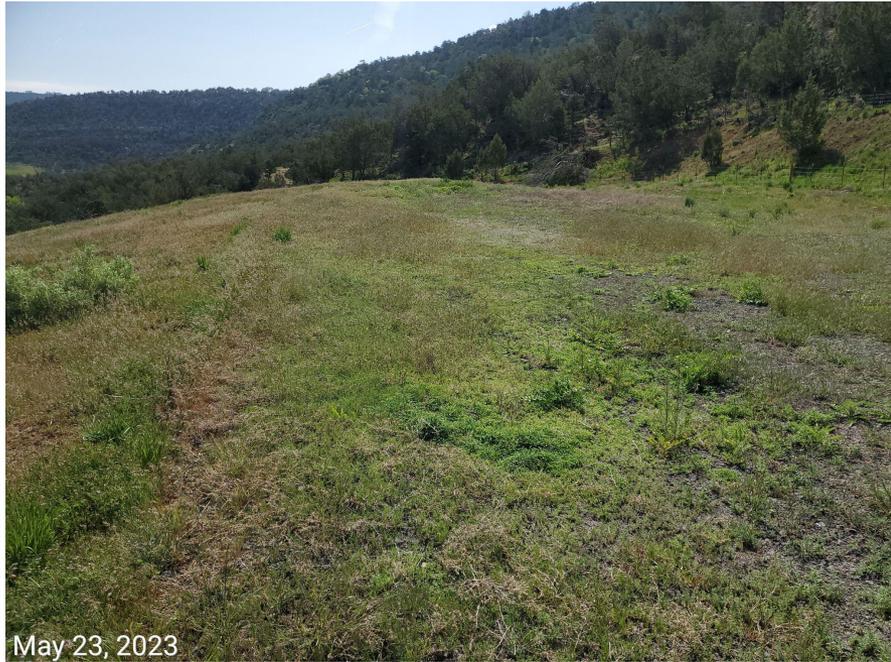
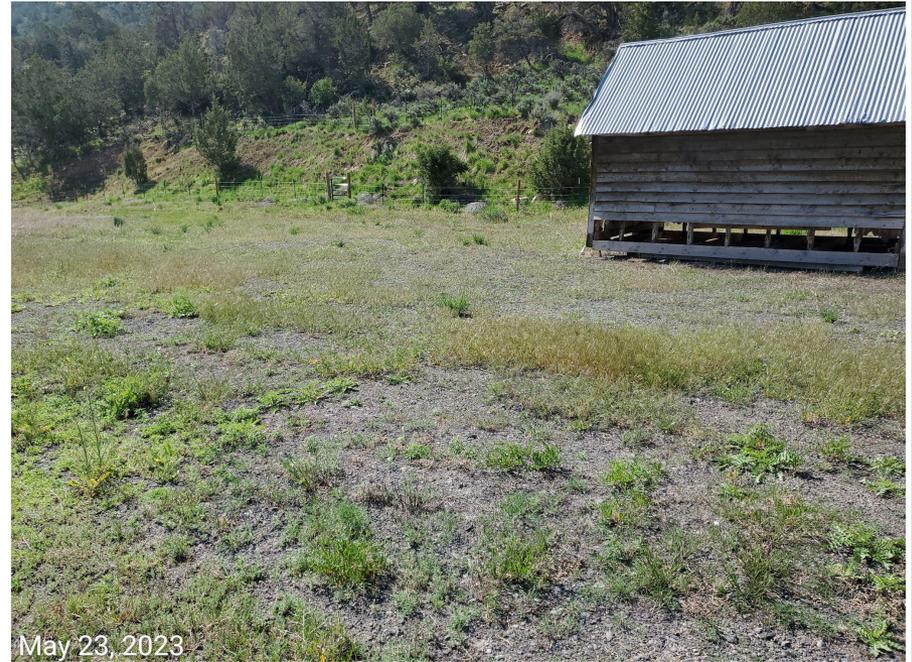
Photo 1: Photos 1-2 taken from the north end of the Location. Photos provide an overview of the Location facing east, southeast, southwest to west. Photo show Location has not been reclaimed in accordance with 1004 Rules; Location/access road have not been decompacted, re-graded and reclaimed; cut/fill slopes remain; gravel remains on Location and access road; no variance request to waive 1004 reclamation requirements have been submitted or approved. Vegetation observed within photos are Undesirable and Noxious Plant Species.

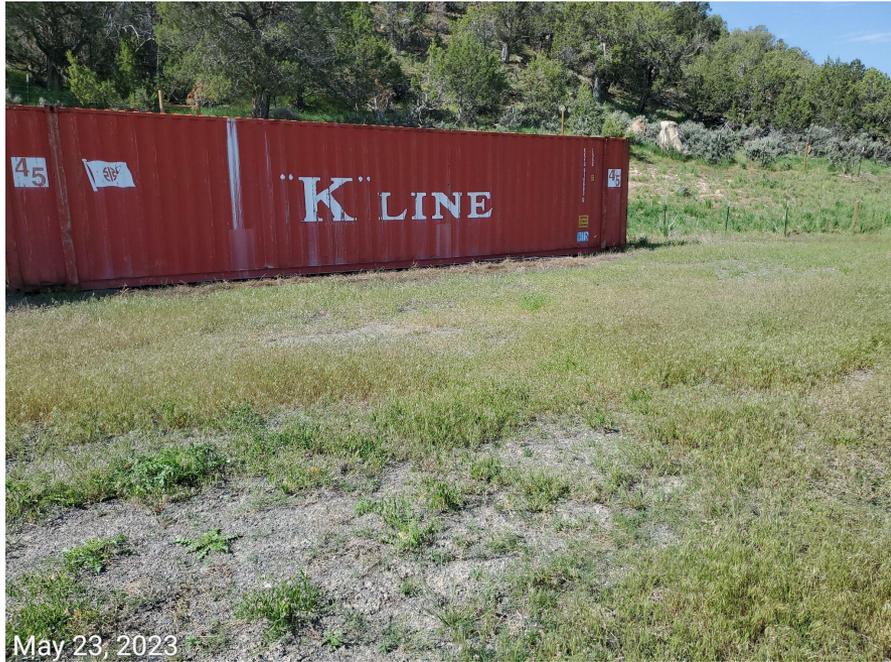
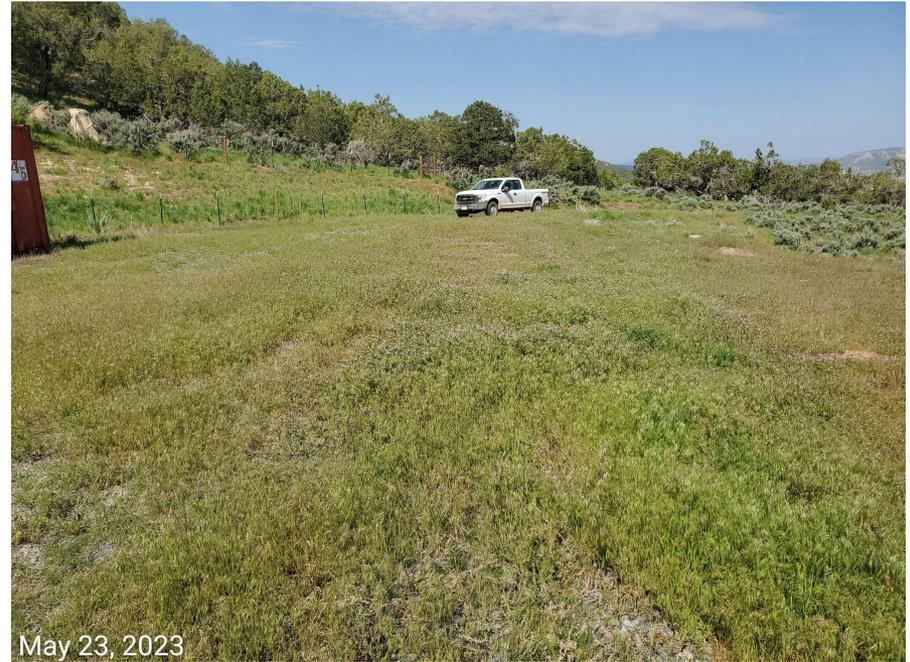
Photo 2: See comments under photo 1. Surface Owner appears to be utilizing Location for storage; No Surface Owner Variance Request pursuant to Rule 1001.c has been submitted/approved. Location will remain out of compliance with COGCC Rules until reclamation has been performed in accordance with 1004 Rules, or a variance to waive reclamation requirements has been approved.

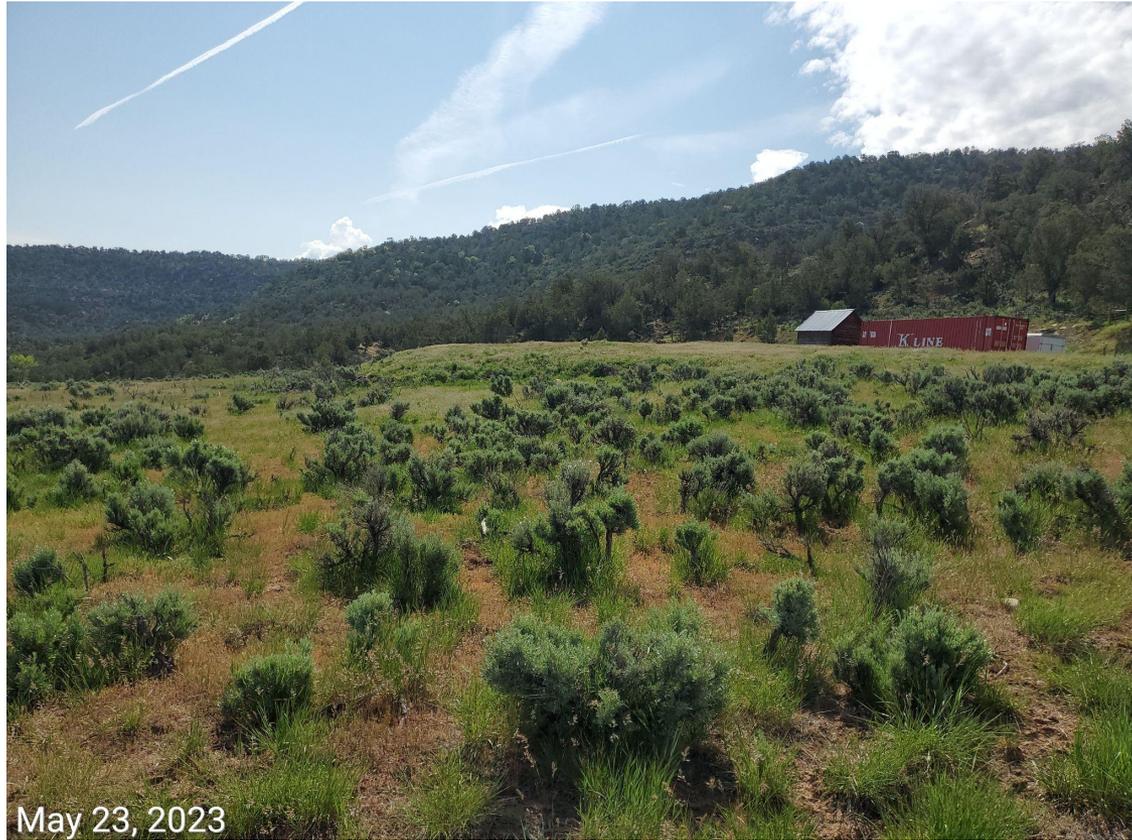
Photo 3: Photo taken from the north of the Location. Photo shows Location has not been recontoured/regradad and reclaimed

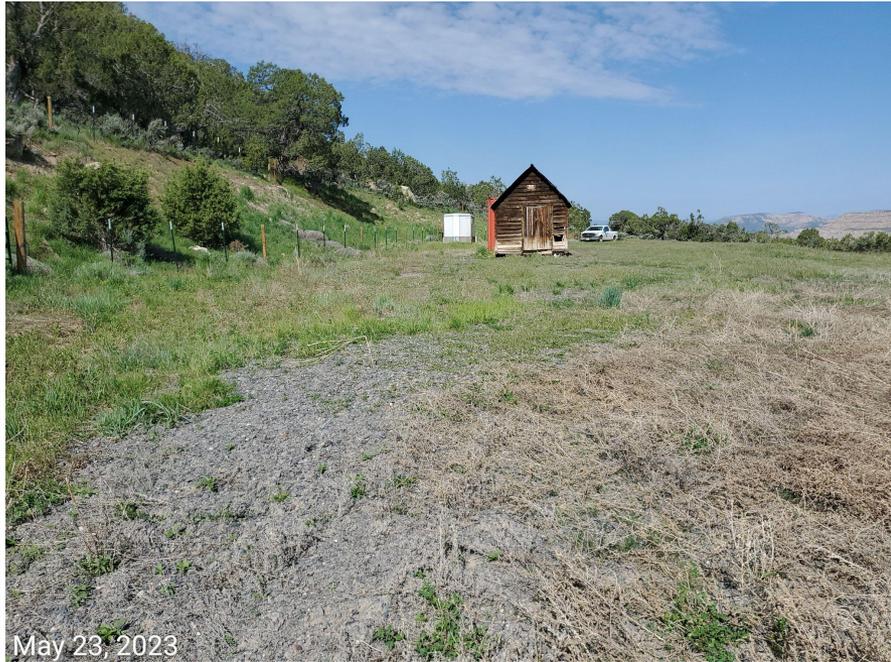
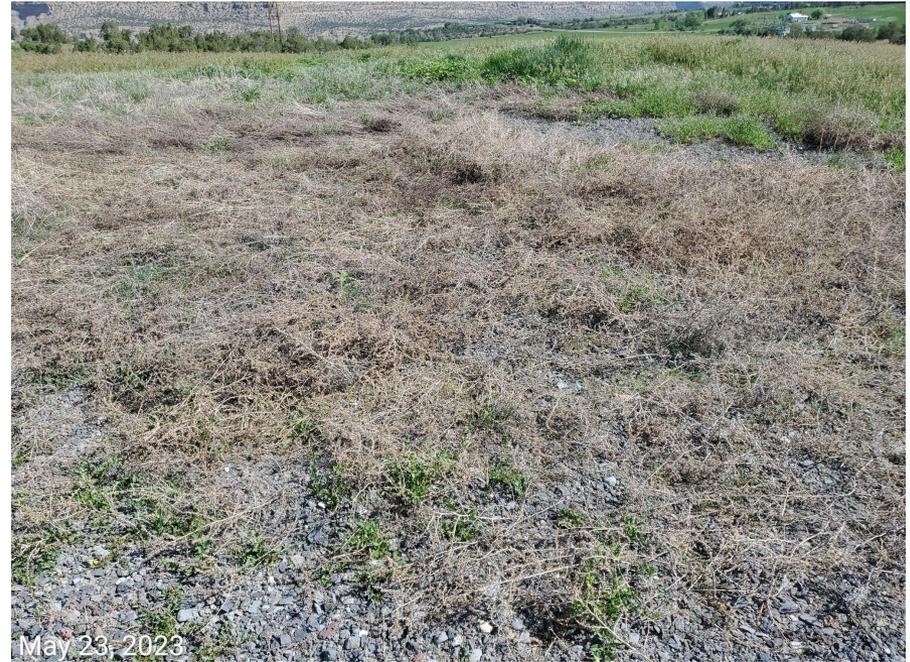
Photo 4: Photos taken from the east end of the Location, facing west. Photo example showing gravel/road base has not been removed from the Location. Photo also example showing weed debris accumulation.

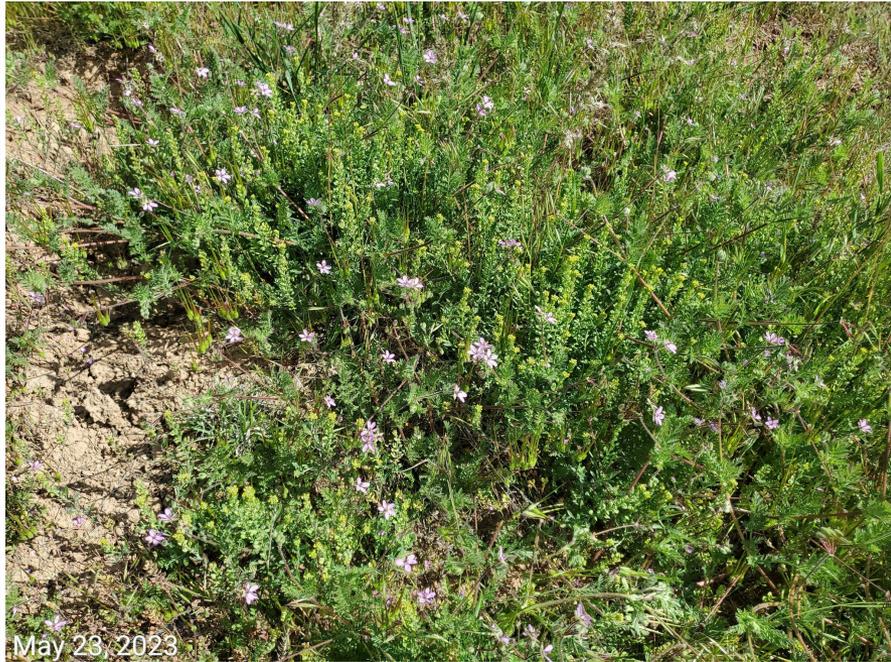
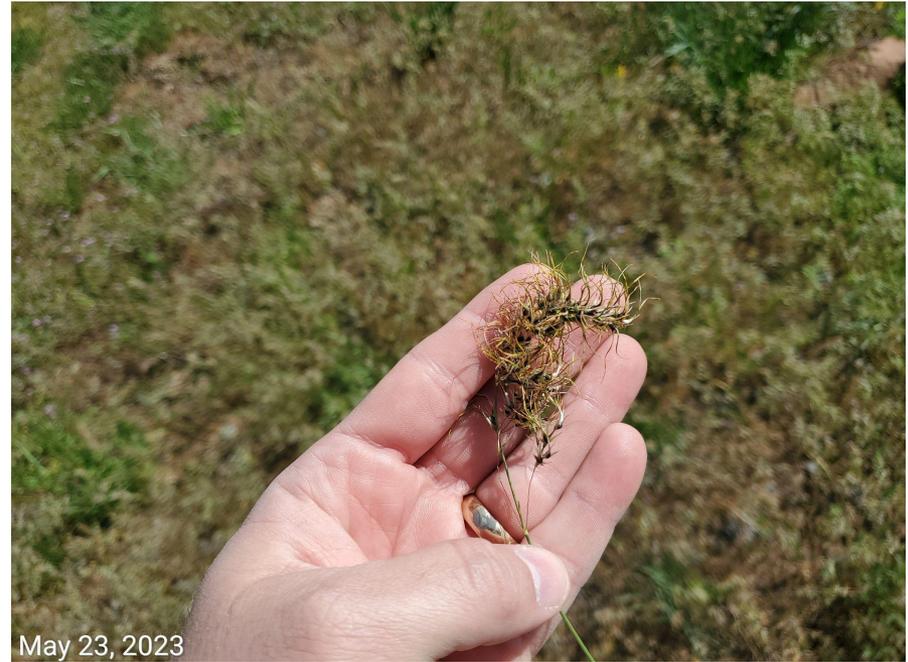
Photo 5: Photos examples of Undesirable and Noxious Plant Species observed on the Location. Species observed include Russian thistle, Kochia, Purple mustard, Cheatgrass, Redstem Filaree, Field penny-cress Bulbous Bluegrass. Ongoing weed management required until Location receives a passing Final Reclamation inspection.

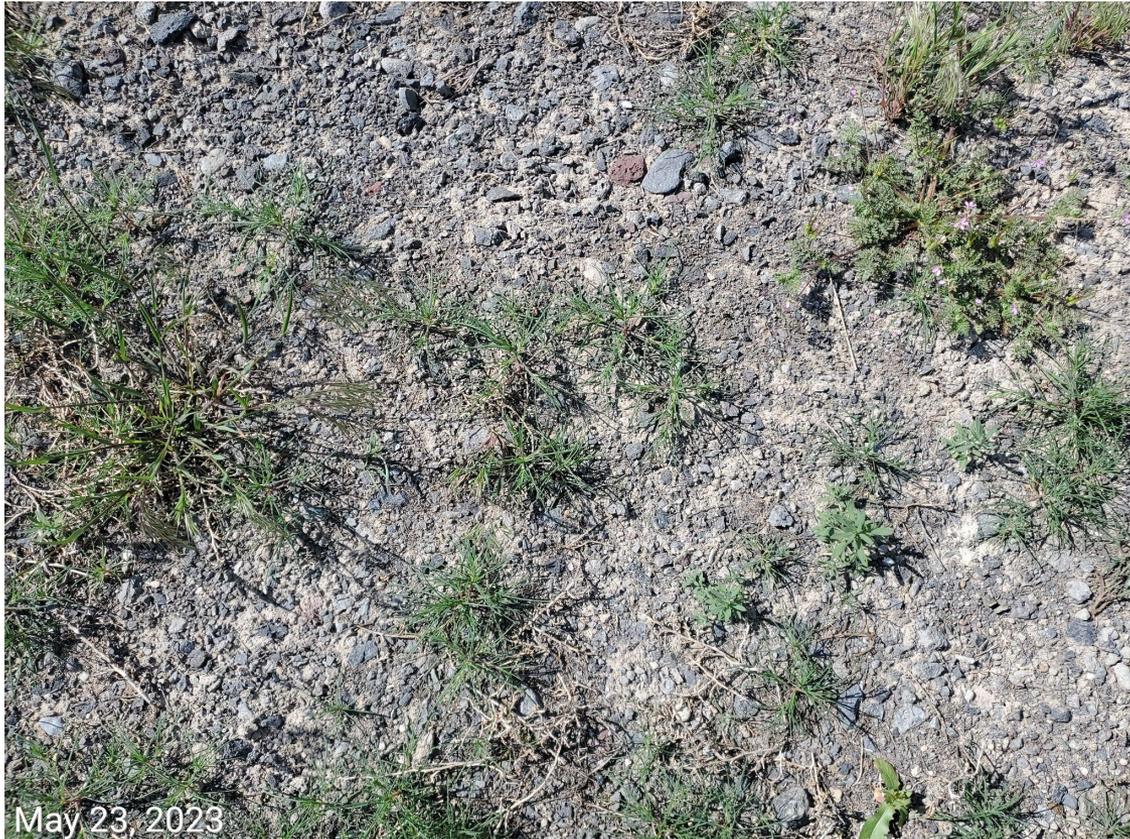
Photo 6: Photos examples of Undesirable and Noxious Plant Species observed on the Location. Species observed include Russian thistle, Kochia, Purple mustard, Cheatgrass, Redstem Filaree, Field penny-cress Bulbous Bluegrass. Ongoing weed management required until Location receives a passing Final Reclamation inspection. Photo also example showing gravel/road base material has not been removed from the Location.

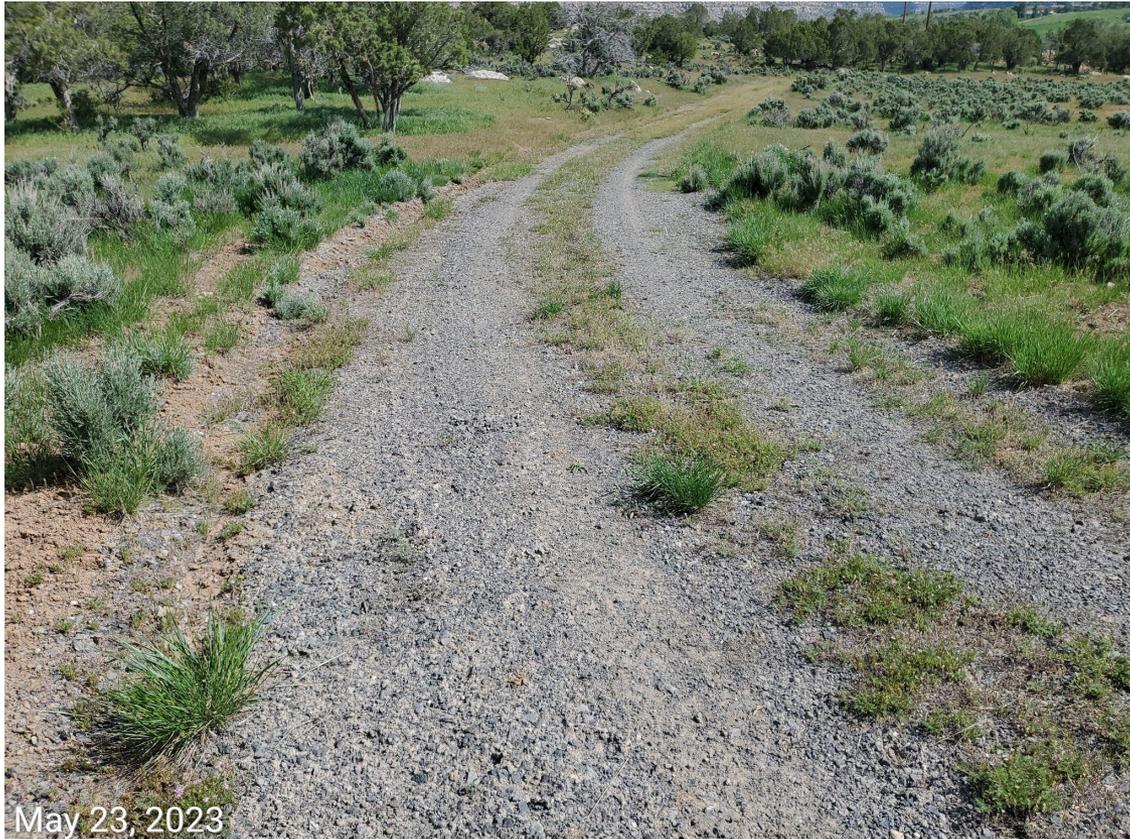
Photo 7: Photo example showing access road has not been reclaimed.
