Inspection Photos

Operator: BLACK HILLS PLATEAU

Location Number: 391225

Mesa County, CO

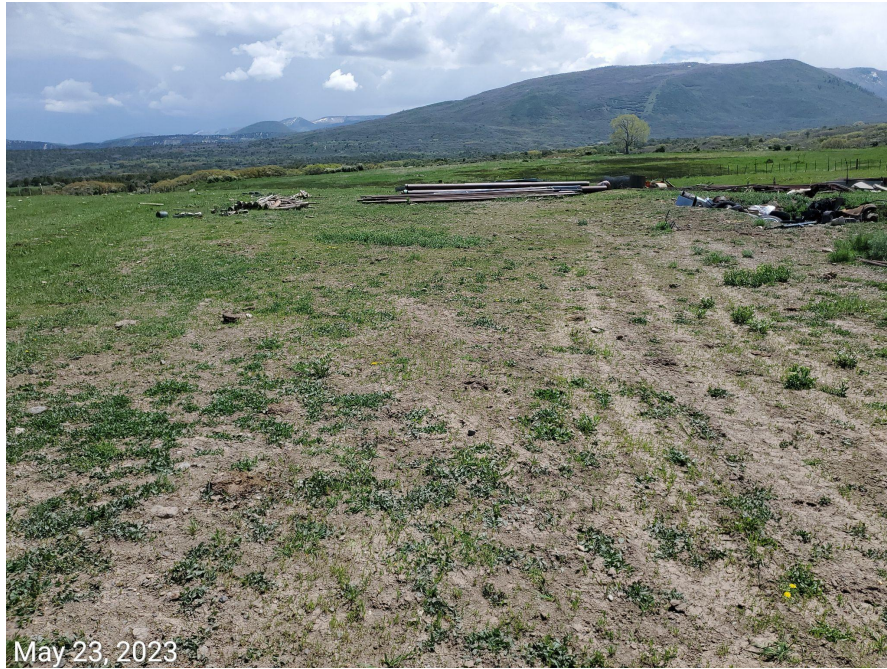
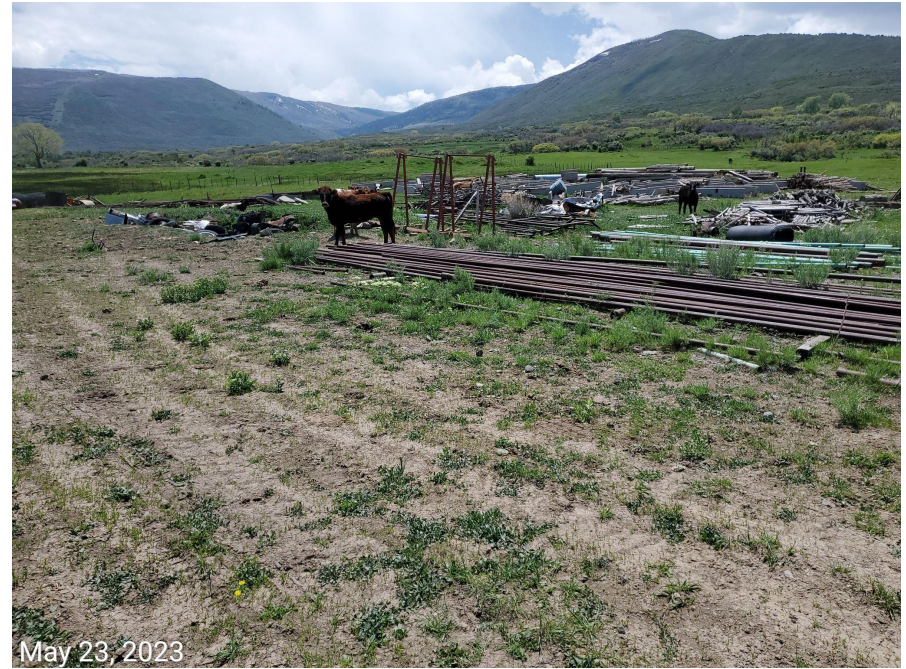
Photo 1: Photos 1-2 taken from the north end of the Location. Photos provide an overview of the Location from east, southeast, southwest to west. Photos show final reclamation of the Location, including compaction alleviation, recontouring/regrading and reclaiming, has not been performed beyond plugging the well. Surface Owner appears to be utilizing the site as a storage area. Note: Vegetation observed within photo is predominantly Undesirable and Noxious Plant species such as Whitetop.

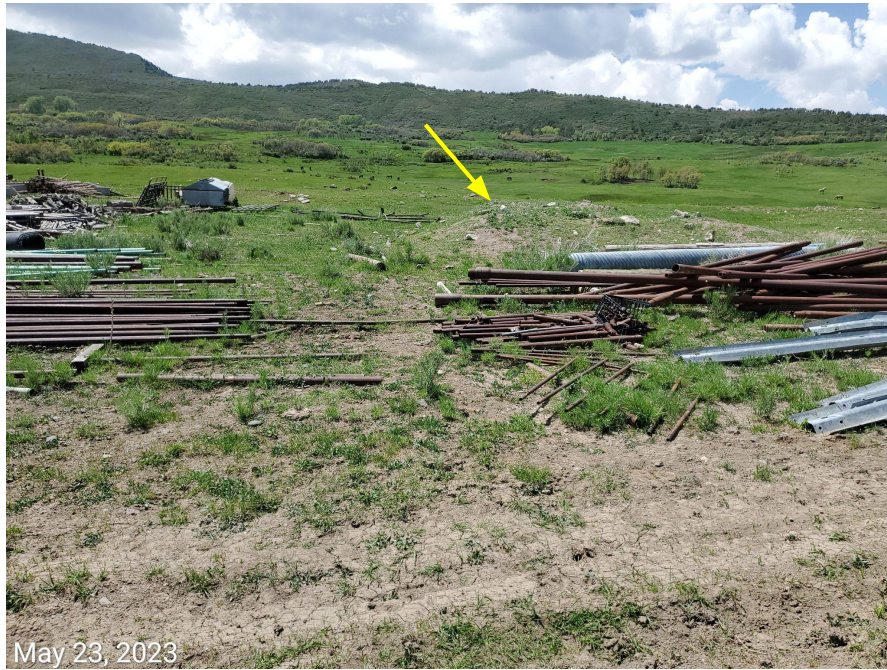
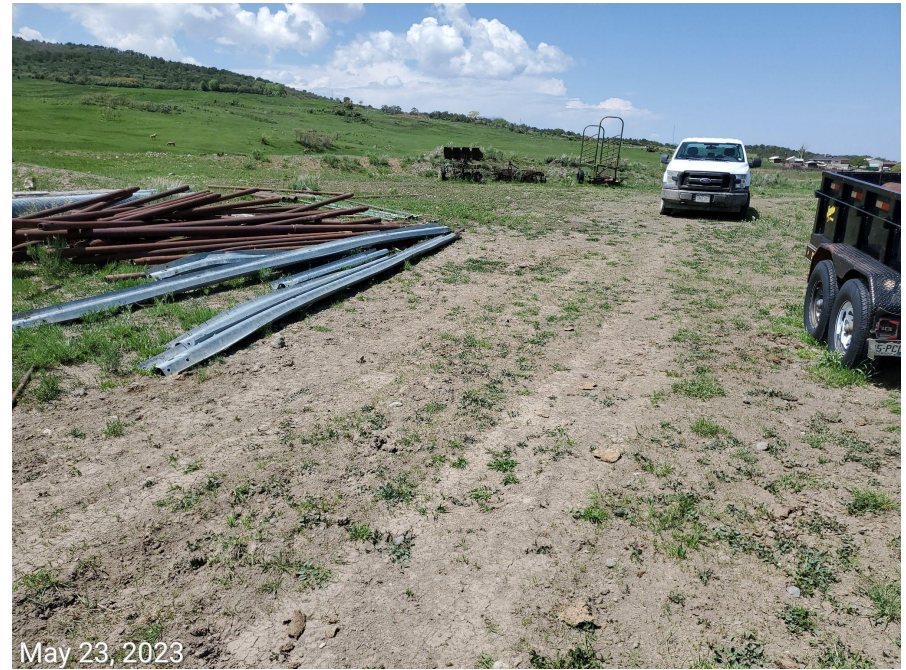
Photo 2: See comments under photo 1. Arrow also shows what appears to be a soil stockpile on the southeast end of the Location.

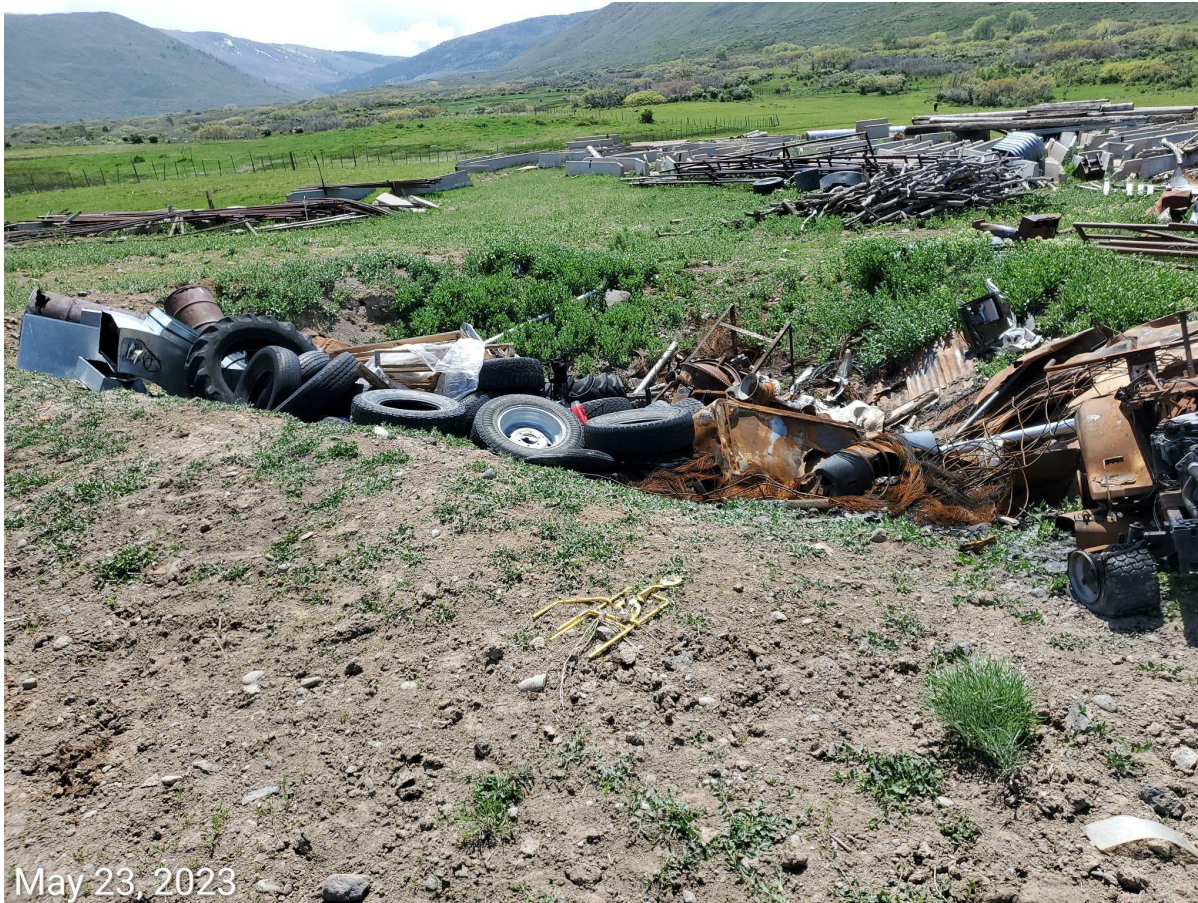
Photo 3: Photo shows what appears to be the unlined pit on the Location has not been closed.

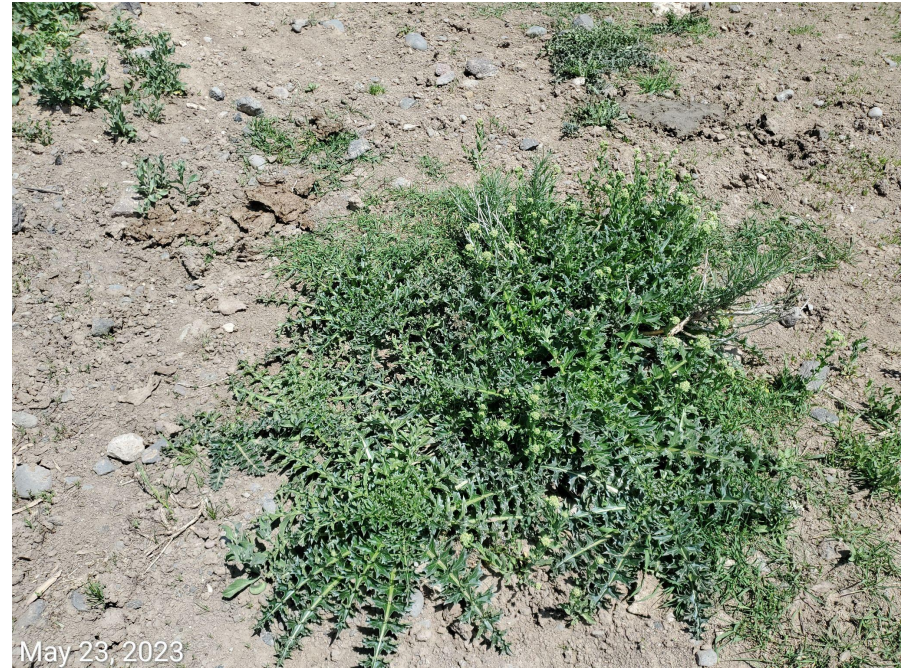
Photo 4: Photos examples showing vegetation on the Location. Vegetation observed on the Location is predominantly Undesirable and Noxious Plant species such as Whitetop. Photo right example of what appears to be Musk thistle rosettes; thistle rosettes observed throughout the Location.

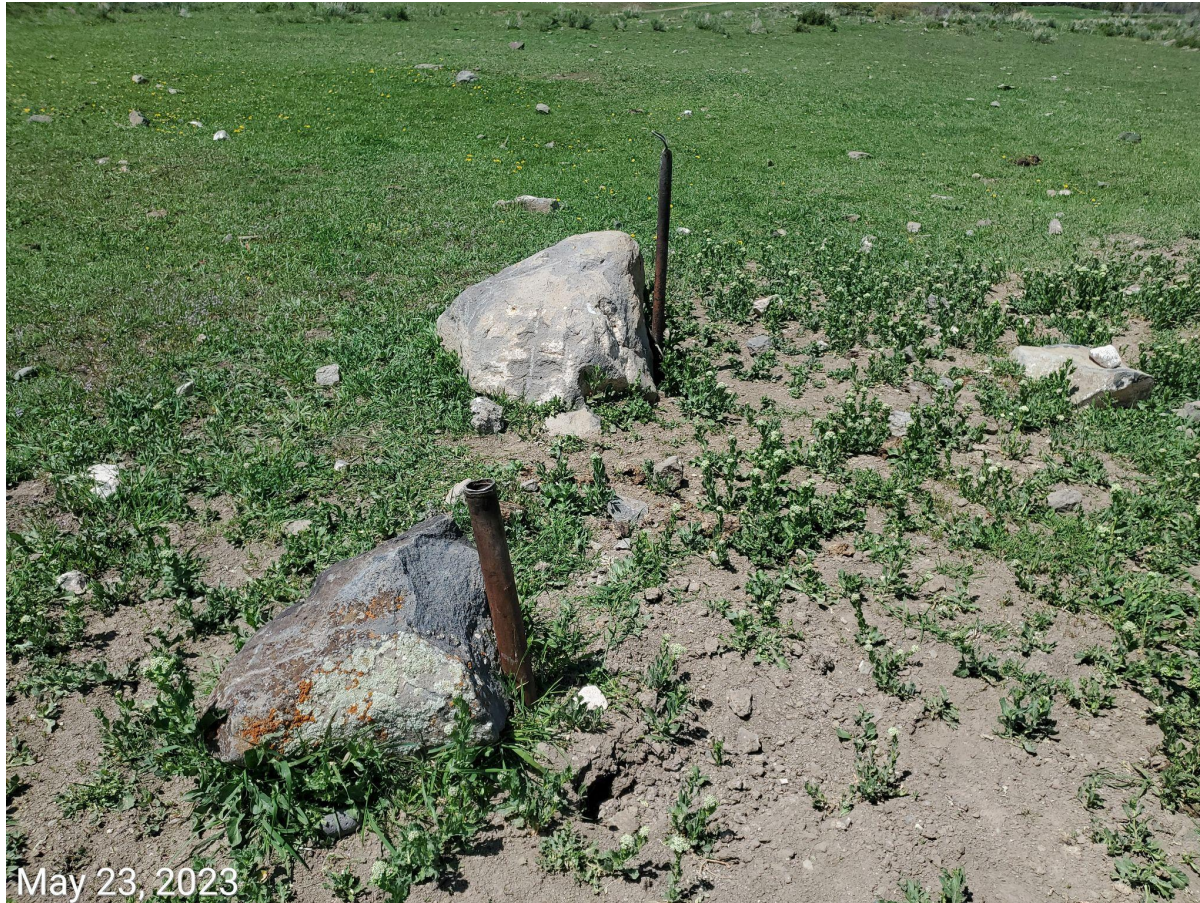
Photo 6: Photo shows what appears to be remaining pipe risers on the north end of the Location.
