# Inspection Photos

API: 043-06219

Operator: AUSCO PETROLEUM INC

Inspection Date: 5/22/2023

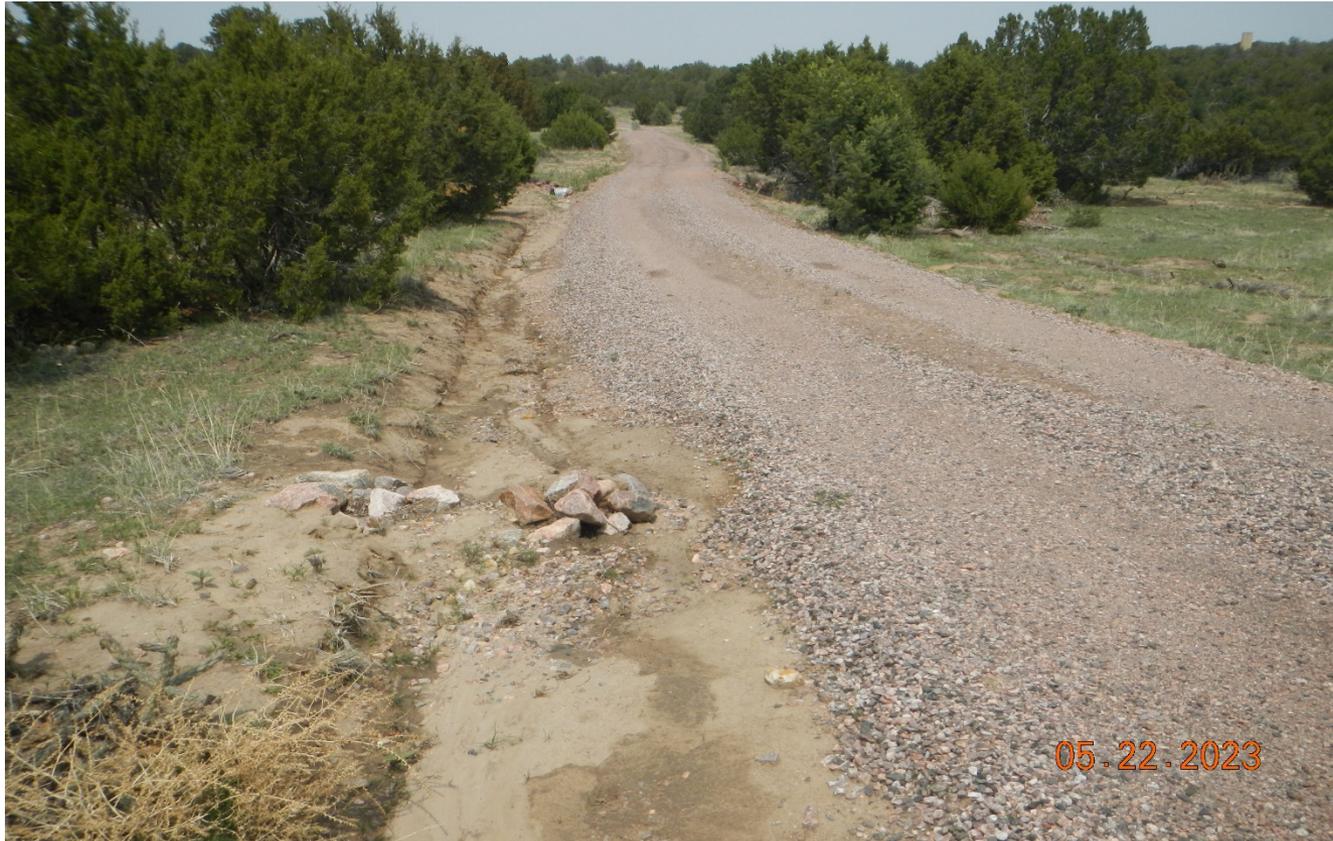
**Photo 1.** Facing northwest along the access road. There are some check dams where stormwater is going around the check dam. BMP maintenance is needed.

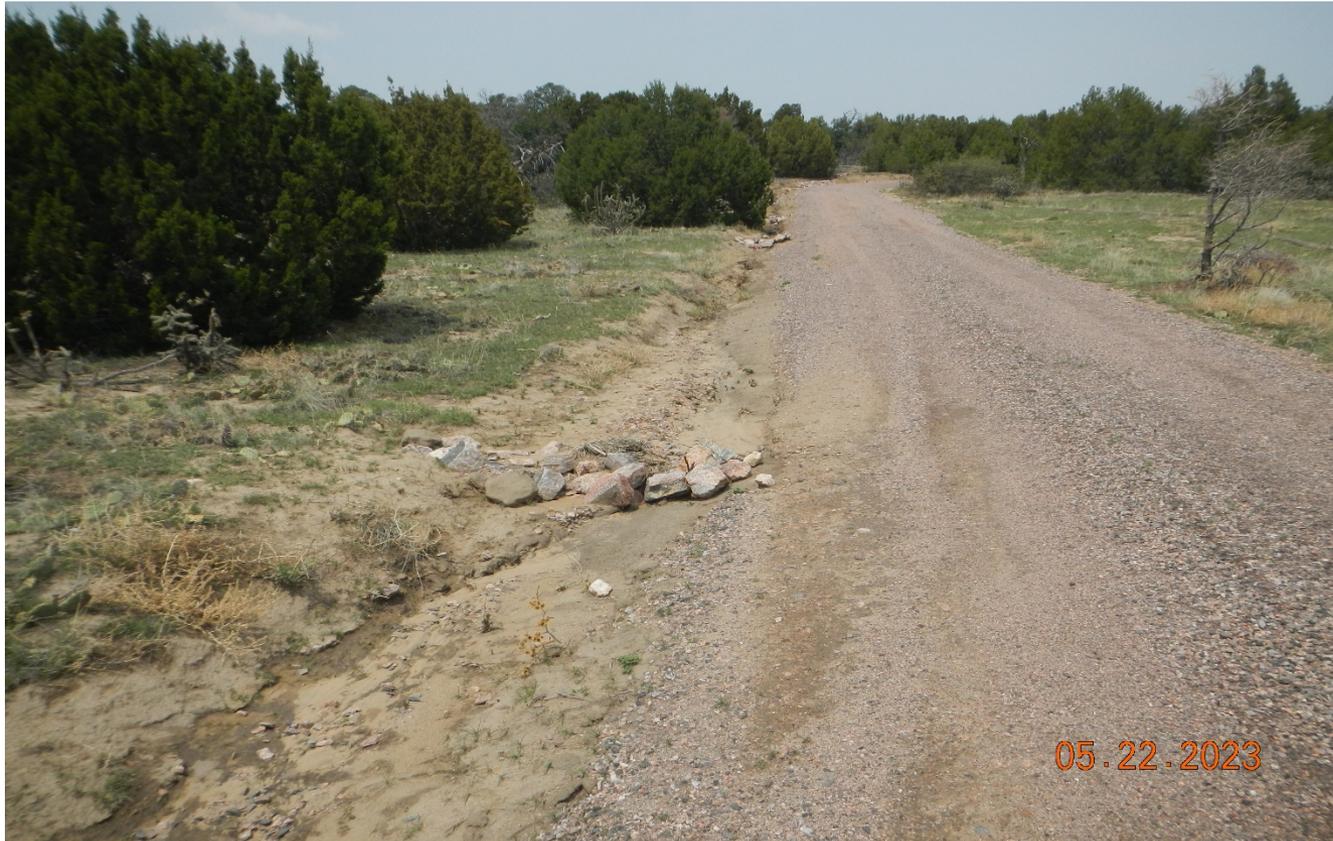
**Photo 2.** Facing northwest along the access road. There are some check dams where stormwater is going around the check dam. BMP maintenance is needed.

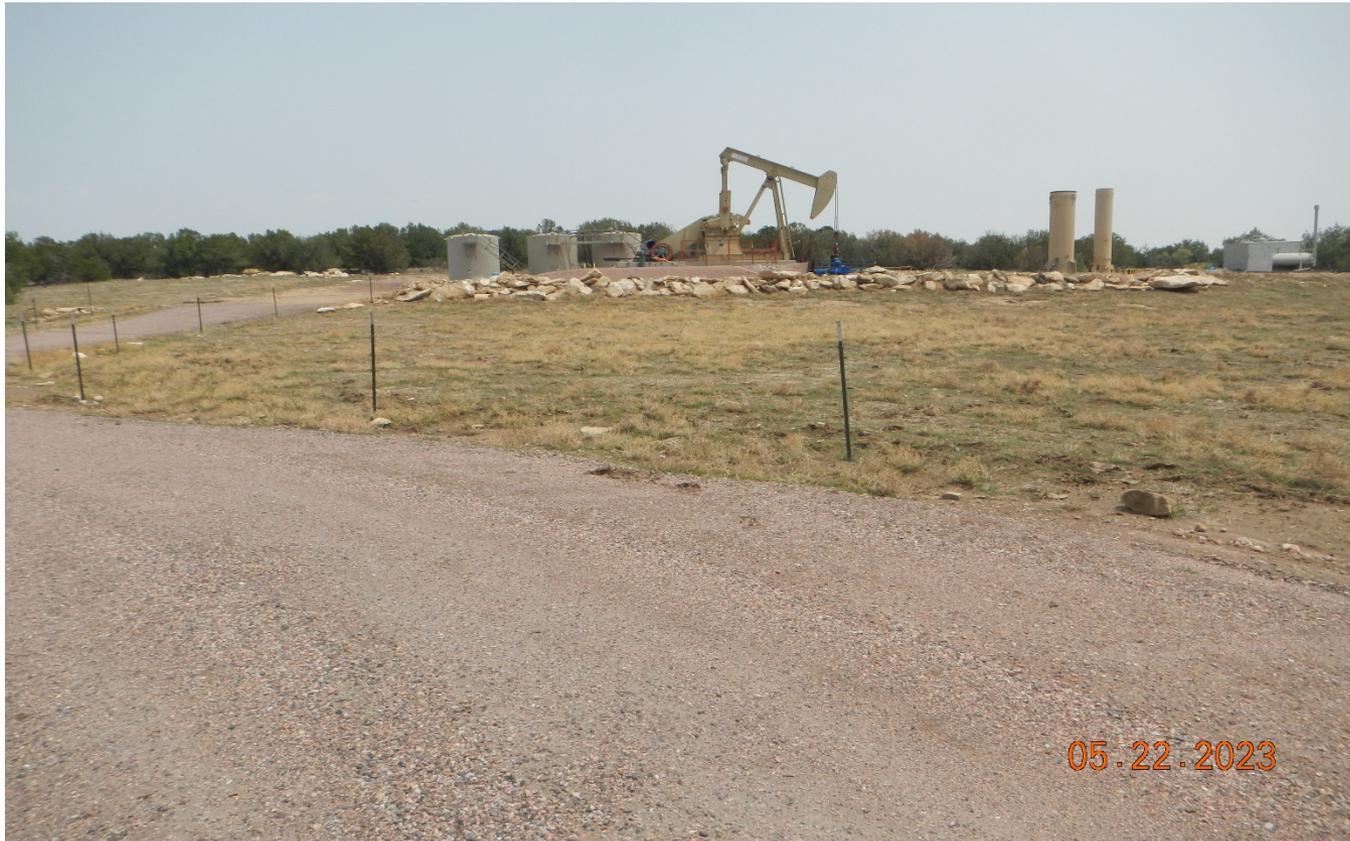
**Photo 3.** Facing north toward the location. Interim reclamation has been performed and the location is reduced in size.

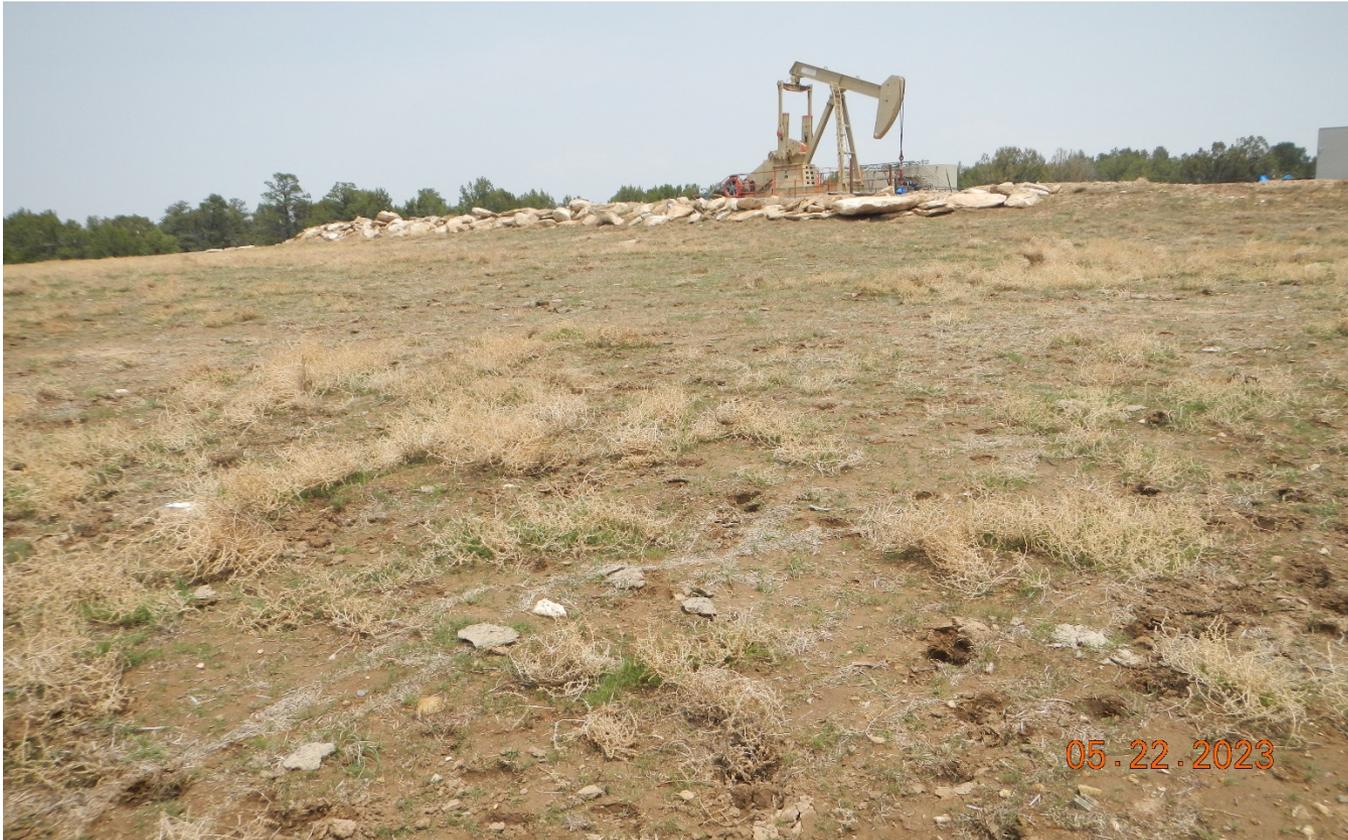
**Photo 4.** There was some desirable vegetation beginning to establish in the reclamation area but there is a lot of undesirable weeds (Russian thistle) that will need to be controlled.

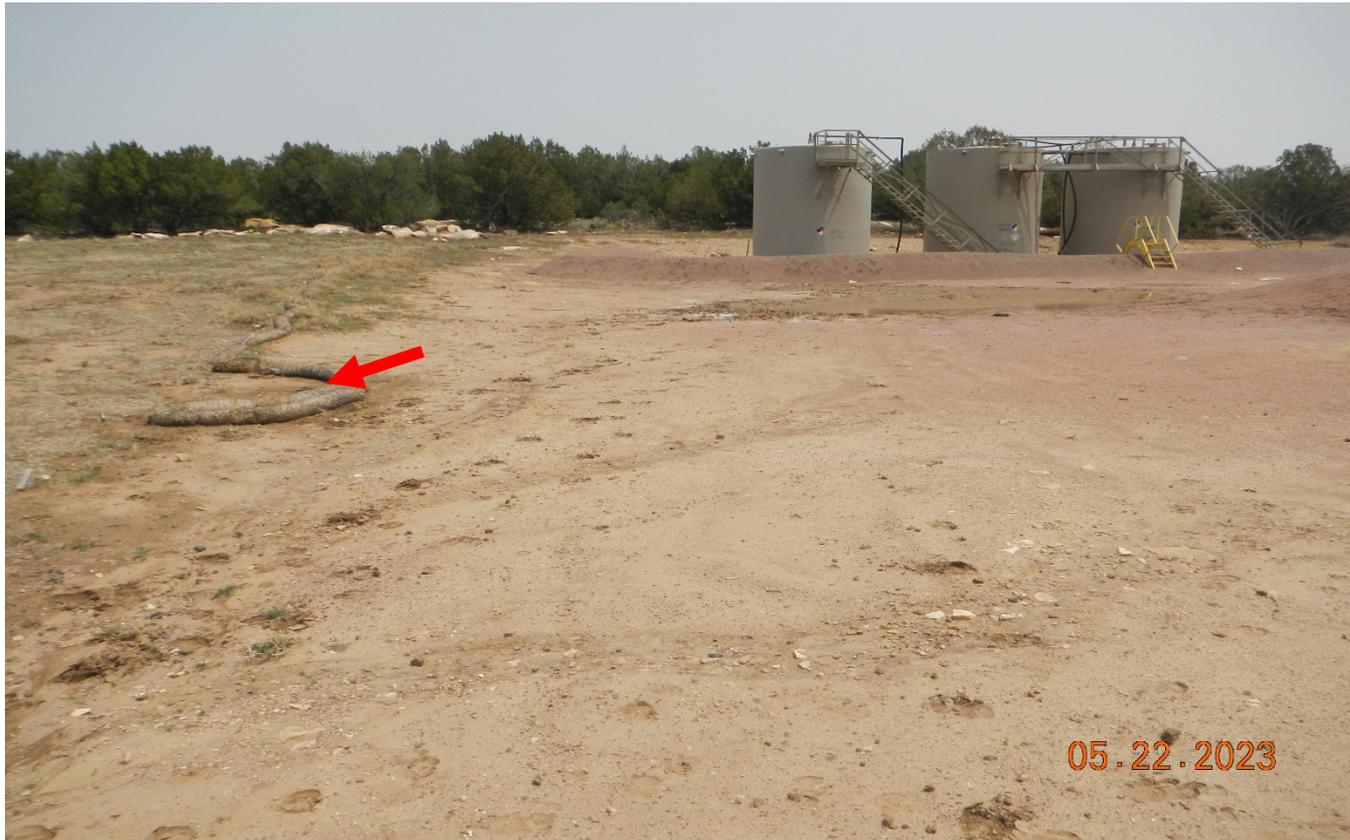
**Photo 5.** Facing north toward the location. There are displaced wattles that need to be repaired.

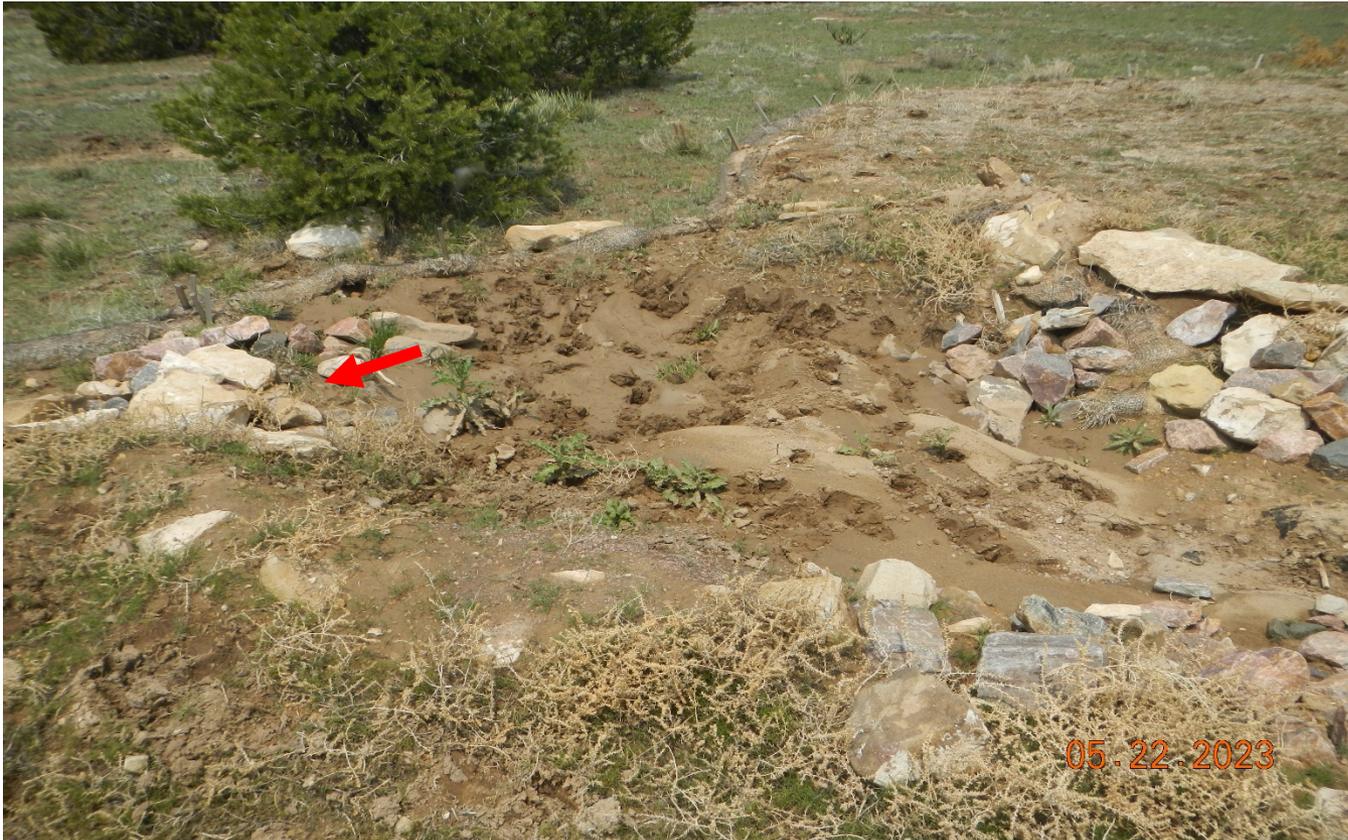
**Photo 6.** The sediment trap at the west side of the location has filled in with sediment and needs to be cleaned out. There are also noxious weeds (Canada thistle) that need to be controlled.

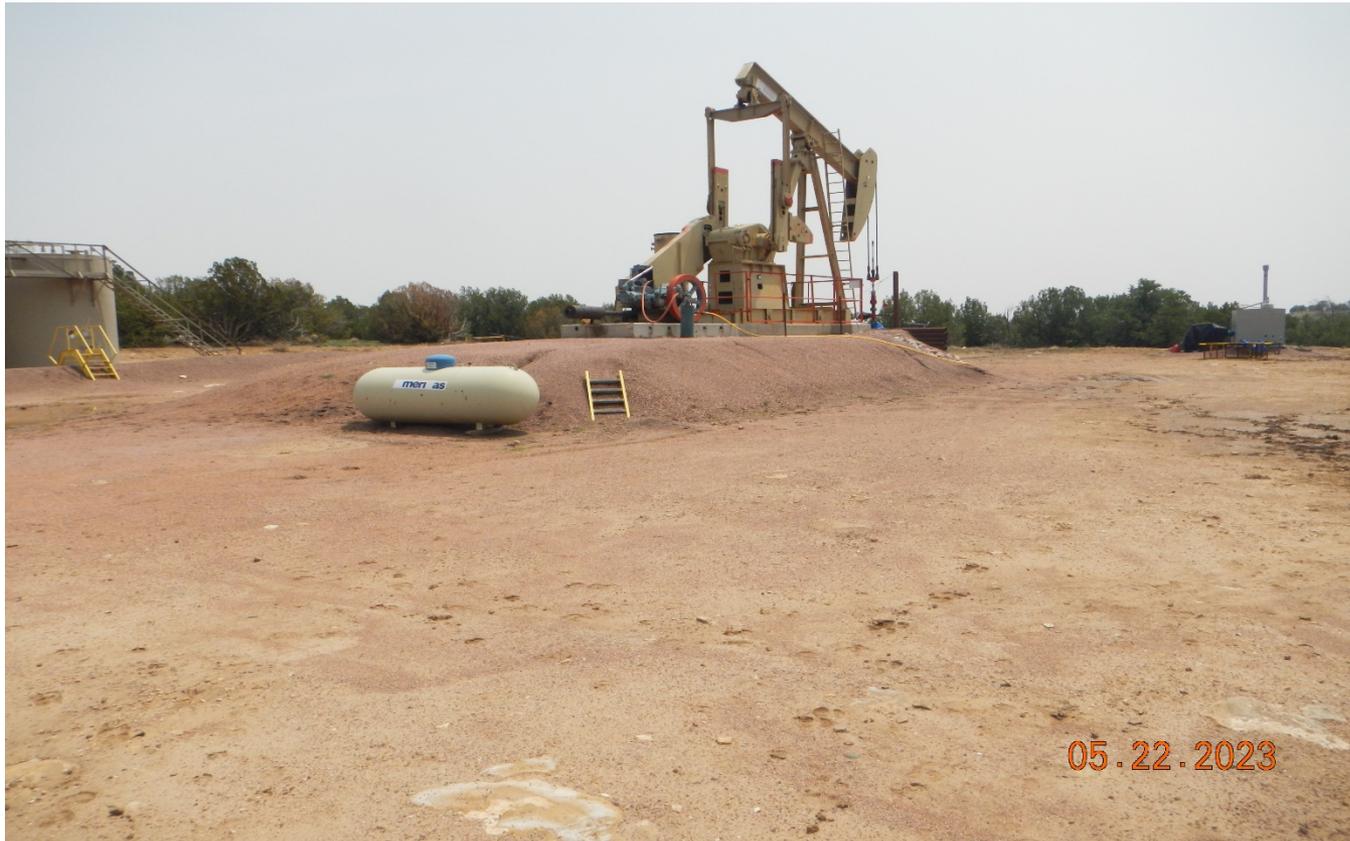
**Photo 7.** Facing northeast toward the wellsite.
